Eversley Court, Minera  
Proposed Residential Development  
Geo-environmental Report- Rev A  
Gower Homes

GroundSolve Ltd

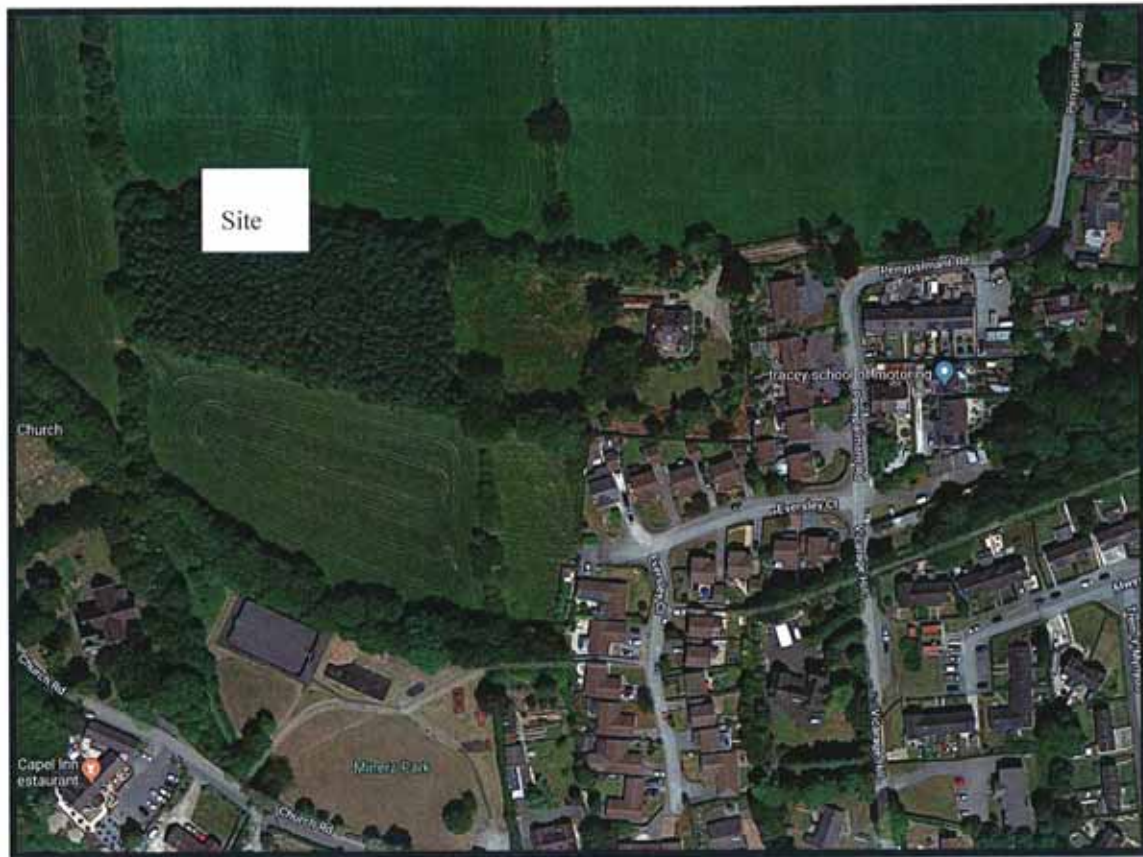
**2019 Aerial Photograph**

A recent image obtained from google maps dated 2019 shows that the site is currently open fields, with the wooded area having been cleared, with only a few trees remaining, which have been felled following the photograph, see below.

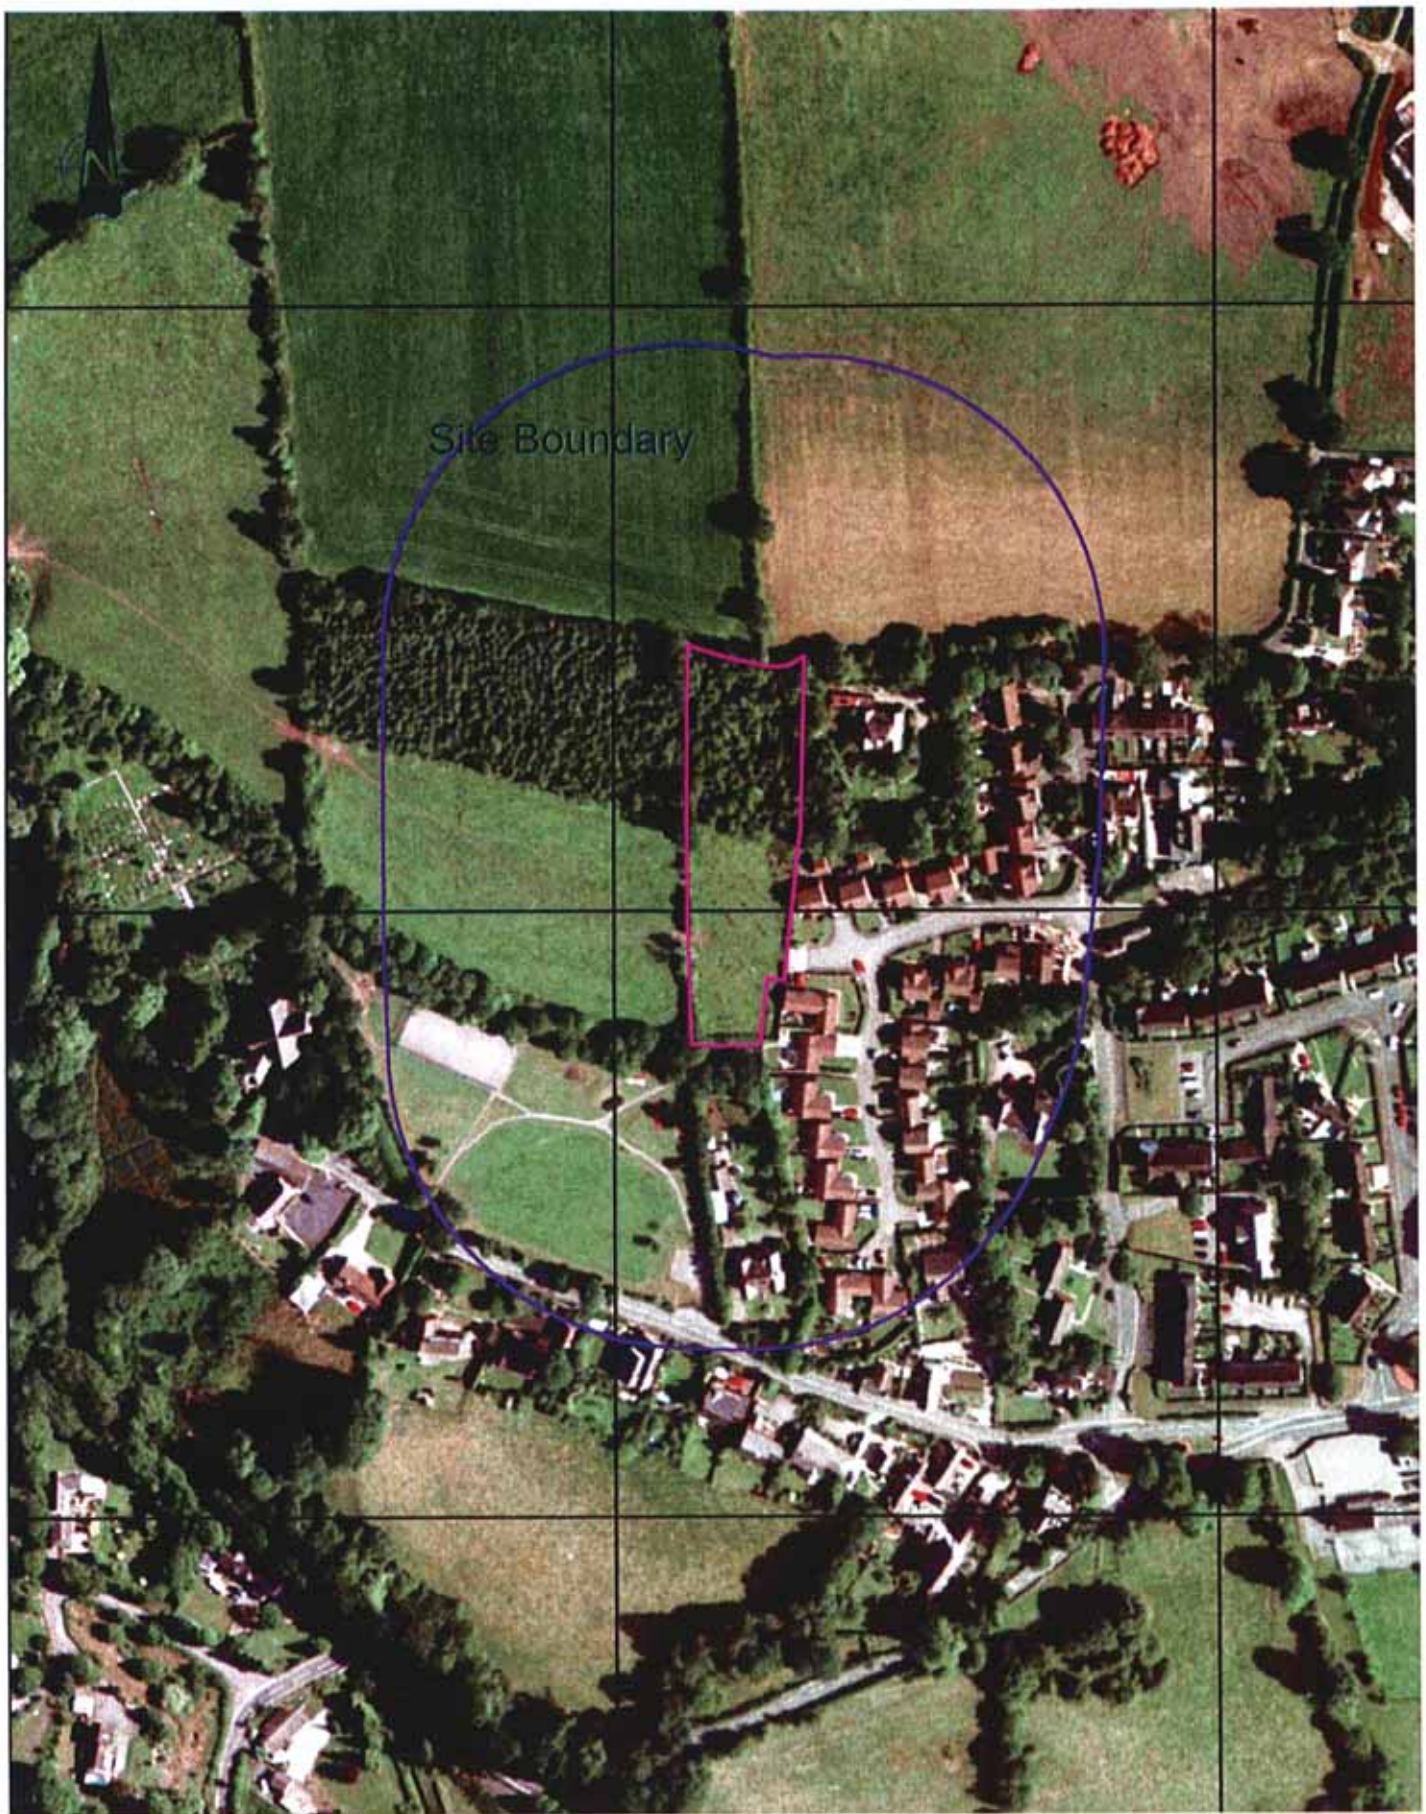
FIGURE 3j

The 2001 aerial photograph (1:2,500 scale) shows that the northern portion of the site is occupied by woodland, which had not been indicated on any previous OS maps, see Figure 3j.

SITE HISTORY  
2001

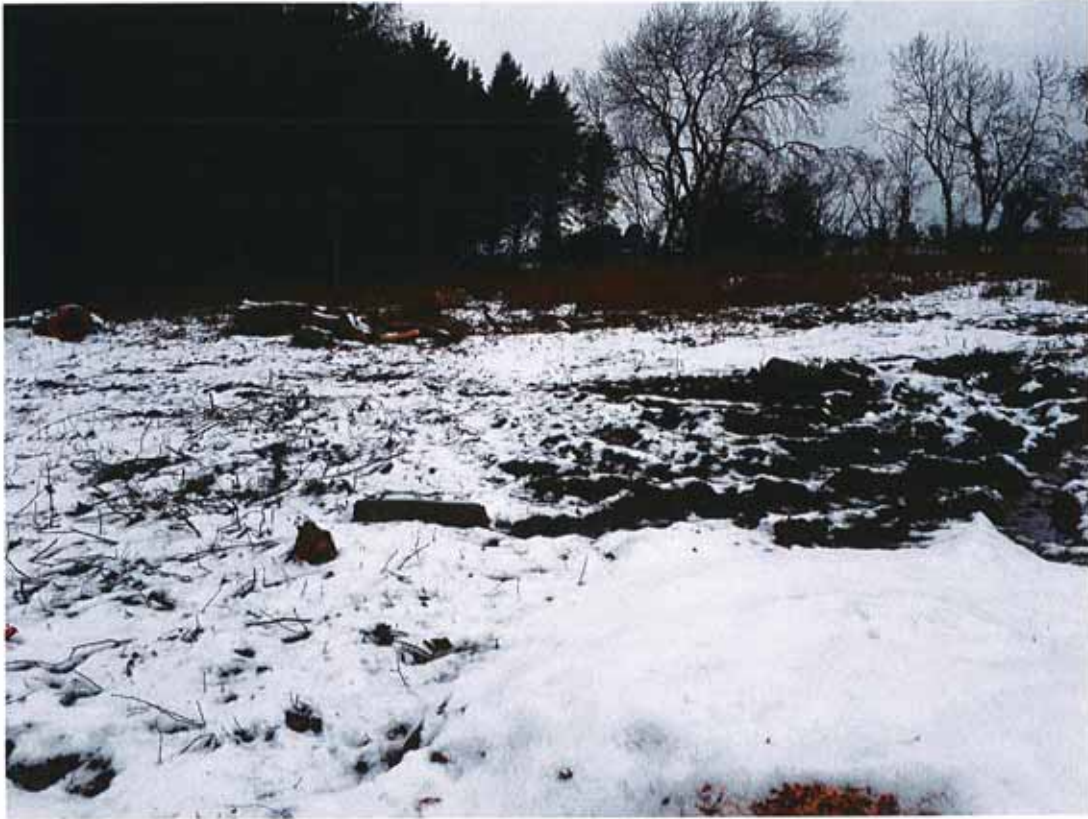
Photograph 3 – Northern part of the site following clearance works

It is likely that some existing hedgerows and trees may need to be removed as part of the development, and any roots should be grubbed out. In addition, the existing stumps observed on the northern section of the site will need to be removed along with their root systems. The resulting excavations should then be backfilled with suitable material, which should be compacted in layers in accordance with an approved earthworks specification, such as the Dtp Highways Specification, Reference 5.

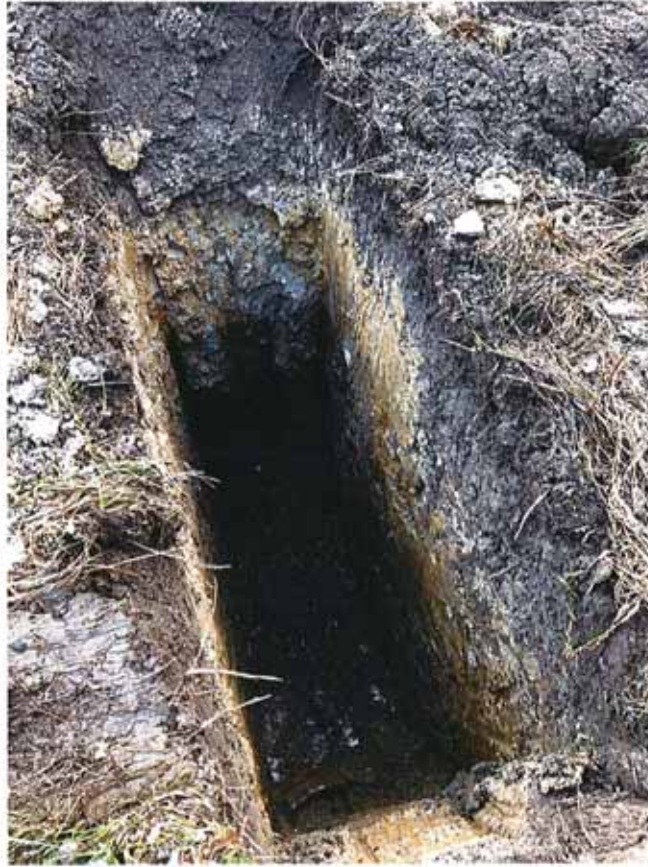
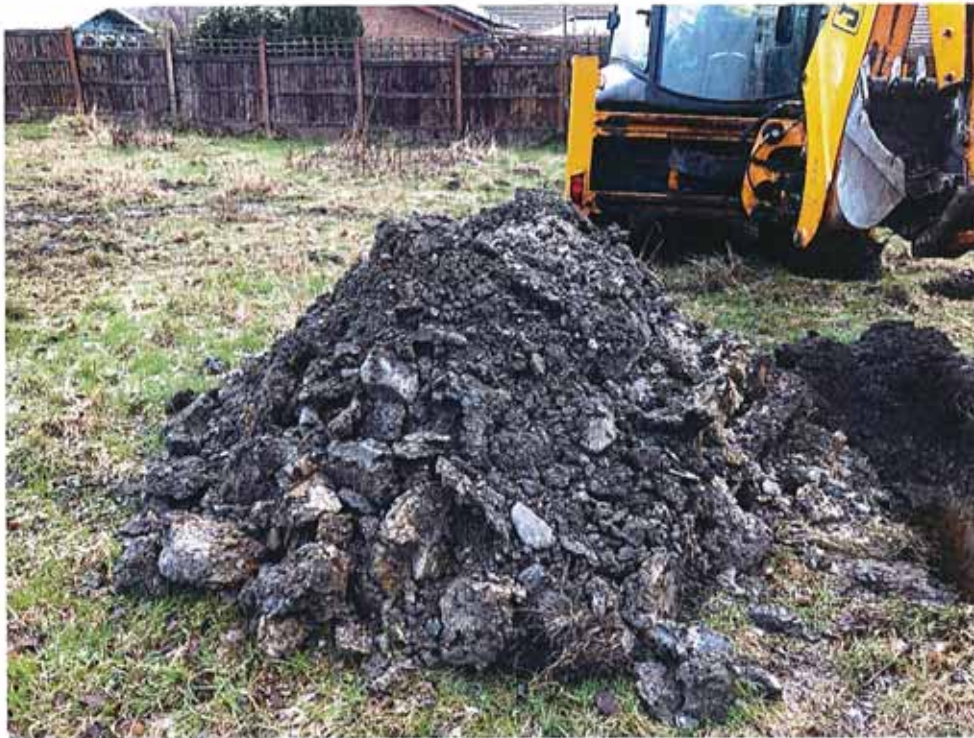
TP1

1. Trial pit terminated at 2.3m depth for soakway test.
2. Pit sides stable.
3. No groundwater encountered.
4. Jar samples taken at 0.1m and 0.8m depth, tub sample taken at 0.9m depth.

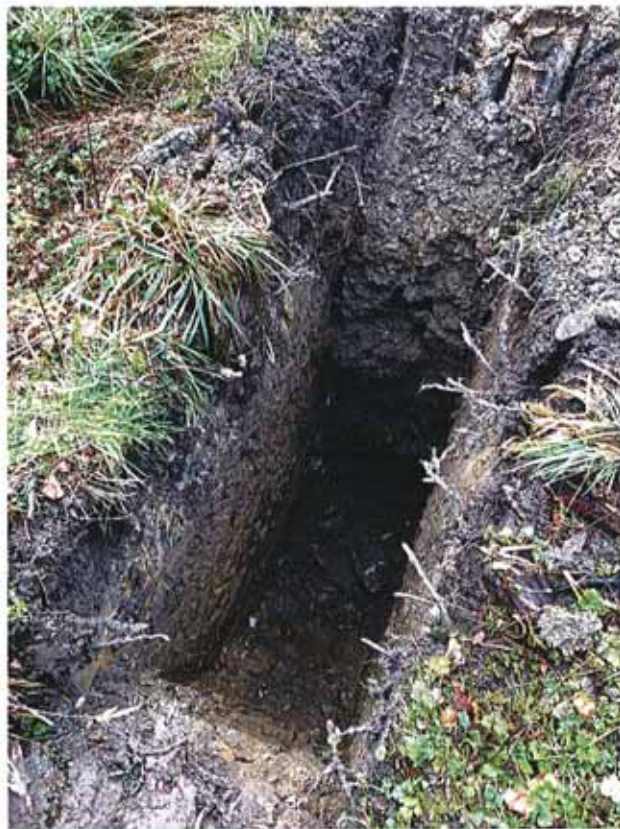
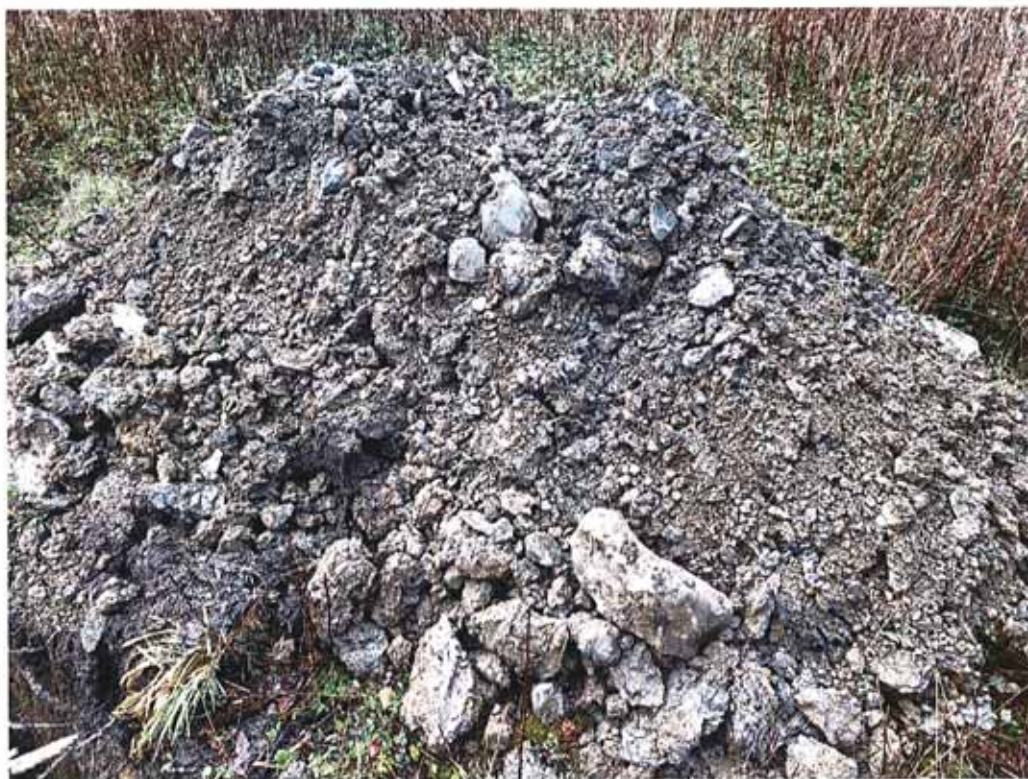
TP2

1. Trial pit terminated at 2.3m depth for soakway test.
2. Pit sides stable.
3. No groundwater encountered.
4. Jar samples taken at 0.1m and 0.4m depth, tub sample taken at 1.0m depth.

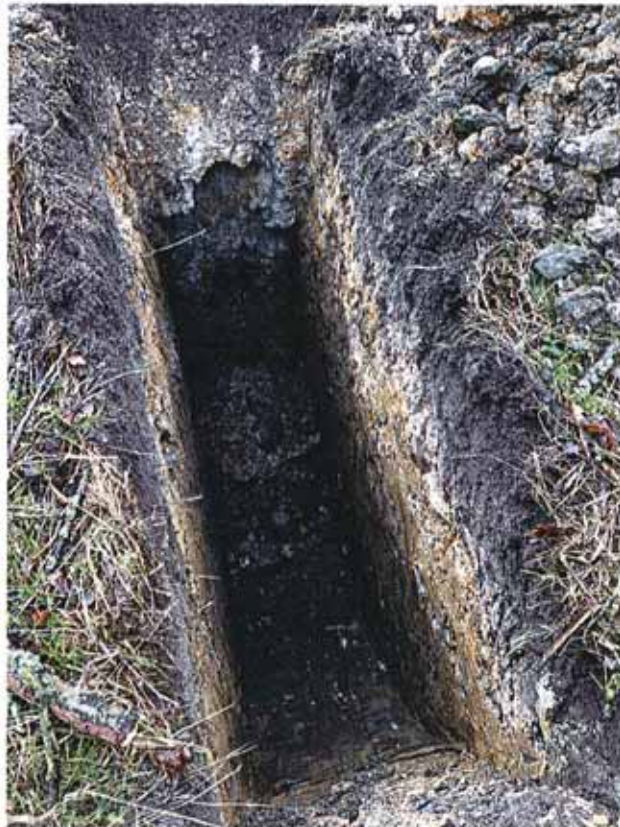
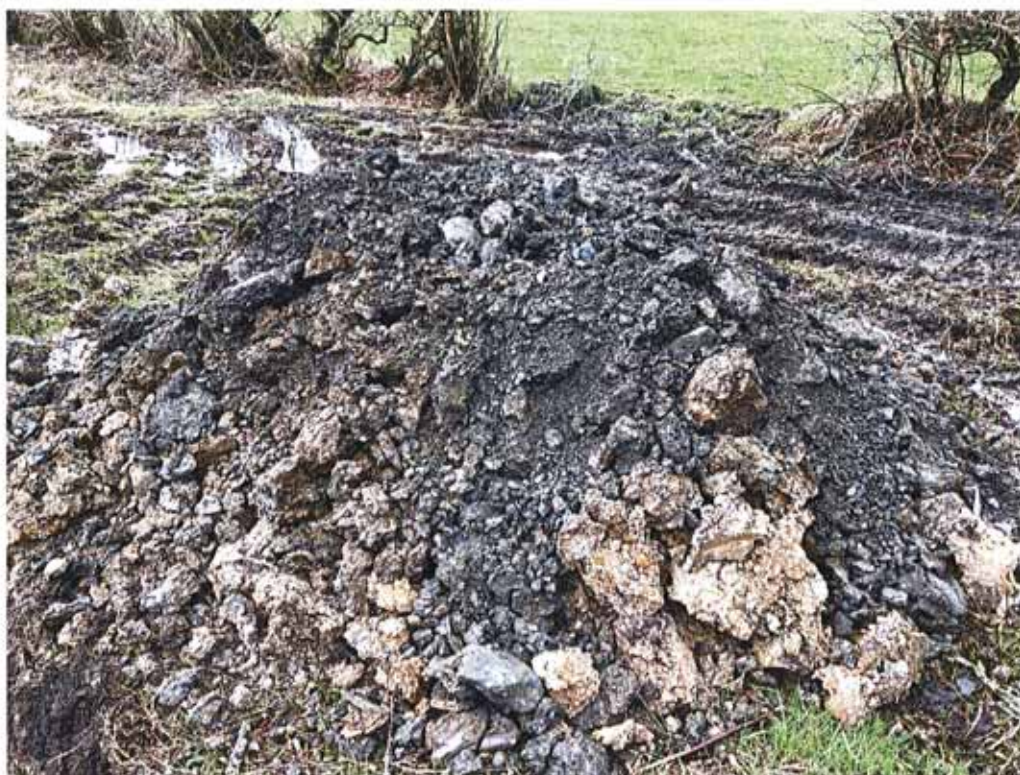
TP4

1. Trial pit terminated at 2.2m depth due to difficult excavation.
2. Pit sides stable.
3. No groundwater encountered.
4. Tub sample taken at 1.1m depth.

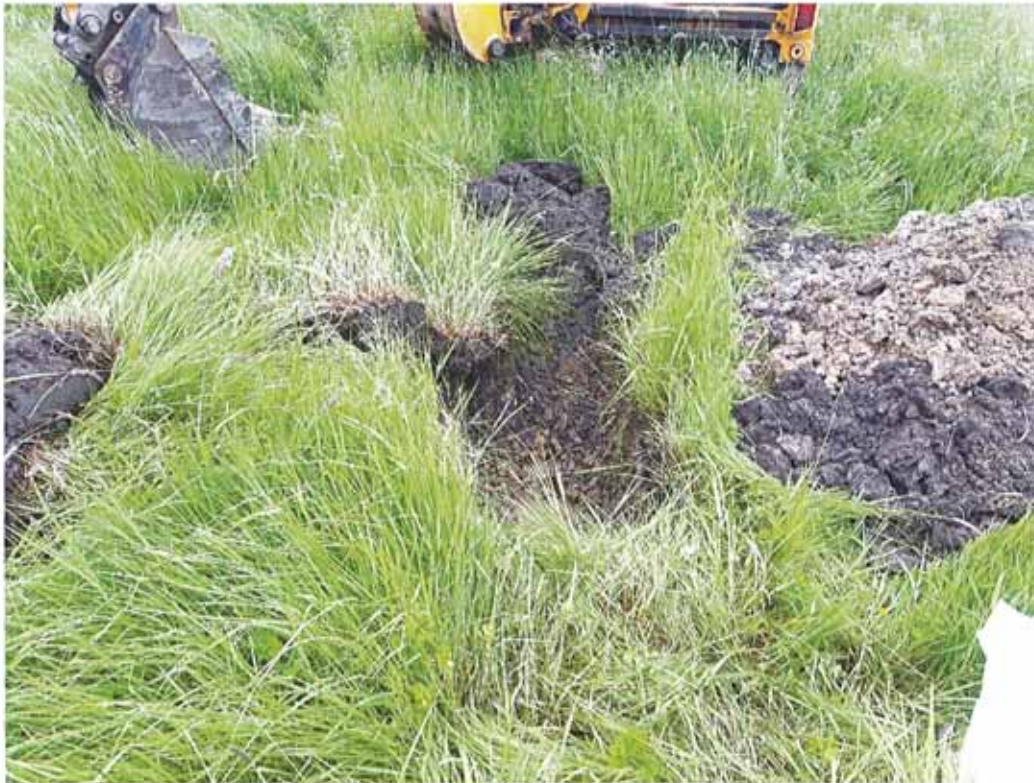
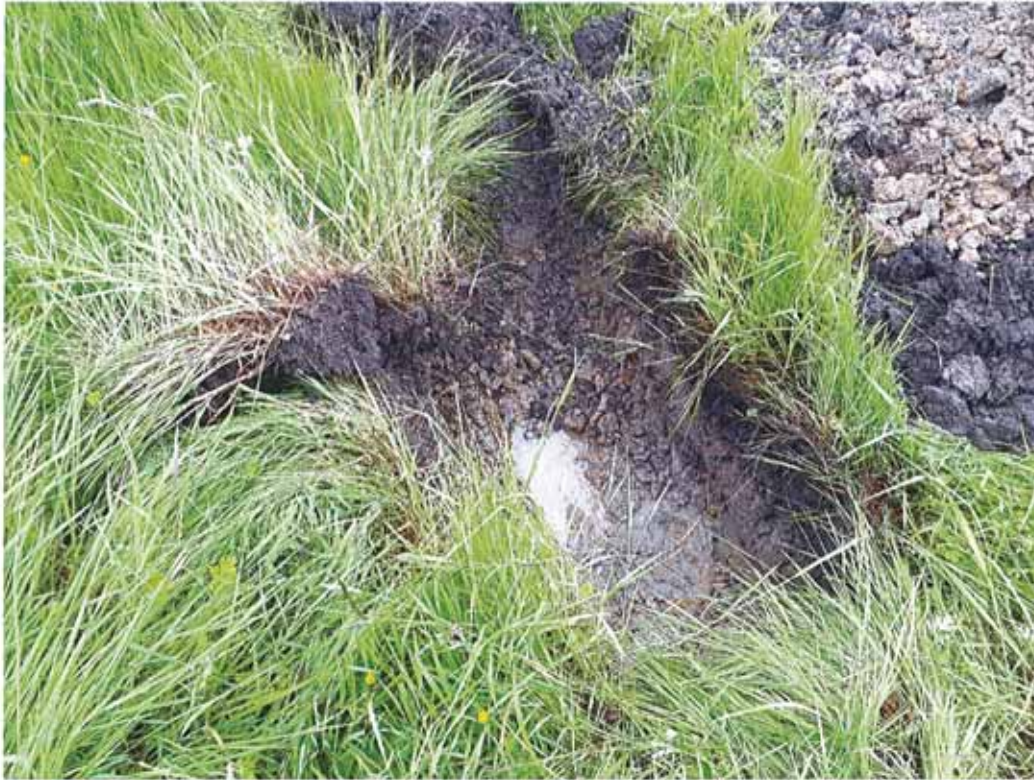
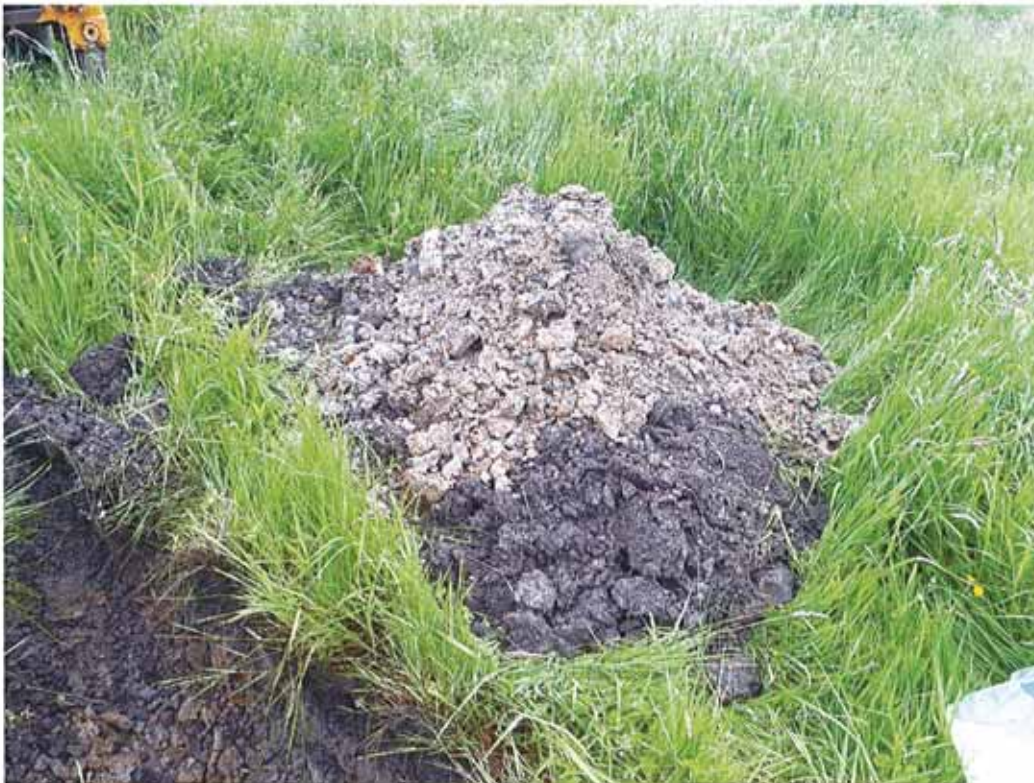
## TP A

1. Pit sides stable.
2. Slight water seepage at 0.50m depth.
3. Jar samples taken at 0.60 – 0.70m depth.

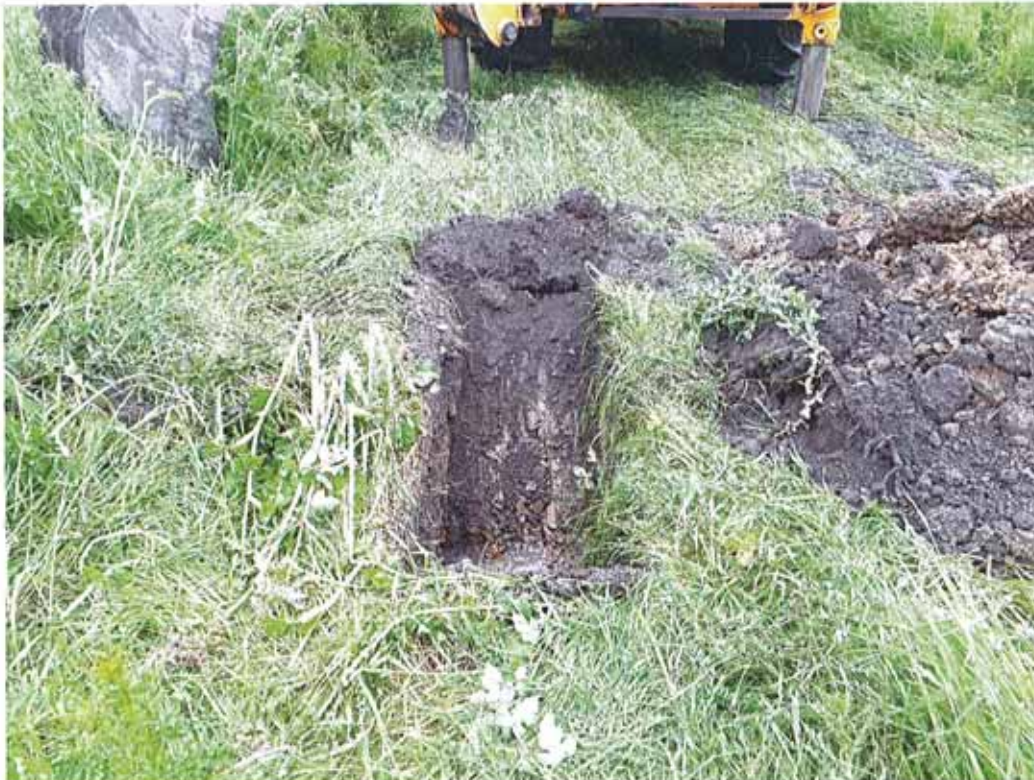
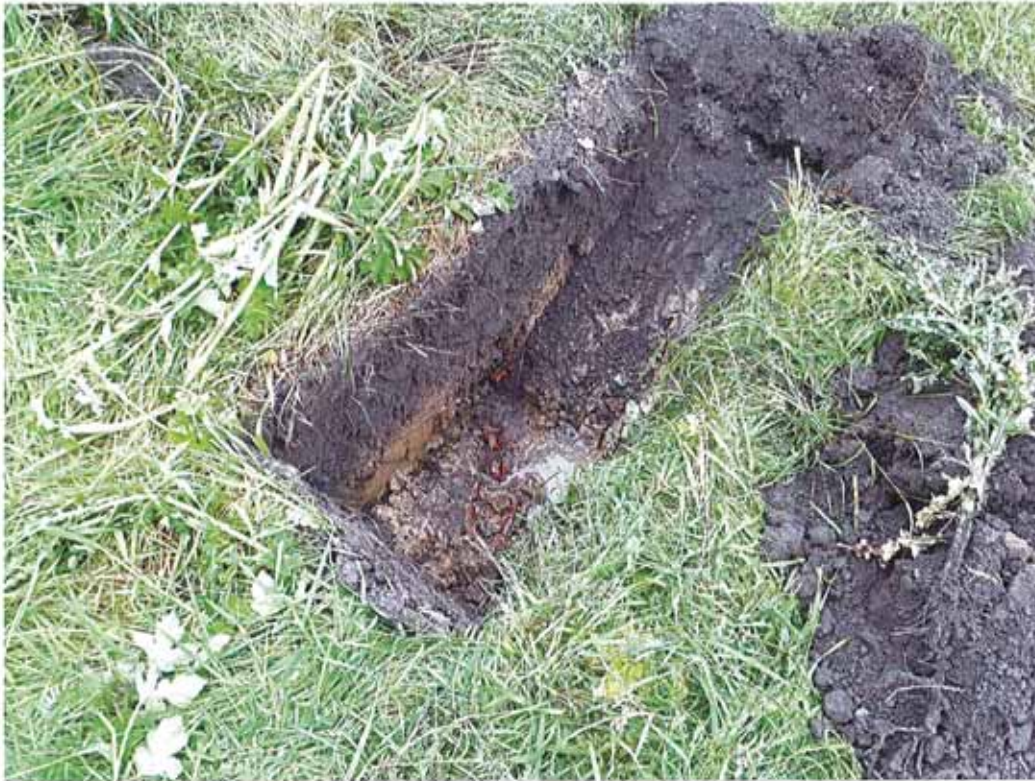
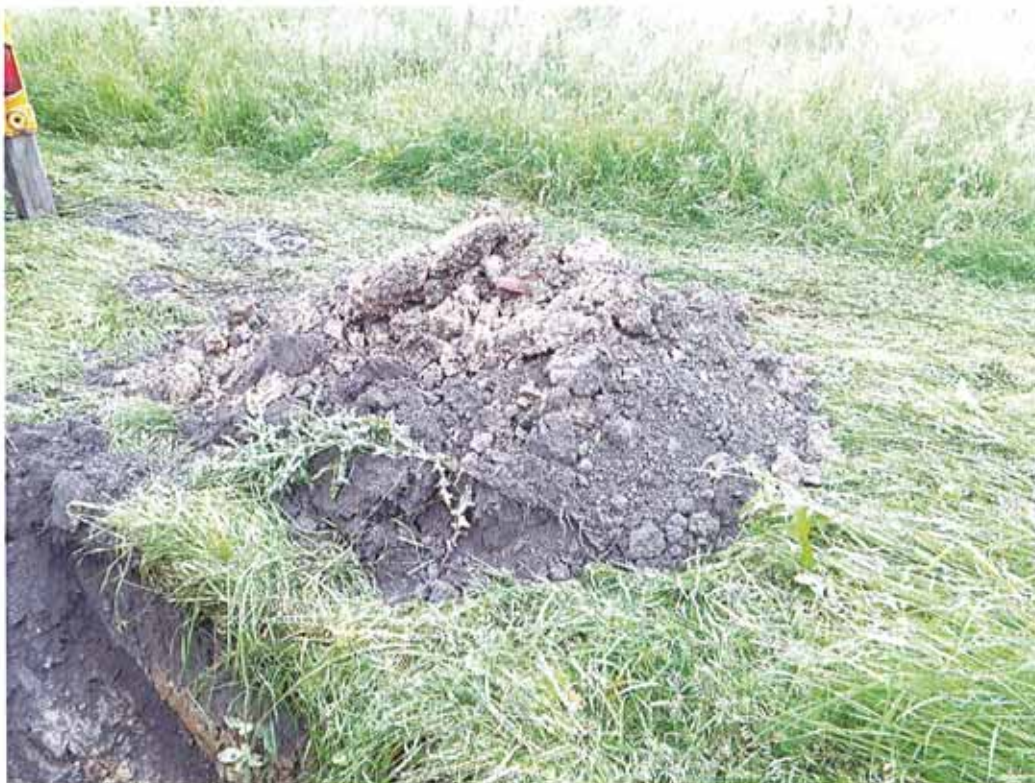
TP B

1. Pit sides stable.
2. No groundwater encountered.
3. Land drain encountered at 0.80m depth.
4. Jar samples taken at 0.70m depth.

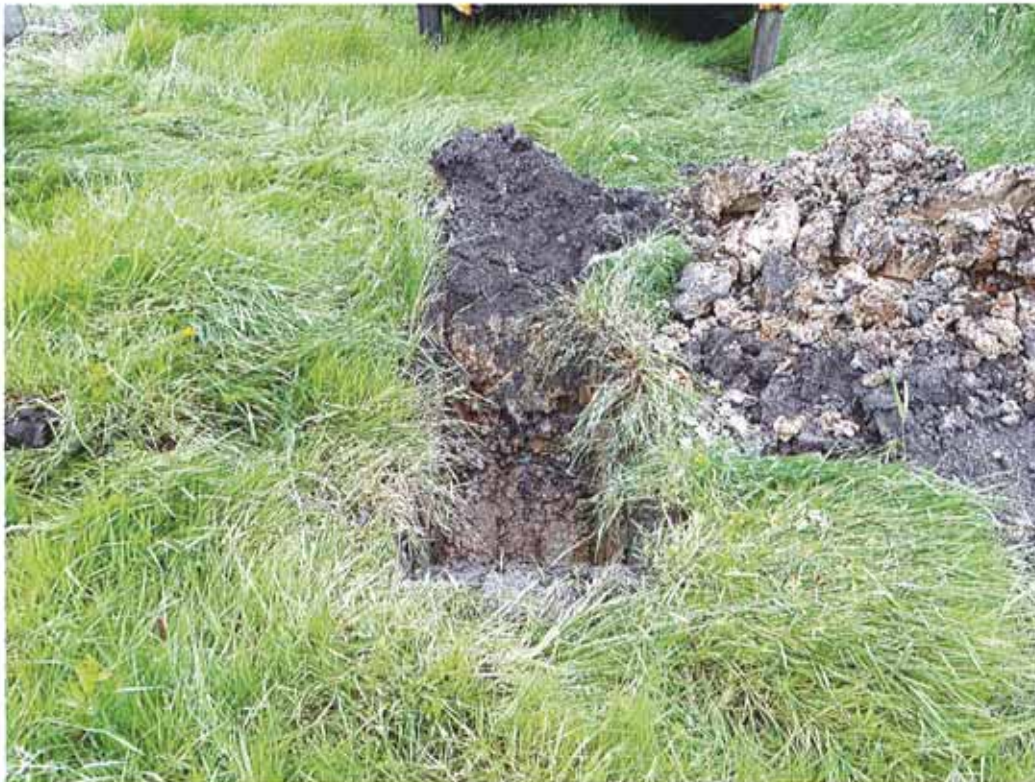
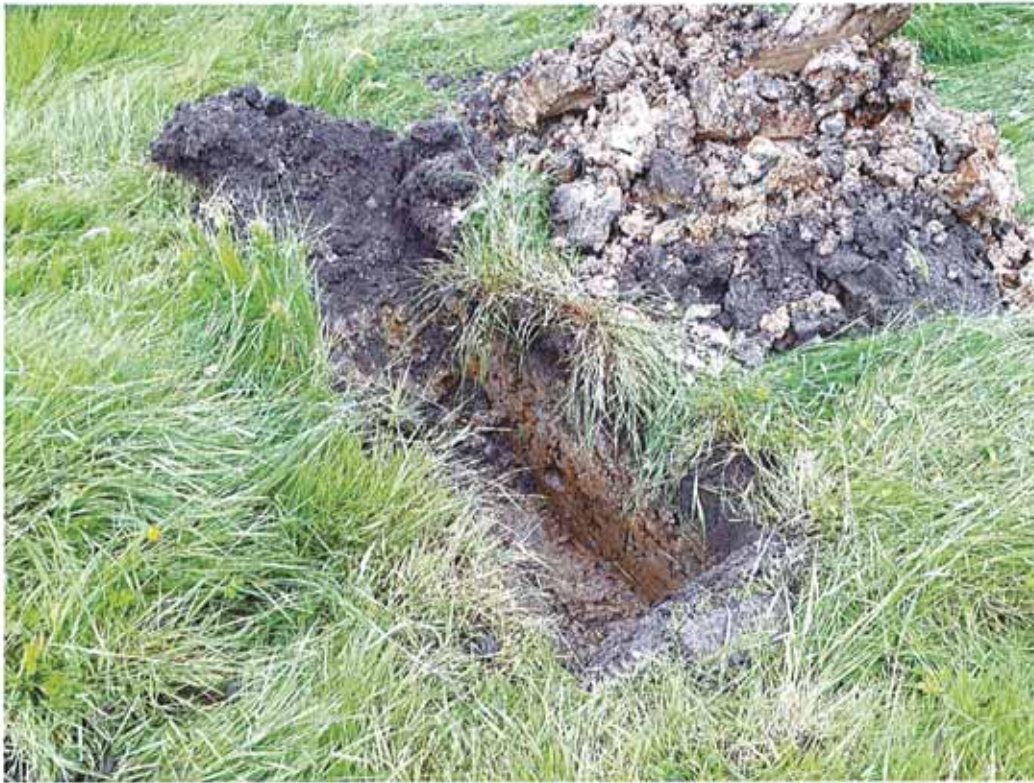
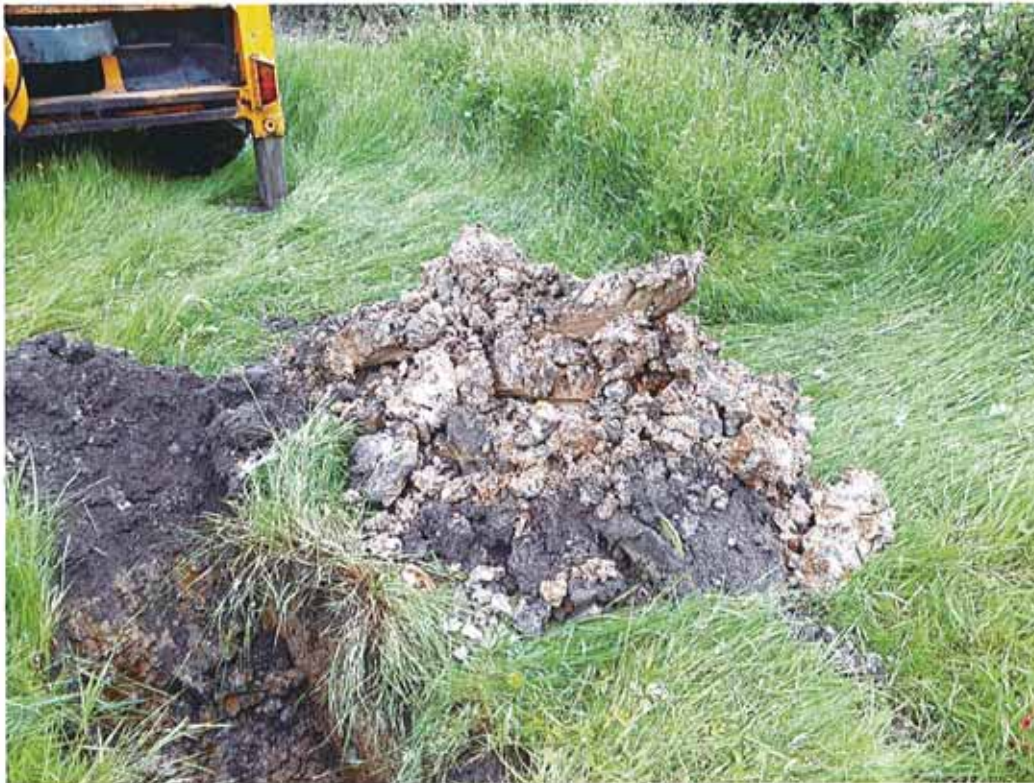
## TP C

1. Pit sides stable.
2. No groundwater encountered.
3. Jar sample taken at 0.60 – 0.70m depth.

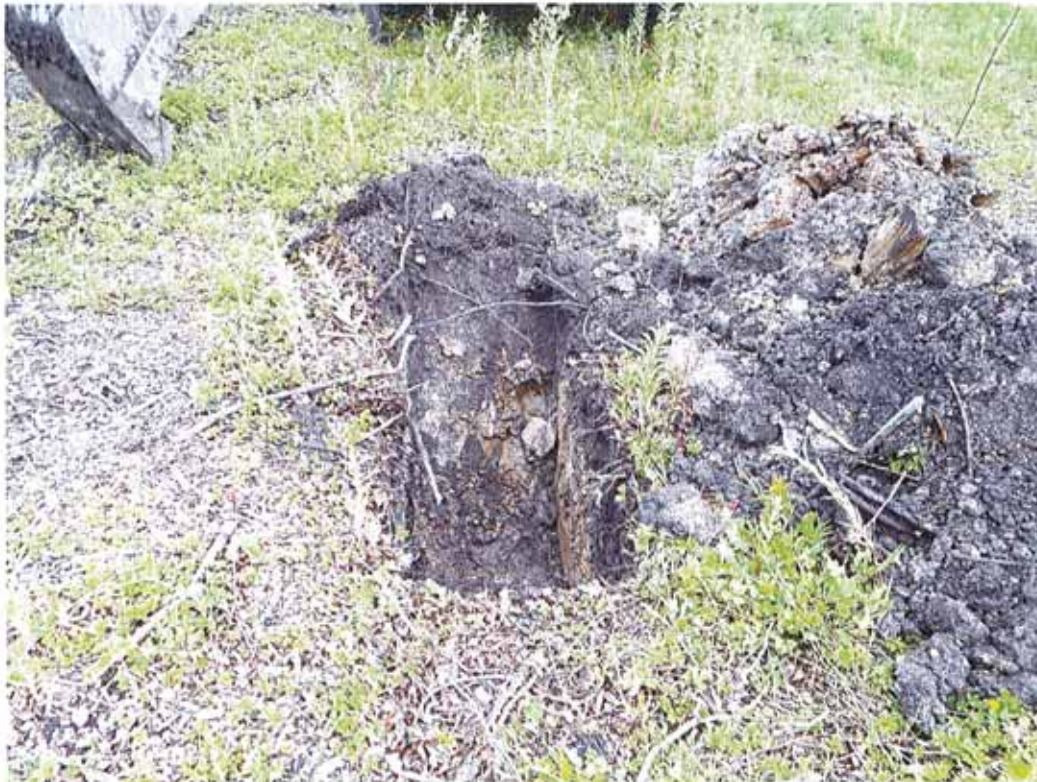
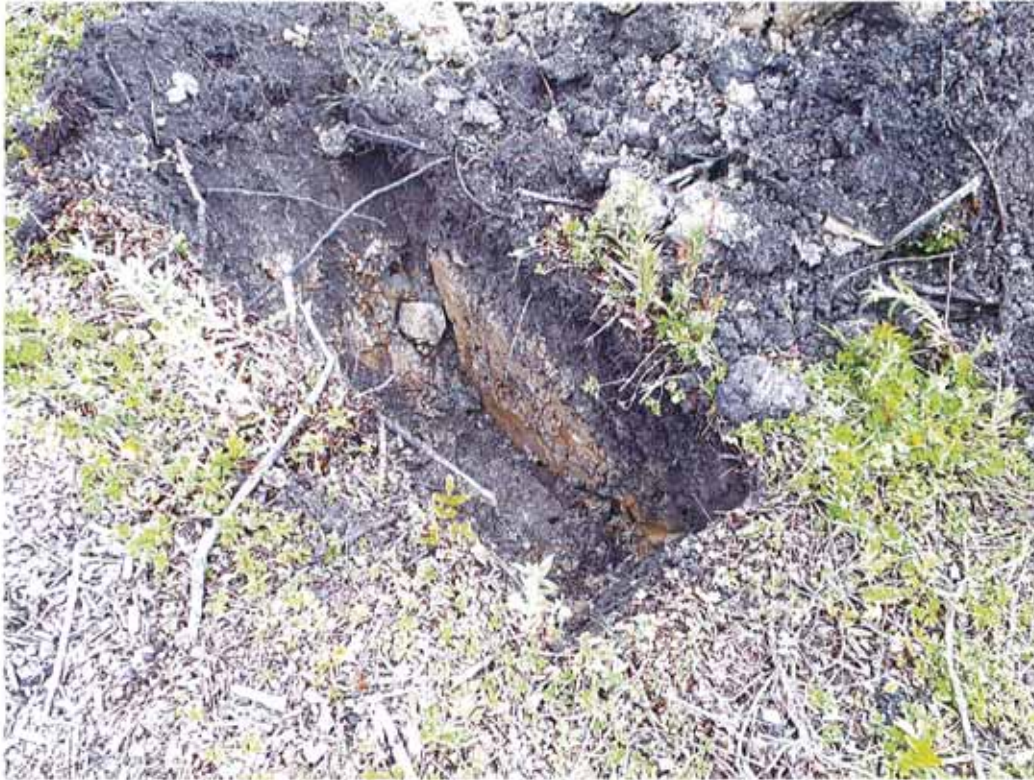
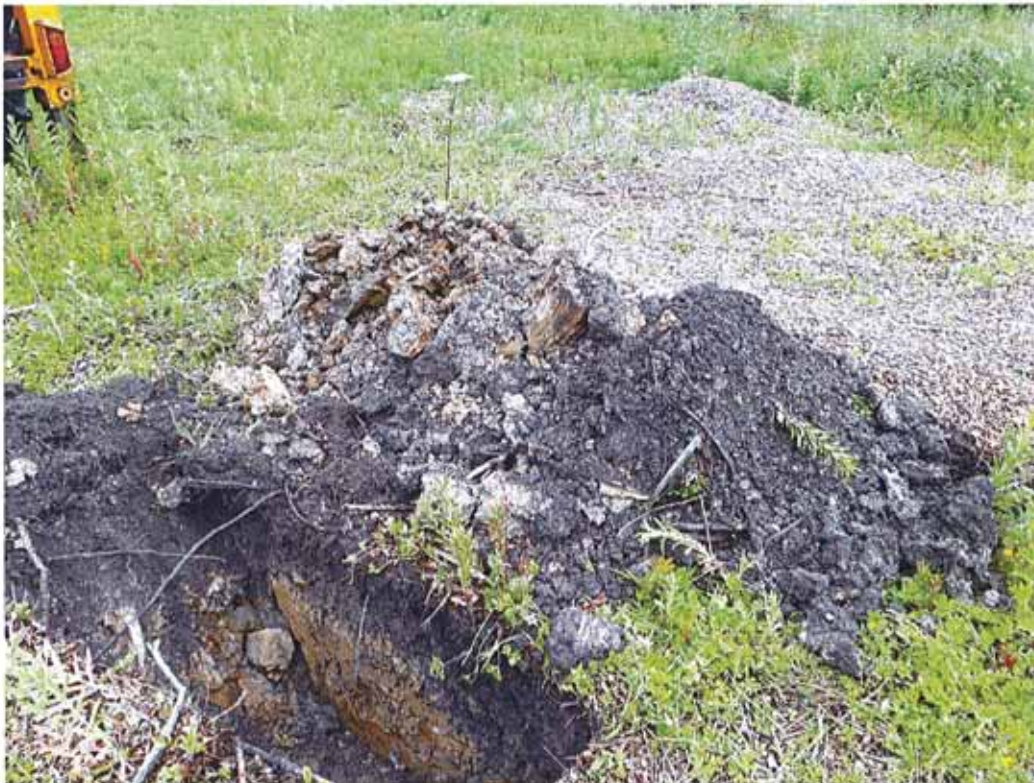
TP D

1. Pit sides stable.
2. Slight water seepage at 0.80m depth.
3. Tree stumps nearby.
4. Jar samples taken at 0.10 – 0.30m depth.
5. Jar samples taken at 0.50 – 0.70m depth.

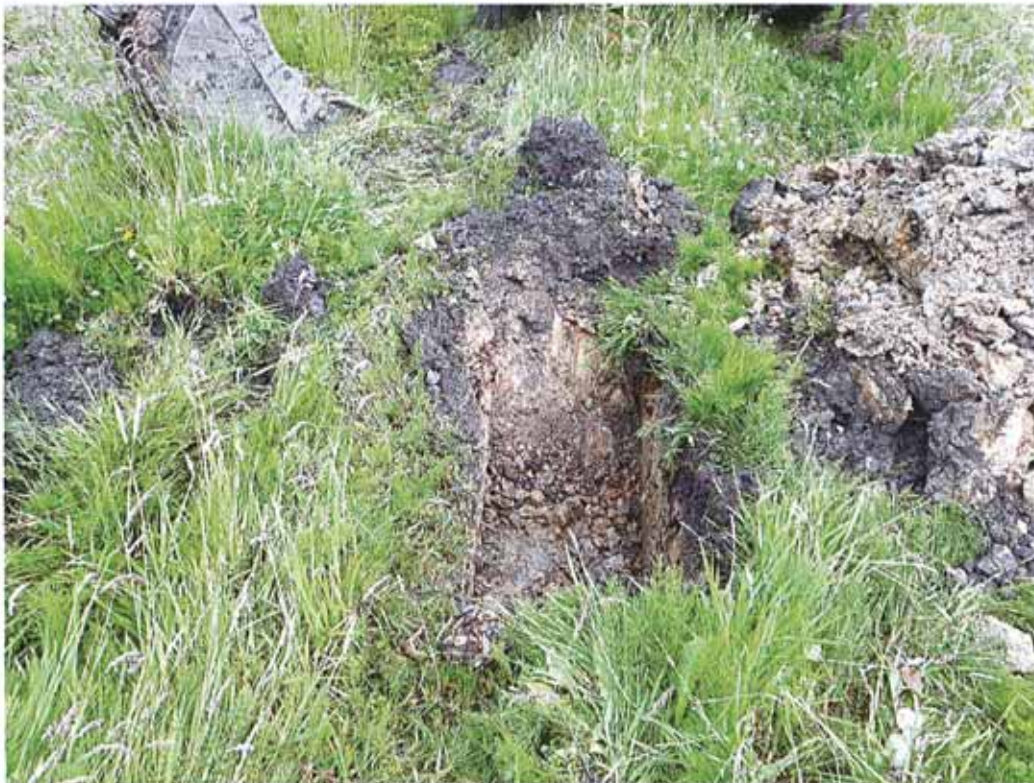
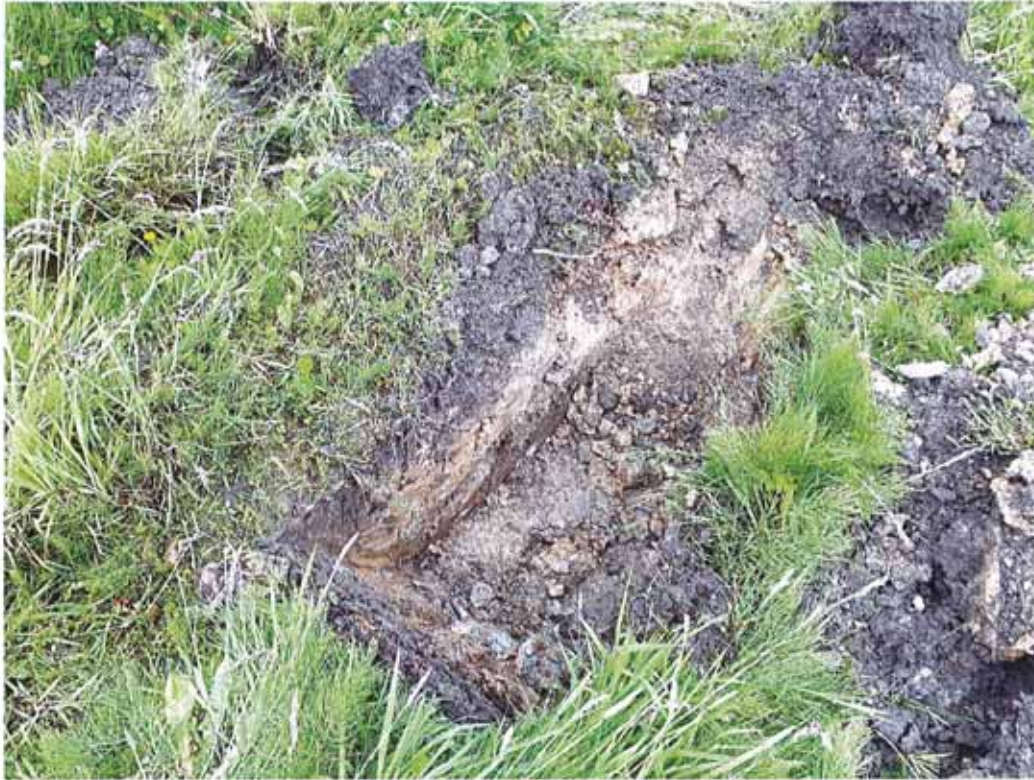
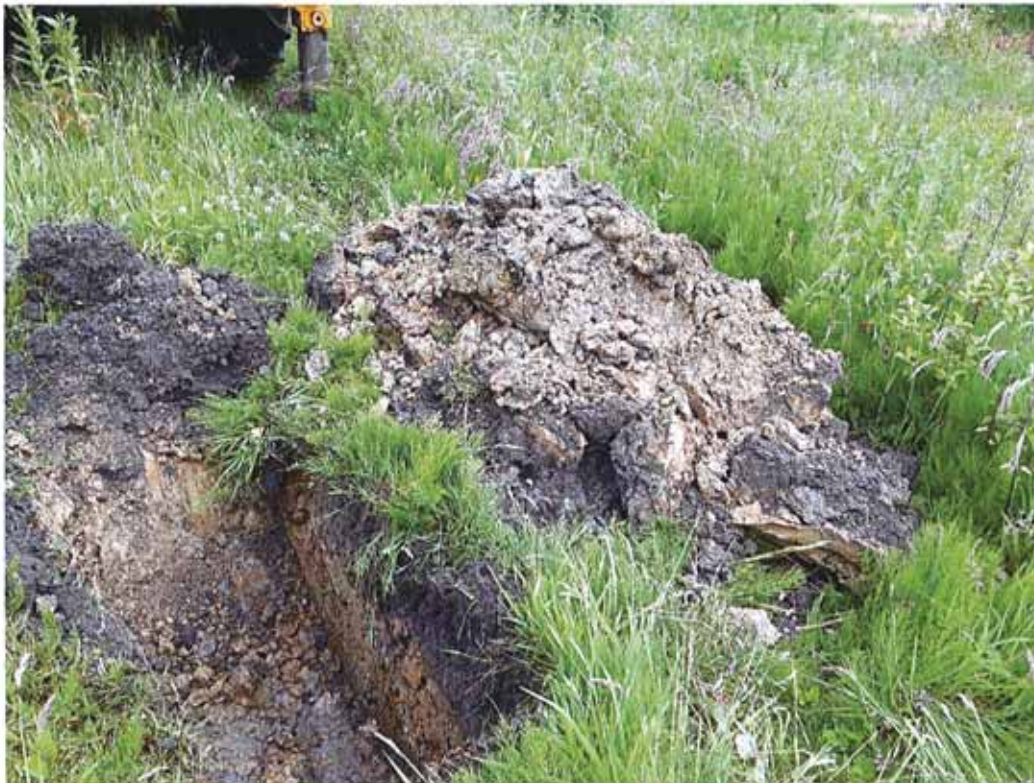
## TP E

1. Pit sides stable.
2. No groundwater encountered.
3. Jar sample taken at 0.60 – 0.70m depth.
