Eversley Court, Minera  
Proposed Residential Development  
Geo-environmental Report- Rev A  
Gower Homes

GroundSolve Ltd

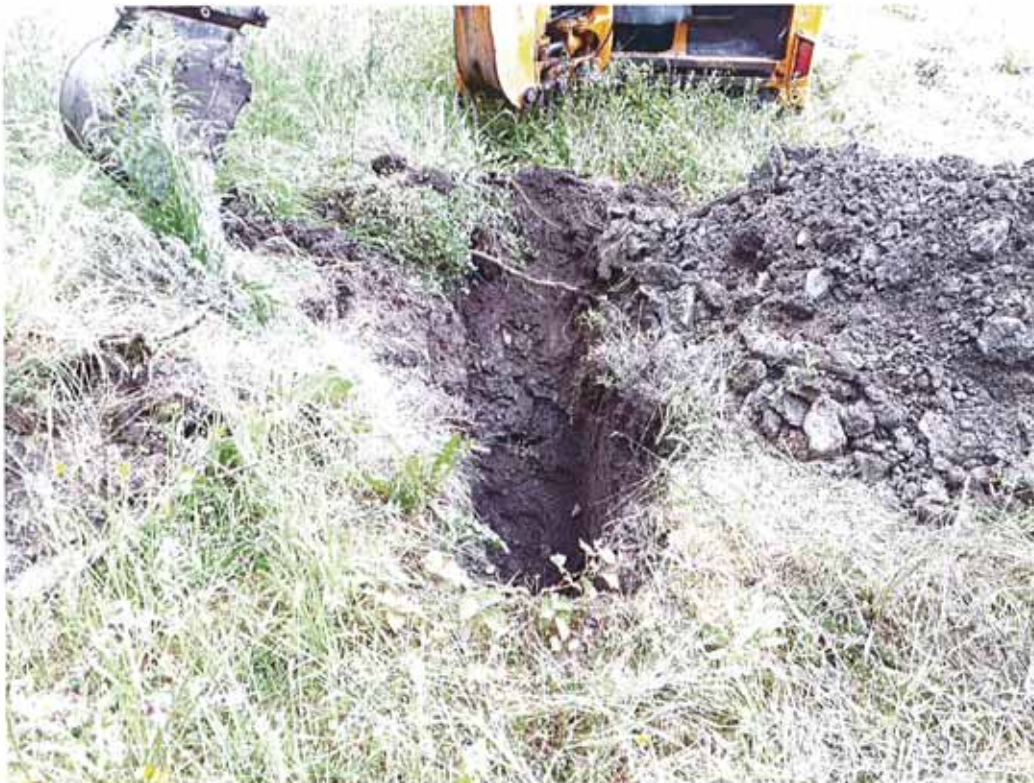
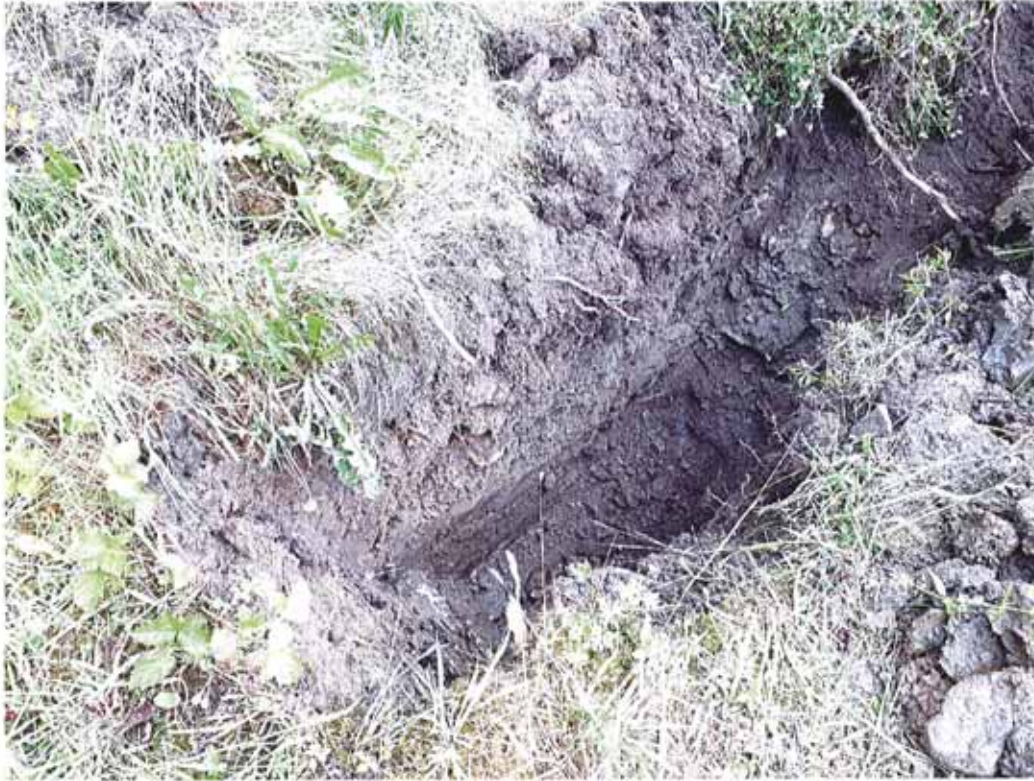
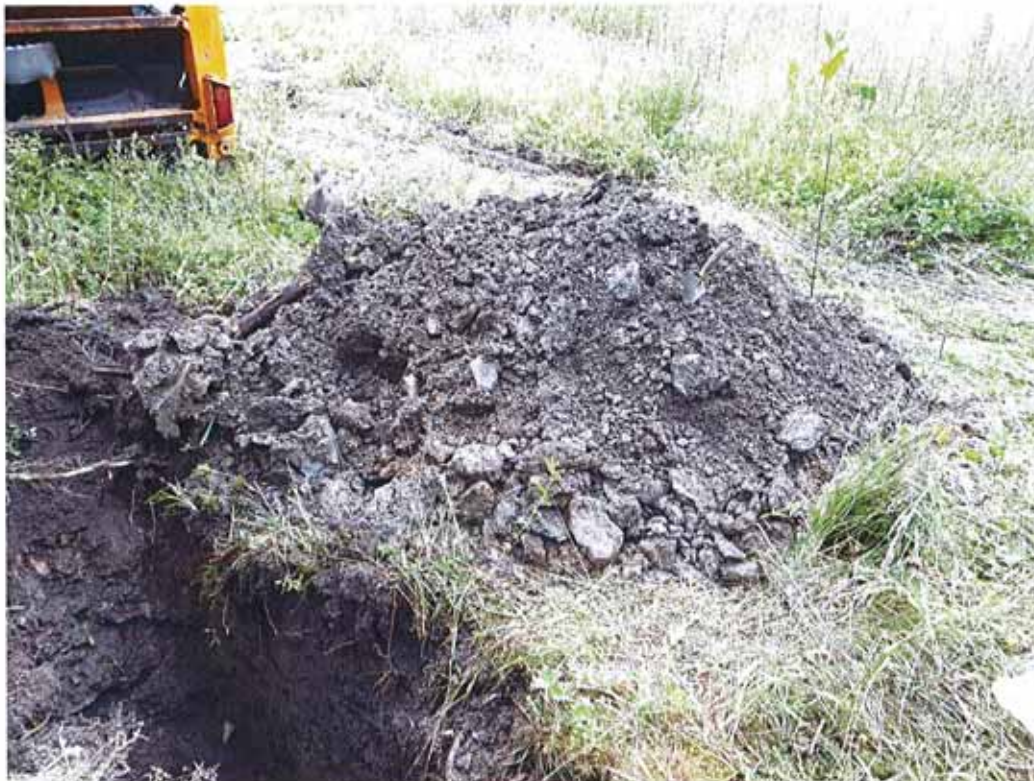
TP F

Topsoil was encountered in of the trial pits, and was described as soft, dark grey and sometimes dark brown, gravelly silt, or slightly silty/silty, slightly gravelly clay with rootlets. Some timber/metal fragments were found in TP F.

1. Pit sides stable.
2. No groundwater encountered.
3. Tree nearby.
4. Below 1.30m depth material became slightly dry.
5. Jar sample taken at 0.60 – 0.70m depth.
6. Tub samples taken at 0.60m and 1.60m depth.

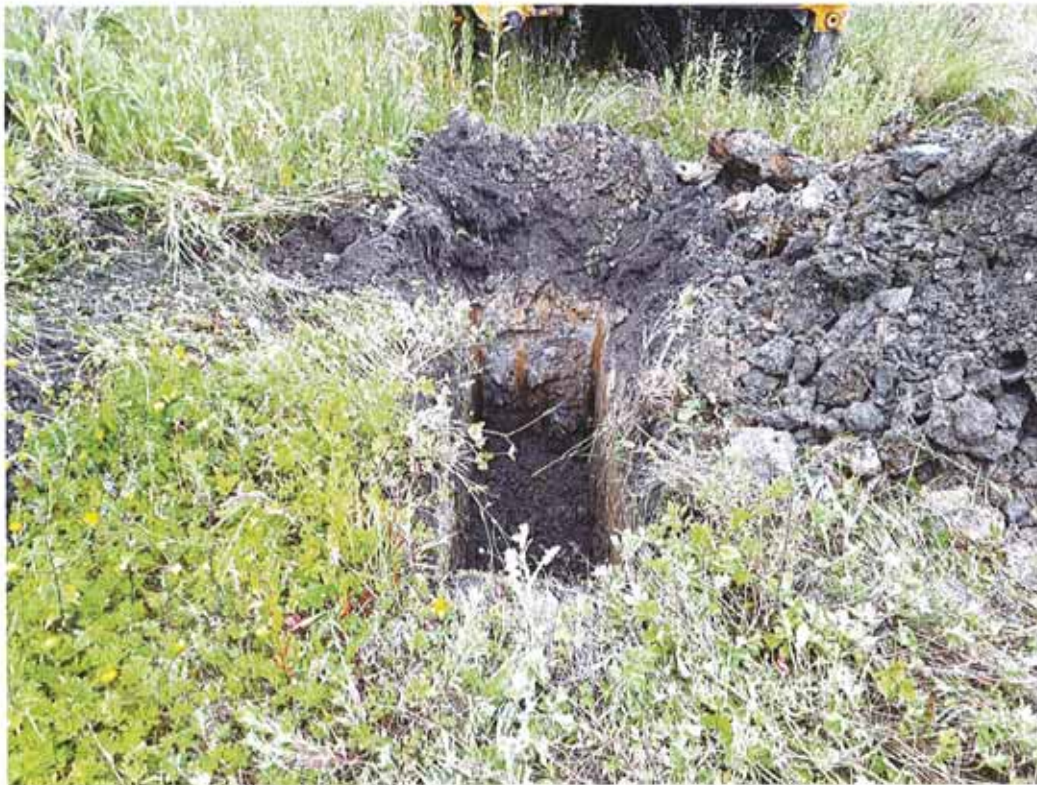
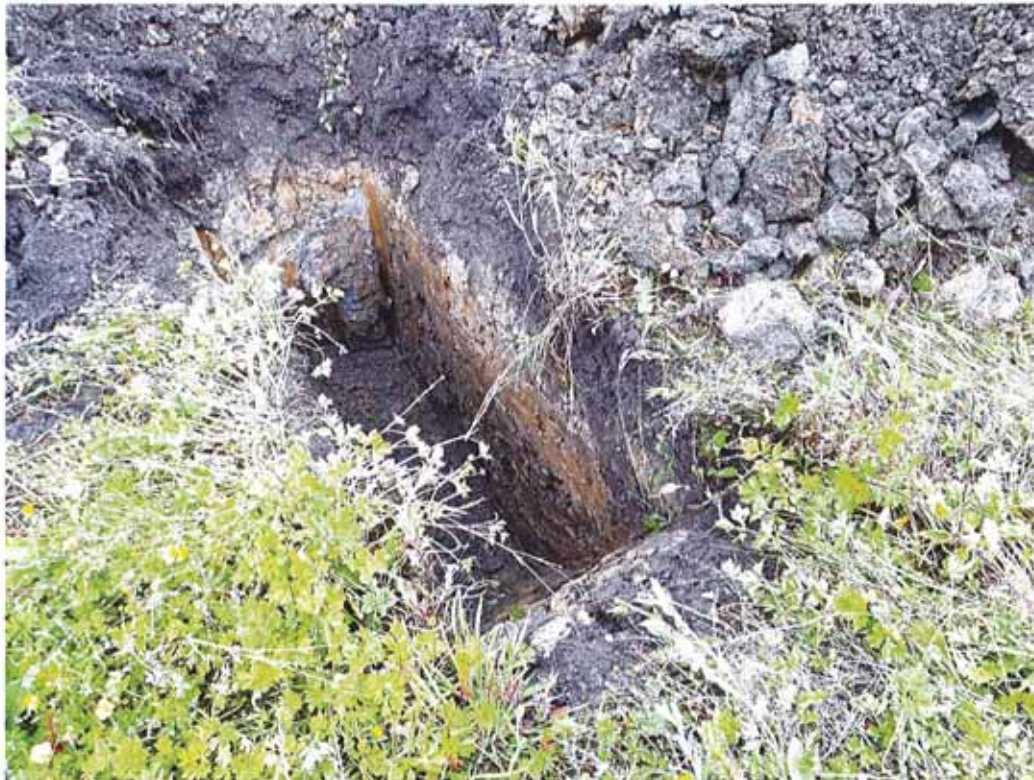
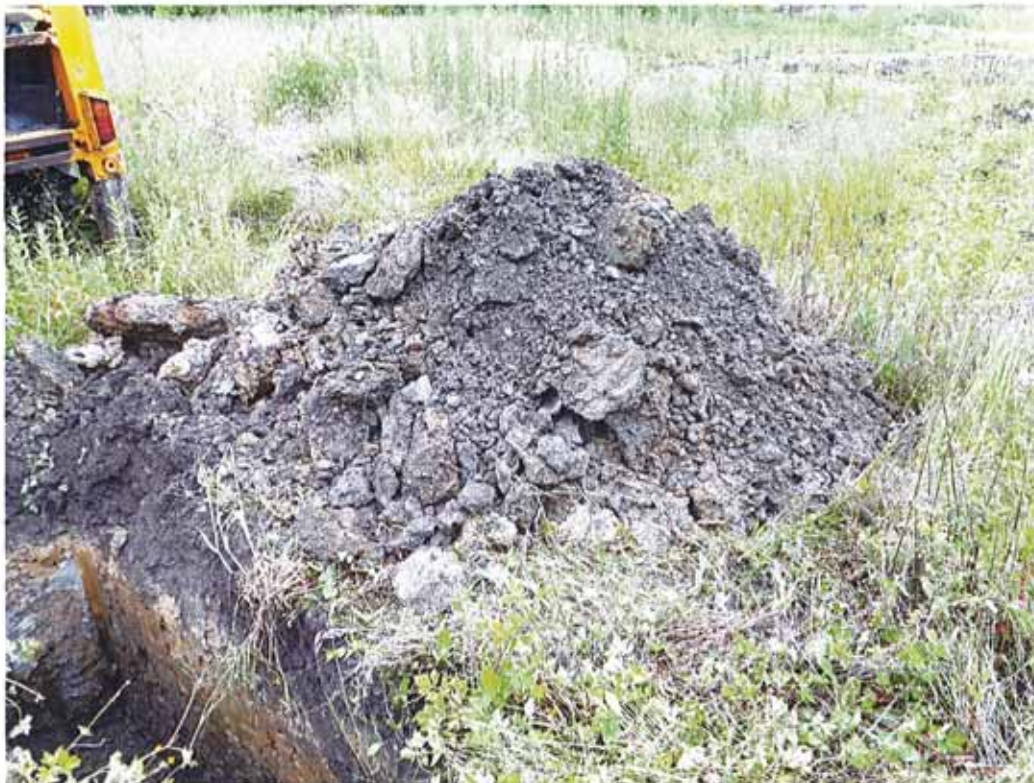
## TP G

1. Pit sides stable.
2. No groundwater encountered.
3. Tub samples taken at 0.50m and 1.50m depth.

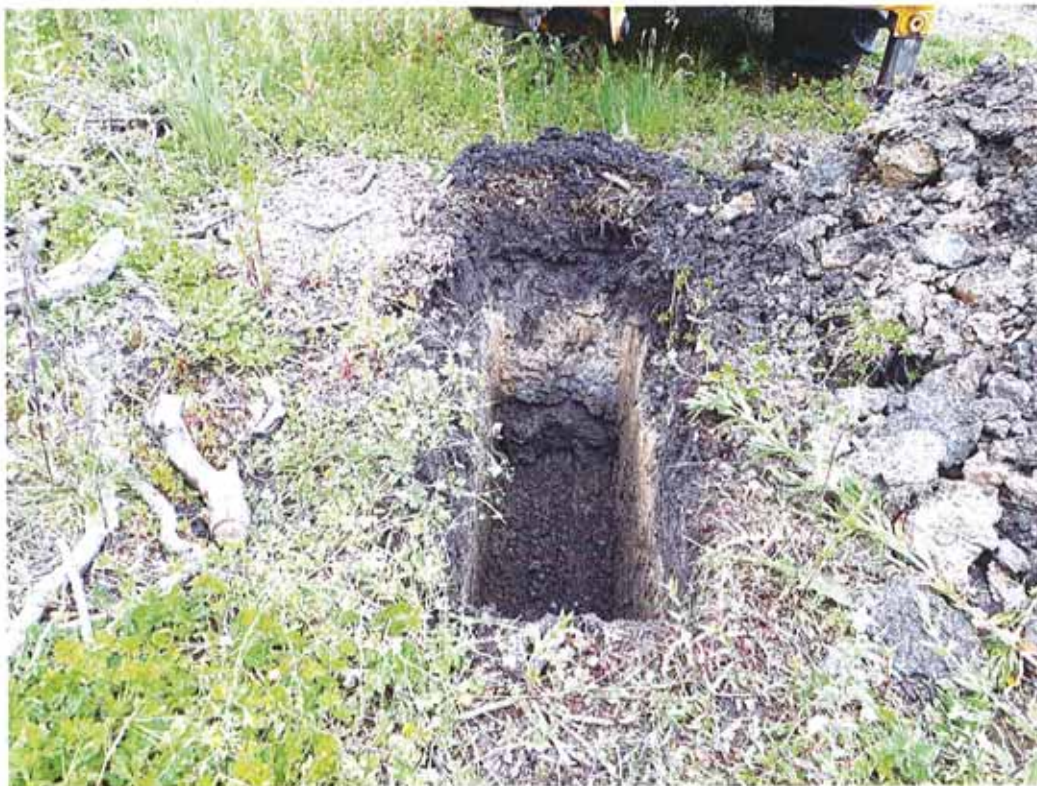
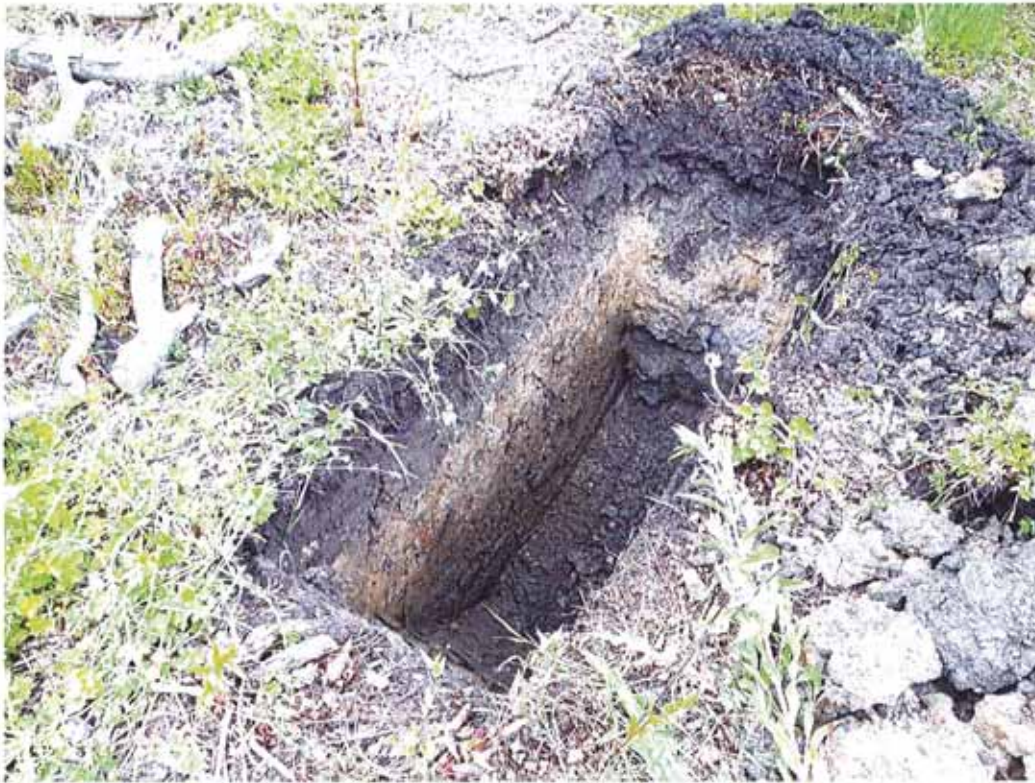
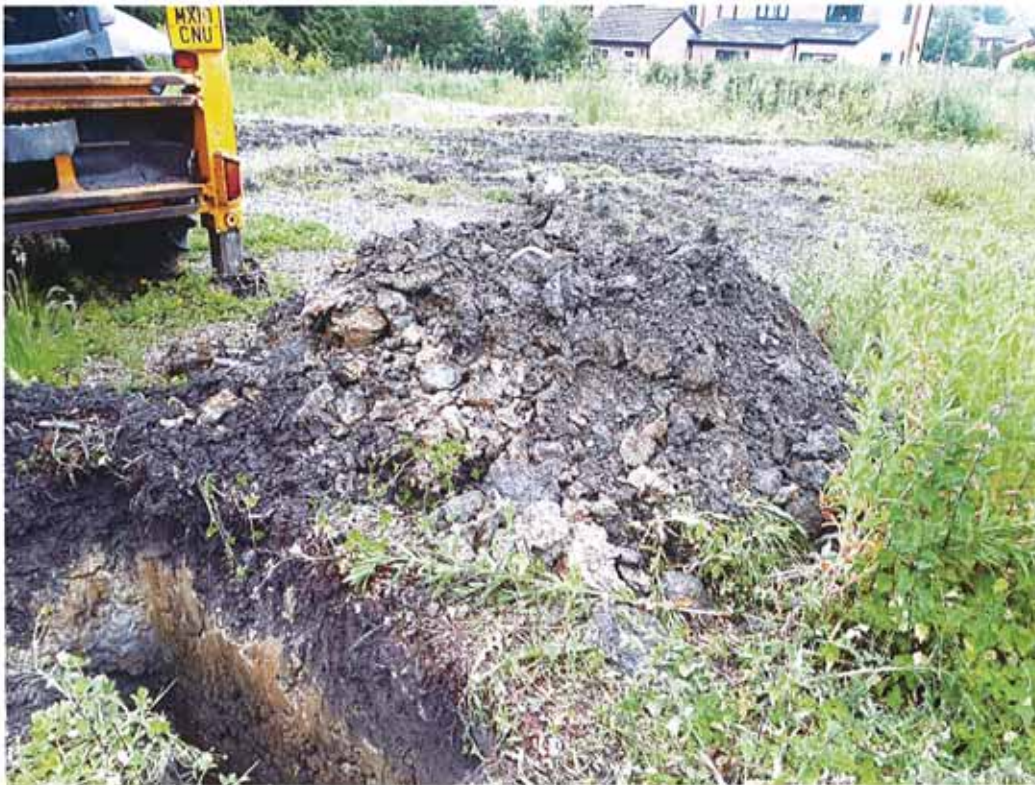
TP H

1. Pit sides stable.
2. Very slight water seepage at 0.90m depth.
3. Pockets of sand are in the shallowest part of the glacial till (up to 1.0m depth)
4. Tree stumps nearby.
5. Material became slightly dry with depth.
6. Tub samples taken at 0.60m and 1.60m depth.

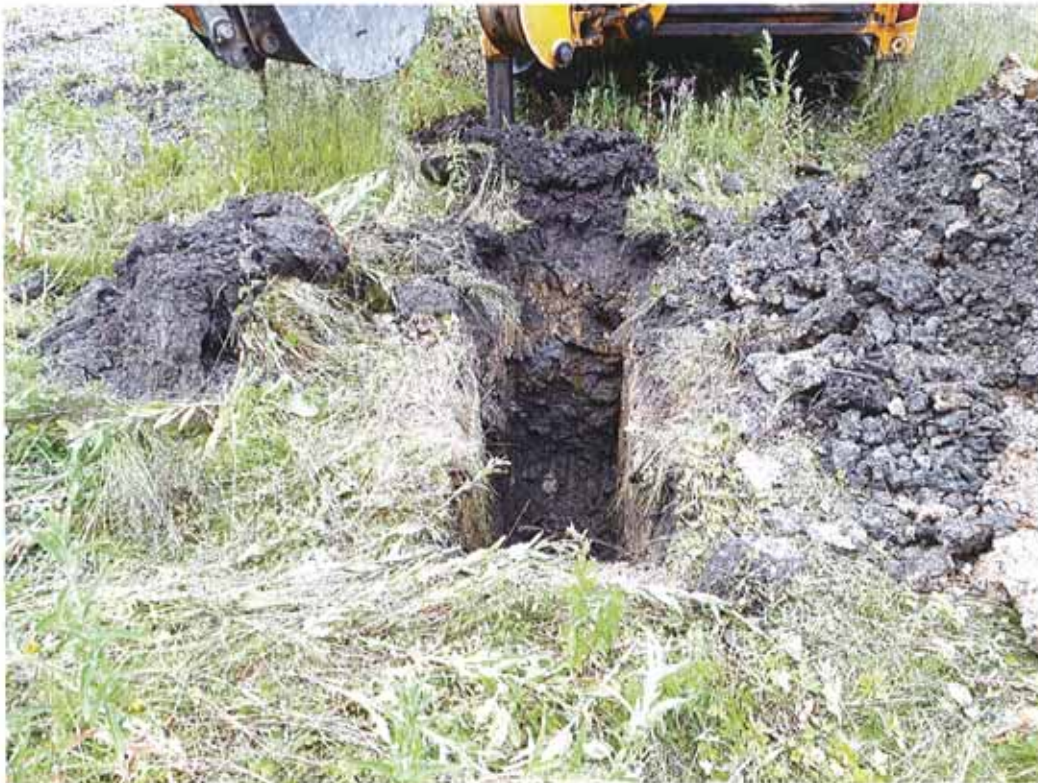
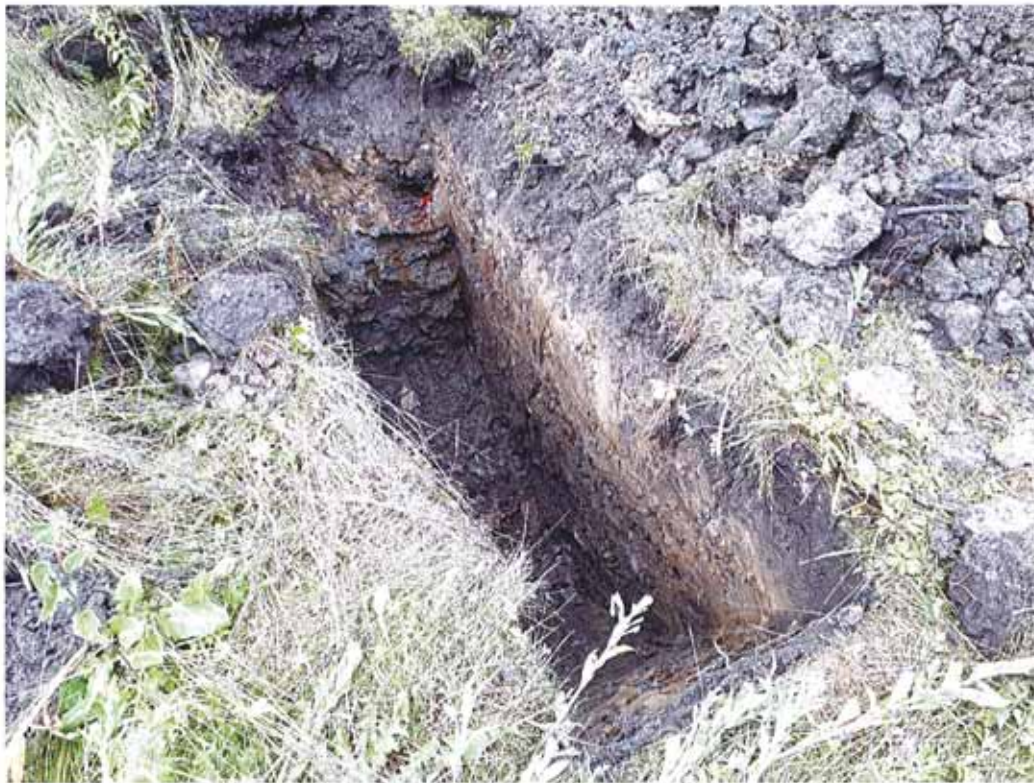
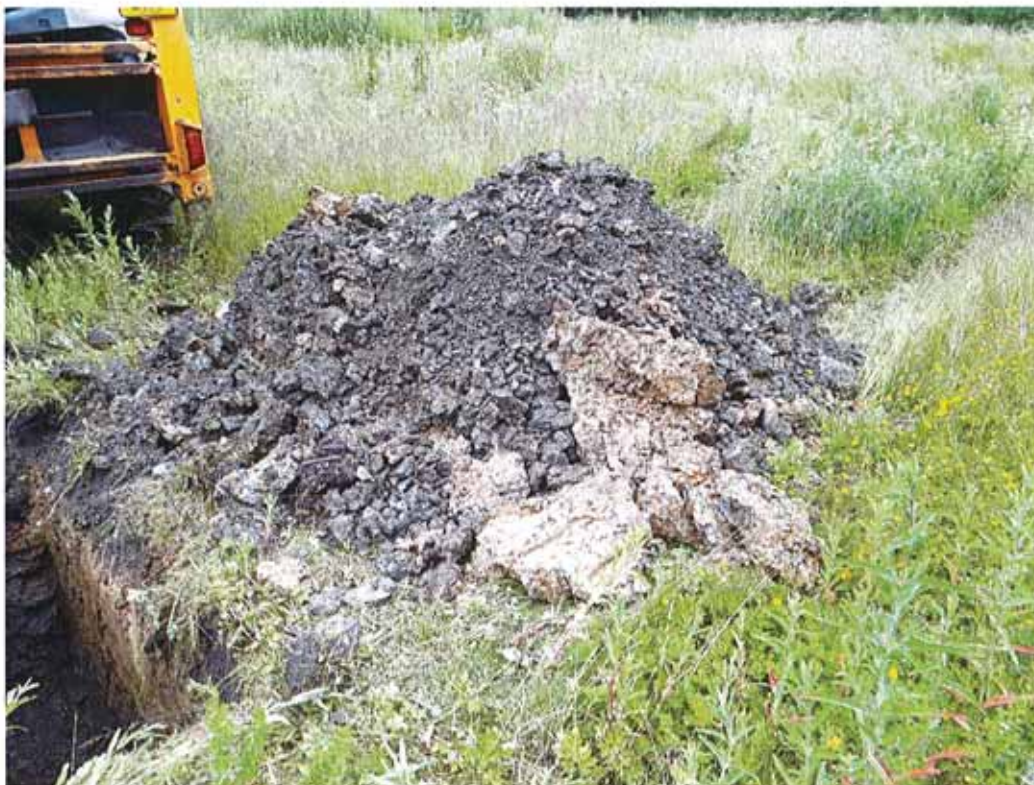
## TP 1

1. Pit sides stable.
2. No groundwater encountered.
3. Land drain encountered at 0.60m depth.
4. Pocket of sand are in the shallowest part of the glacial till (up to 1.0m depth)
5. Cobble content increased with depth.
6. Tub samples taken at 1.00m and 2.00m depth.
