63 King Street, Wrexham

## Existing Features-Photographic Schedule

Lawray Architects  
The Byre  
Croesnewydd Hall  
Wrexham  
LL13 7YP

June 2017

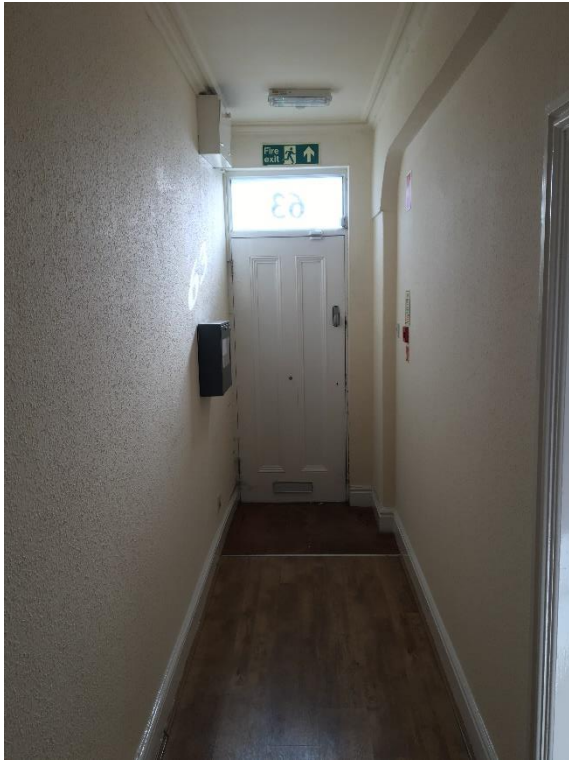
Fig 1-Hallway to entrance door

Fig 1: Hallway to Entrance Door;

Existing external door retained, coving and skirting remain. Floor finish under over-boarding to be exposed.

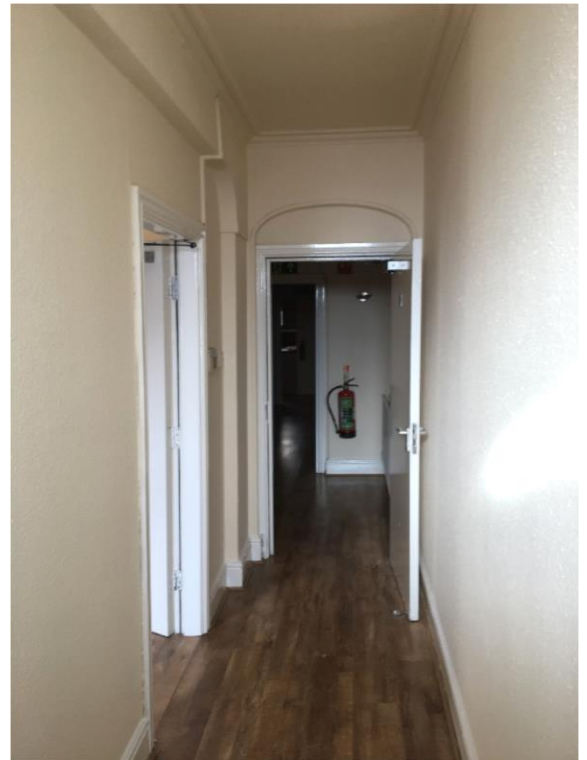
Fig 2-Hallway from Entrance

Fig 2: Hallway from Entrance;

Door surrounds, coving and skirtings retained.

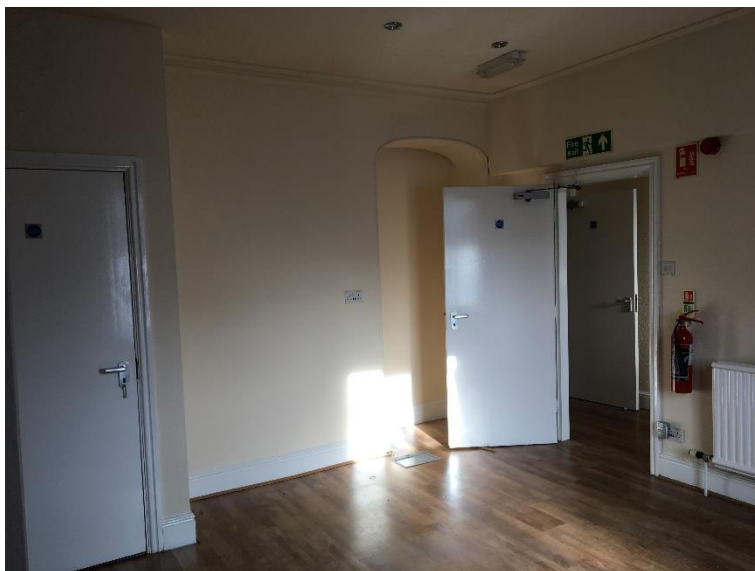
Fig 3-Ground Floor Office/Hallway  
door

Fig 3: Ground Floor Office/Hallway Door;

Covings, door surround, skirting and recess retained.

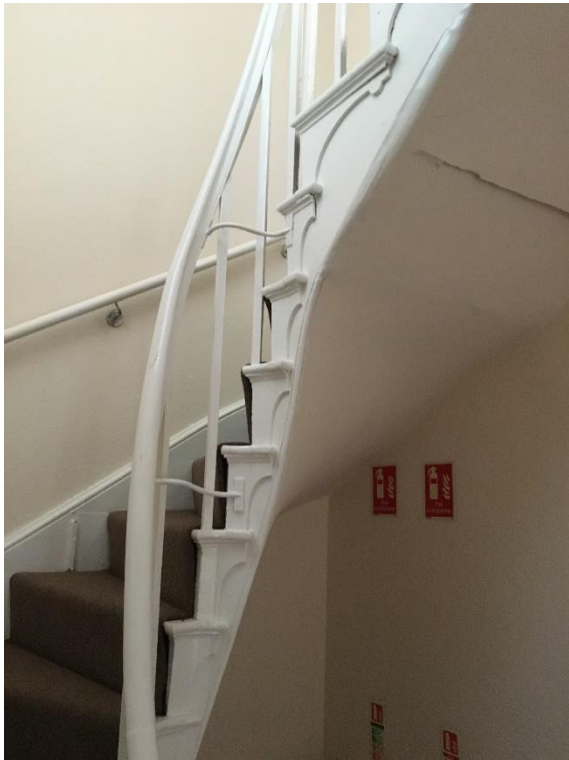
Fig 4-First to Second Floor Stair String

Fig 4: First to Second Floor Stair String;

Flight to remain intact (Flight from Ground to First Floor previously replaced).

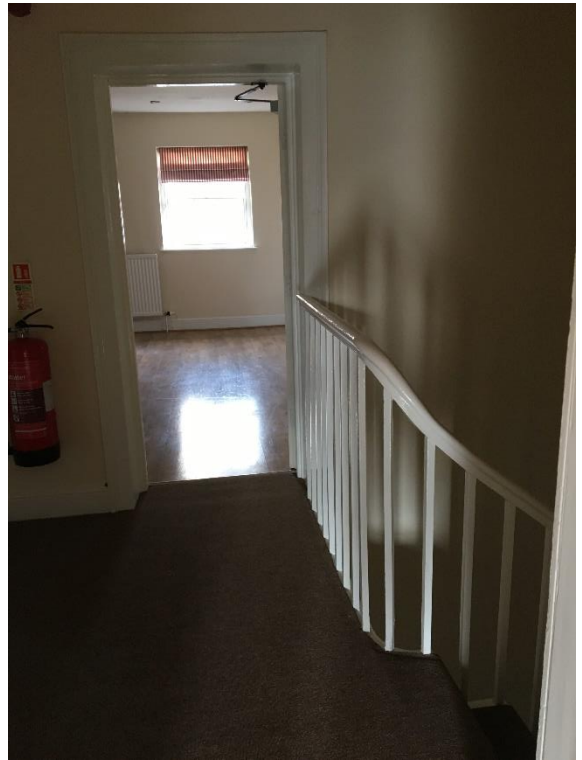
Fig 5-Second Floor Landing

Fig 5: Second Floor Landing;

Flight and Balustrading to remain intact.

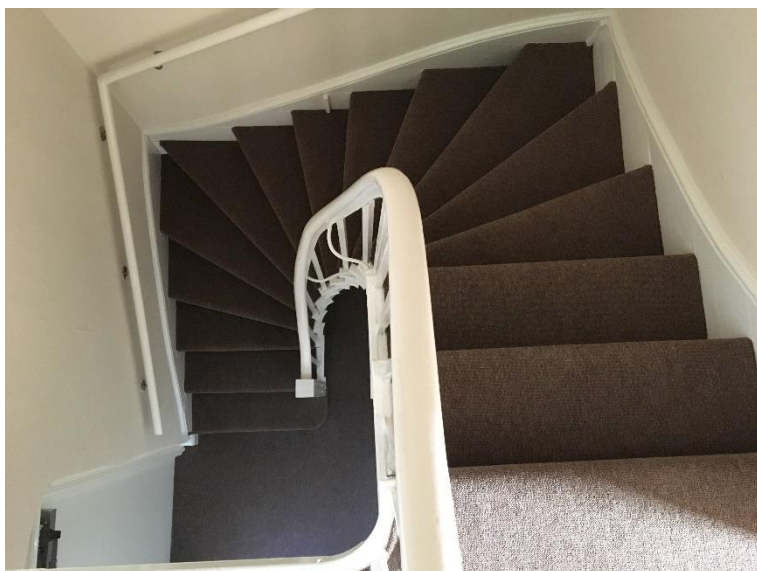
Fig 6-First to Second Floor Stair Flight

Fig 6: First to Second Floor Stair Flight;

Flight to remain intact.

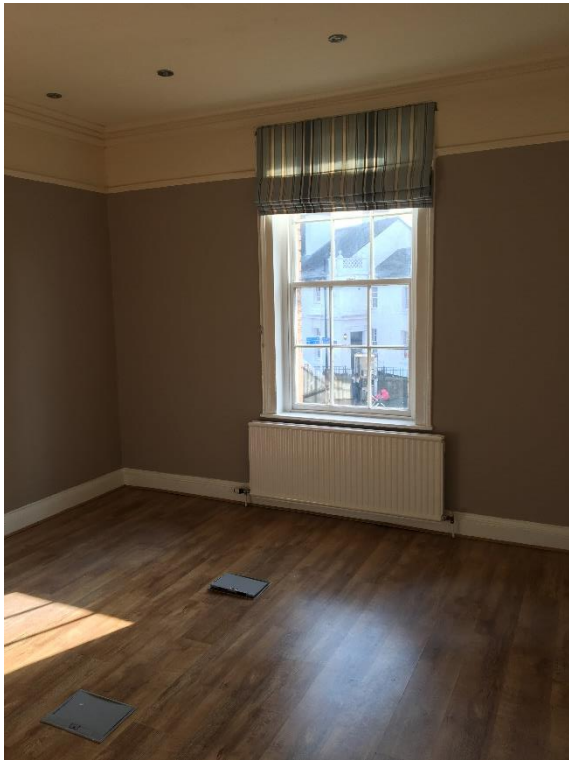
Fig 7-First Floor Front Office

Fig 7: First Floor Front Office;

Coving, picture rail, window surround and skirting retained. Original floor boarding to be exposed.

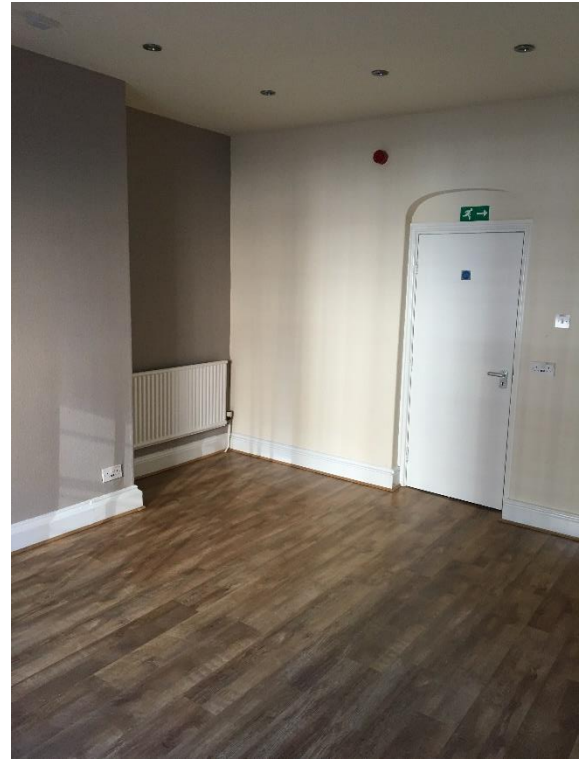
Fig 8-First Floor Rear Office doorway to Landing

Fig 8: First Floor Rear Office;

Door surround and skirting retained. Original floor boarding to be exposed.

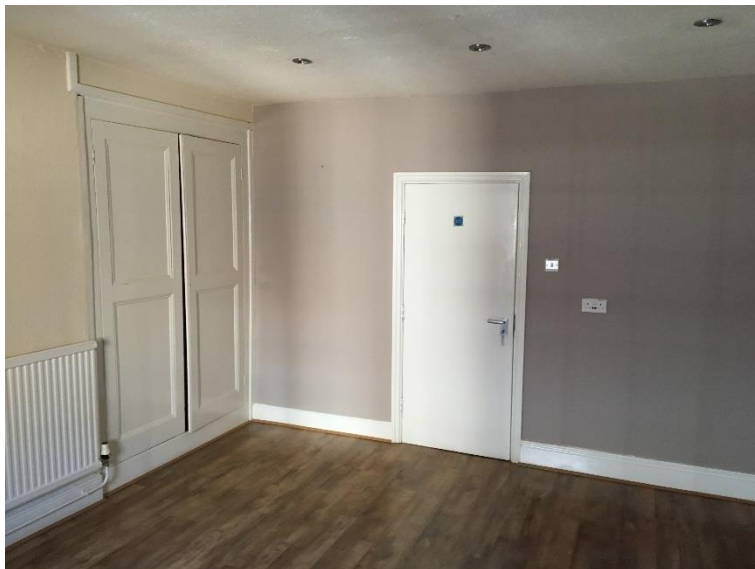
Fig 9-Second Floor Office Cupboard

Fig 9: Second Floor Rear Office;

Door surround and skirting retained. Cupboard door retained for re-use.
