Conrad Energy,  
Units D and E,  
Windrush Court  
Backlands Way,  
Abingdon,  
OX14 1SY.

**Scheme : w10833 – Abbey Road, Wrexham Industrial Estate**

**Subject : Assessment of Ditch**

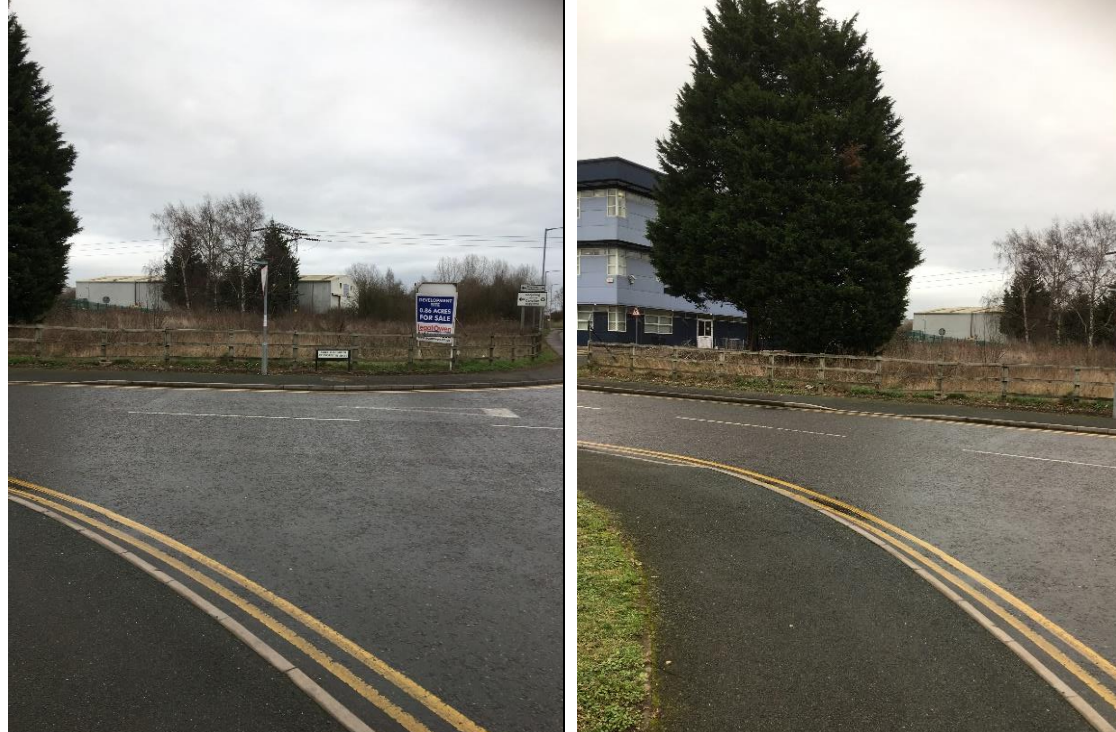
| Photo No. <b>1 &amp; 2</b> | Job Reference & Number:<br>w10833 – Abbey Road, Wrexham Industrial Estate | |

The site covers an area of approximately 3,385m<sup>2</sup> and is located at the southern extent of Wrexham Industrial Estate at National Grid Reference: 338686, 349512 (photographs 1 and 2). A site location plan and aerial image are enclosed. The site comprises an area of disused land which was overgrown with several large trees, bushes and brambles covering the site (photograph 3). The site is bordered by Abbey Road with industrial units to the west, industrial units to the north and east and Oak Road with scrubland beyond to the south.

| Photo No. <b>1 &amp; 2</b> | Job Reference & Number:<br>w10833 – Abbey Road, Wrexham Industrial Estate | |
|---|---|--|
| <p><b>Description:</b></p> <ol style="list-style-type: none"> <li>1. Looking east towards the site.</li> <li>2. Looking north-east towards the site</li> </ol> | | |

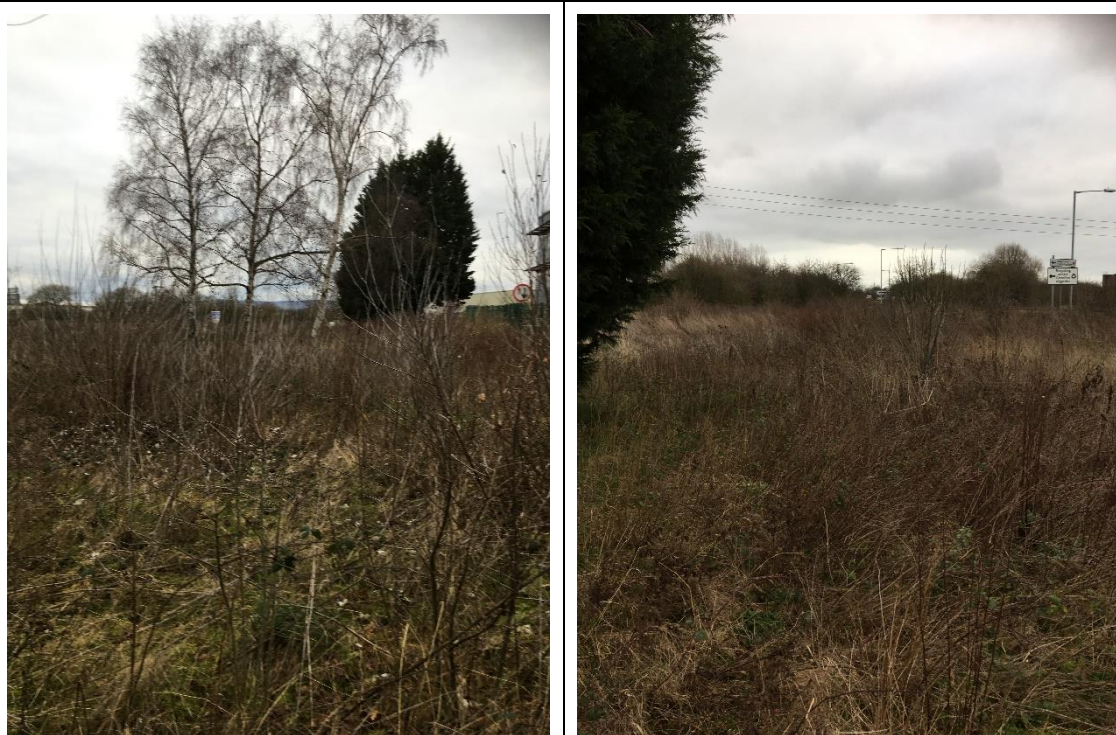
A ditch, approximately 46m in length, was identified running north-west to south-east, across the central extent of the site (photograph 4). The ditch was between 0.5m-1m deep and approximately 3.5m wide. The ditch was edged with stone at the north-western extent for approximately 4m (photograph 5). The remainder of the ditch appeared to be edged by natural banks. The ditch was overgrown and contained small trees and other vegetation (photograph 6). The ditch appeared generally dry (taking account of the damp conditions) with no significant evidence of flowing water or standing water within the ditch.

| Photo No. <b>3 &amp; 4</b> | Job Reference & Number:<br>W10833 – Abbey Road, Wrexham Industrial Estate | |
|---|---|--|
| <p><b>Description:</b></p> <ol style="list-style-type: none"> <li>3. Looking north-west – Site overgrown with trees and vegetation</li> <li>4. Looking south-east – location and orientation of ditch hidden by undergrowth</li> </ol> | | |

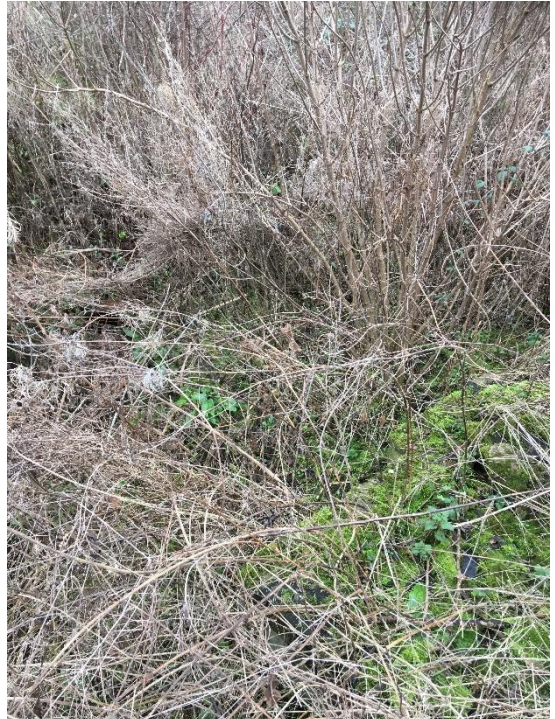
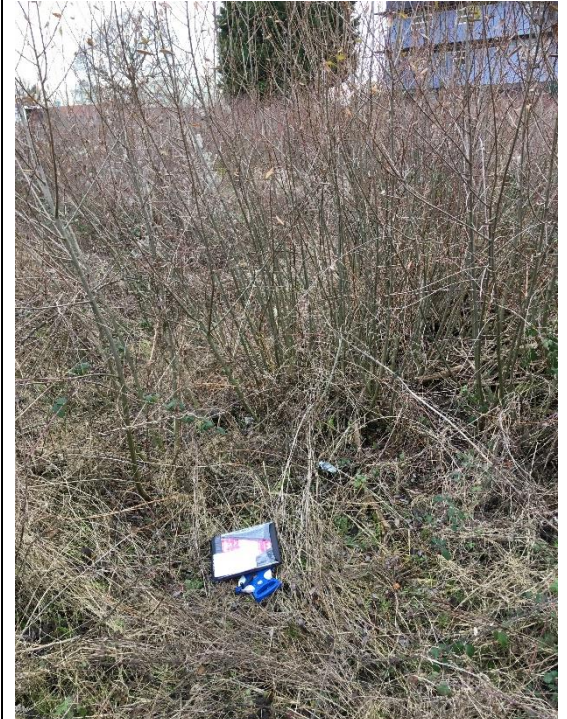
| Photo No. <b>5 &amp; 6</b> | Job Reference & Number:<br>W10833 – Abbey Road, Wrexham Industrial Estate | |
|---|---|---|
| <p><b>Description:</b></p> <p>5. Looking north-east – showing stone edge of ditch</p> <p>6. Looking north-west – showing ditch filled with trees and undergrowth</p> | | |

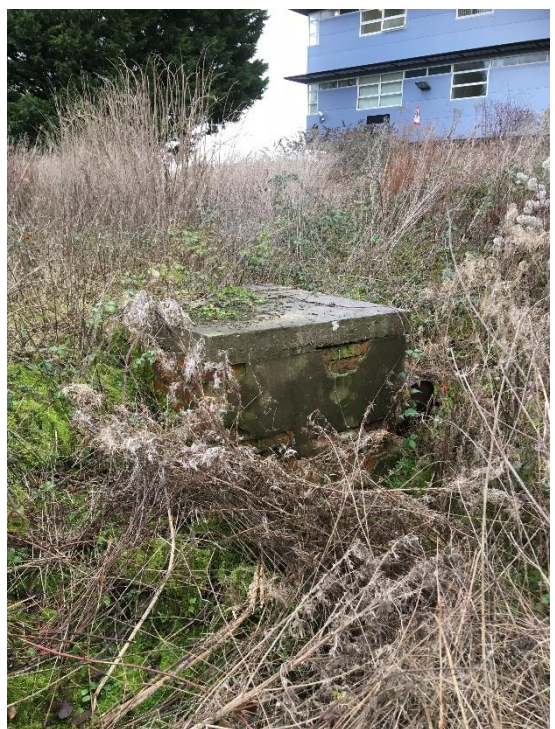
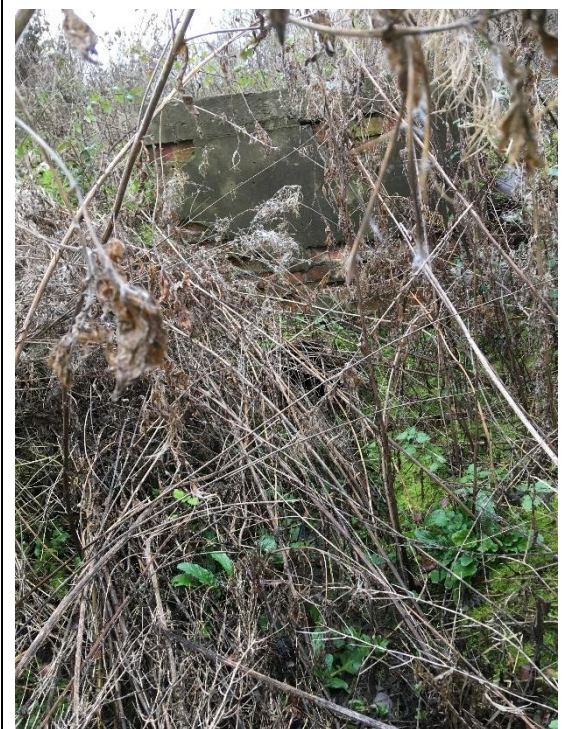
A 1.5m wide x 1.5m long x 1.2m deep manhole chamber (external measurements) was identified at the north-western extent of the ditch (photographs 7 and 8). The manhole chamber is brick built with a concrete cover. No inspection cover associated with the manhole was identified, or evidence of any openings observed. A 0.5m diameter clay pipe outfall was identified protruding from the base of the manhole chamber (photograph 9). No water was witnessed flowing from the clay pipe outfall, although the surrounding ground was wet with silt over vegetation observed at the outfall, indicating evidence of recent flows (photograph 10).

| Photo No. <b>7 &amp; 8</b> | Job Reference & Number:<br>W10833 – Abbey Road, Wrexham Industrial Estate | |
|---|---|---|
| <p><b>Description:</b></p> <p>7. Looking north – showing manhole chamber at origin of ditch</p> <p>8. Looking north-west – manhole chamber from the ditch</p> | | |

At the downstream extent of the ditch the 375mm diameter clay pipe inlet to the ditch was found to contain water to 6.15m upstream of the inlet. However, beyond 6.15m the drain was found to be 90% blocked with sludge and silt. The origin of the 375mm drain is unknown, however it is likely based on the very small flows to the ditch that the drain is redundant or serves a very limited catchment. Based on the very small amount of water observed to be entering the ditch from the 375mm inlet, it can be assumed that the 2No. 300mm outlets from concrete manhole chamber MH01 are largely unused. It can be concluded that the ditch does not have connectivity to the surrounding watercourses and facilitates negligible flows within the public / highway sewer system and could therefore be dismantled and the ditch infilled subject to a diversion of both the upstream and the downstream inlets.

In order to facilitate the infilling of the ditch and the removal of MH01 and associated infrastructure, a new piped drain will be formed from the inlet upstream of the ditch to MH03 within the north-west of the site or MH02, following a path conducive to the development. This will allow the ditch, MH01

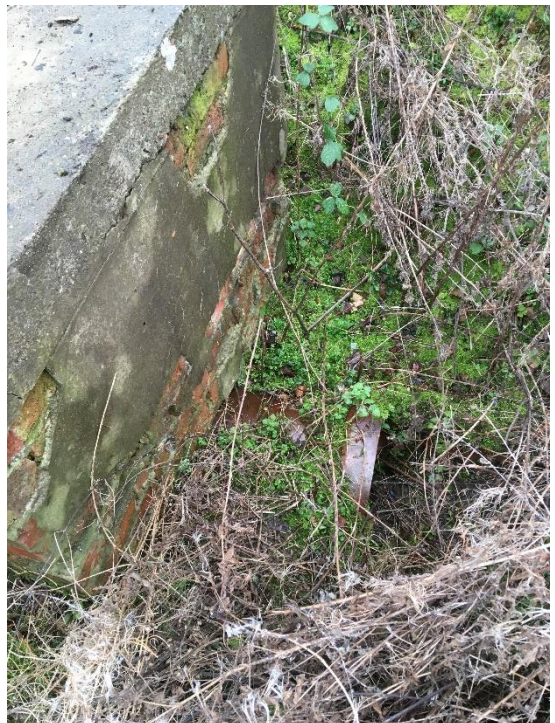
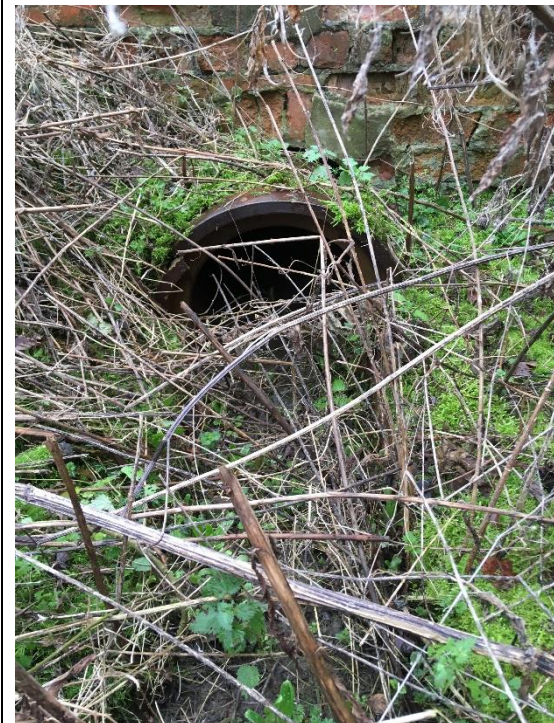
| Photo No. <b>9 &amp;10</b> | Job Reference & Number:<br>W10833 – Abbey Road, Wrexham Industrial Estate | |
|---|---|---|
| <p><b>Description:</b></p> <p>9. Looking down at 0.5m clay pipe outfall protruding from manhole chamber</p> <p>10. Looking at 0.5m clay pipe outfall - showing silt over vegetation within pipe. No water present</p> | | |

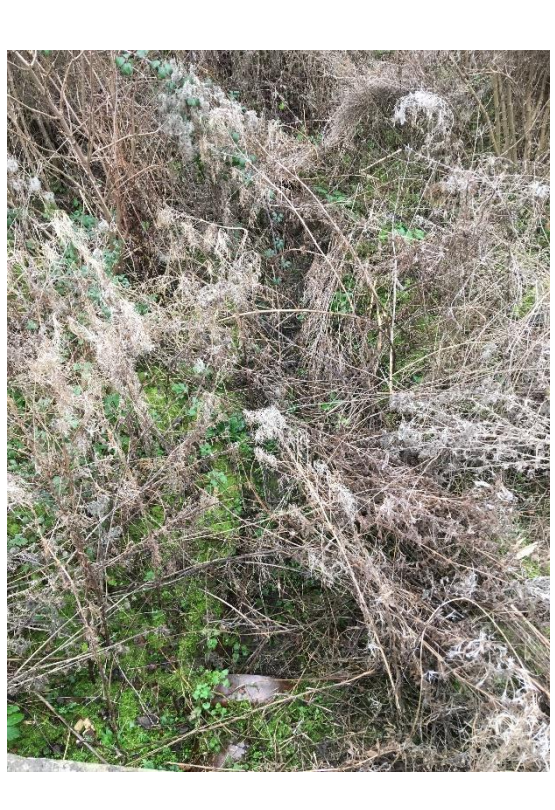
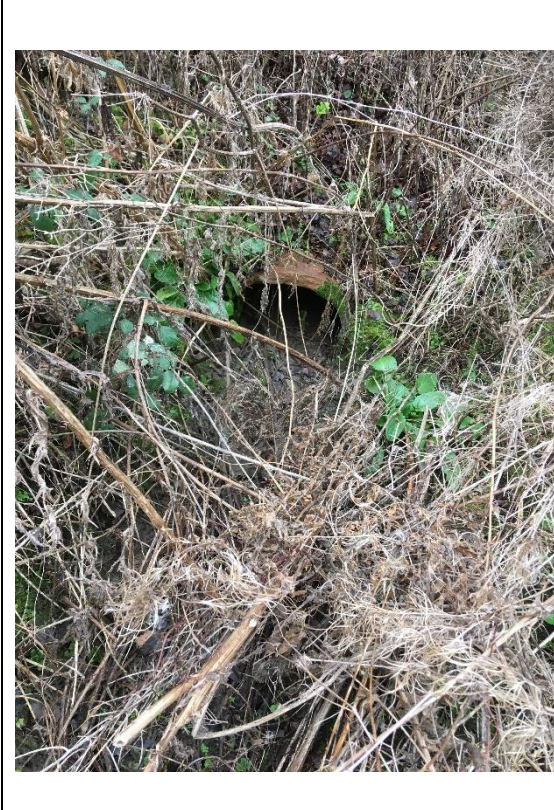
Approximately 4m east of the manhole chamber a 0.4m diameter clay pipe outfall was identified protruding from the ground (photograph 11 and 12). The 0.4m clay pipe outfall appears to feed into the ditch with silt over vegetation observed at the outfall, however no water was witnessed flowing

| Photo No. <b>11&amp;12</b> | Job Reference & Number:<br>W10833 – Abbey Road, Wrexham Industrial Estate | |
|---|---|---|
| <p><b>Description:</b></p> <p>11. Looking south-east from manhole chamber -showing 0.4m clay pipe outfall approximately 4m east</p> <p>12. Looking at 0.4m clay pipe outfall - showing debris and silt over vegetation within the pipe</p> | | |

Furthermore, if the 375mm pipe identified at the downstream extent of the ditch is traced as part of the enabling works and is found to be active, this should be replaced with a new pipe outfalling to MH03 following a path conducive to the development. Alternatively, the 375mm drain could be diverted to the to the drain identified adjacent to the eastern boundary of the site.

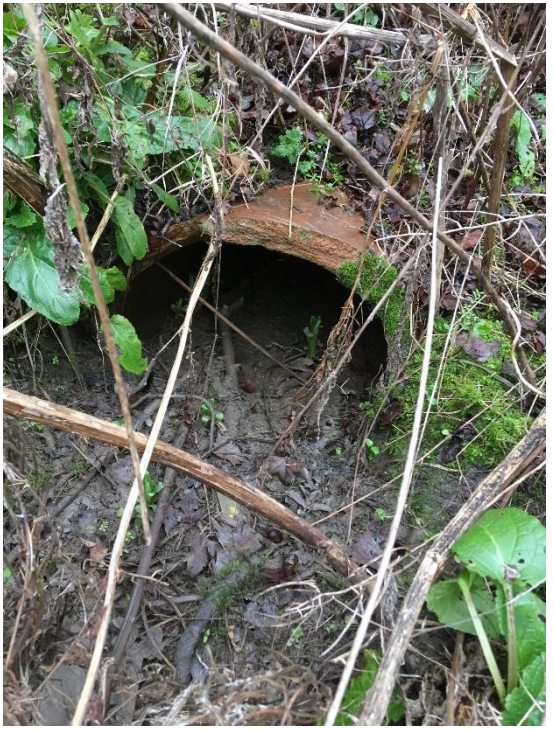
| Photo No. <b>13&amp;14</b> | Job Reference & Number:<br>W10833 – Abbey Road, Wrexham Industrial Estate | |

from the pipe. The 0.4m clay pipe outfall also contained debris and was overgrown with vegetation (photograph 13).

A stone wall was located at the south-eastern extent of the ditch (approximately 2.5m from the southern boundary of the site) (photographs 14 and 15). The stone wall is 2m wide x 0.5m deep and forms the end of the ditch. The ground at the south-eastern extent of the ditch was dry with no evidence of water present. An outlet was not identified within the wall however, if present this may have been obscured from view by vegetation and/or siltation. An annotated Site Plan, which shows key features and photograph locations is enclosed.

| Photo No. <b>13&amp;14</b> | Job Reference & Number:<br>W10833 – Abbey Road, Wrexham Industrial Estate | |
|---|---|--|
| <p><b>Description:</b></p> <p>13. Looking at 0.4m clay pipe outfall showing debris and silt. No water present in pipe</p> <p>14. Looking south-east showing stone wall at south-eastern end of ditch</p> | | |
