**Mrs Hughes**

Home Farmhouse, Wrexham Road, Holt

**Bat Survey**

June 2019

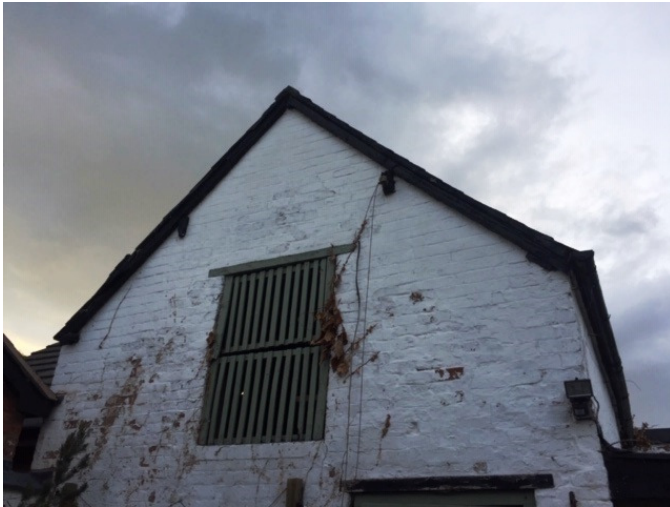
The building itself is a small (size of a garage) old two storey brick-built barn building with a pitched slate roof (Plates 1-6). The upper and lower floors are separated by a wooden floor with wooden stairs leading to the upper section. The roof void was exposed with no separate loft space, with exposed wooden beams present. Beams were clean, with no cobwebs or detritus. There was no insulation or underfelt present on the roof itself exposing the underside of the roof slates. On the southern aspect of the building, a wooden slatted, disused entrance door was present. A single storey, flat roofed brick building was present attached to the west side of the building (plate 2).

A1.1      Plate 1: View of the Southern Aspect of the building

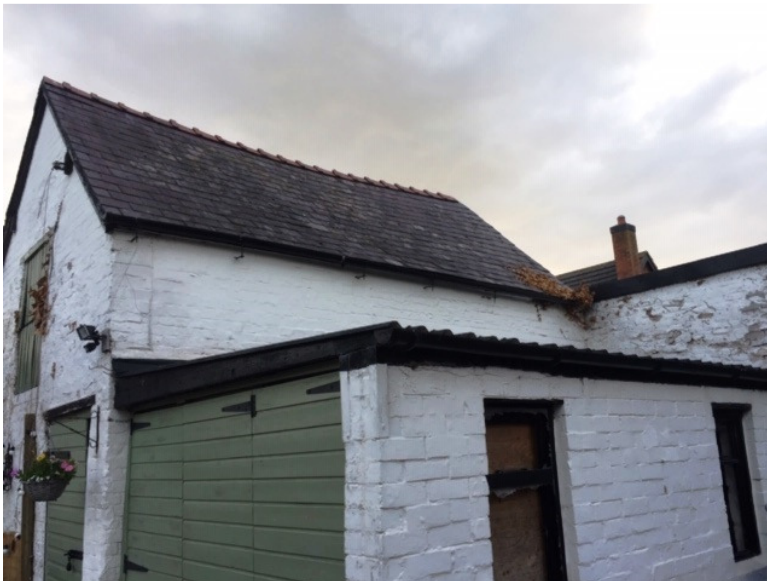
3.2.4 The single storey flat roofed garage building connected to the two storey building had no features that could be used by bats and no evidence of usage by bats or actual presence of bats were found during the external and internal inspection.

A1.2.      Plate 2: View of the western side of building with adjoining single storey garage

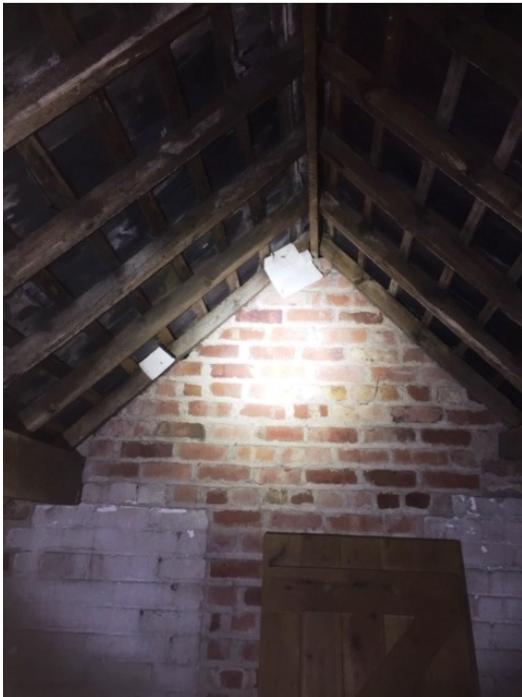
A1.4: Plate 4: Interior view of Northern aspect of building

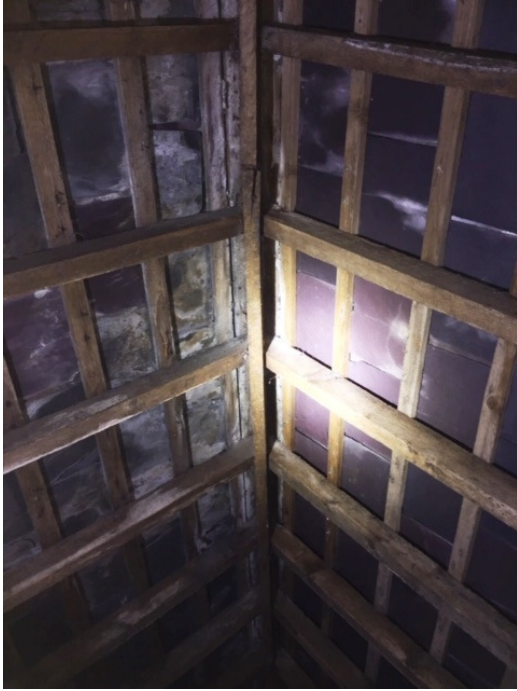
3.2.2 Some gaps suitable for bats did exist within the building. These included gaps between wooden slats of the first floor door allowing access in to the outbuilding, small gaps under wooden facias on the north gable end, and gaps from occasional slipped, missing and broken tiles on both sides of the pitched roof. The space behind the fascia boards was checked using torches and binoculars and gaps present did appear to predominantly be shallow and covered in cobwebs. The gaps within the slates did not provide roosting opportunities for bats that could not be visually assessed because the underside of the slates could be checked as no roof membrane was present and no bats or evidence of bats using the internal roof structure was seen. The brick walls were single skin and had no insulation therefore did not provide any potential for roosting bats.

A1.5: Plate 5: Interior view of roof showing exposed wooden beams.

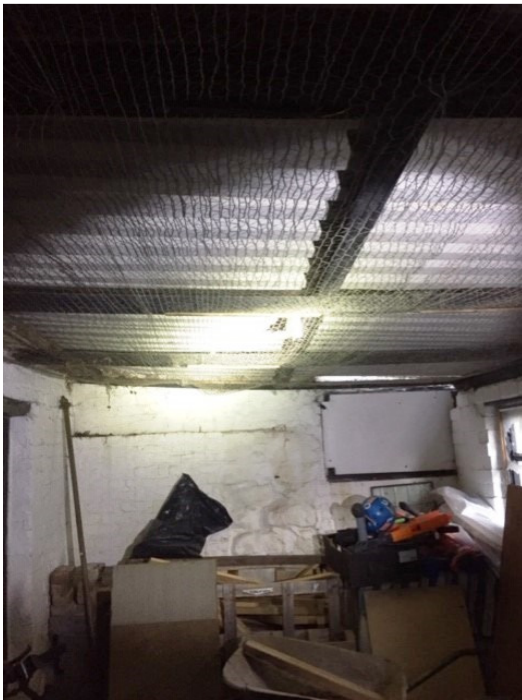
A1.6: Plate 6: Interior view of adjoining single storey garage of building.
