**Gatewen Road, Wrexham, Wales**

**Road Safety Audit Stage 1**

**TMS reference no: 15050**  
**Date: 28<sup>th</sup> June 2019**

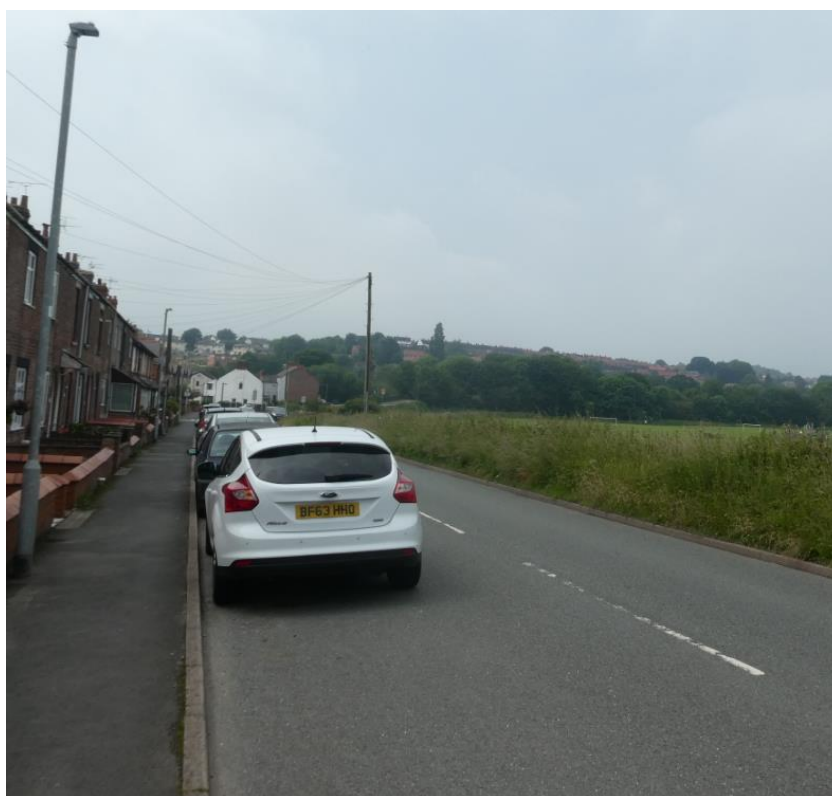
### 2.1 PROBLEM

Location – Gatewen Road, proposed pedestrian crossing west of the development access

Summary: Risk of obstruction or injury for pedestrians

Existing on-street parking was observed on Gatewen Road at the location of the proposed pedestrian crossing, west of the development access. Parked vehicles may obstruct movements and inter-visibility for pedestrians attempting to cross and increase the risk of potential injury or collisions.

Measures to prevent parked vehicles obstructing the crossing point should be introduced at detailed design stage.

It may be beneficial to provide the crossing point on a ramped raised table in place of the proposed speed cushions, providing a traffic calming feature and level surface for crossing pedestrians. An existing example of this was observed just west of the proposed access location on Gatewen Road.

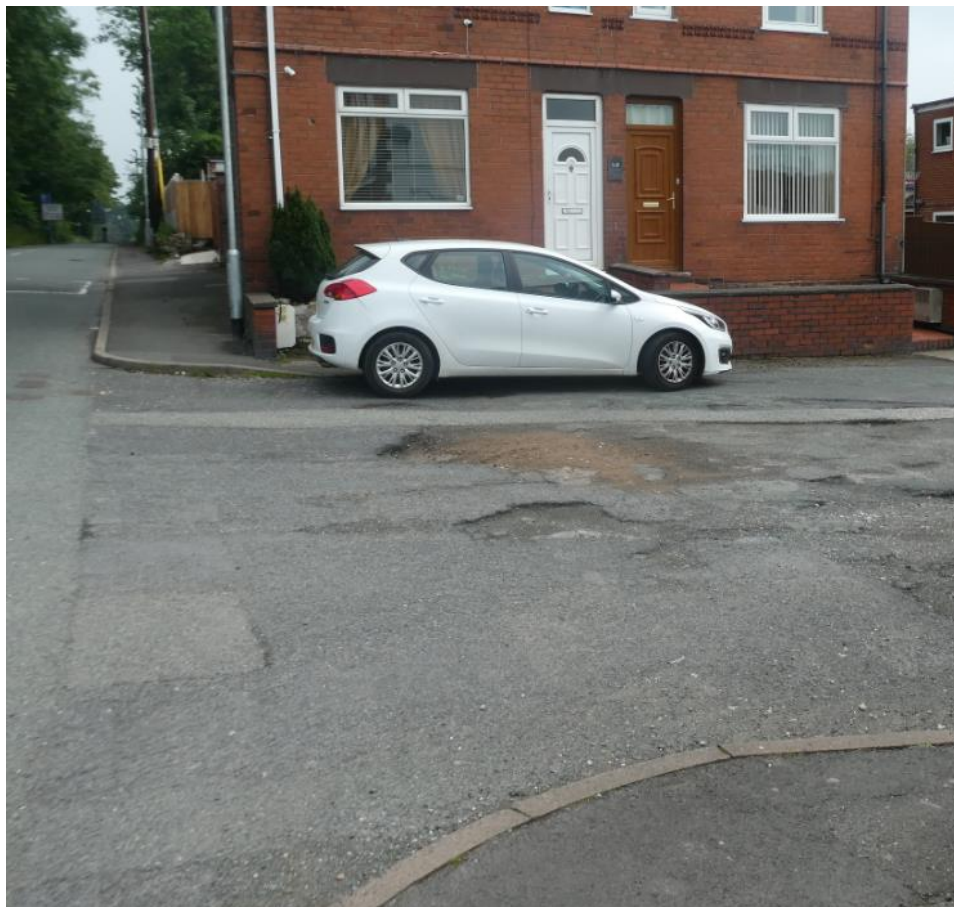
## 2.3 PROBLEM

Location – Gatewen Road, junction with New Road

Summary: Risk of tripping or injury for pedestrians

There are no existing dropped kerb crossing facilities at the junction of New Road and Gatewen Road and the existing carriageway surface was observed to be in poor condition with large potholes. The proposed development may create a desire line for pedestrians to cross at this location, increasing the risk of trips and falls, and potential injury when crossing at high kerbs and travelling on the uneven surface.

Potential pedestrian desire lines created by the development should be assessed and pedestrian crossing facilities provided or improved where required at detailed design stage.

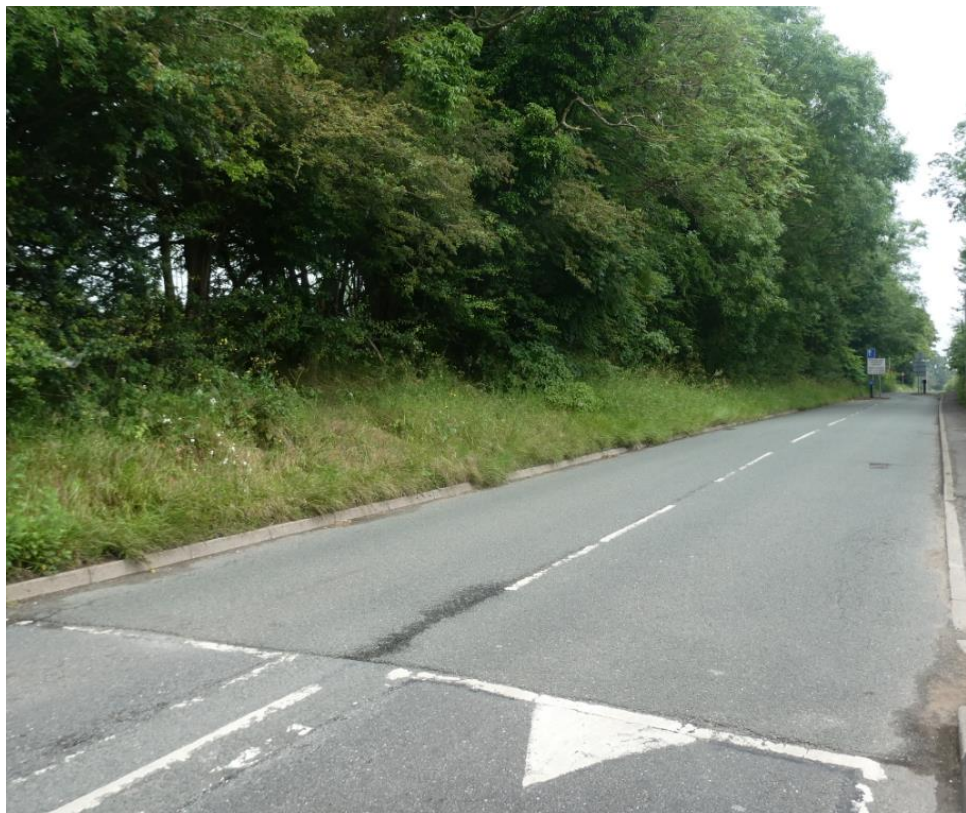
## 2.4 PROBLEM

Location – Gatewen Road, proposed footway link east of development

Summary: Risk of injury or collisions for road users during darkness

The existing street lighting on the northern side of Gatewen Road currently terminates at the location of the development access, which means the proposed footway link on the east side of the development may not be illuminated. Pedestrians and cyclists travelling along the northern side of Gatewen Road may not be visible to other users approaching and be at risk of injury or collision.

The existing street lighting should be reviewed and improved as necessary to ensure the proposed footway and junction are sufficiently illuminated (see also 2.5).

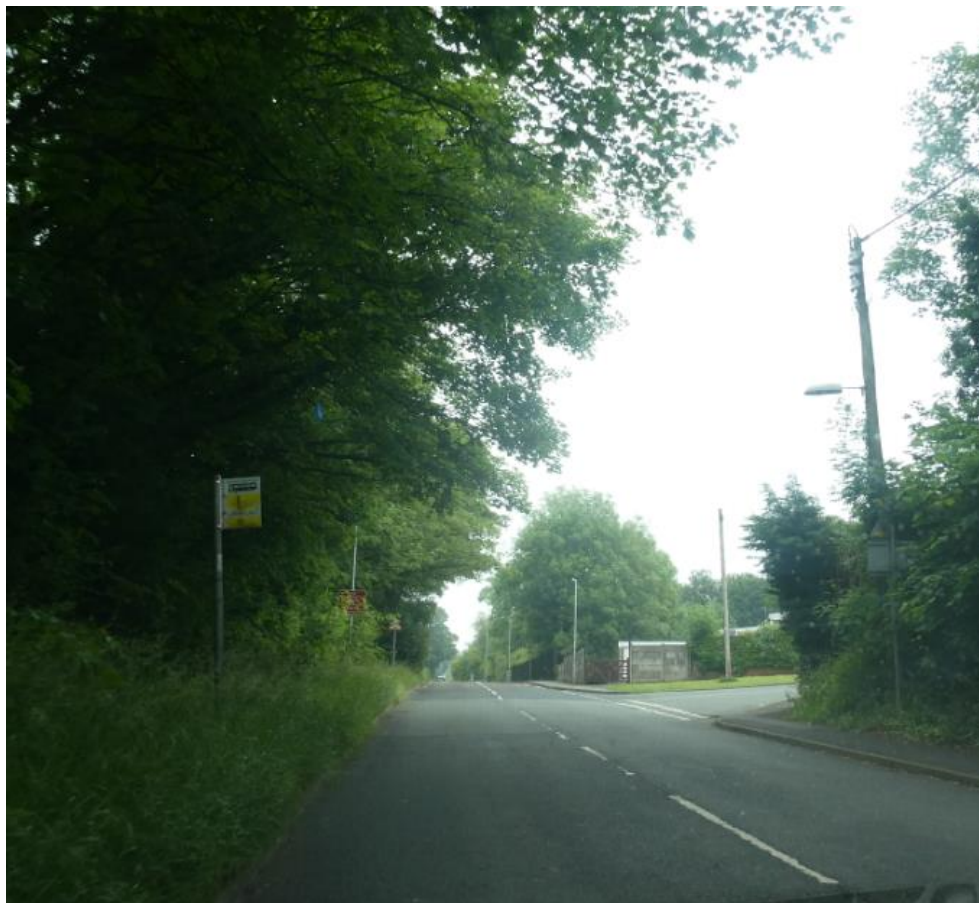
## 2.5 PROBLEM

Location – Gatewen Road, proposed footway link east of development

Summary: Risk of collisions for non-motorised users

The intended distance of the footway link on the eastern side of the development is not shown. If the footway terminates at an unsuitable location, non-motorised users may be at risk of being struck by approaching vehicles if they are required to travel in the carriageway to reach surrounding facilities, for example, an eastbound bus stop on Gatewen Road (pictured) and the existing shared footway / cycleway at the Gatewen Road roundabout.

The proposed footway on the northern side of Gatewen Road should connect to existing footway or cycleway provisions east of the development.

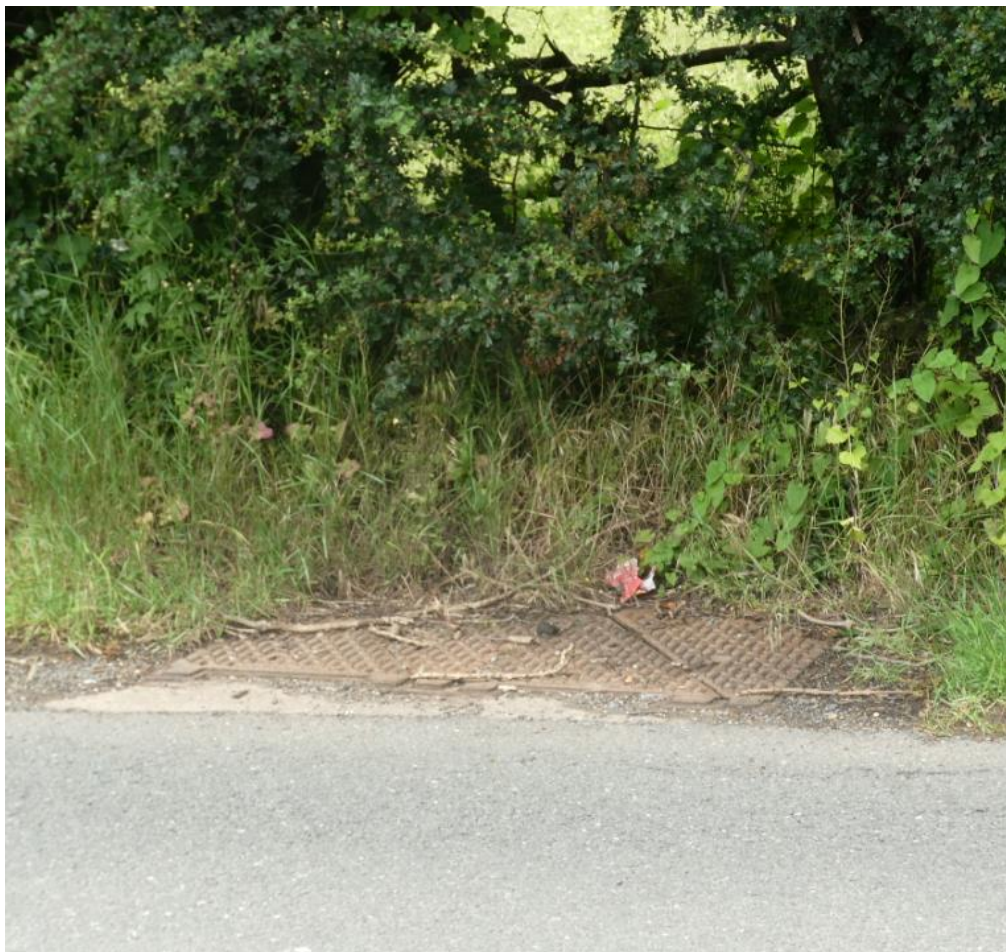
## 2.6 PROBLEM

Location – Gatewen Road, proposed access junction

Summary: Risk of skidding or loss of control for motorcycles

An existing services chamber in the northern verge on Gatewen Road may be in the bell mouth of the proposed access junction. This may present a skidding hazard for turning motorcycles, particularly during wet or icy conditions. If the cover is not designed for vehicle loading it may become sunken or dislodged, further presenting a loss of control hazard for vehicles.

The cover should be relocated from the proposed junction carriageway.

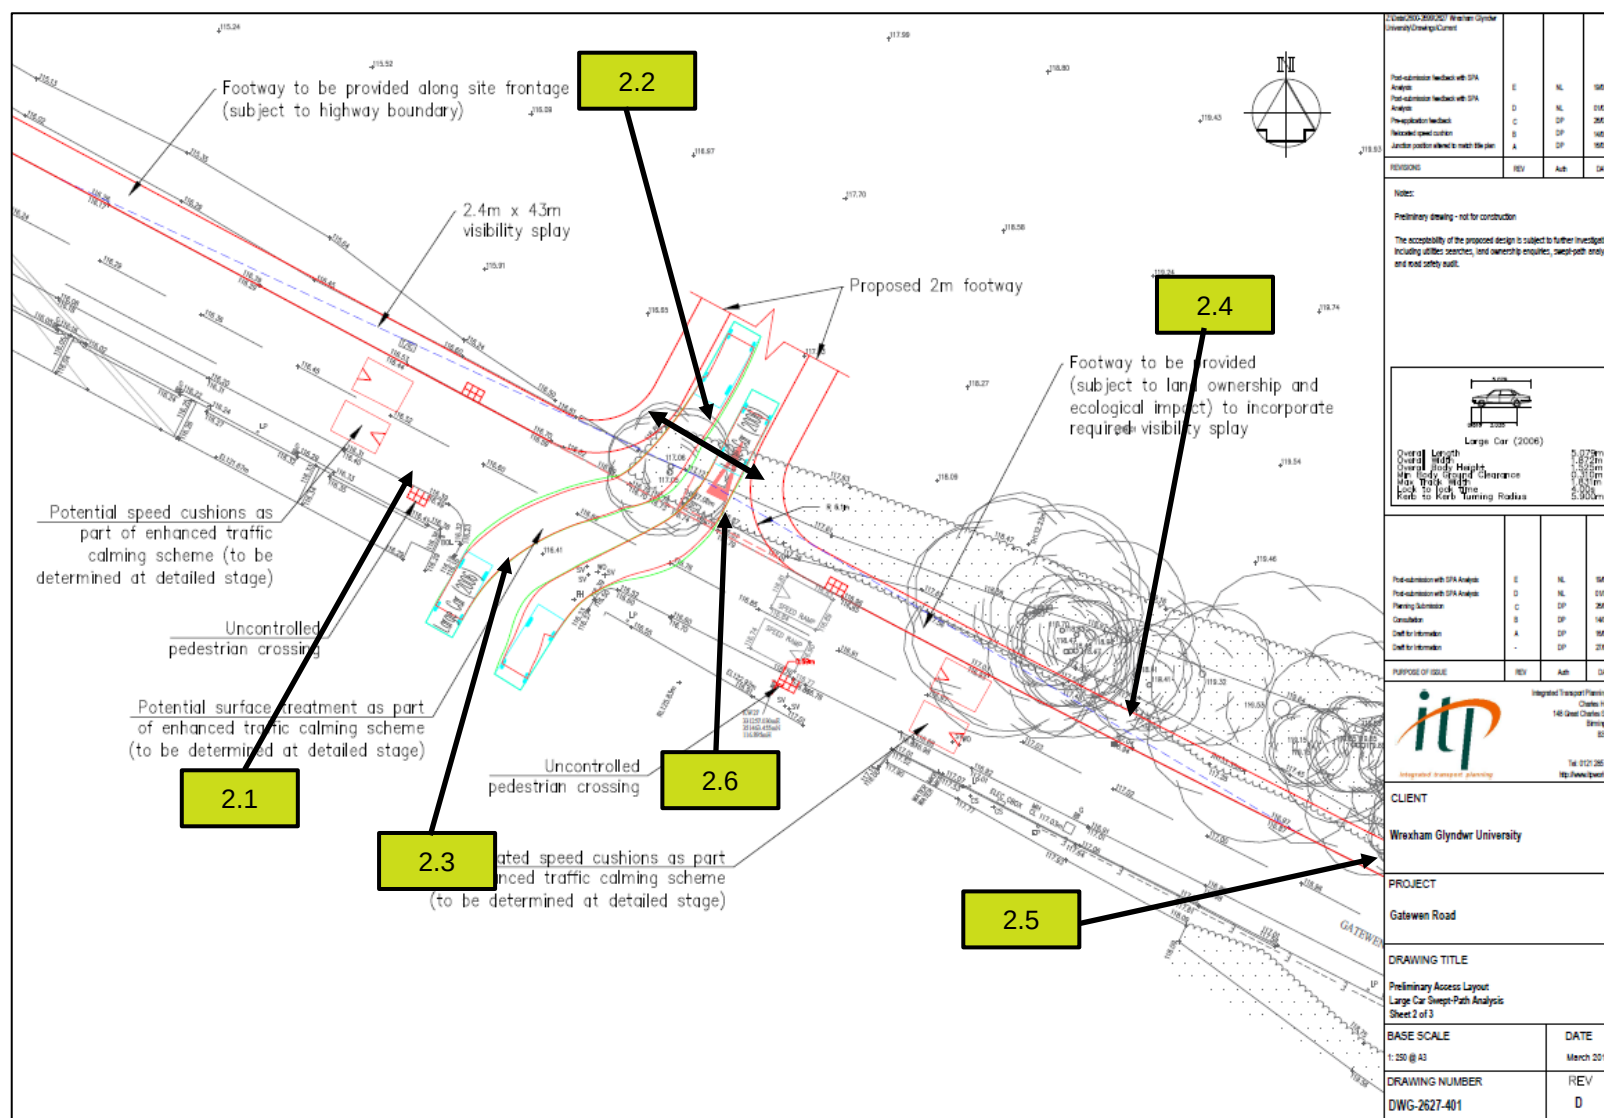
Scheme: Gatewen Road, Wrexham, Wales

Please refer to the following page for a plan illustrating the locations of the problems identified as part of this audit (location numbers refer to paragraph numbers in the report).
