## Geo-Environmental Investigation & Assessment

Coch Road

Wrexham

**Report Ref: A2217/17**

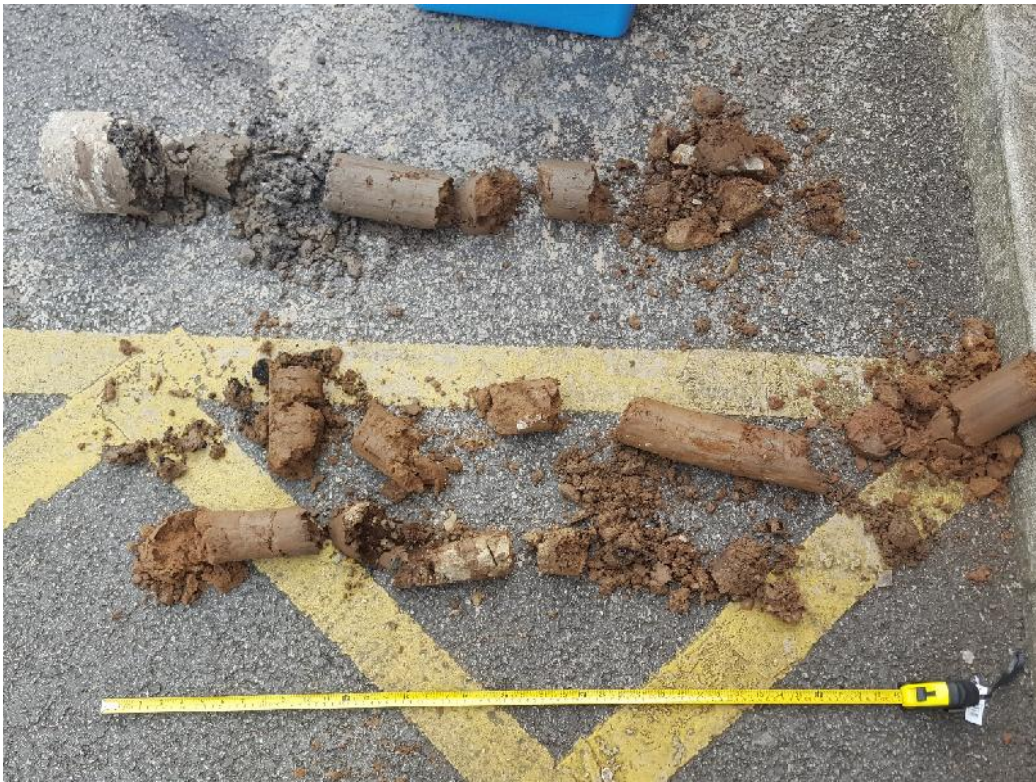
Figure 7 Photograph of samples recovered from WS1

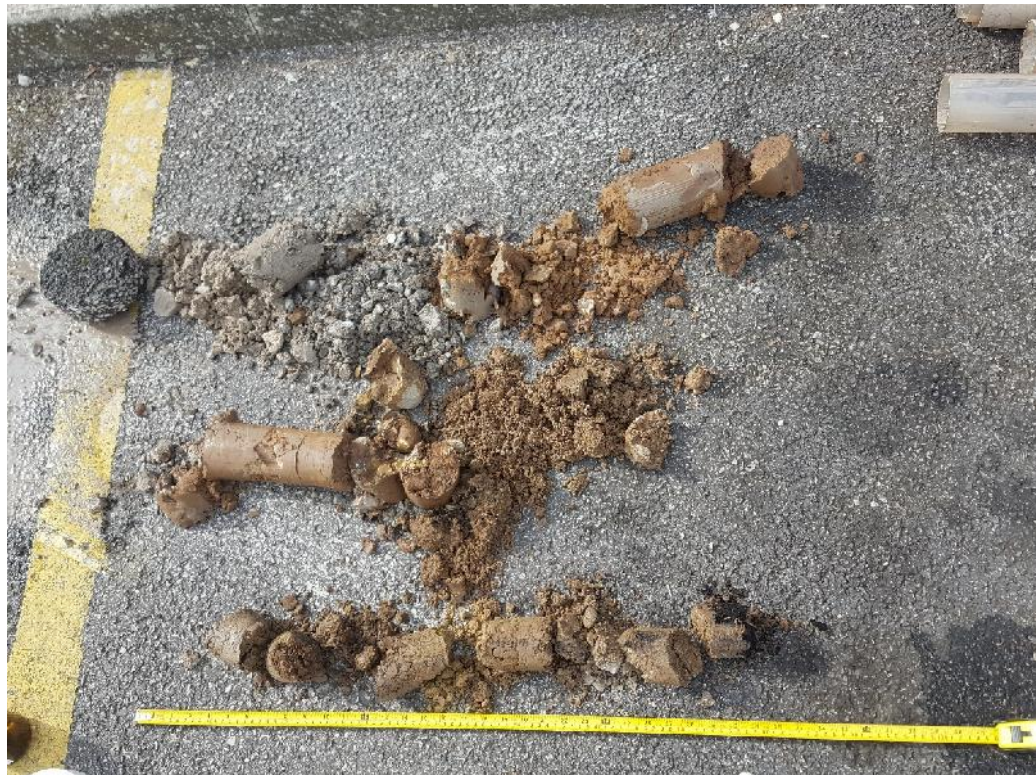
Figure 8 Photograph of samples recovered from WS2

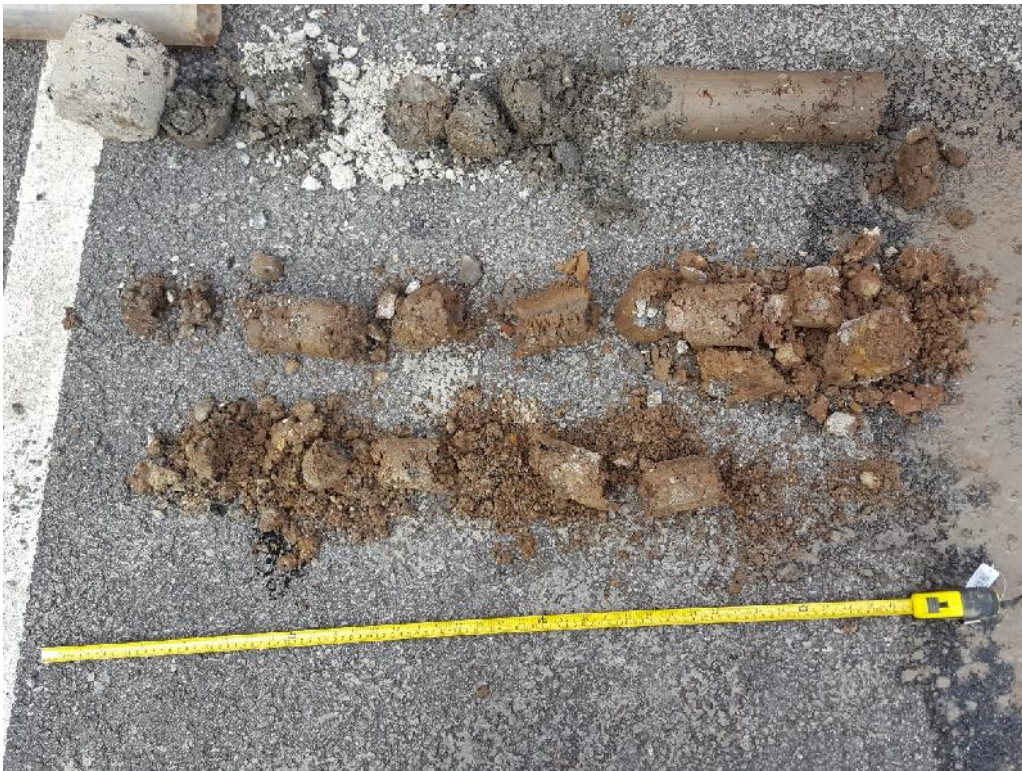
Figure 9 Photograph of samples recovered from WS3

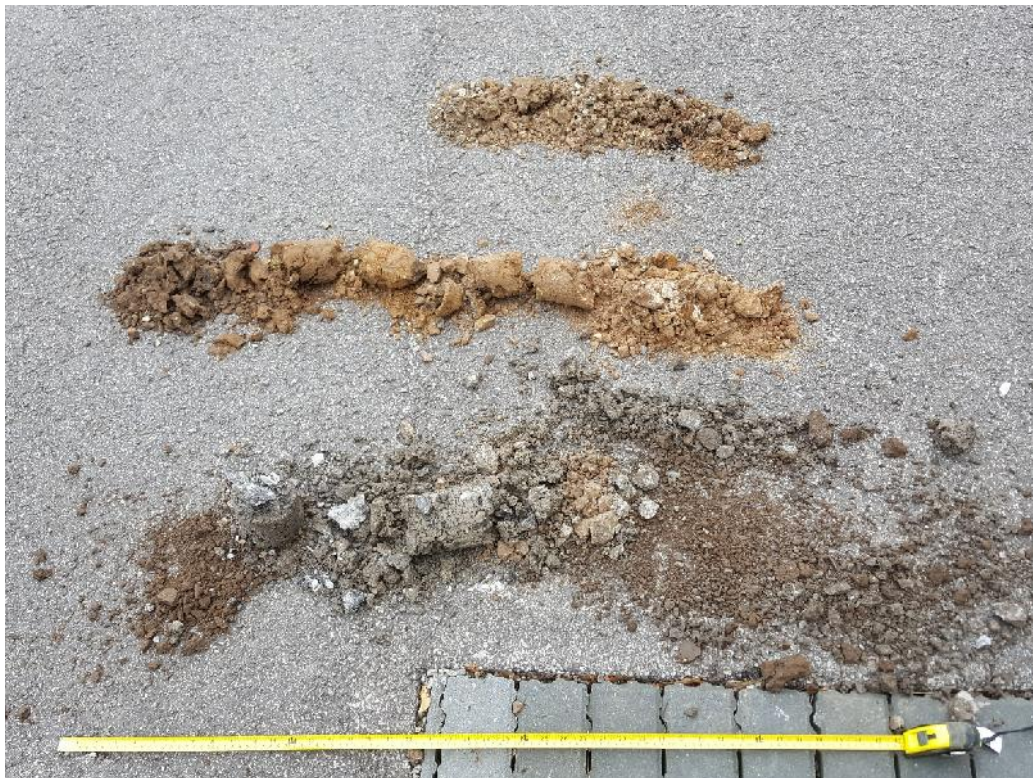
Figure 10 Photograph of samples recovered from WS4

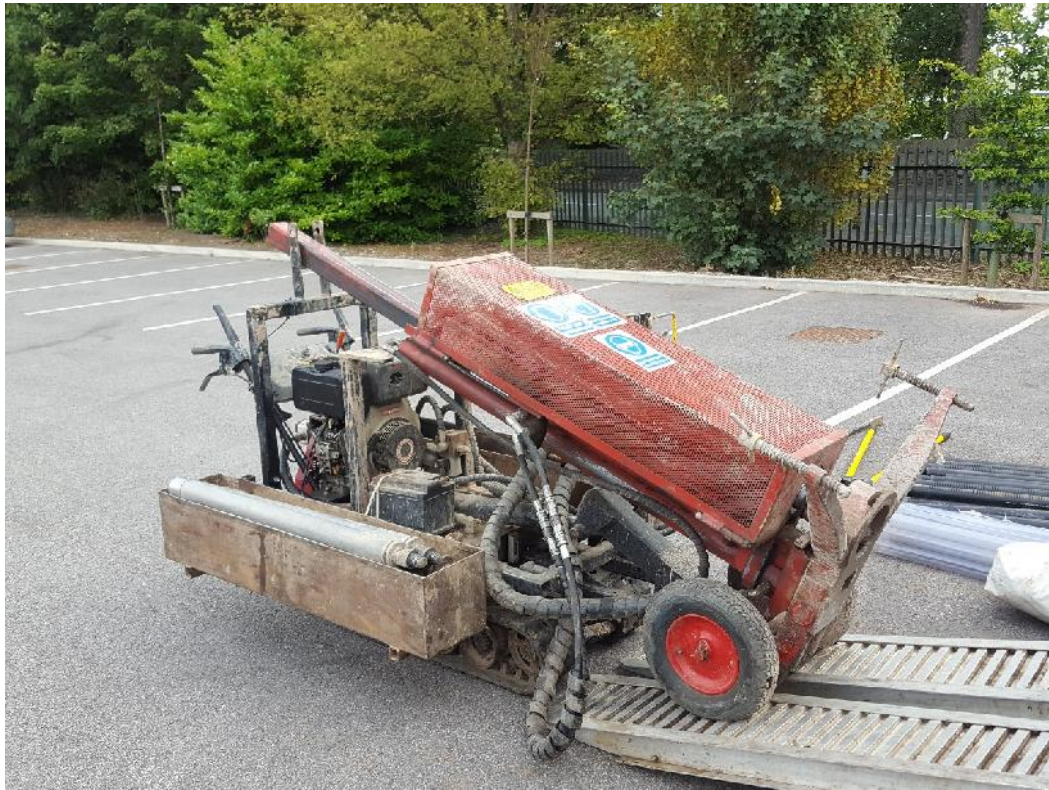
Figure 11 Photograph of rig used to carry out drilling

- Four window sample boreholes (designated WS1 to WS4 inclusive) were each sunk to depths of 3.00m below existing ground level. Window sampler boring is carried out with a small, track-mounted rig, which uses a chain-driven trip hammer to drive sampling tubes or penetrometers into the ground. These tools are coupled to the anvil of the hammer by solid drill rods. Sampling tubes comprise “windowless samplers”, which are plain sampler tubes in which a continuous disturbed sample is recovered within a semi-rigid plastic liner. In order to reduce friction within the borehole, sampling tubes of progressively smaller diameter are used as the borehole depth increases. Sampler diameters generally range from between approximately 90mm to 50mm. Standard Penetration Tests (SPTs) were undertaken in the boreholes in accordance with BS EN ISO 22476-3. Exploratory Hole logs are included in Appendix 1.
