**REDWITHER CENTRAL AREA,  
WREXHAM INDUSTRIAL ESTATE,  
WREXHAM**

**STAGE 1 PRELIMINARY  
ENVIRONMENTAL RISK  
ASSESSMENT**

**For: Wrexham County  
Borough Council**

**R1570-R01-v2**

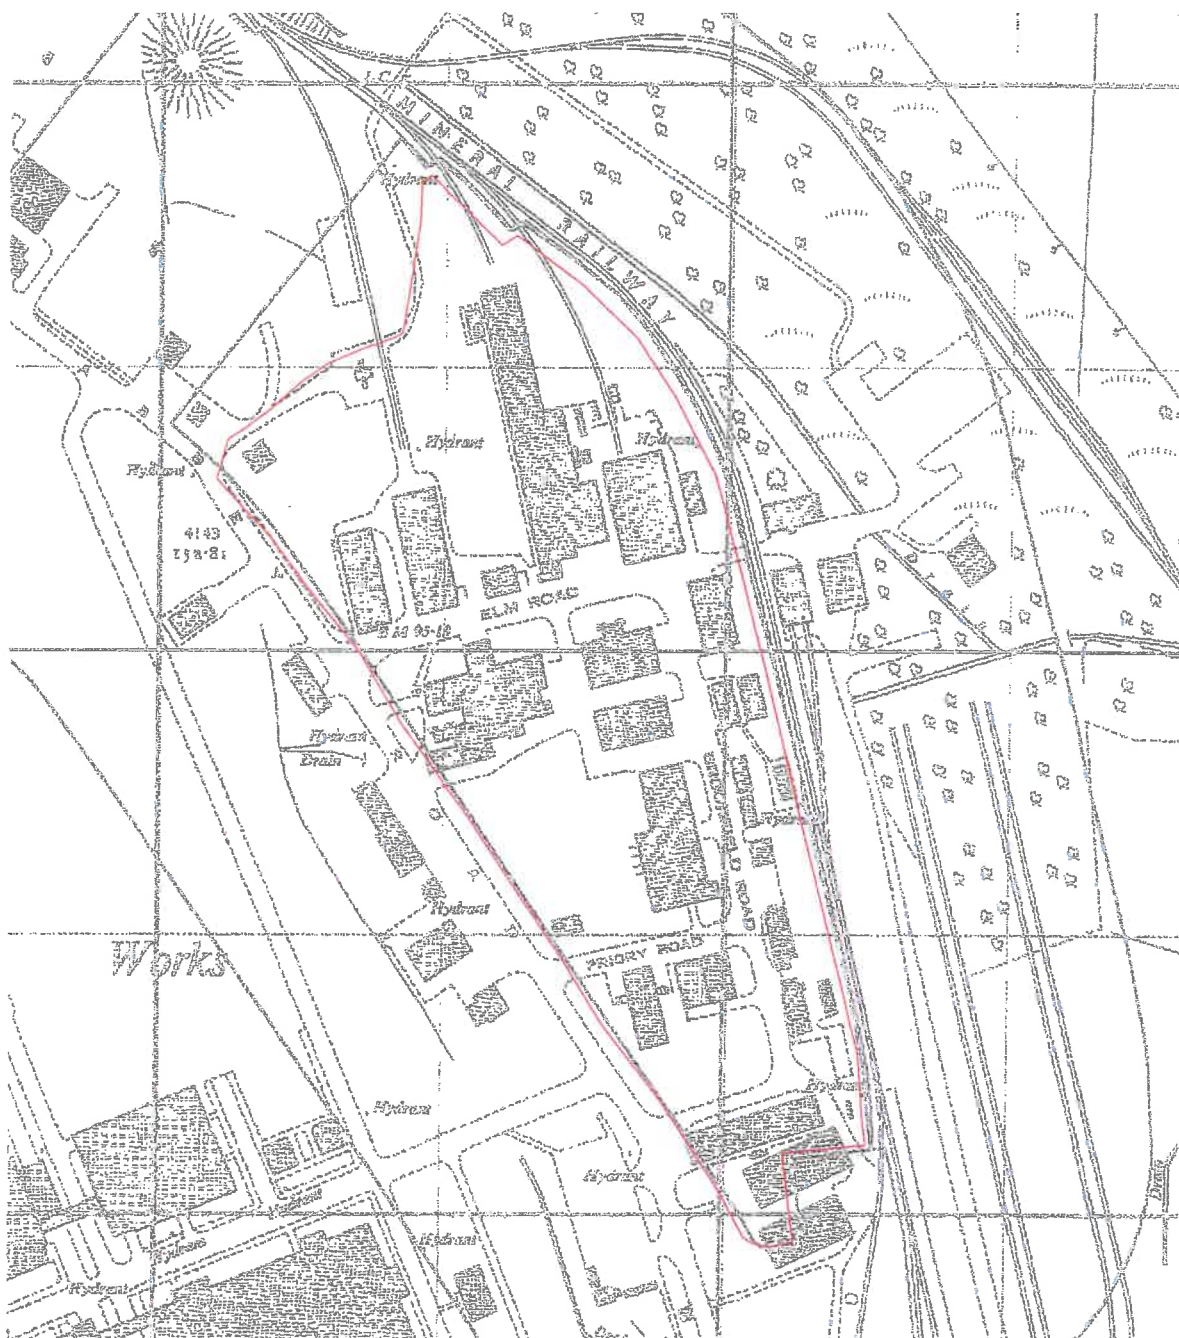
Drg No: D04

| map | site | surrounds |
|---|---|---|
| 1961, 1:2,500<br>1964, 1:10,000<br>see Drawing D04 | Site is fully developed to series of works buildings located on Abbey Road, Elm Road, Priory Road and Brookfield Road. A mineral railway line bounds the site to the north and east and from which a number of branch lines enter the site in the north. A drain appears to pass west to east across the centre of the site emerging as an open drain to the east. | <p>Surrounding land has been extensively developed to industrial / works facilities. A mineral railway bounds the site to the east with sidings present to the southeast. Ground to the east is shown as rough ground with a number of mineral railway lines and drains. A large works is present to the southwest across Abbey Road, and further works are present to the northwest.</p> <p>A small unidentified mound or shaft is marked 120m to the northwest.</p> <p>Large number of individual buildings located within bunkers present within 400m to the southeast, south and southwest typical of military explosive manufacture facilities.</p> |

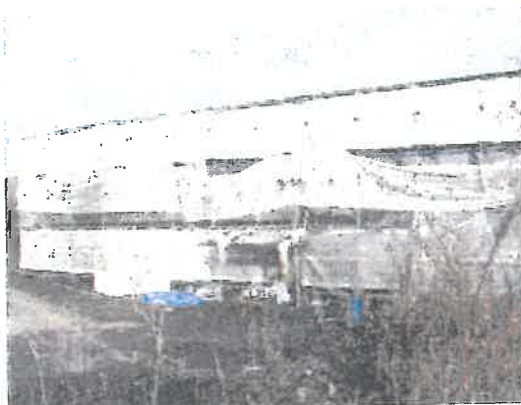
13. Residual scaffolding to rear of Unit 226

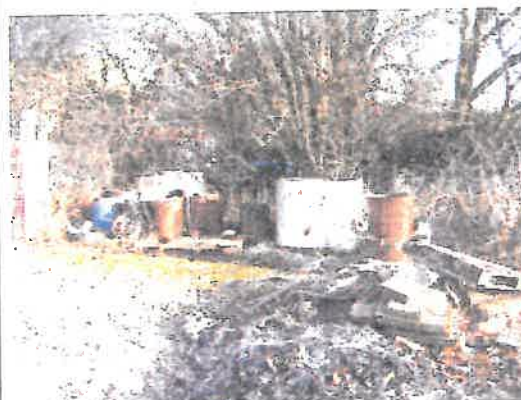
15. Alongside Unit 230

| Unit No | Occupier | Comments |
|---|---|---|
| 230 | | disused metal drums and remains of burnt rubbish present |

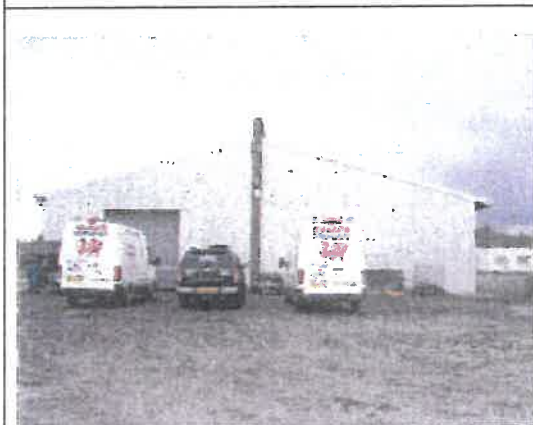
23. Unit 245 – Dragon Hydraulics

| Unit No | Occupier | Comments |
|---|---|---|
| 245 | Dragon Hydraulics (hydraulic and engineering supplies and sales) | New construction; sheet metal and brick; burning of rubbish being undertaken externally |
