**BEESELEY**

**ECOLOGICAL APPRAISAL**

**REDBROOK VIEW  
REDBROOK  
MAELOR  
WHITCHURCH  
SY13 3AD**

**MARCH 2019**

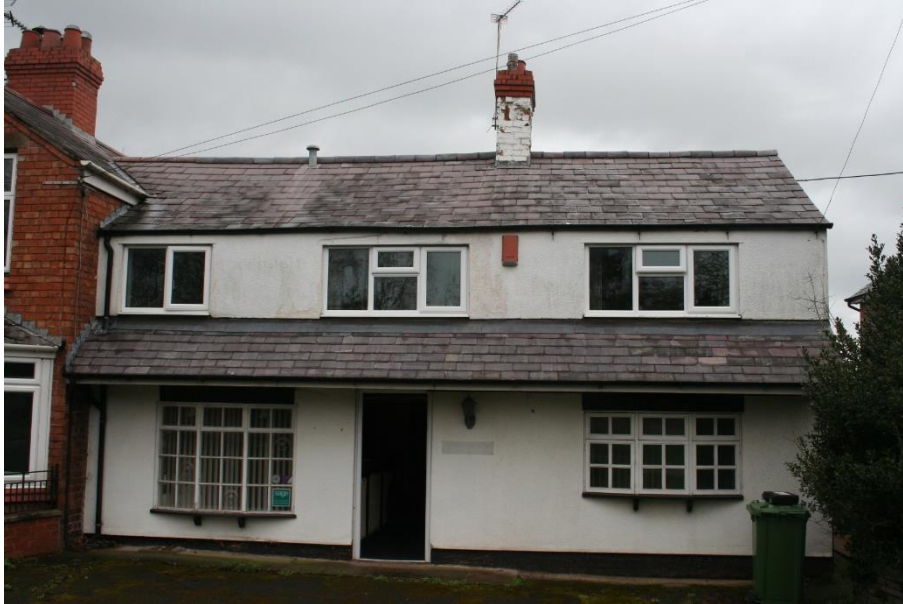
The main building is composed of the original cottage and an extension into the rear garden. The building is composed of brick and is well mortared and then painted, showing no evidence of cracks or crevices accessible for bats. No greasing or staining was present along the brickwork.

**Figure 4.2: Photo of the front of the main building, showing sealed brickwork and slate tile roof and canopy.**

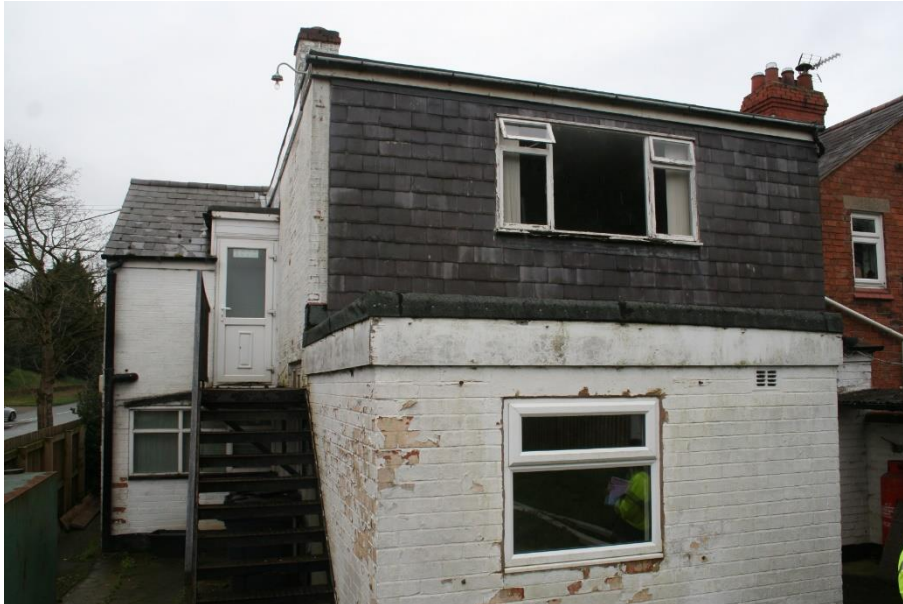
**Figure 4.3: Photo of the rear of the main building, showing hanging tiles and slate tile roof and well mortared brickwork**

The slate tile roof of the building shows few opportunities for crevice dwelling bats and no staining or greasing was evident. The slate hanging tiles showed no access points for bats.

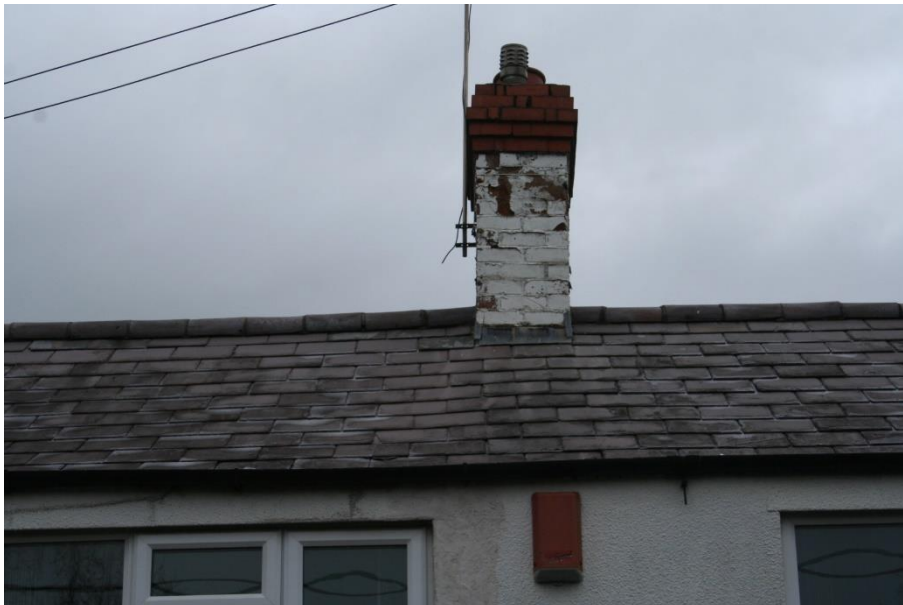
**Figure 4.5: Raised ridge tile to the west of the chimney, showing continuous gap.**

Few gaps were evident between the slate roof tiles; however, no staining or greasing was evident and only a small section of the north facing roof is to be removed to connect the new extension.

The gaps in the tiles still have potential for supporting bats, so it is recommended that these are removed by soft demolition (hand) to minimise the risk to bats.

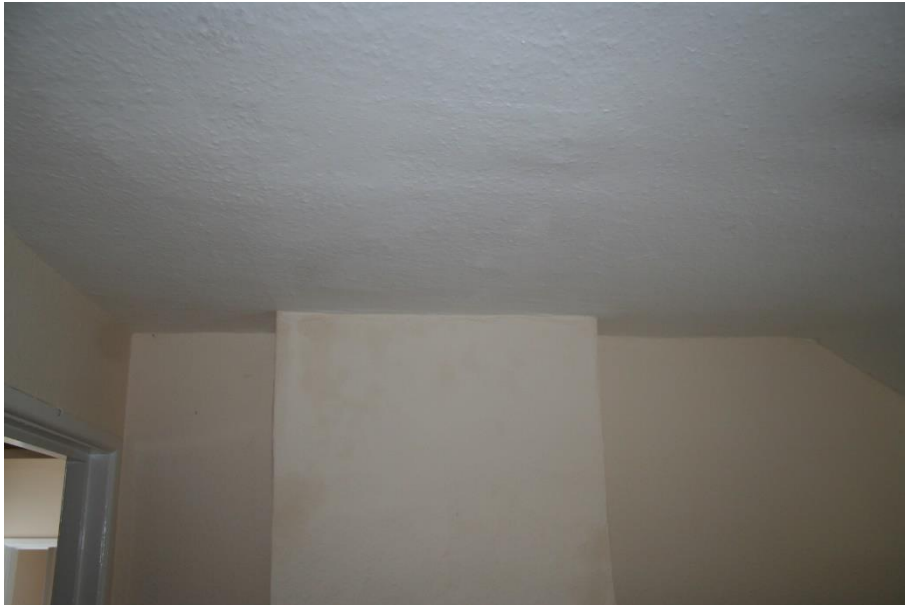
An internal assessment of the building showed no evidence of bats. No loft hatch was found to gain access to the small roof void. All storage areas were checked for the potential to support protected species.

**Figure 4.6: Internal assessment of the flat to the first floor**

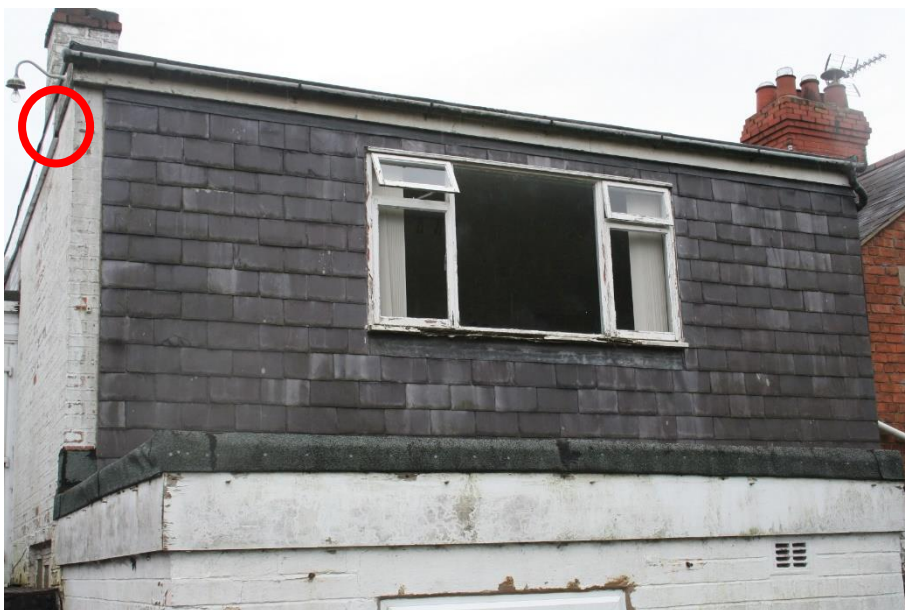
An exposed plastic fascia board was found to have potential to support bats. However, investigation with an endoscope found no evidence of bats using the board as an access point.

**Figure 4.7: Exposed plastic fascia board circled in red**

The building is of low value for bats, with no potential roost features inside the building, and the main areas of interest being the exposed plastic fascia board on the NE face of the building. The plastic fascia was examined with an endoscope and no evidence of bats was found.

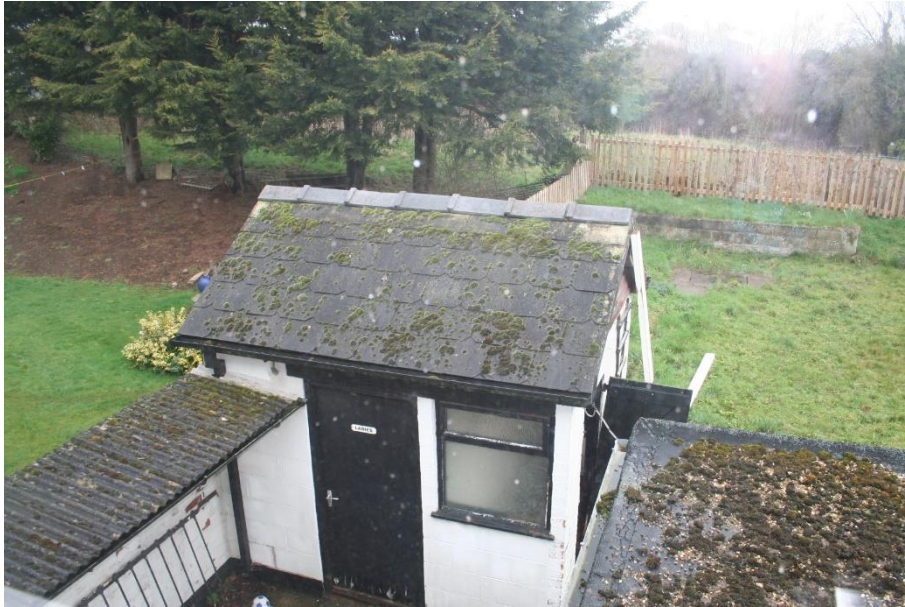
The small one-storey brick outbuilding is well mortared, showing no cracks or crevices, with well fitted semi-concrete roof tiles and wooden soffits. The out building is connected to the main building by a joining wall.

**Figure 4.8: Aerial photo of the outbuilding used as an external toilet**

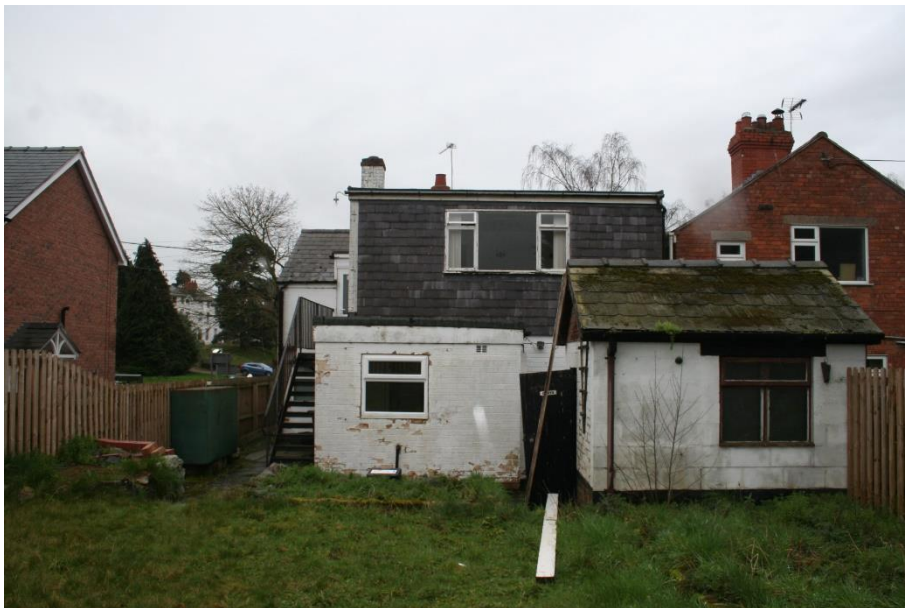
**Figure 4.9: Photo of the north facing side of the outbuilding and main building, showing hanging tiles**

No greasing or staining was found on the roof tiles or the wooden soffits. A wooden block below the soffits was found with a hole in it. The hole was investigated with an endoscope and was found to have an inactive nest inside. No evidence of bats was found.

Only one birds nest was found on site, but if this was to be reused prior to demolition then an offence would be committed by disturbance of nesting birds.

It will be recommended that nesting boxes are erected post-construction on the east facing wall, to provide a minor enhancement for any potential nesting birds.

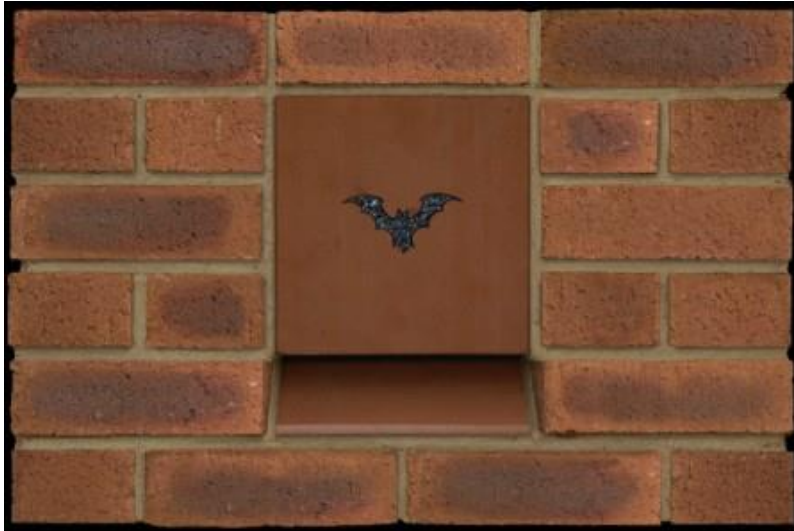
**Figure 6.1. Integral bat box**

1. It is recommended that permanent provision will be made for roosting opportunities for bats with the inclusion of an integral bat box in the extension for the east facing wall. This will be erected at a height of 3-4m.

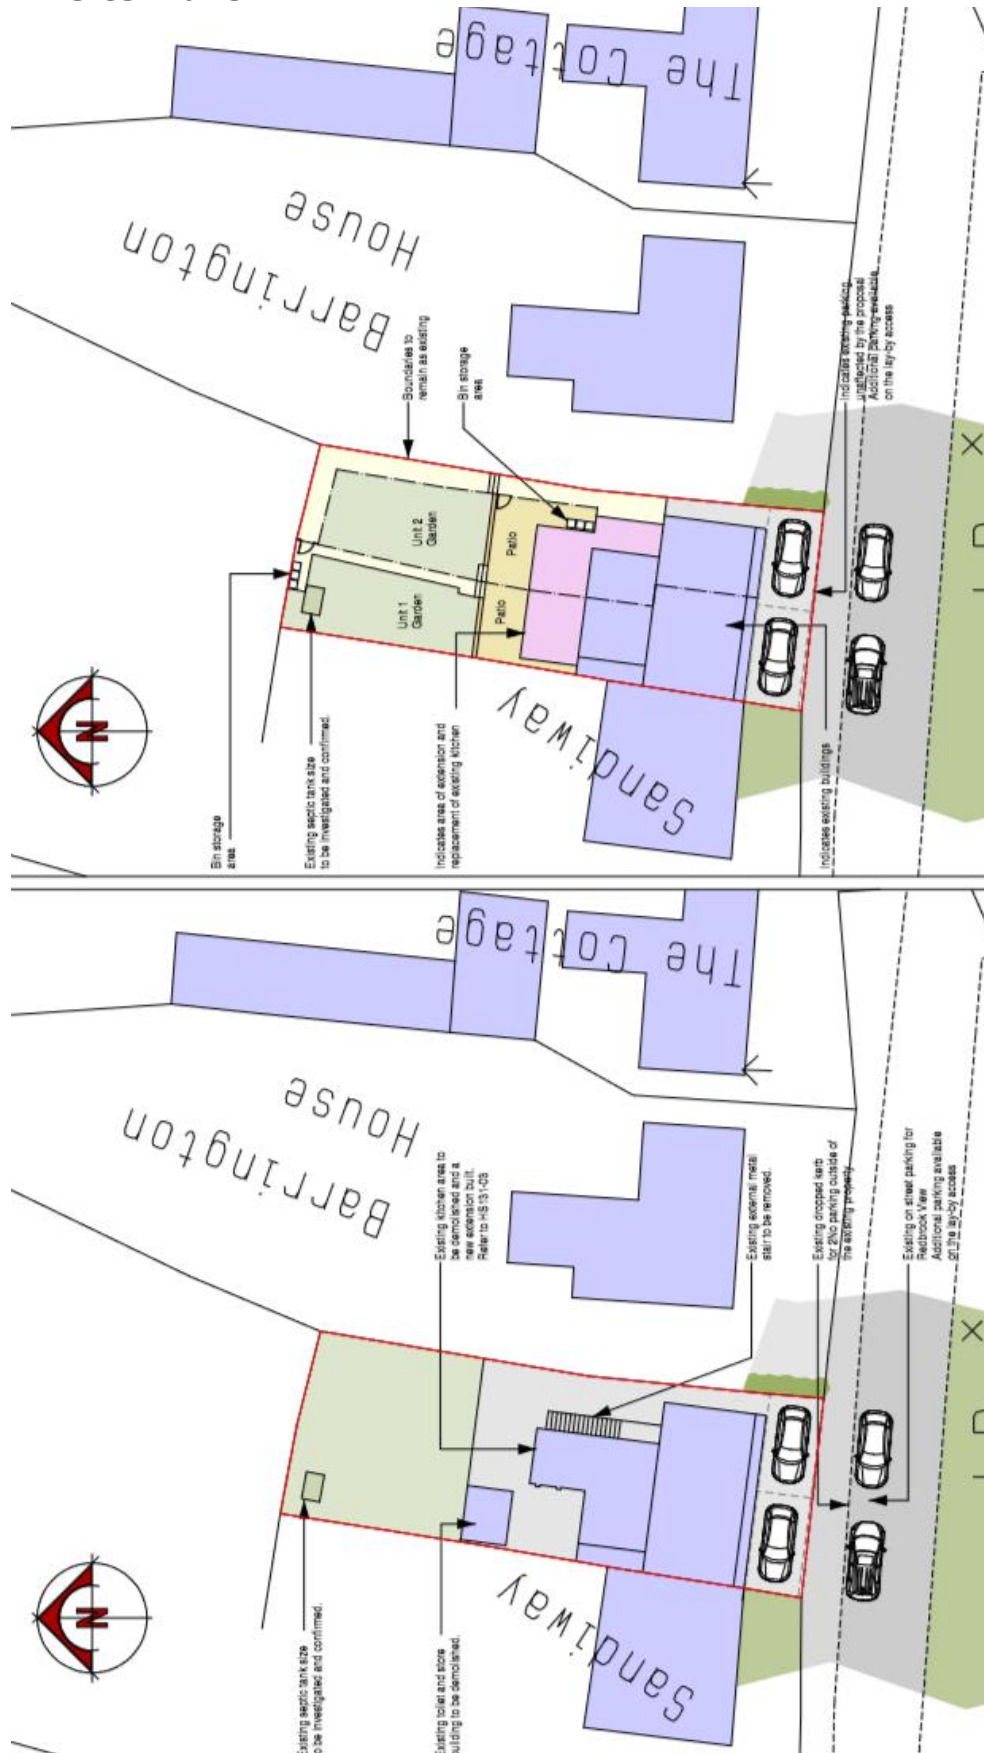
**Figure D.1: existing site plan to the left and proposed site plan to the right, for Redbrook View, Maelor**

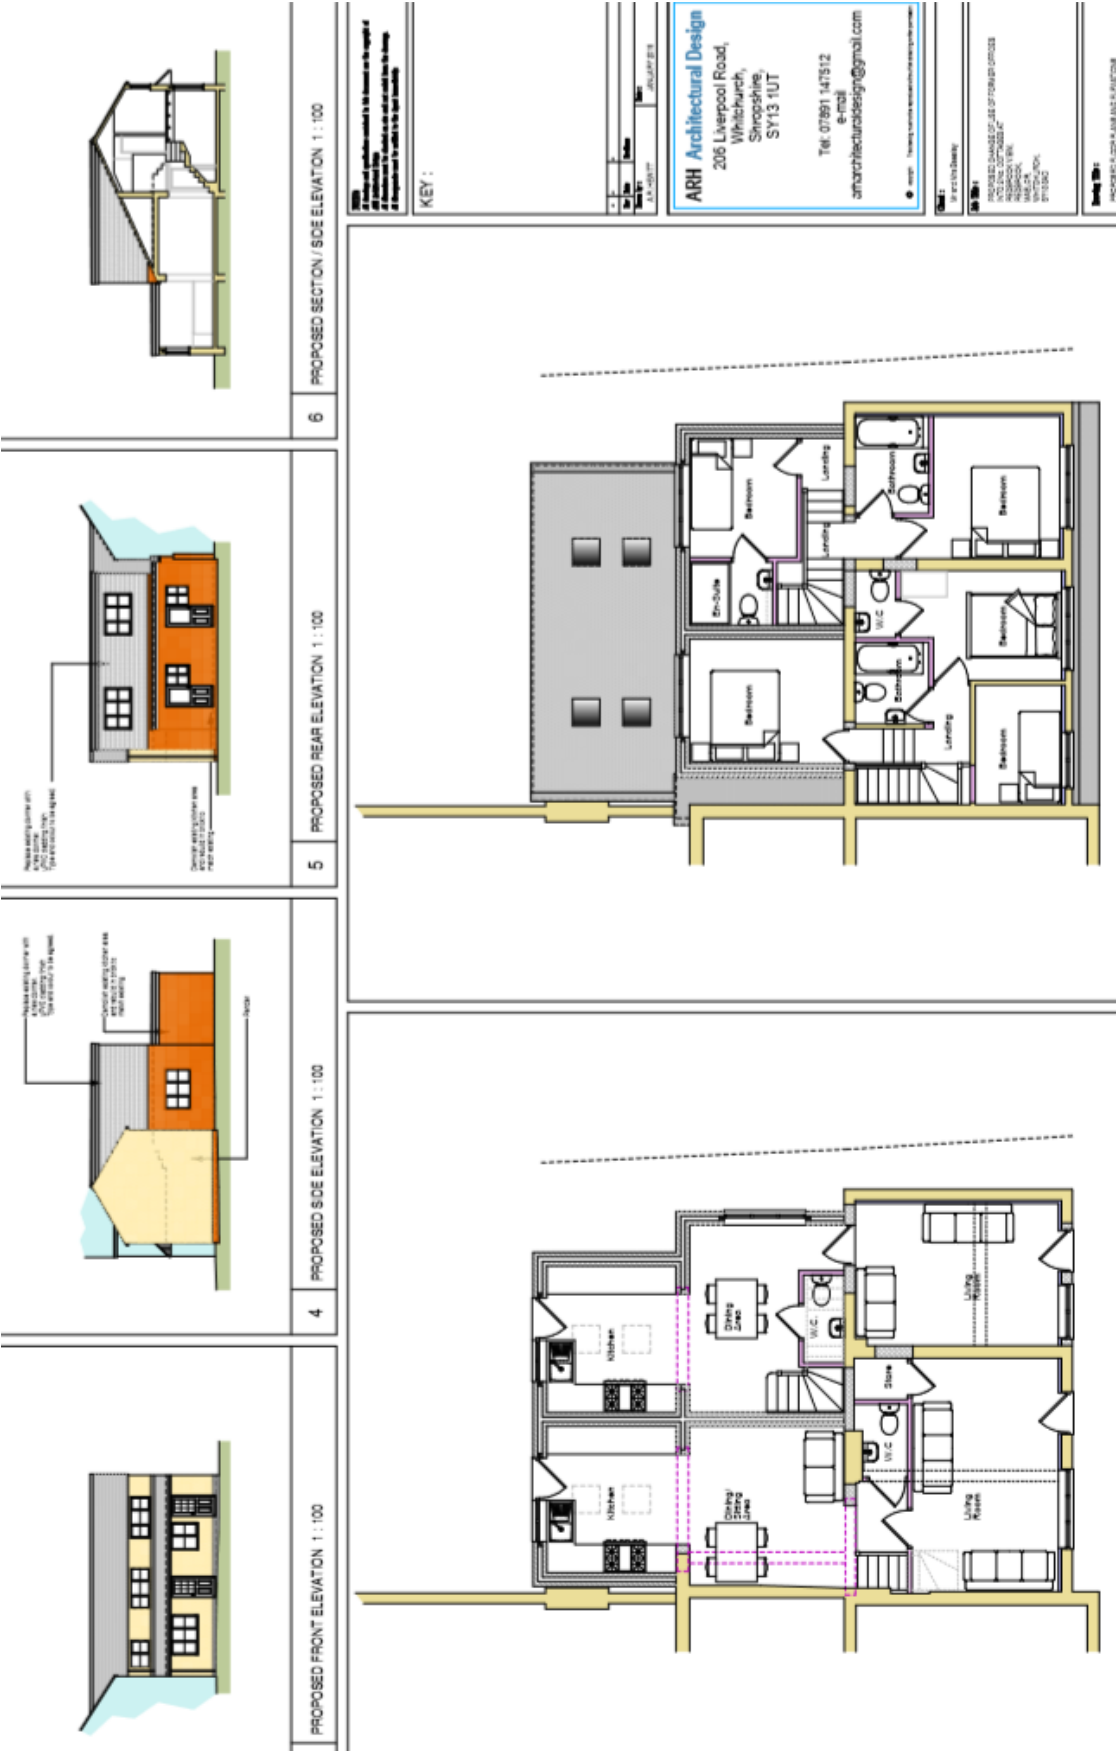
Figure D.3: Proposed site elevations

1. It is recommended that two bird boxes are erected around the site to provide an enhancement for passerine birds. This will include the installation of a pair of house martin nest boxes to the eastern extension and a sparrow terrace box to the original eastern face of the building.
