Abbey Road, Wrexham Industrial Estate  
Proposed Distribution Centre  
Geo-environmental Report  
McCarthy Haulage Ltd

GroundSolve Ltd  
*Consulting Geotechnical, Engineering Geology and Environmental Engineers*

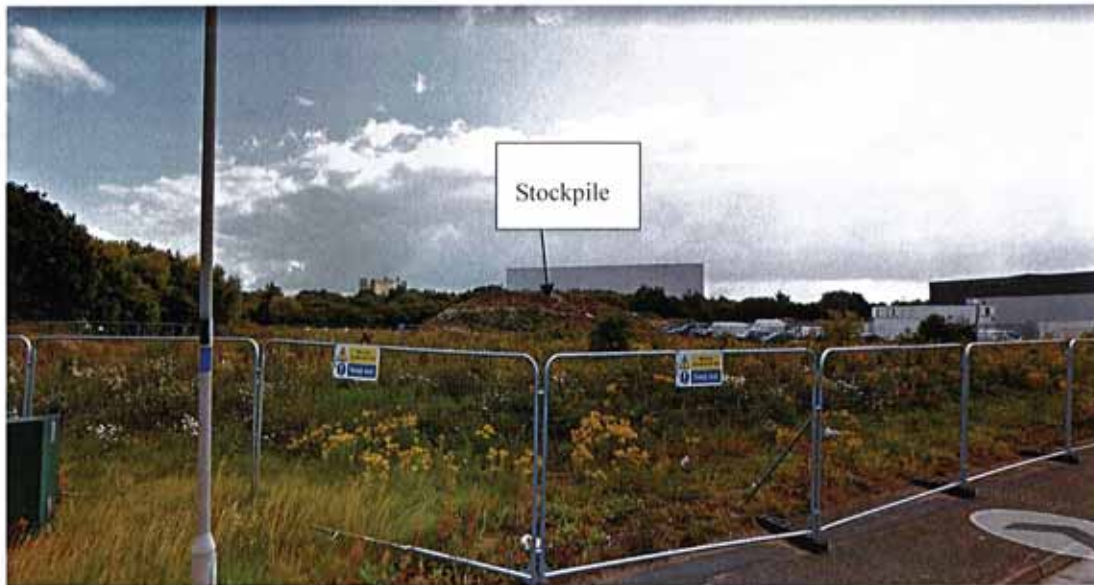
August 2016

An oblique photograph obtained from Google earth is presented below, taken in 2016 it shows the Clwyd Compounders building had been constructed and there was a large mound of spoil stockpiled on site.

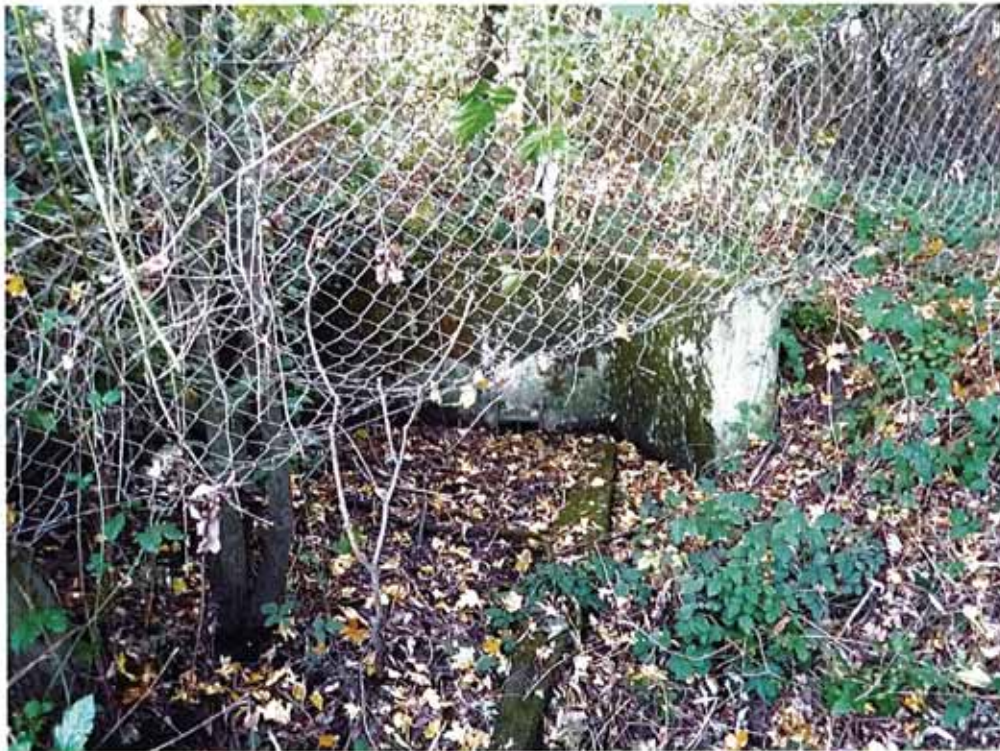
Photograph 14 Concrete headwall in northern corner of site

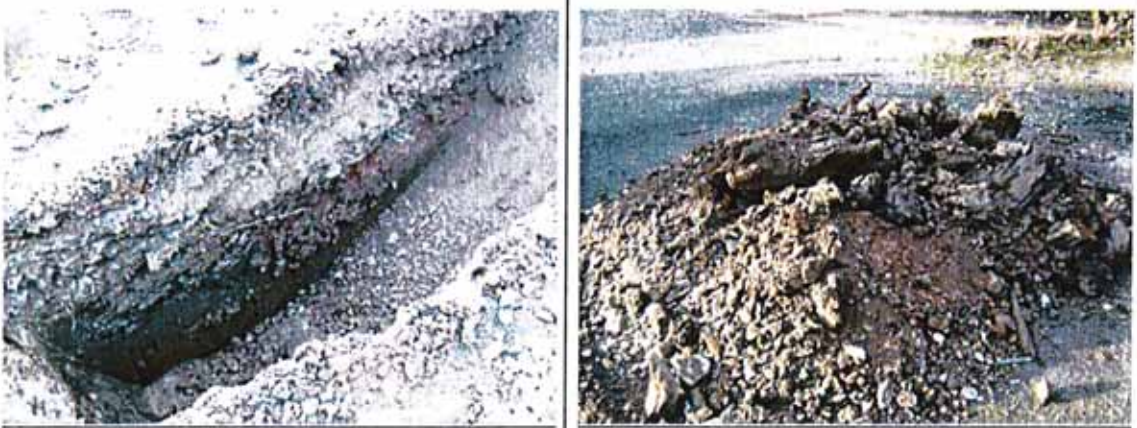
| Depth (m) | Description of strata | Sample | Type | Water | Remarks |
|---|---|---|---|---|---|
| 1.2 | Stiff red clay with grey mottles | TP1.S2<br>(1.3-1.5m) | | | Natural glacial deposits |
| 1.5 | Base of excavation | | | | |
| <b>Comments:</b><br>No odour, no hydrocarbons<br>PID <0.1ppm | | | | | |

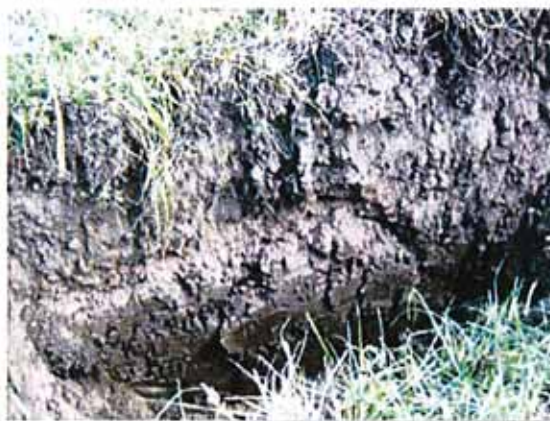
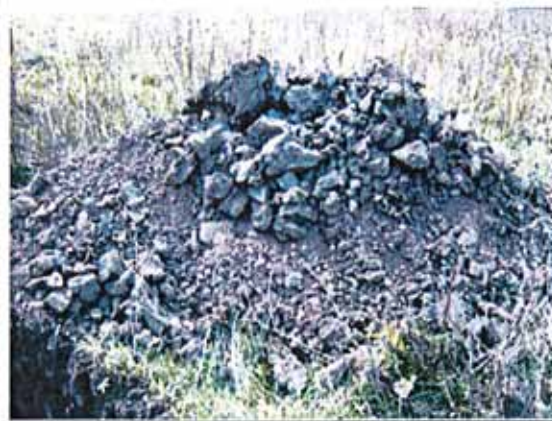
| Depth (m) | Description of strata | Sample | Type | Water | Remarks |
|---|---|---|---|---|---|
| 0.6 | Very stiff dark grey clay . Possible relict cast iron pipe intercepted at ~1m bgl | | | | Natural glacial deposits |
| 1.2 | Soft grey silty clay | | | | Natural glacial deposits |

**Comments:**

No odour, no hydrocarbons

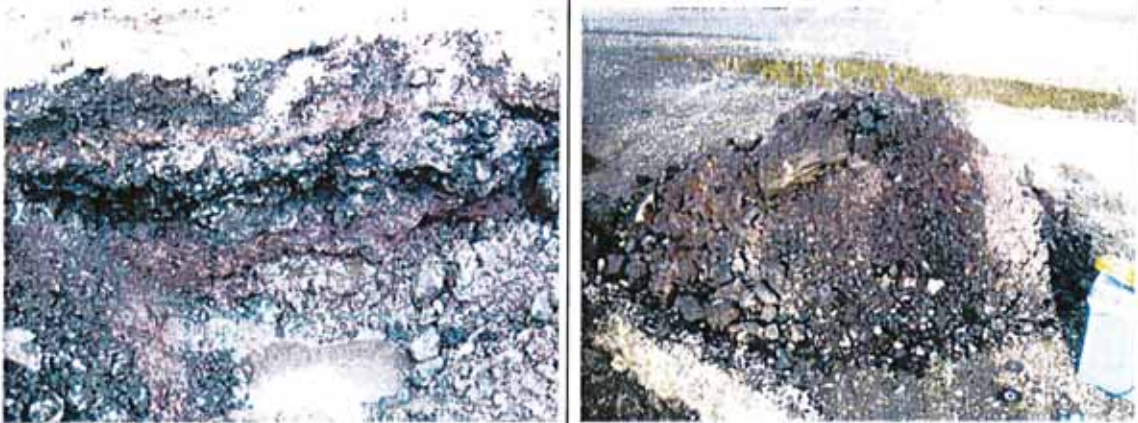
| Depth (m) | Description of strata | Sample | Type | Water | Remarks |
|---|---|---|---|---|---|
| 1.1 | Very stiff light brown clay | TP3.S3<br>(1.1-1.3m) | | | Natural glacial deposits |
| 1.3 | Base of Excavation | | | | |
| <b>Comments:</b><br>Strong hydrocarbon odour through Made Ground until Natural. Oily water entering trial-pit alongside concrete slab and green viscous secretion through horizon of sand<br>PID <0.1ppm | | | | | |

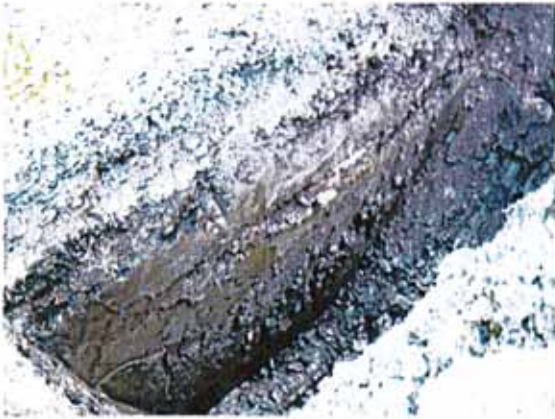
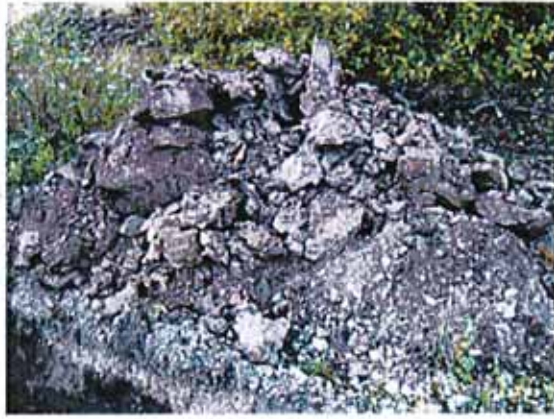
| Depth (m) | Description of strata | Sample | Type | Water | Remarks |
|---|---|---|---|---|---|
| 0.3 | Stiff light brown clay | TP4.S2<br>(1.5-1.8m) | | | Natural glacial deposits |
| 1.8 | Base of excavation – sidewalls collapsing | | | | Natural glacial deposits |
| <b>Comments:</b><br>No odour, no hydrocarbons<br>PID <0.1ppm | | | | | |

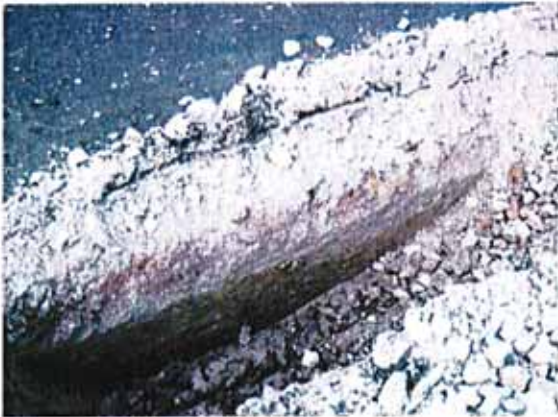
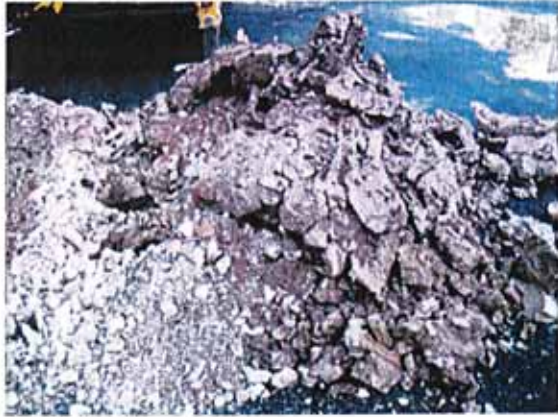
| Depth (m) | Description of strata | Sample | Type | Water | Remarks |
|---|---|---|---|---|---|
| 0.5 | Stiff light brown clay | TP5.S2<br>(0.8-1.0m) | | | Natural glacial deposits |
| 1.0 | Base of excavation | | | | |

Comments:  
Mild hydrocarbon odour  
PID <0.1ppm

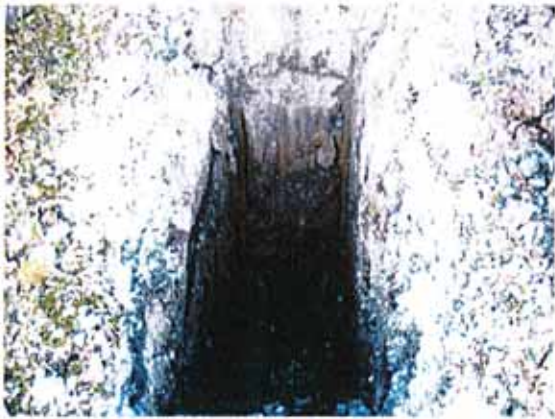
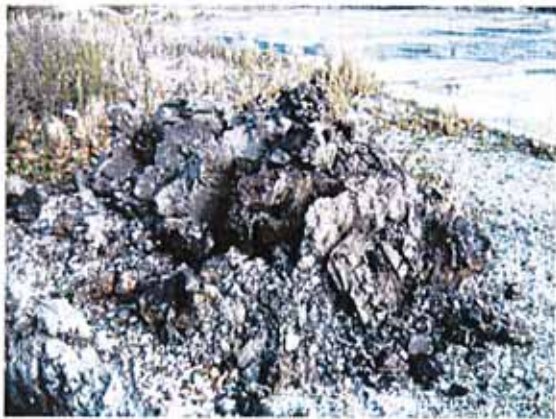
| Depth (m) | Description of strata | Sample | Type | Water | Remarks |
|---|---|---|---|---|---|
| 2.3 | Soft light brown clay | | | | Natural glacial deposits |
| 2.3 | Base of Excavation | | | | |

**Comments:**  
 No odour, no hydrocarbons  
 PID <0.1ppm

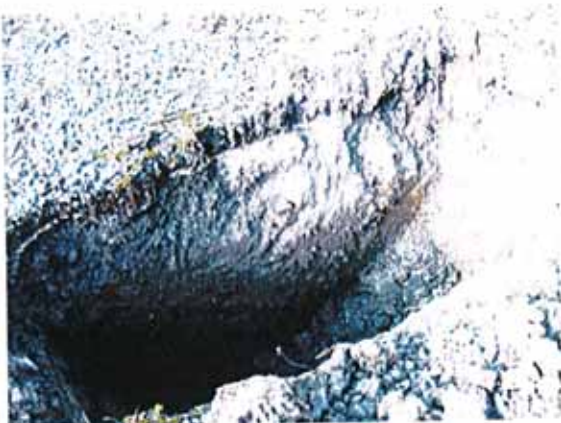
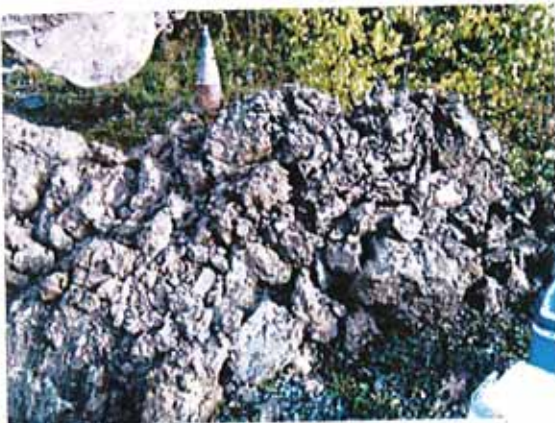
| Depth (m) | Description of strata | Sample | Type | Water | Remarks |
|---|---|---|---|---|---|
| 0.5 | Dark brown stiff clay | TP8.S2<br>(1.0-1.3m) | | | Natural glacial deposits |
| 2.0 | Base of excavation | | | | |

**Comments:**  
 No odour, no hydrocarbons  
 PID <0.1ppm

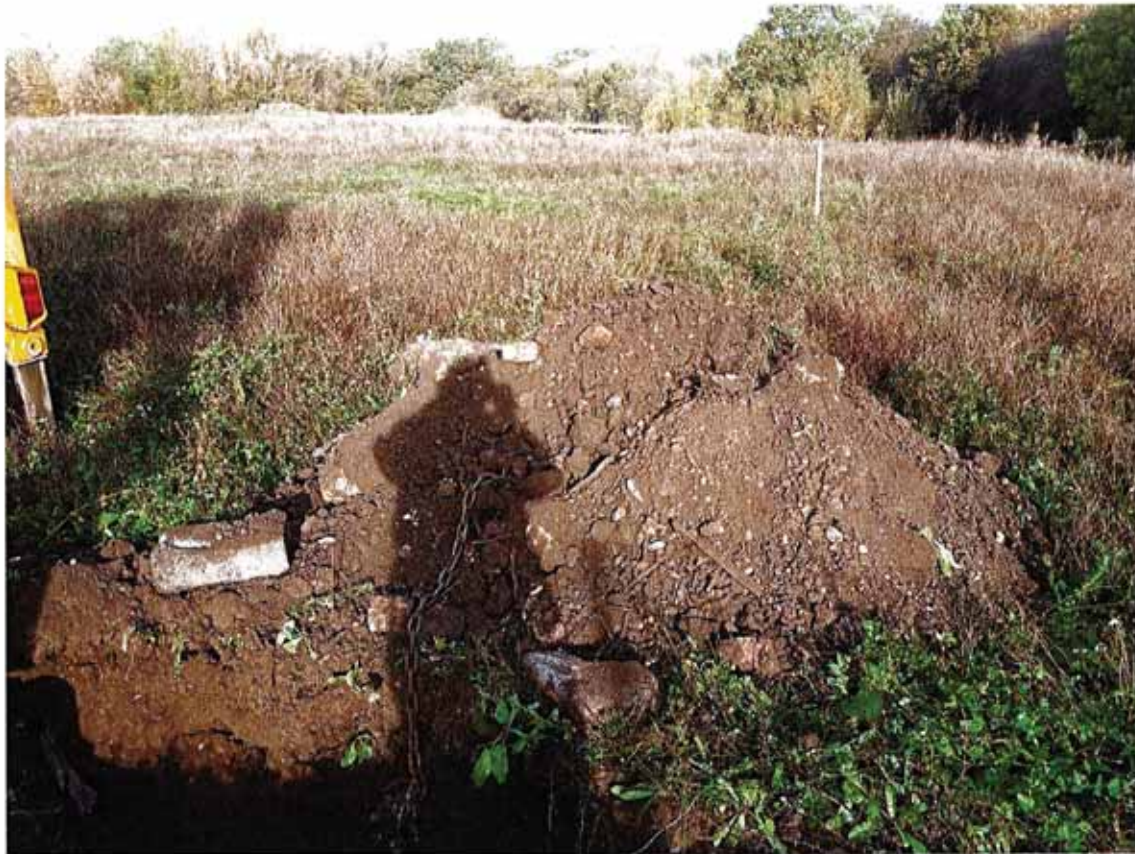
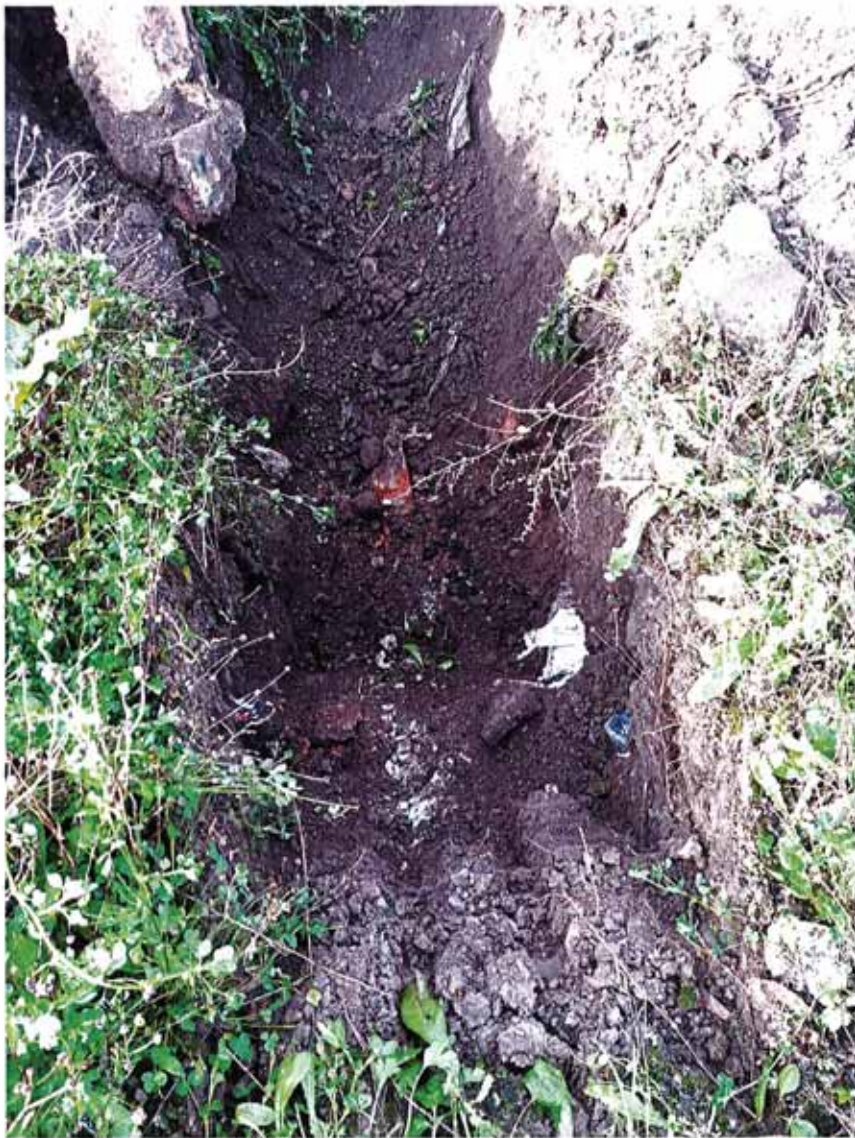
Trial Pit 1

1. Unable to progress past 0.90m.
2. No groundwater seepage.

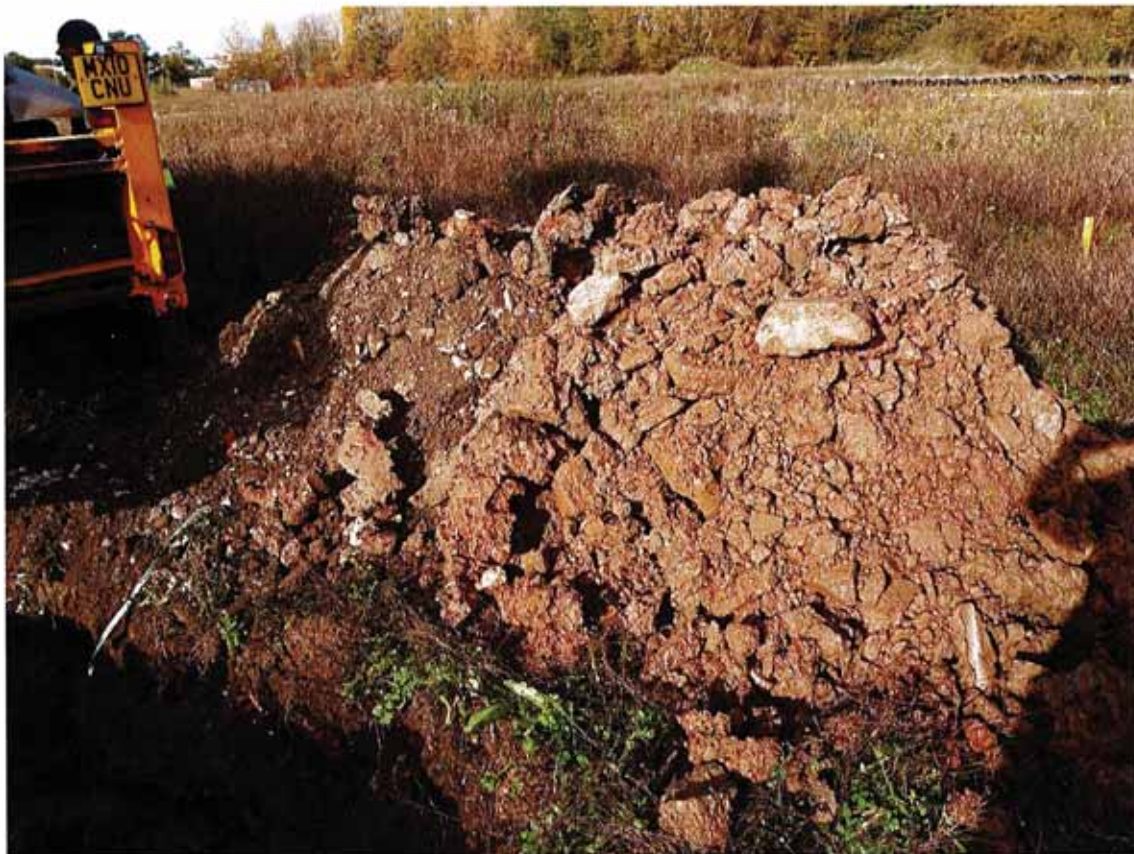
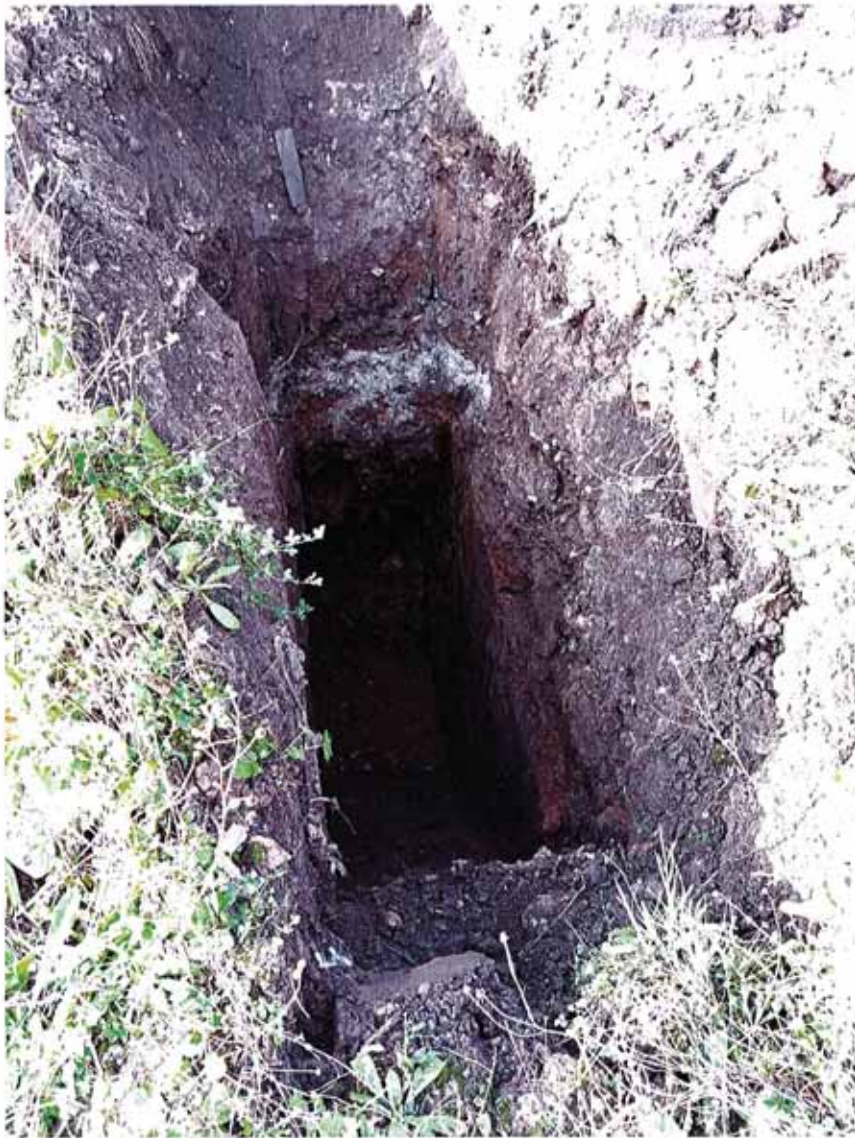
Trial Pit 2

1. Slight water seepage at 2.30m
2. Sides of pit stable.

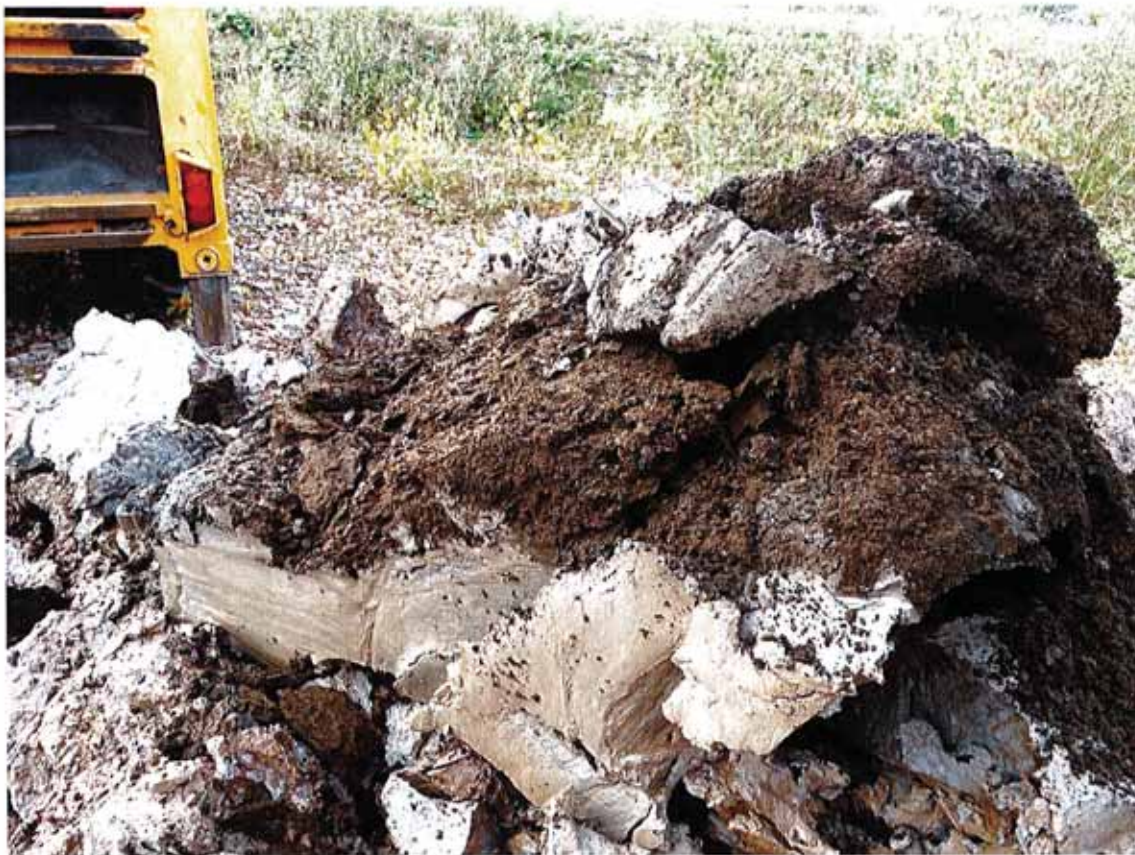
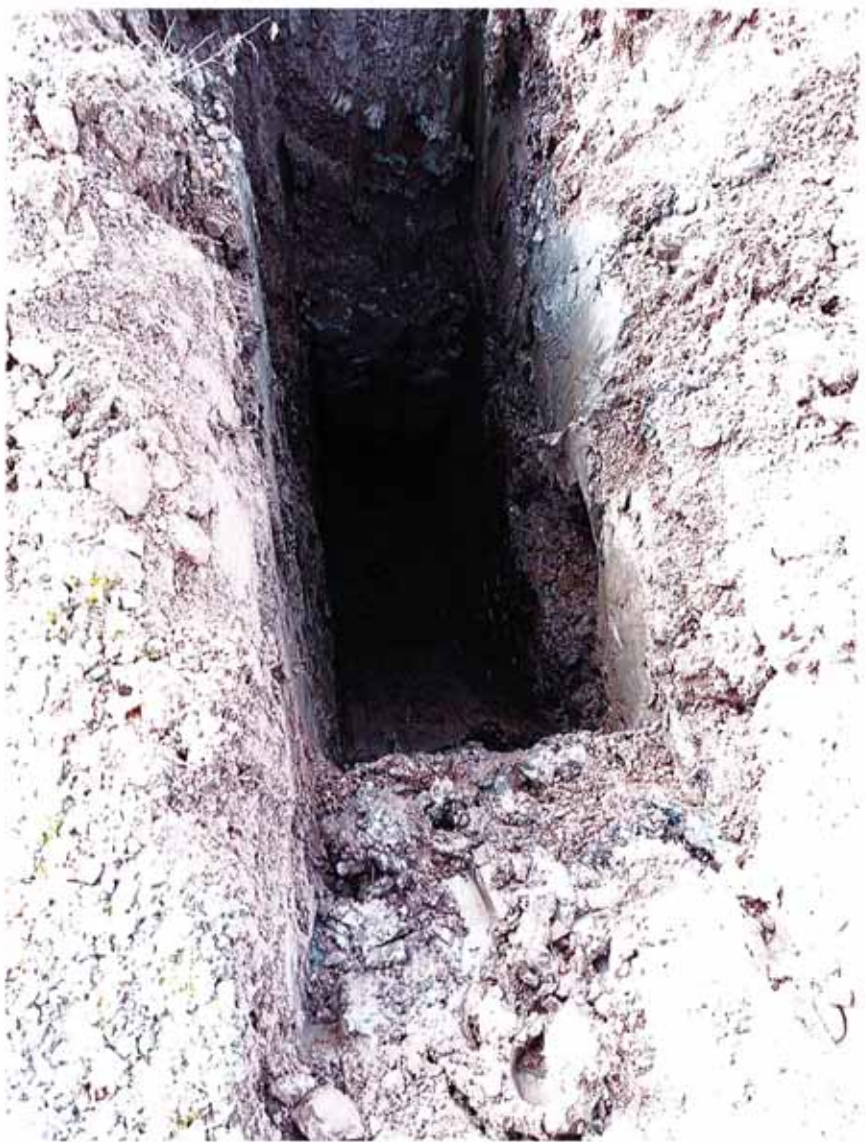
Trial Pit 3

1. Sides of pit stable.
2. Steady water seepage at 1.0m.
3. Water seepage from Peat as well.

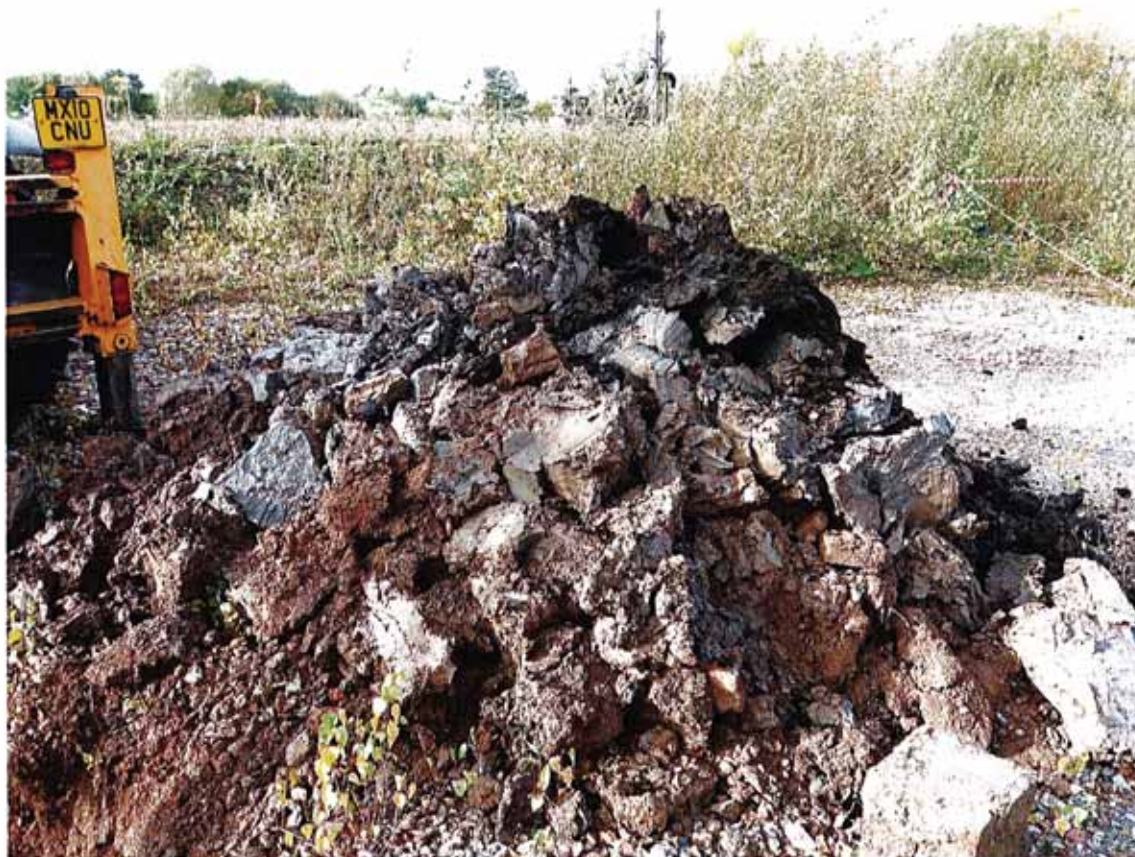
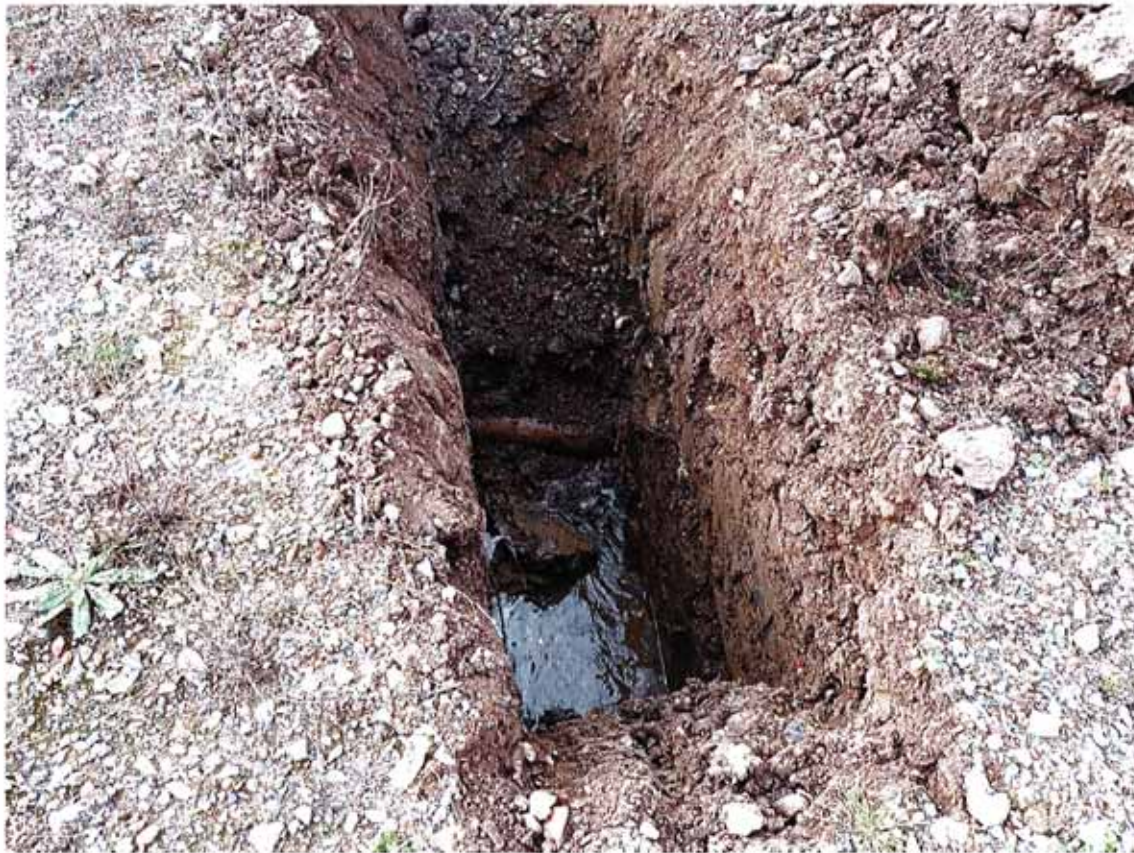
Trial Pit 4

1. Sides of pit stable.
2. Old clay drain encountered at 1.20m
3. Large drain encountered at one end of pit at 1.80m, pit abandoned.

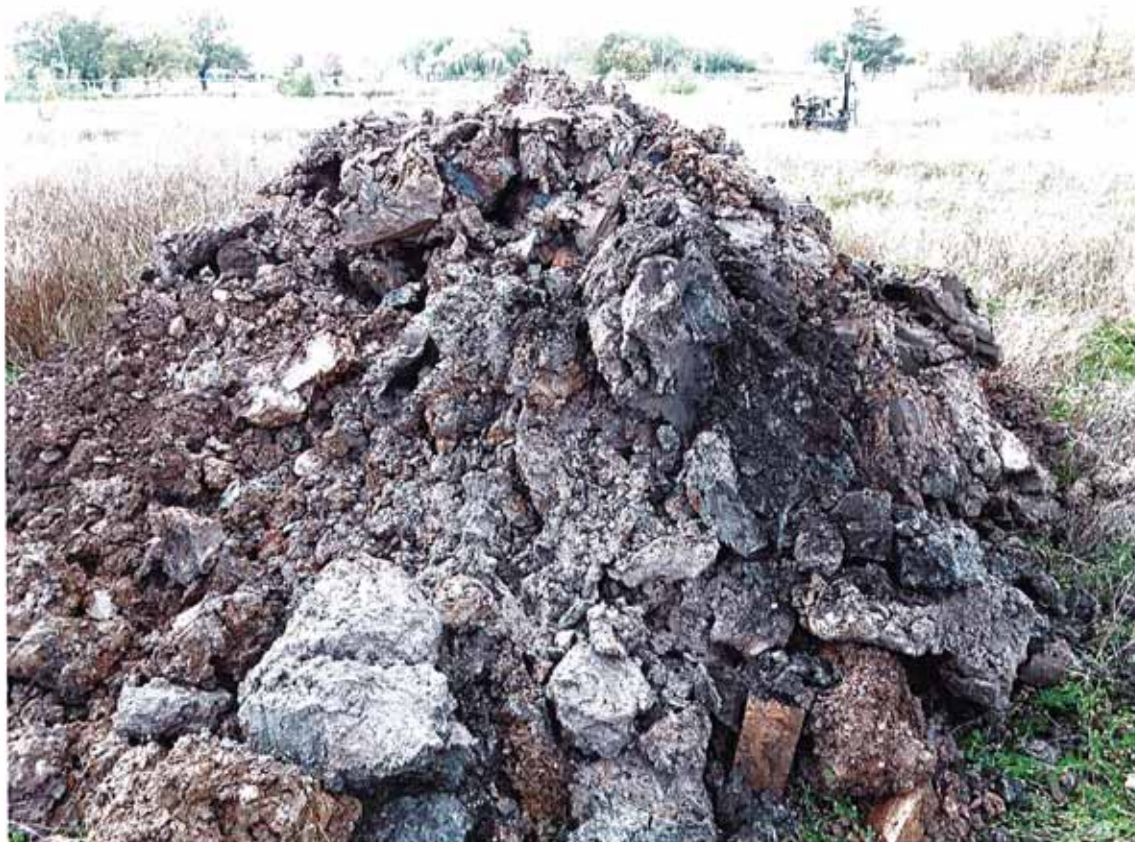
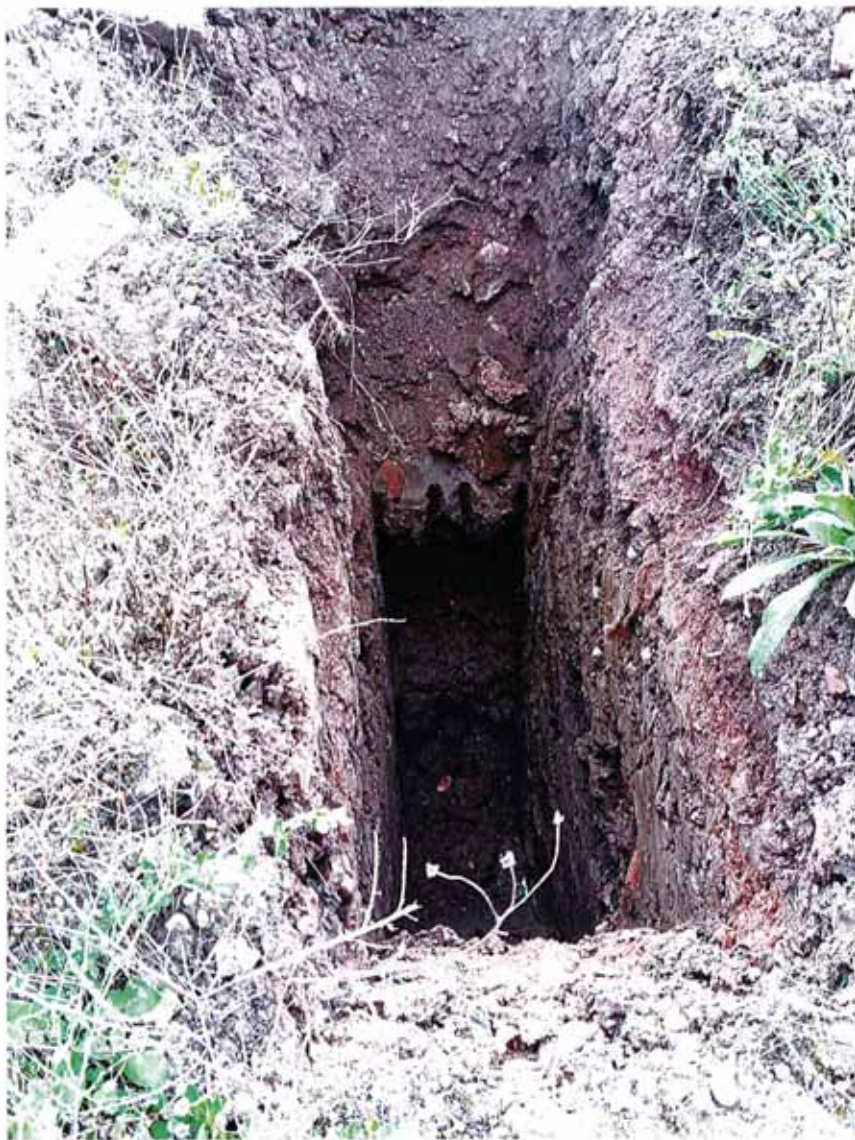
Trial Pit 5

1. Sand lens saturated.
2. Slight water seepage below 3.0m.
3. Sides of pit stable.

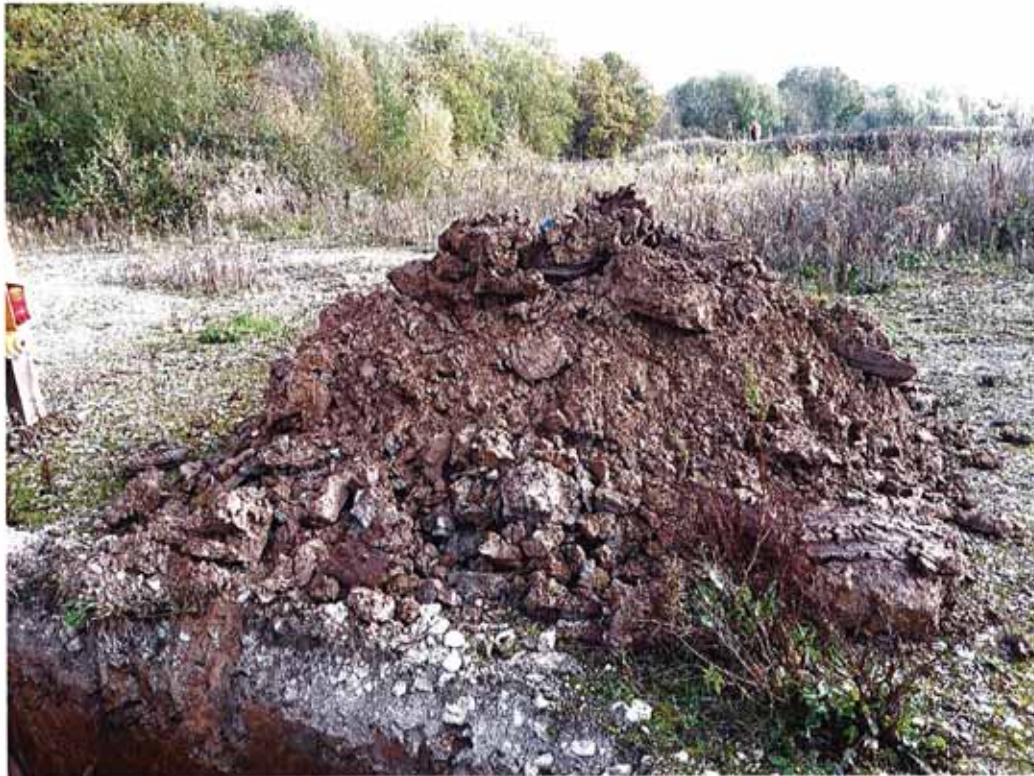
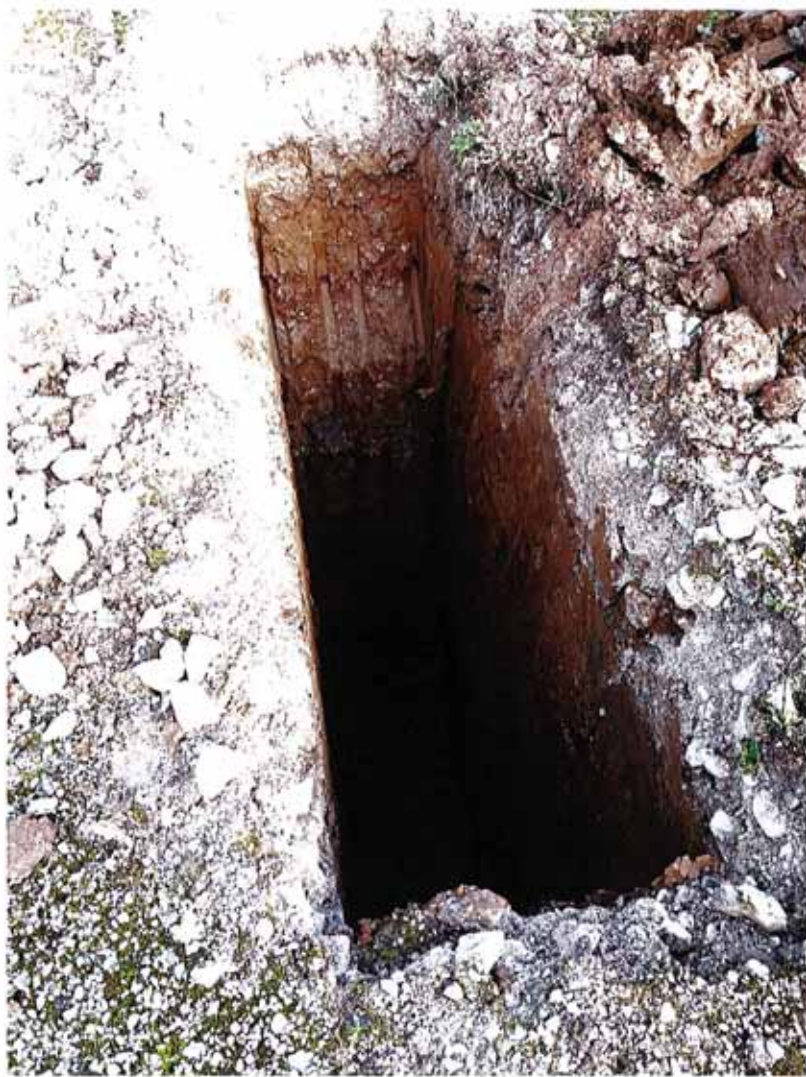
Trial Pit 6

1. Slight seepage at base of sand
2. Sides of pit stable.

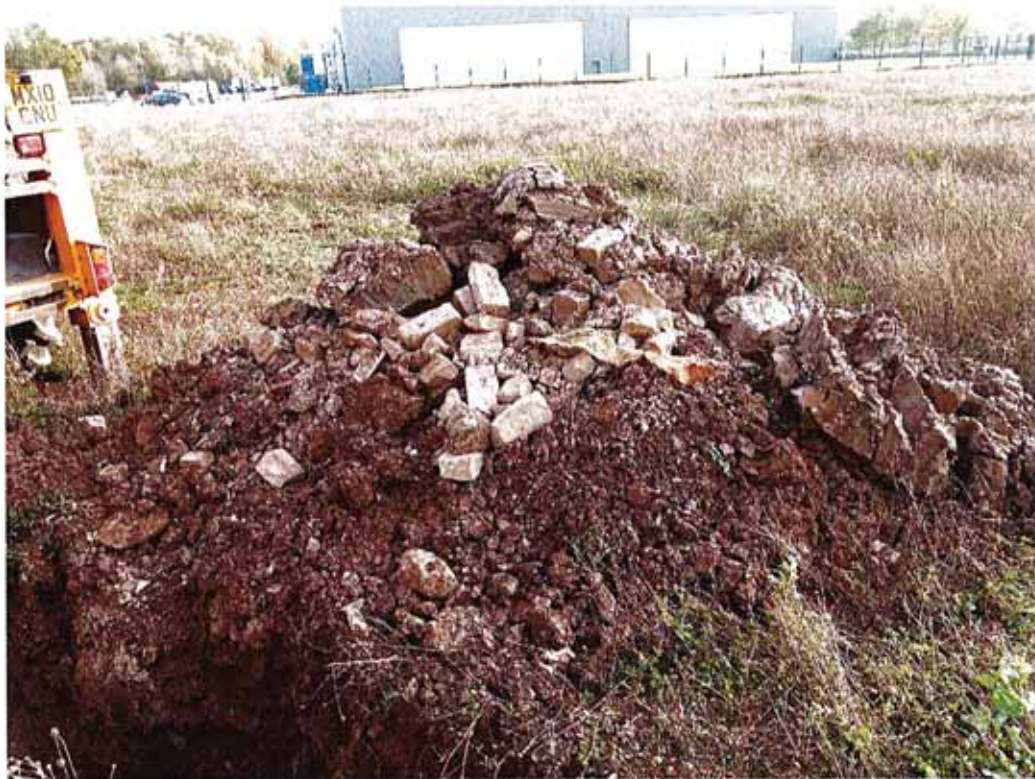
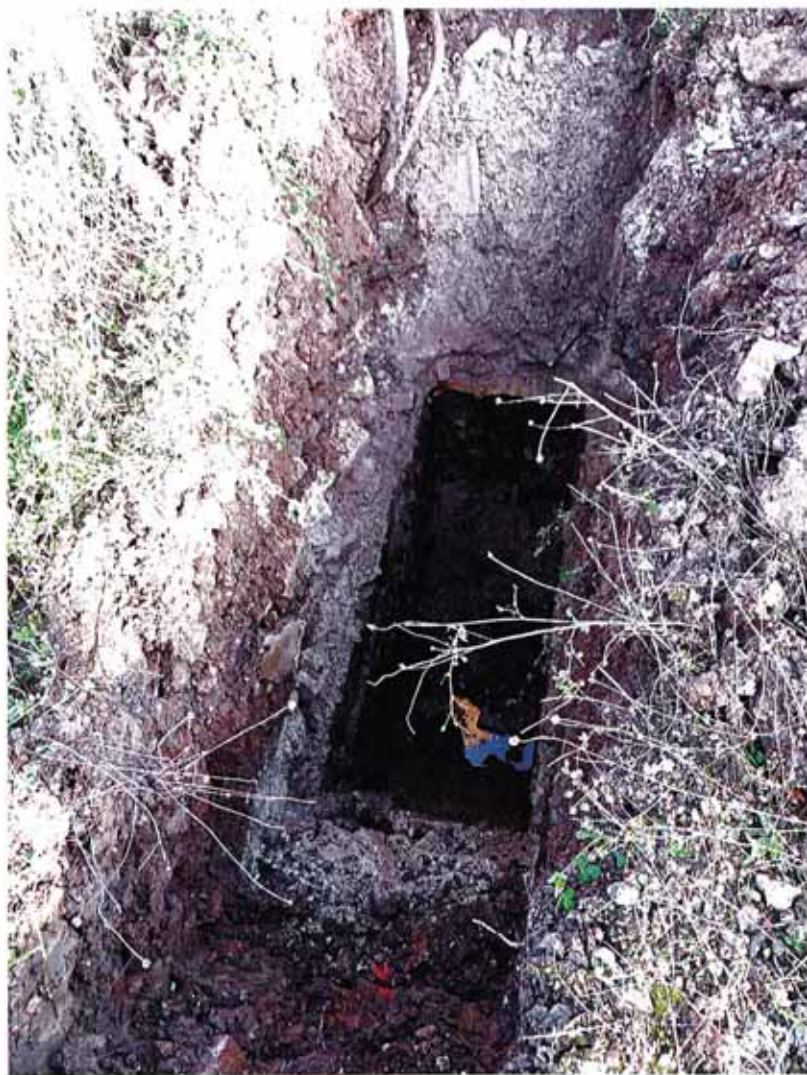
Trial Pit 8

1. Unable to progress any deeper as clay too stiff.
2. High water flow from bricks below sub base, quickly ceased.

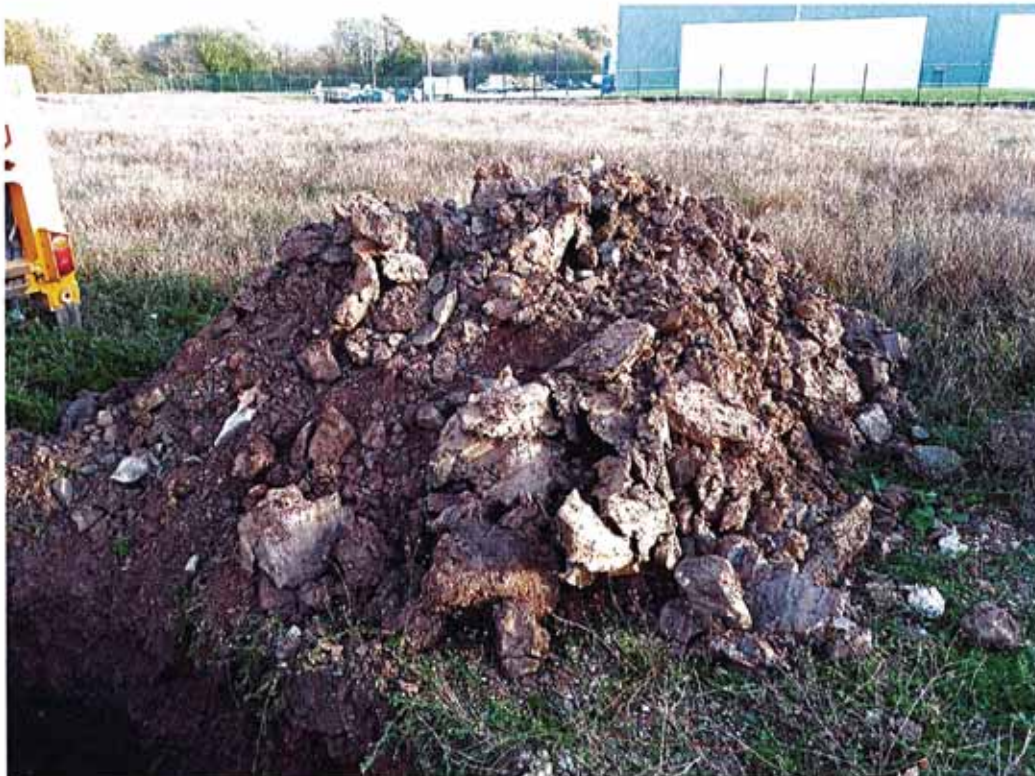
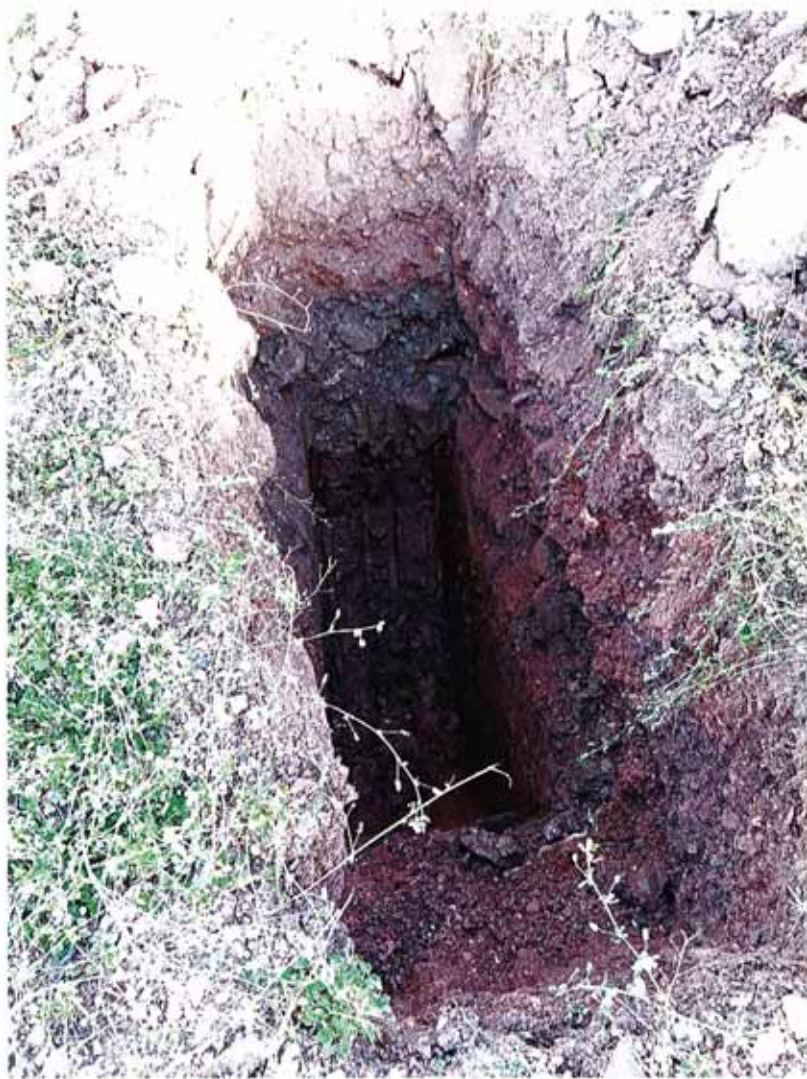
Trial Pit 9

1. No groundwater seepage encountered, very slight seepage at base of made ground.
2. Sides of pit stable
3. Unable to penetrate any deeper
