## YSGOL CLYWEDOG, WREXHAM

# PRELIMINARY BAT ROOST ASSESSMENT

Ref EE.423.RL

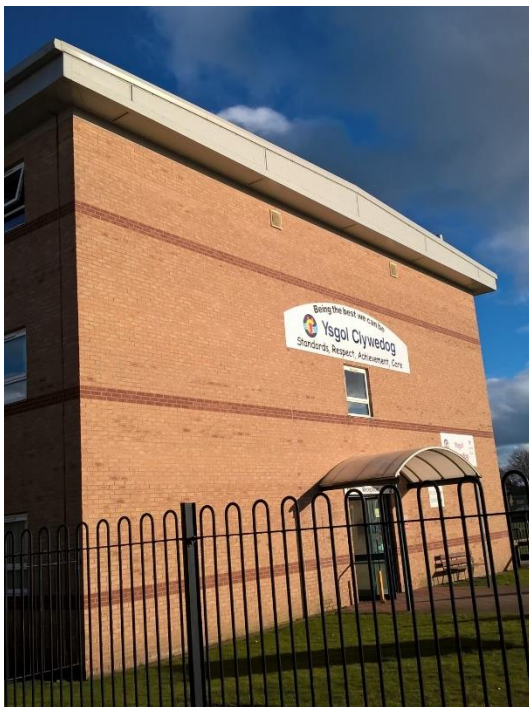
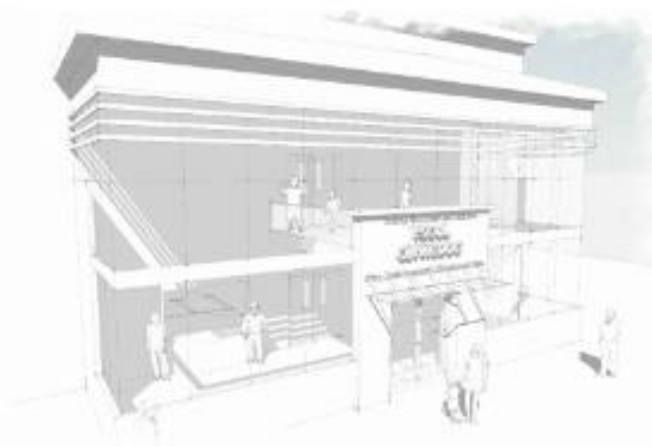
**FIGURE 1.1 & 1.2 EXISTING ENTRANCE THE SCHOOL & PROPOSED EXTENSION TO THE FRONT**

- 1.2 The proposed works are to build a two storey extension onto the front of the admin block, to create a new entrance way into the building (Figures 1.1 & 1.2).

- 6.1 The proposed works are to build a two storey extension onto the front of the admin block, to create a new entrance way into the building. The current plan is for the new extension to tie into the existing wall of the school at a lower level than the existing roof, however the plans have the potential to change and the new extension may tie in higher up and into the existing roof.

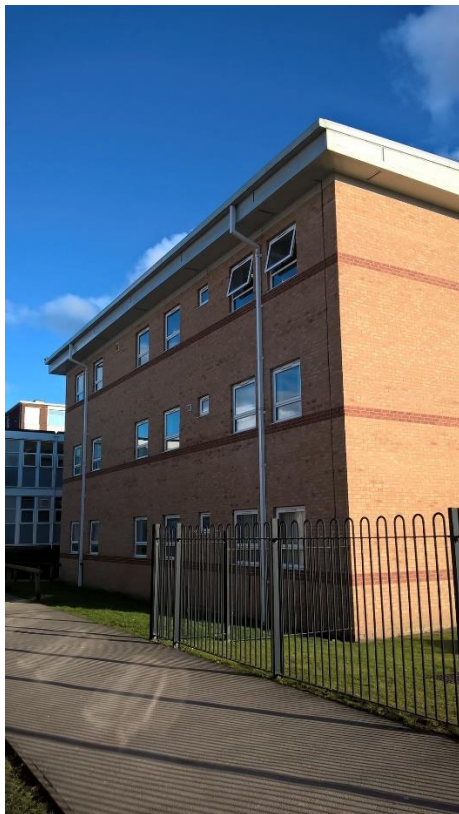
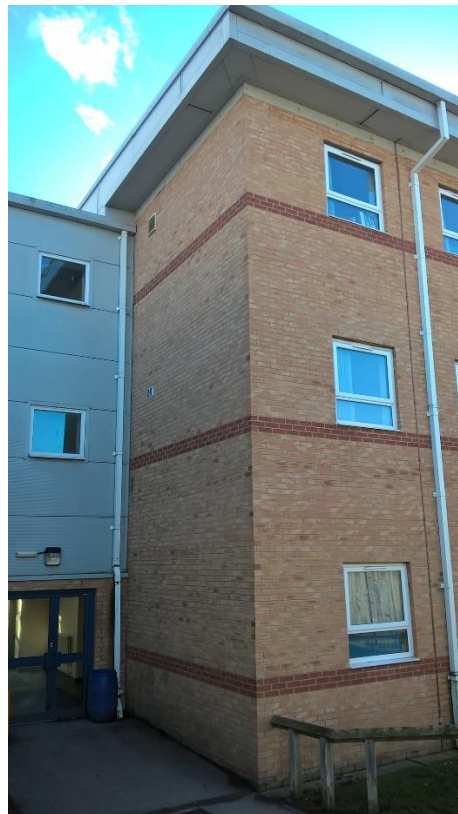
**FIGURE 4.3. NORTHERN SIDE OF BUILDING** **FIGURE 4.4. NORTH EASTERN CORNER OF BUILDING**

- 4.1 The building was three stories high and of brick construction. The roof was metal clad at the eaves, with a shallow pitch, which was almost flat (Figure 4.3). The building was joined to the rest of the school at the rear (eastern side) (Figure 4.4).
