## **BAT SCOPING SURVEY**

### **The Boat Inn**

Erbistock  
Wrexham  
LL13 0DL

| UES reference: | UES02603/02 |

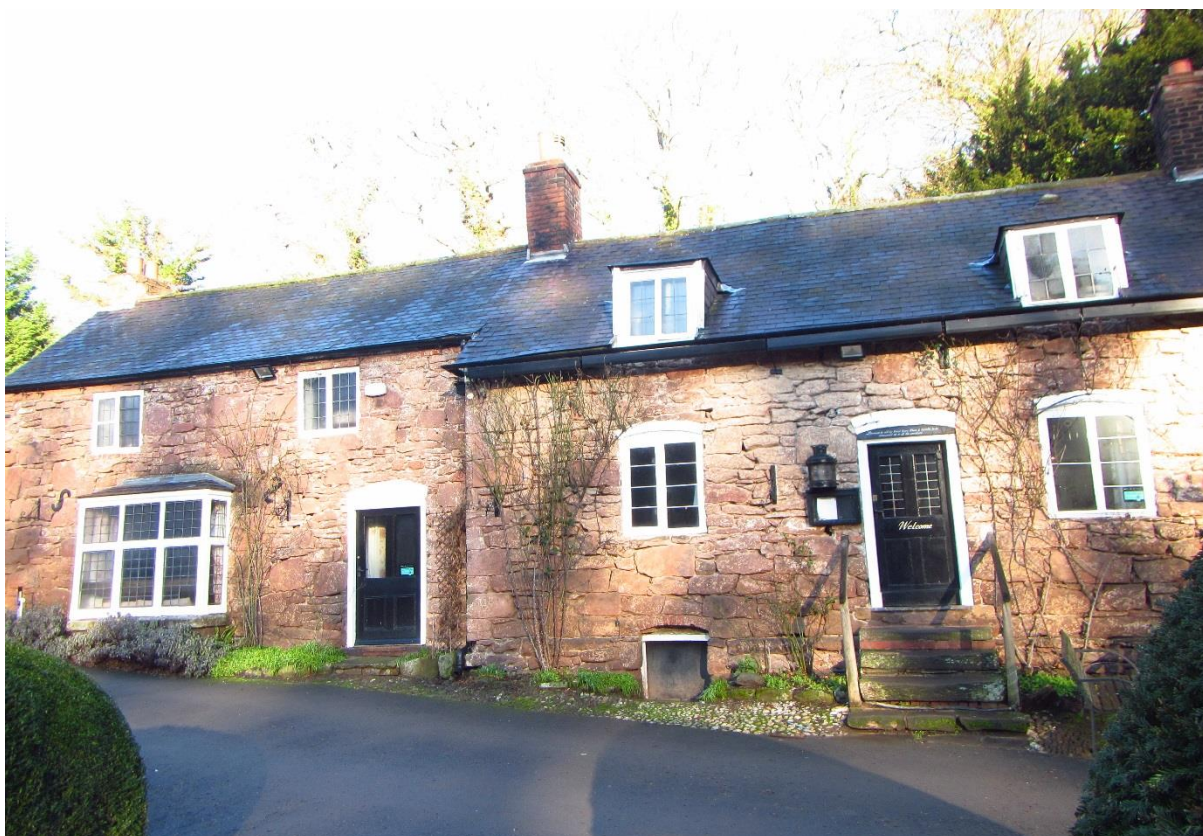
**A.** The former cottage has a sandstone wall and pitched, slate roof construction (See Appendix 2 – Photo 1). The roof contains two dormers with hipped roofs and three chimneys. The roof tiles are in relatively good condition, however there are a couple of PRFs under raised lead flashing and gaps in the ridge tiles (Photo 2). The roof overhangs at the eaves with a small gap present at the eastern corner leading into a small cavity under the tiles (Photo 3).

Photo 1. The Boat Inn – Building A southern elevation facing the River Dee.

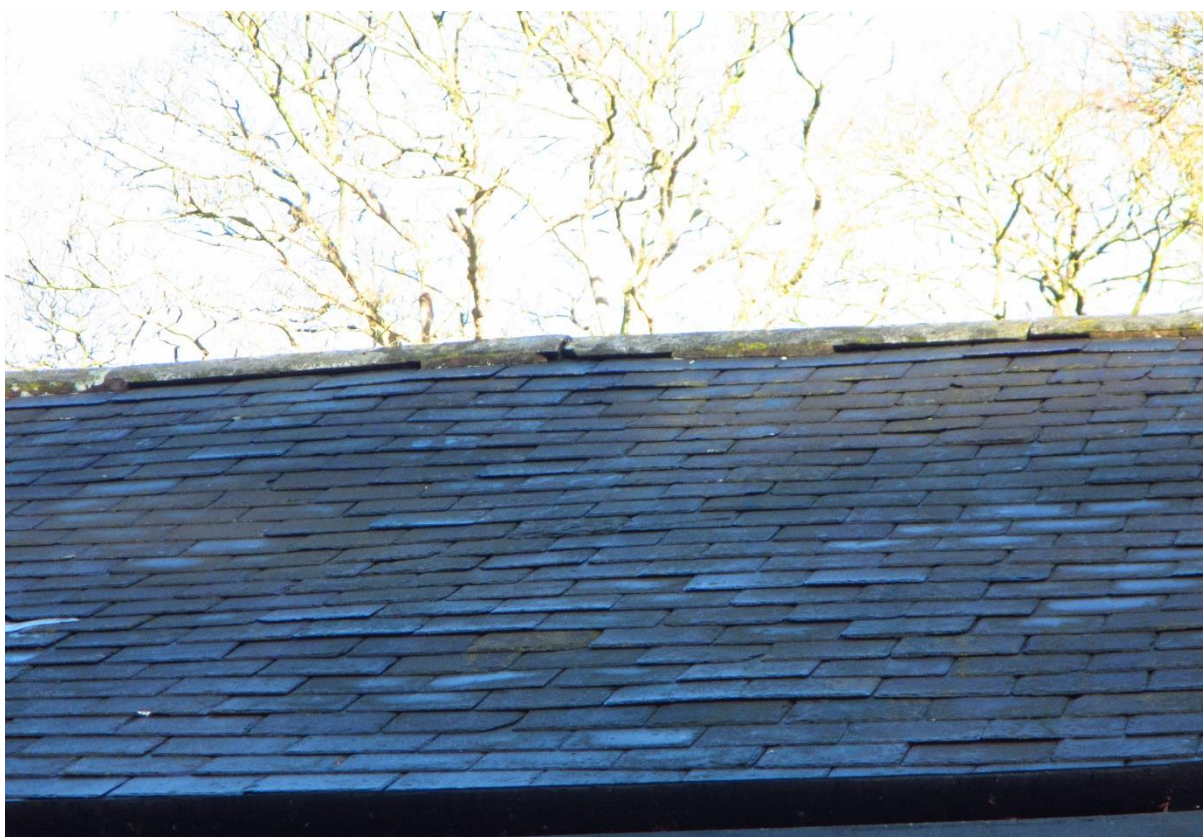
Photo 2. Gaps under ridge tiles of Building A.

Due to the external PRFs and proposed re-roofing works, further presence / absence surveys are required in order to determine the species and numbers of bats using the buildings. These surveys should be undertaken by an appropriately licensed ecologist during the bat survey season, May to September inclusive.

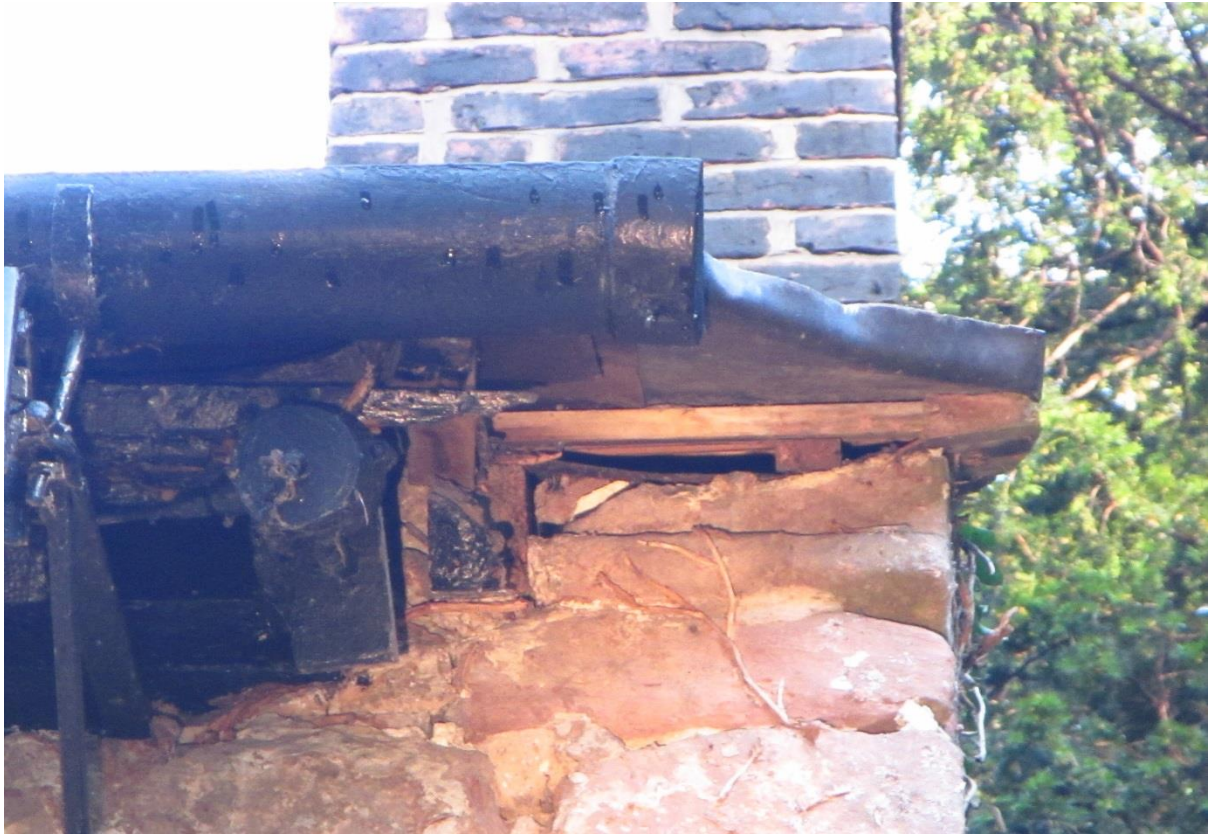
Photo 3. Gap at the eastern corner eaves - Building A.

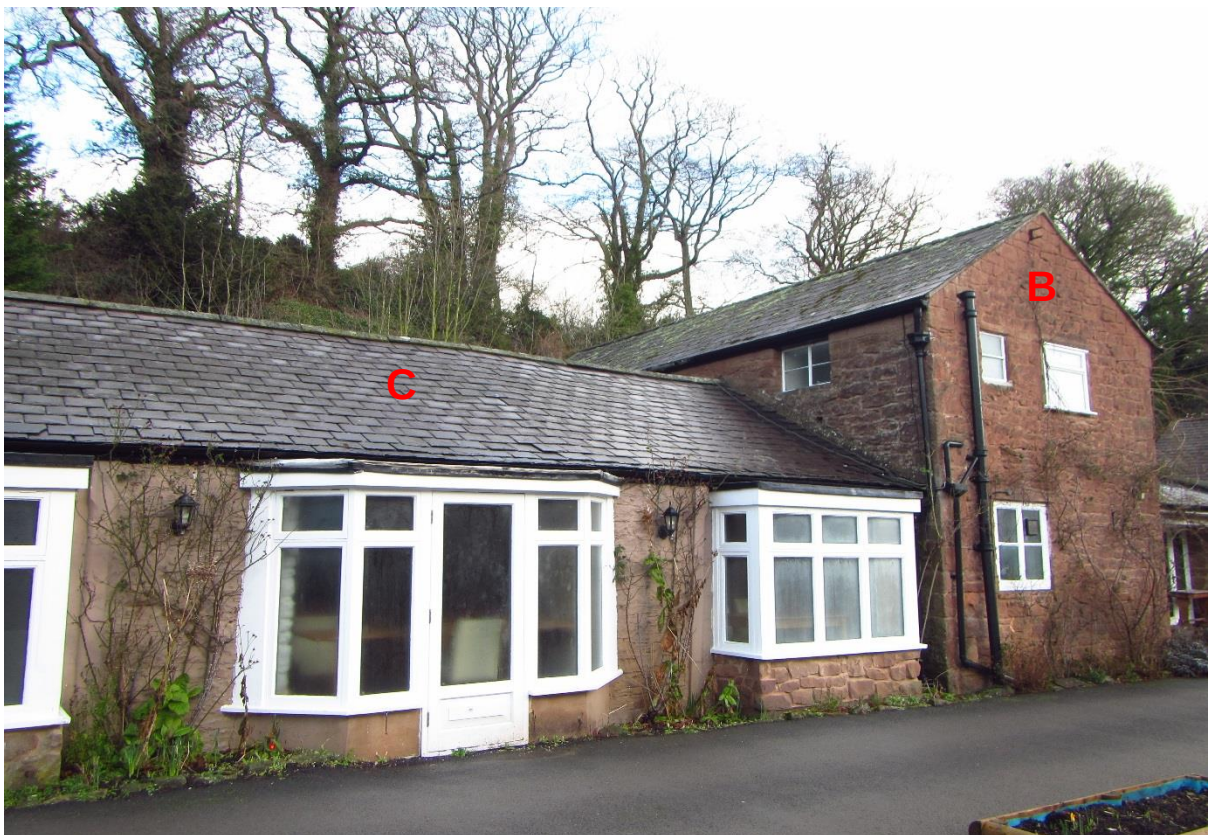
**B.** The two-storey 17<sup>th</sup> Century building has a sandstone wall and pitched, slate roof construction (Photos 6 and 7). The roof and slate tiles are generally in good condition with no raised, slipped or missing tiles.

**C.** The single storey modern extension is connected to the western wall of Building B (Photos 6 and 8). It has a brick wall with pitched roof construction. The roof is clad with slate tiles which is in poor condition with a number of raised and slipped tiles and gaps at the ridge, particularly on the northern aspect (Photo 9).

Photo 6. Front (south) elevation of Building B and Building C.

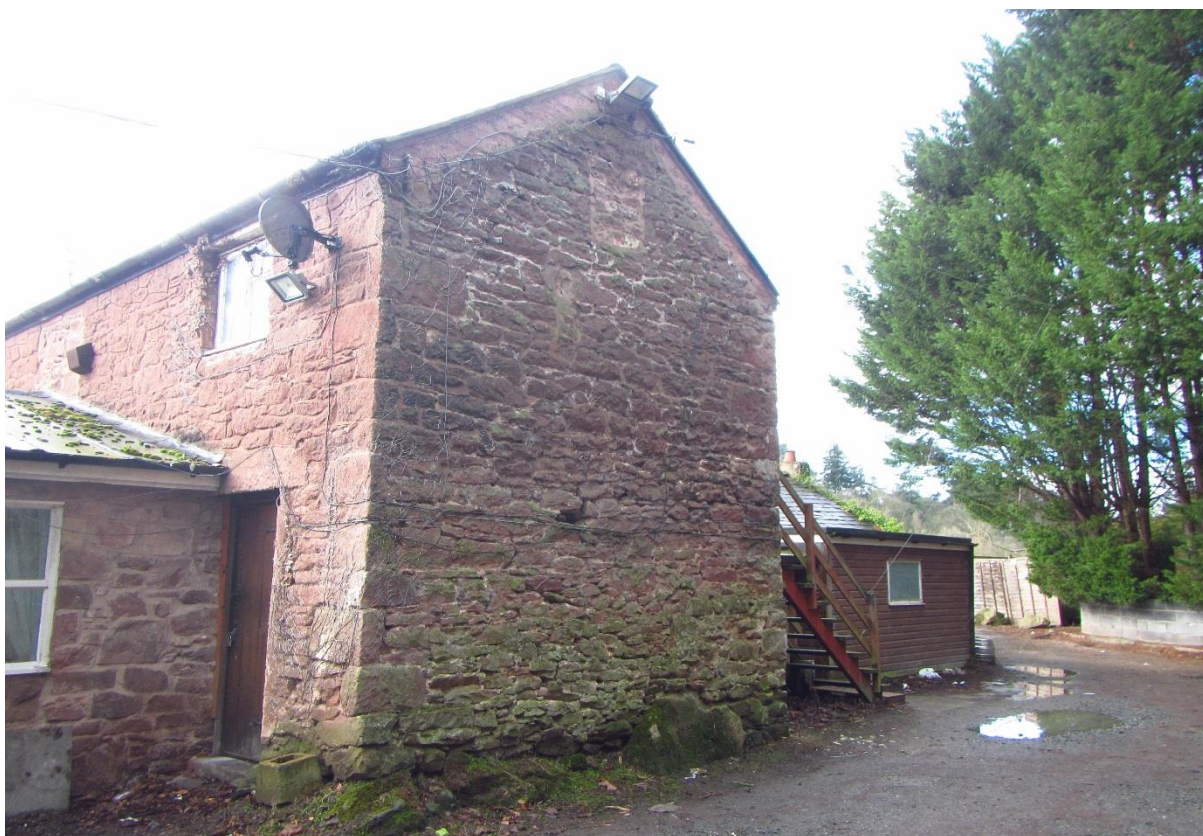
There are two gable ends (north and south) which contain no suitable features due to well-sealed end tiles and well-pointed stonework.

Photo 7. Rear (north) gable end of Building B.

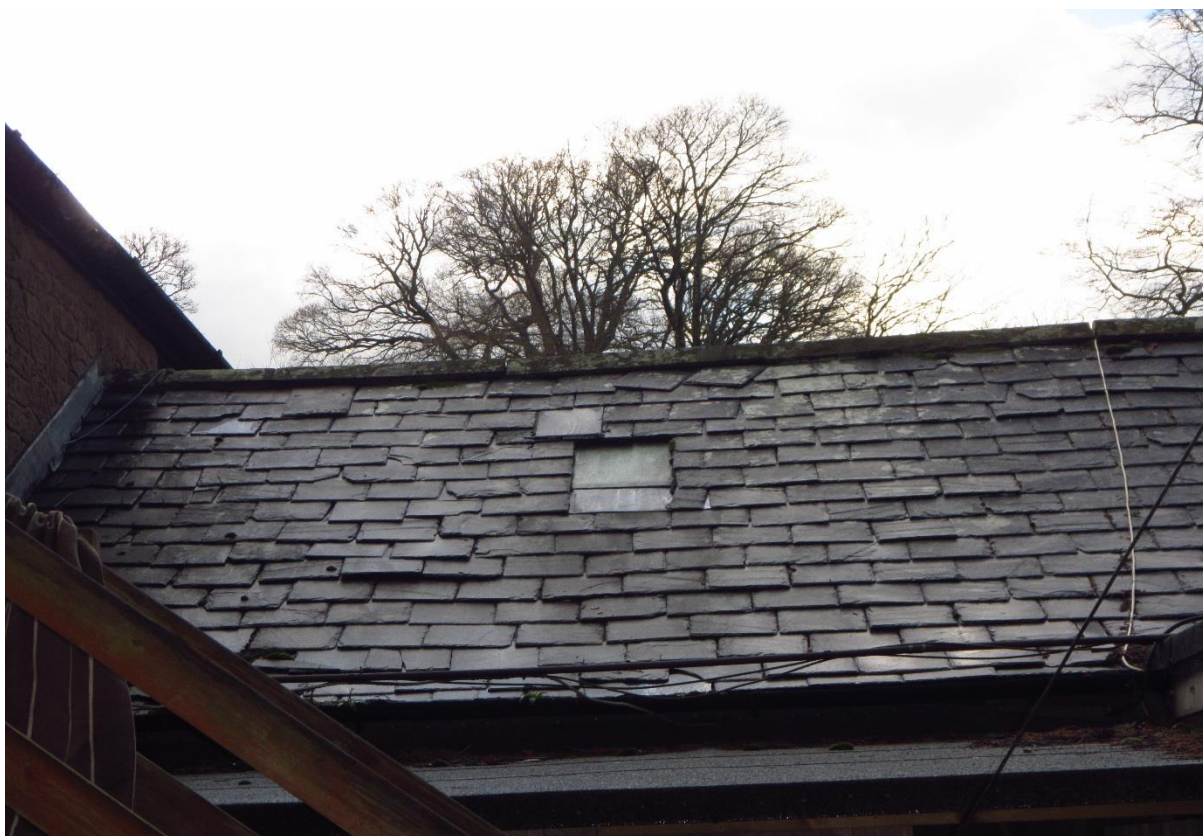
Photo 9. Raised and slipped roof tiles - Building C.

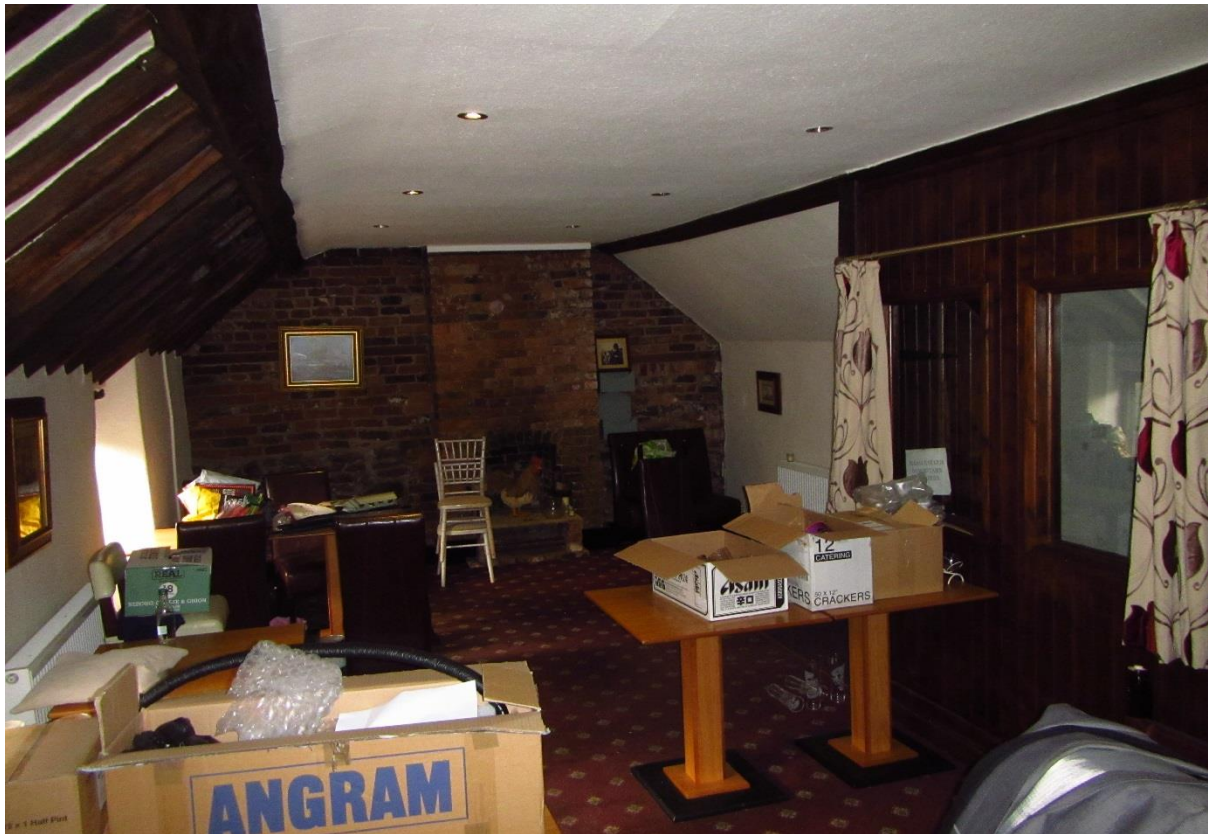
**A.** The attic of the former cottage has been converted into office and storage space for the public house (Photo 11). As such, the ceiling is vaulted and no loft space is present.

Photo 11. Upper floor of Building A.

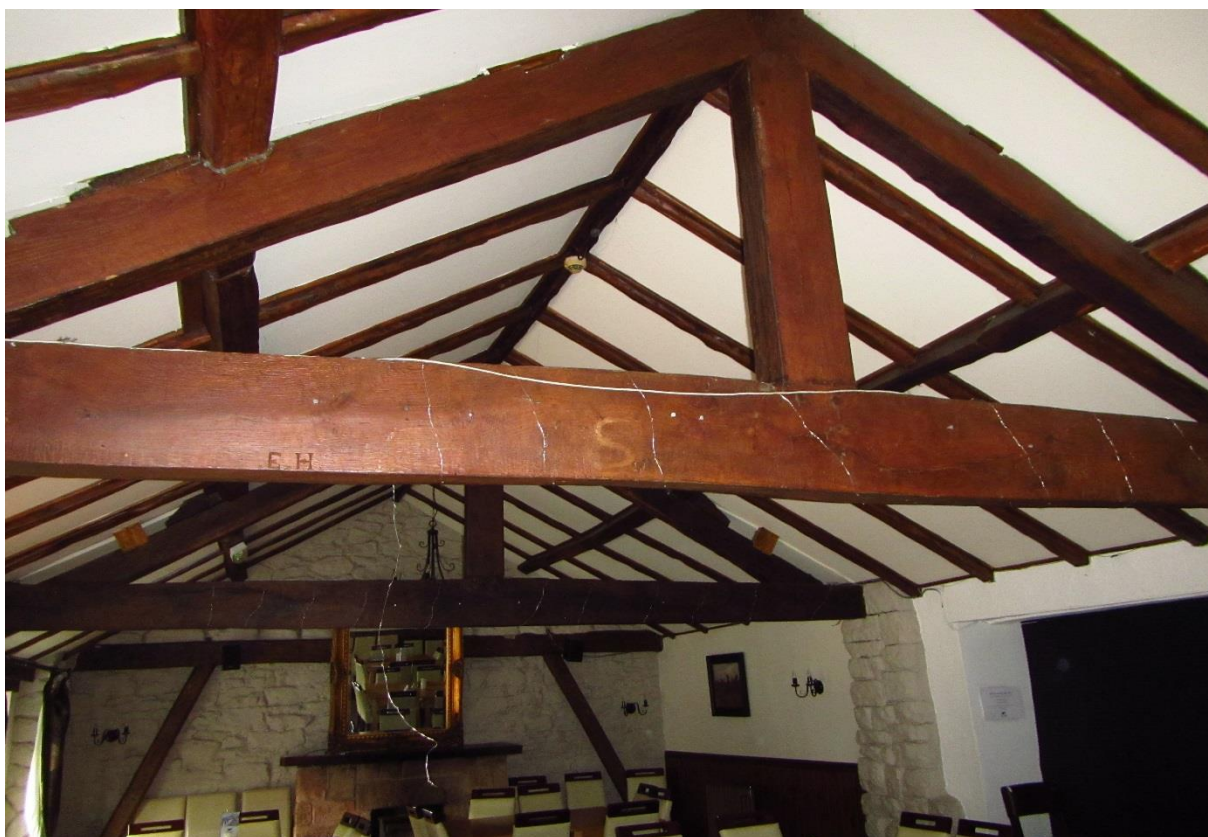
**B, C and D.** There are no loft spaces present (Photos 12 and 13).

Photo 12. Interior of Building C.
