# FORMER CAPARO WIRE FACTORY

## ECOLOGICAL SITE WALKOVER

Enfys Report Ref: EE/410/LB

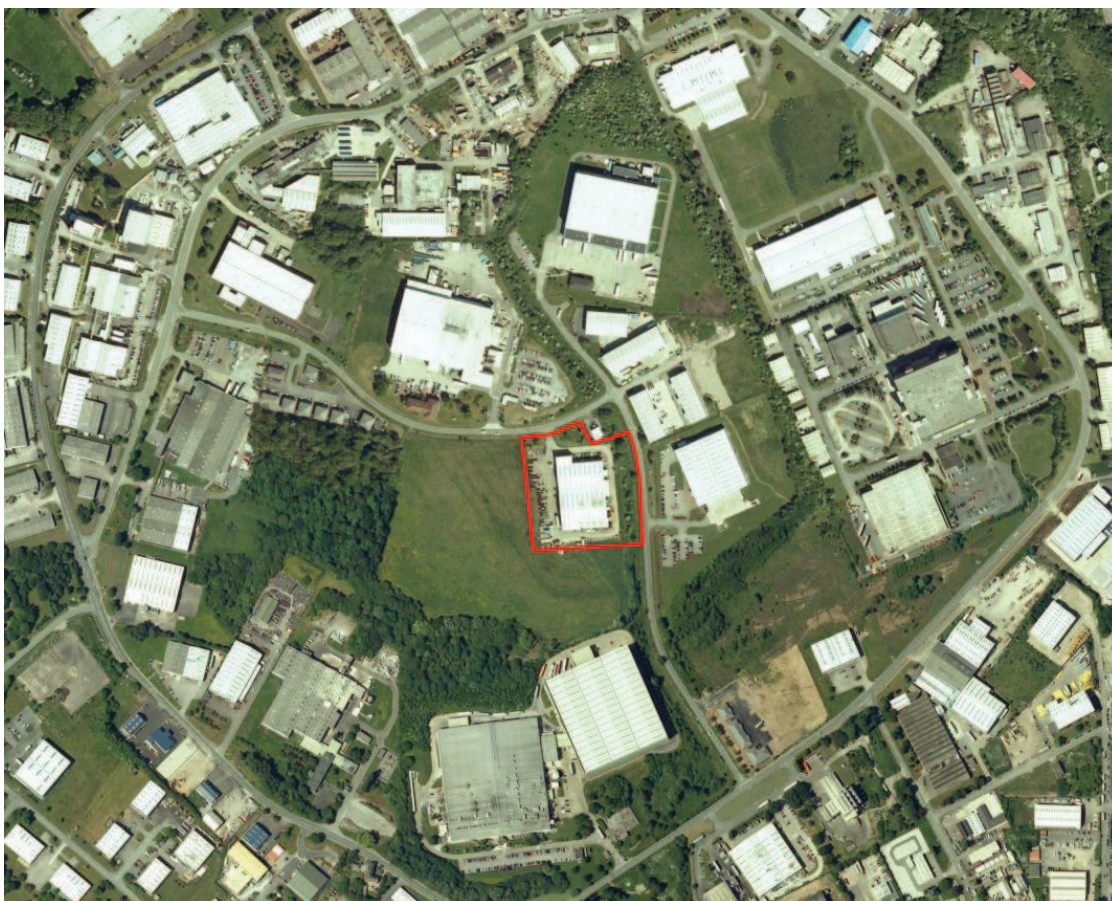
- 2.1 The site boundary and area surveyed is shown by the red boundary line in Figure 2.1.
- 2.2 The site is located within the centre of Wrexham Industrial Estate, a large area of industrial units and open grassland with pockets of semi-natural broadleaved woodland.

- 2.3 Prior to summer 2017, the land to the south and west of the site, was semi-improved grassland (as shown in Figure 2.1), however this area (apart from the area immediately to the south of the site) was vegetation and soil stripped in anticipation for a new factory development. At the time of survey this area was bare ground. Beyond this area to the south and west is a large area of semi-natural broadleaved woodland.

**FIGURE 2.1. SITE BOUNDARY AND SURVEY AREA SHOWN IN RED. (THIS IMAGE WAS TAKEN PRIOR TO 2017 AND DOES NOT ACCURATELY REPRESENT WHAT IS ON THE GROUND AT PRESENT) © GOOGLE 2017.**

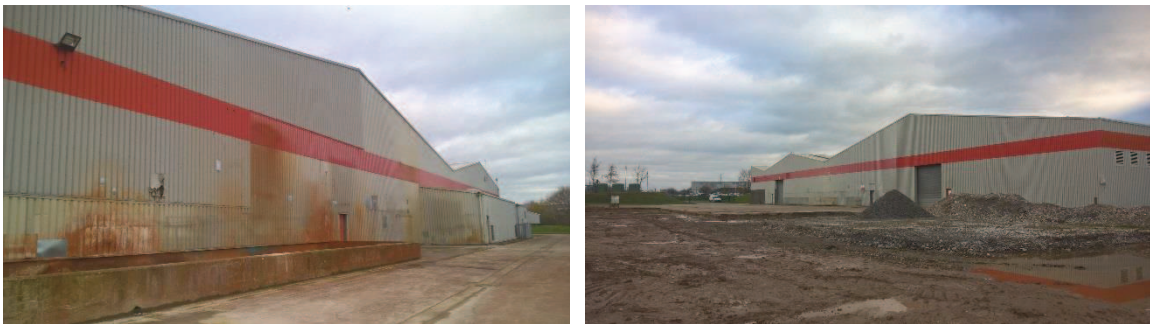
- 4.2.1 The former factory building comprised a large corrugated metal structure with a small brick section on the northern side. The main roofs were pitched with a small lean to section on the eastern side of the building. There were a number of standard sized entrance doors on all sides of the building and two large delivery entrances with metal shutters on the western side. There was a row of five large vents at the rear of the building to the south.

**PHOTO 4.1 & 4.2. EASTERN AND WESTERN SIDES OF THE FACTORY BUILDING**

5.4.1 The proposed extensions will tie into the existing factory building on all four sides. The building has negligible potential for roosting bats as its walls and roof are constructed from metal apart from a small area of wall constructed from brick. The temperature variation within potential roosting spaces would be too great for it to be suitable for bats. Therefore the works to the building will not have an impact on bats.

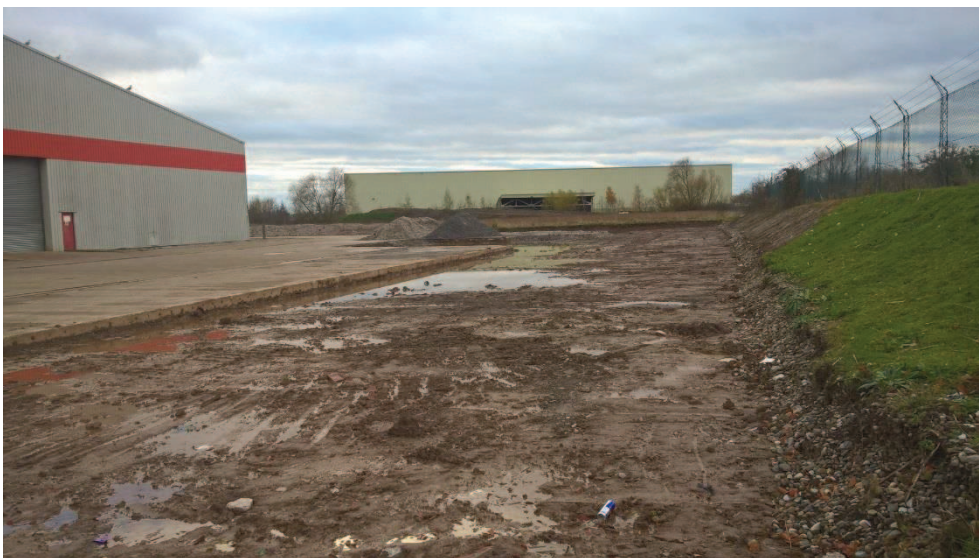
- 4.2.2 The area immediately surrounding the building predominantly comprised a concrete yard, which had no vegetation growing up through it. Along the southern boundary, adjacent to the area of semi-improved grassland and part way up the western boundary was an area of bare ground (mud). This was an area hard core, which had been recently excavated. On the area of concrete, were several large piles of hard-core, which looked to have been from the excavations.

**PHOTO 4.3. SOUTH WESTERN CORNER OF THE SITE SHOWING BARE GROUND**

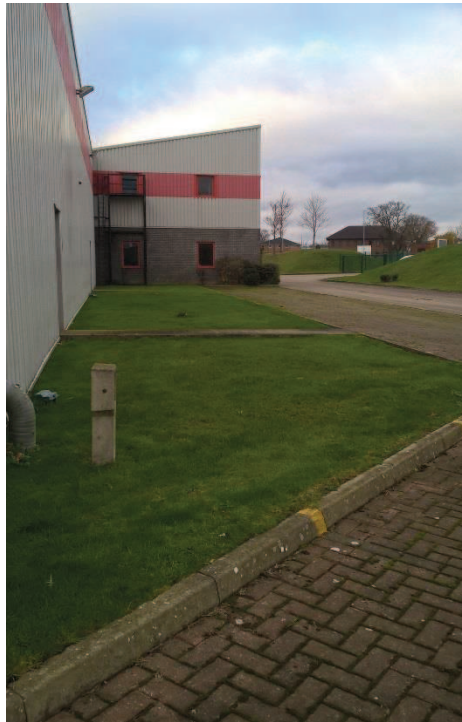
- 4.2.3 Running along the north side of the building was a small strip of amenity grassland followed by concrete hard standing and further amenity grassland along the northern boundary of the site. The amenity grassland areas looked to be regularly mown short.

***PHOTO 4.4. AMENITY GRASSLAND ALONG NORTHERN SIDE OF THE BUILDING***

5.2.1 There are no protected or notable habitats present on site. The proposed works will exclusively be carried out on existing hard standing and bare ground (previously gravel) and amenity grassland. The extension onto the northern end of the building will be on a small isolated area of amenity grassland, which will therefore be lost.

5.3.1 There is a known large population of GCN within the semi-improved grassland areas adjacent to the southern, eastern and western boundaries of the site. Apart from the small area of amenity grassland along the northern side of the building, which will be lost as part of the development, and the erection of the perimeter fence along amenity grassland on the eastern boundary, all other proposed works are to be on existing concrete or bare ground (previously gravel). The small area of amenity grassland, which is to be lost, was mown short and was isolated from further areas of grassland by hard standing. This area of short amenity grassland would not provide suitable foraging habitat for GCN and therefore its loss will not result in the loss of suitable GCN habitat.

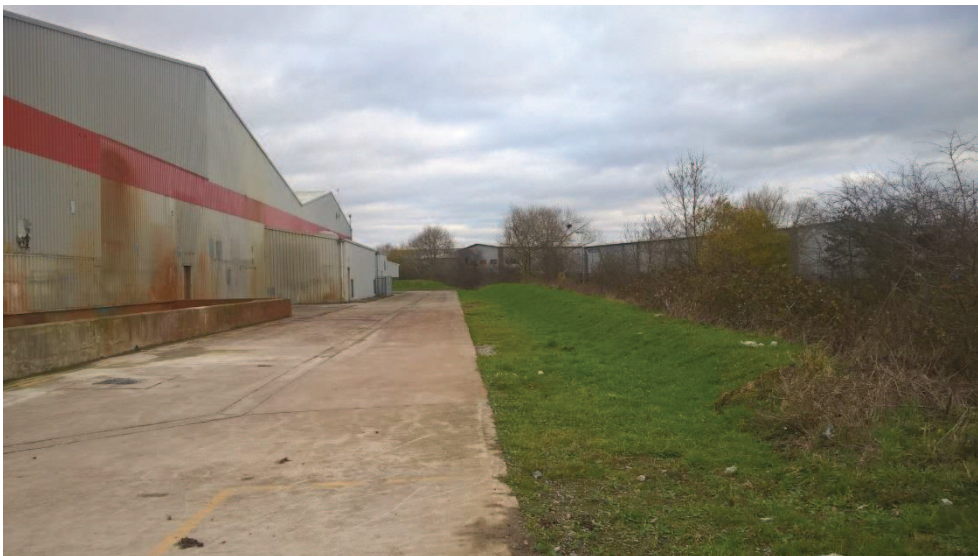
- 4.2.4 Beyond the concrete, to the east of the site, was a strip of amenity grassland, continuous scrub including bramble, a ditch with running water and semi-improved grassland before reaching the road.

***PHOTO 4.5. EASTERN SIDE OF SITE***

5.4.2 Bats may use the ditch and scrub vegetation along the eastern boundary as commuting and foraging habitat. The development itself will not affect these habitats, however to reduce the impact of any light spillage on foraging and commuting bats along this boundary during the construction and post construction phases of the development, light levels should be minimised along this boundary. This can be implemented through the types of light used, the orientation of the lights and use of accessories to direct the light away from the sensitive areas.

- Prior to works commencing fencing should be erected along the edge of the amenity grassland, along the eastern boundary to protect the ditch area from the works. The

planned newt fencing along this section will fulfil this requirement. This area shall be off limits to site workers at all times, except for the purpose of undertaking specific, pre agreed works.

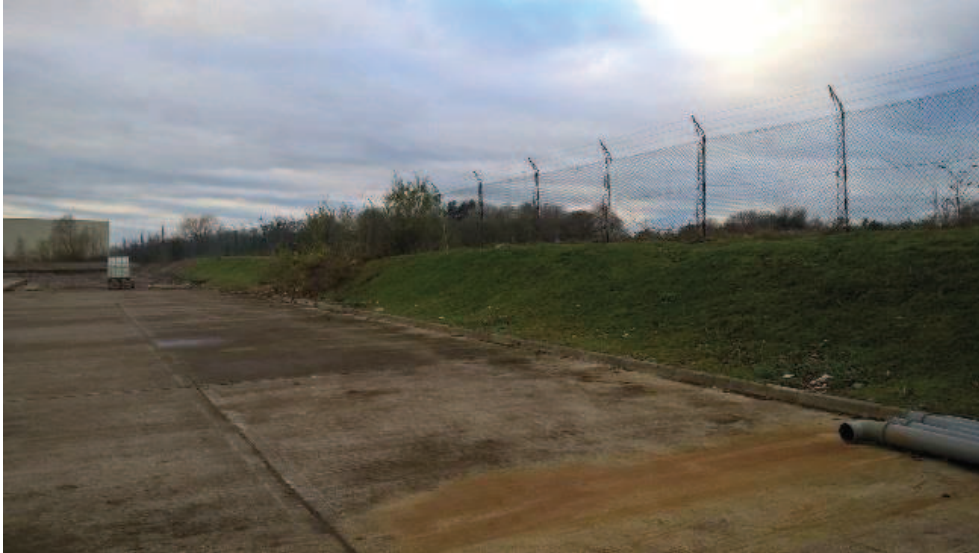
- 4.2.5 The western boundary, beyond the concrete and bare ground, was a narrow bank of amenity grassland to the north and bare ground to the south. At the top of the bank was the boundary

fence, with a small strip of long semi-improved grassland before reaching the newt fencing surrounding the adjacent site.

***PHOTO 4.6. WESTERN SIDE OF SITE LOOKING SOUTHWARDS***

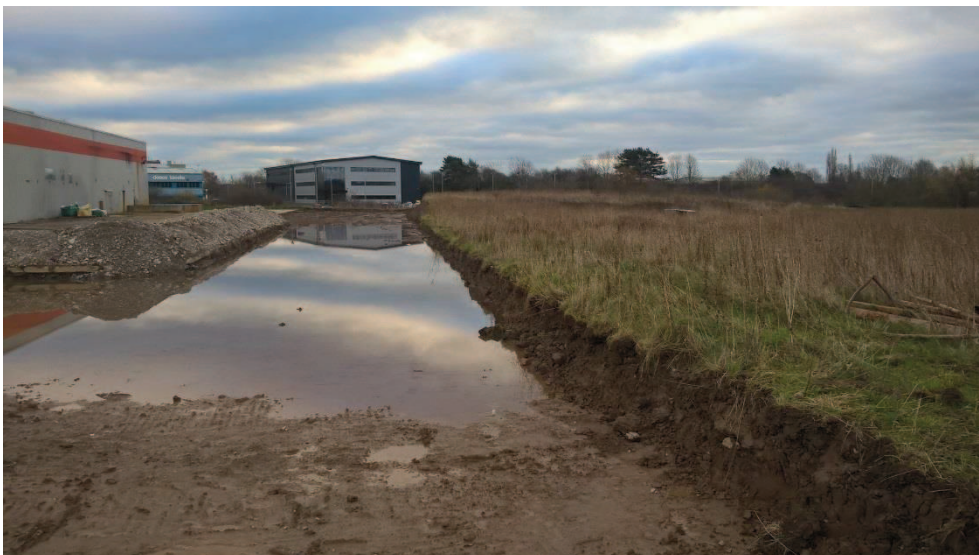
- 4.2.6 At the time of survey, the bare ground to the south of the site had standing water, which was approx. 10cm deep. There was no vegetation present within the standing water. The bare ground bordered a large area of long semi-improved grassland to the south of the site boundary. There was no physical boundary between these two areas, however the grassland area was approx. 1m higher with exposed earth along the edge.

***PHOTO 4.8. SOUTHERN BOUNDARY***

5.3.2 As all works are to be carried out on existing hard standing, bare ground (previously gravel) and amenity grassland, GCN will not be present within these areas. To prevent GCN from moving into the area during the development works, a temporary newt fence will be erected around the site prior to works commencing until all works are complete. The fence will be installed using Reasonable Avoidance Measures along the boundary between the hard standing/amenity grassland and semi-improved grassland areas with the route to be agreed by a suitably qualified ecologist. A suitably qualified ecologist will be present during the newt fence installation and will undertake a fingertip search prior to fencing works commencing. Installing the newt fencing on the boundary between the hard standing/amenity grassland and semi-improved grassland and using Reasonable Avoidance Measures will minimise the risk of harming or disturbing GCN. An EPS licence will therefore not be required.
