# Garage at Romney, Marford

Heritage Impact Assessment

D2 Architects

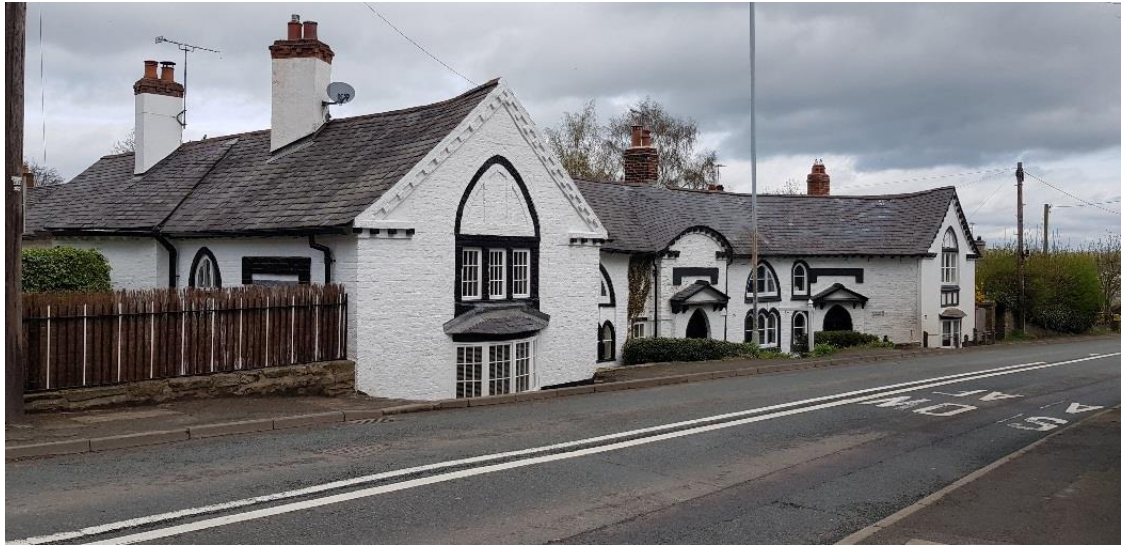
Figure 1. Front Photograph

The Exterior is painted brick, render, stone and timber framing to Stone Cottage, slate roof, brick and chimneys, some rendered. Long curved street frontage with dentil eaves cornice, projecting gabled bays at each end. Symmetrical with slightly projecting central bay with segmental pediment and entrance with arched head and pediment. On each side of this 3 grouped arched windows, a single arched window and a door with arched opening, triangular pediment and heavy label. Upper floor has large Diocletian style tripartite window. Gables with upswept roofs, the dentil cornice returns for a short distance at eaves level and there are large arched openings at first floor, that to left partly blocked, and C20 bowed windows at ground floor. Return elevations have full-height semi-circular bays and a

similar disposition of arched openings. Rear elevation has central garage doors with taking-in door above and gabled dormer windows.

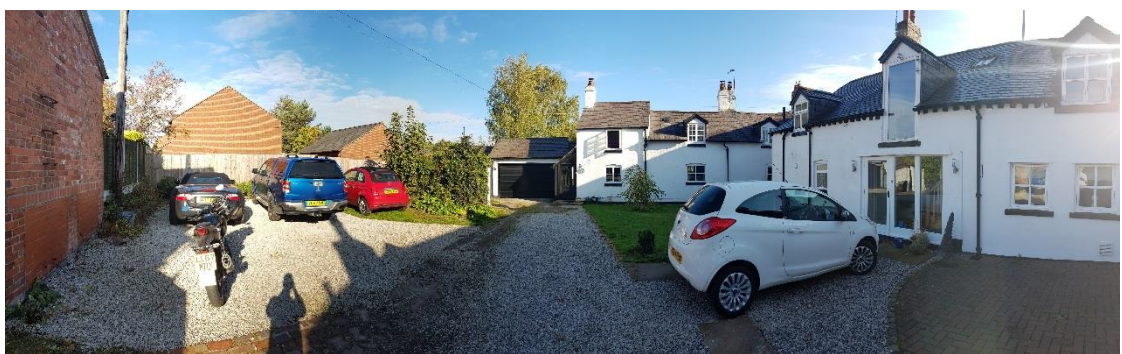
Figure 2. Rear Photograph

The Cottages are currently being used as a homes which have been altered or extended with modern additions, included a number of garages having been built both attached and detached to the cottages in the area.

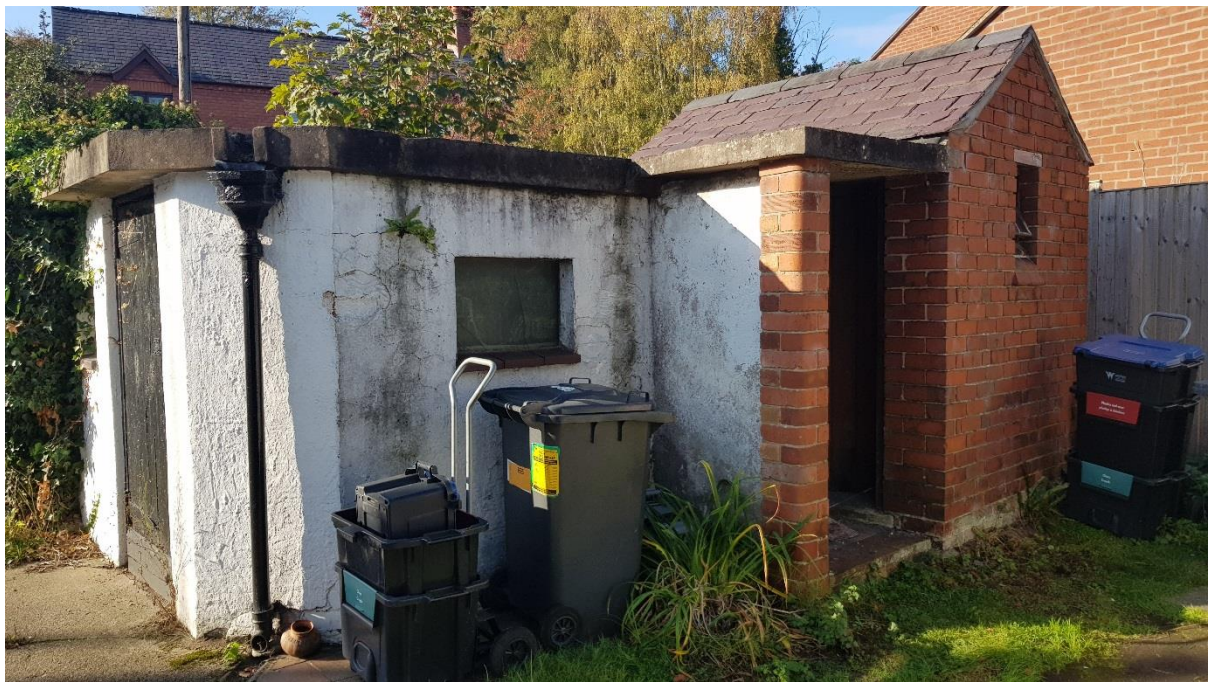
The outbuildings at Romney are believed to have originated circa mid-20<sup>th</sup> Century due to the construction and materials used, namely the flat concrete roof. Two compartments of which are W/C's with the third being a coal shed.

The outbuildings bear no architectural value in terms of the listed building having been constructed much later than the cottages and in an entirely different architectural style.

They are currently disused and the demolition of these outbuildings would not detrimentally impact the overall character of the property.

The outbuilding is not only in an unusable condition but its use as outside W/C's and coal store is no longer necessary and completely redundant.
