# Phase 5 Bryn-Y-Groes Gresford REMEDIATION STRATEGY SG Estates

**REPORT No: 15SGE008/RS**

Date: 13.02.19

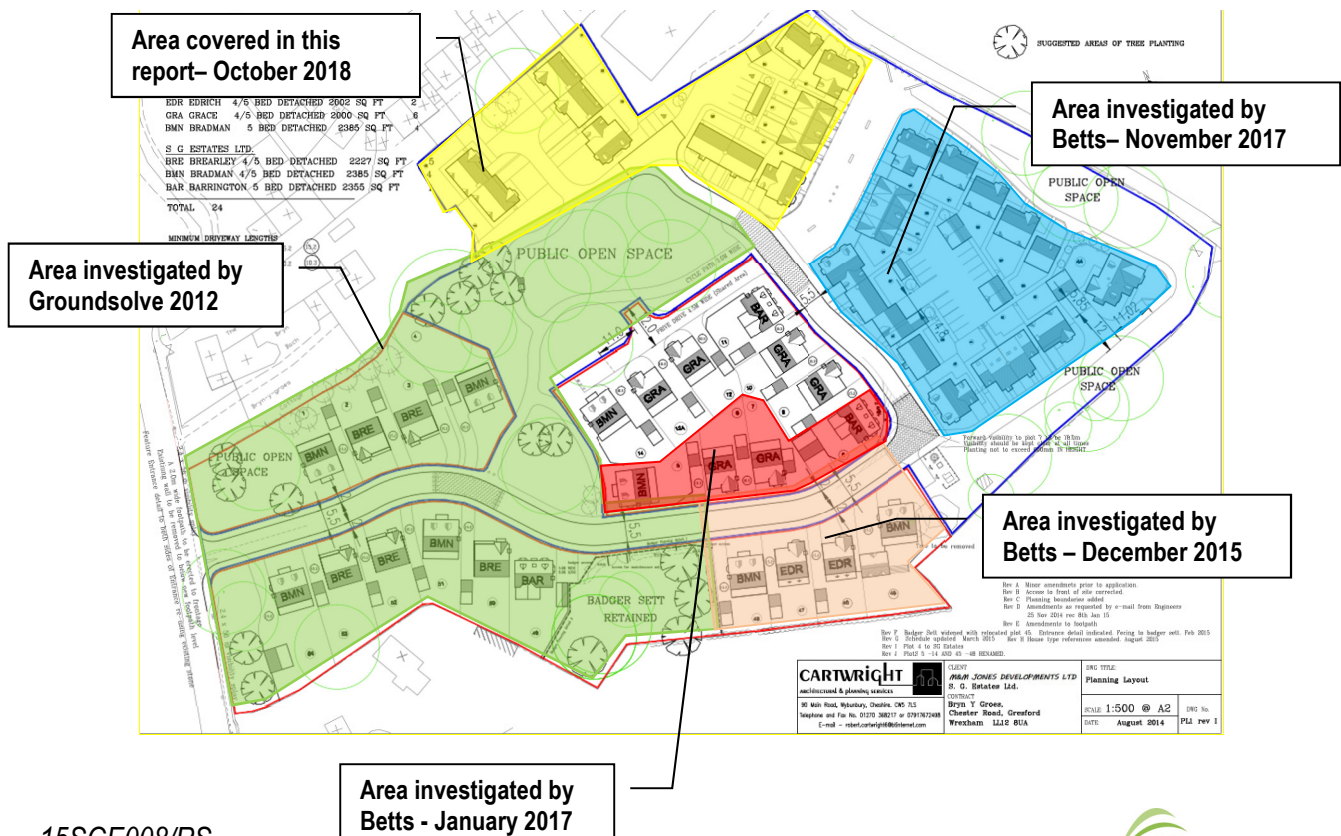
Betts were contracted to undertake further trial pitting and chemical testing in October 2018 to investigate the ground conditions and confirm geotechnical requirements for plots 22-33. The additional investigation area is outlined in yellow on the extract below;

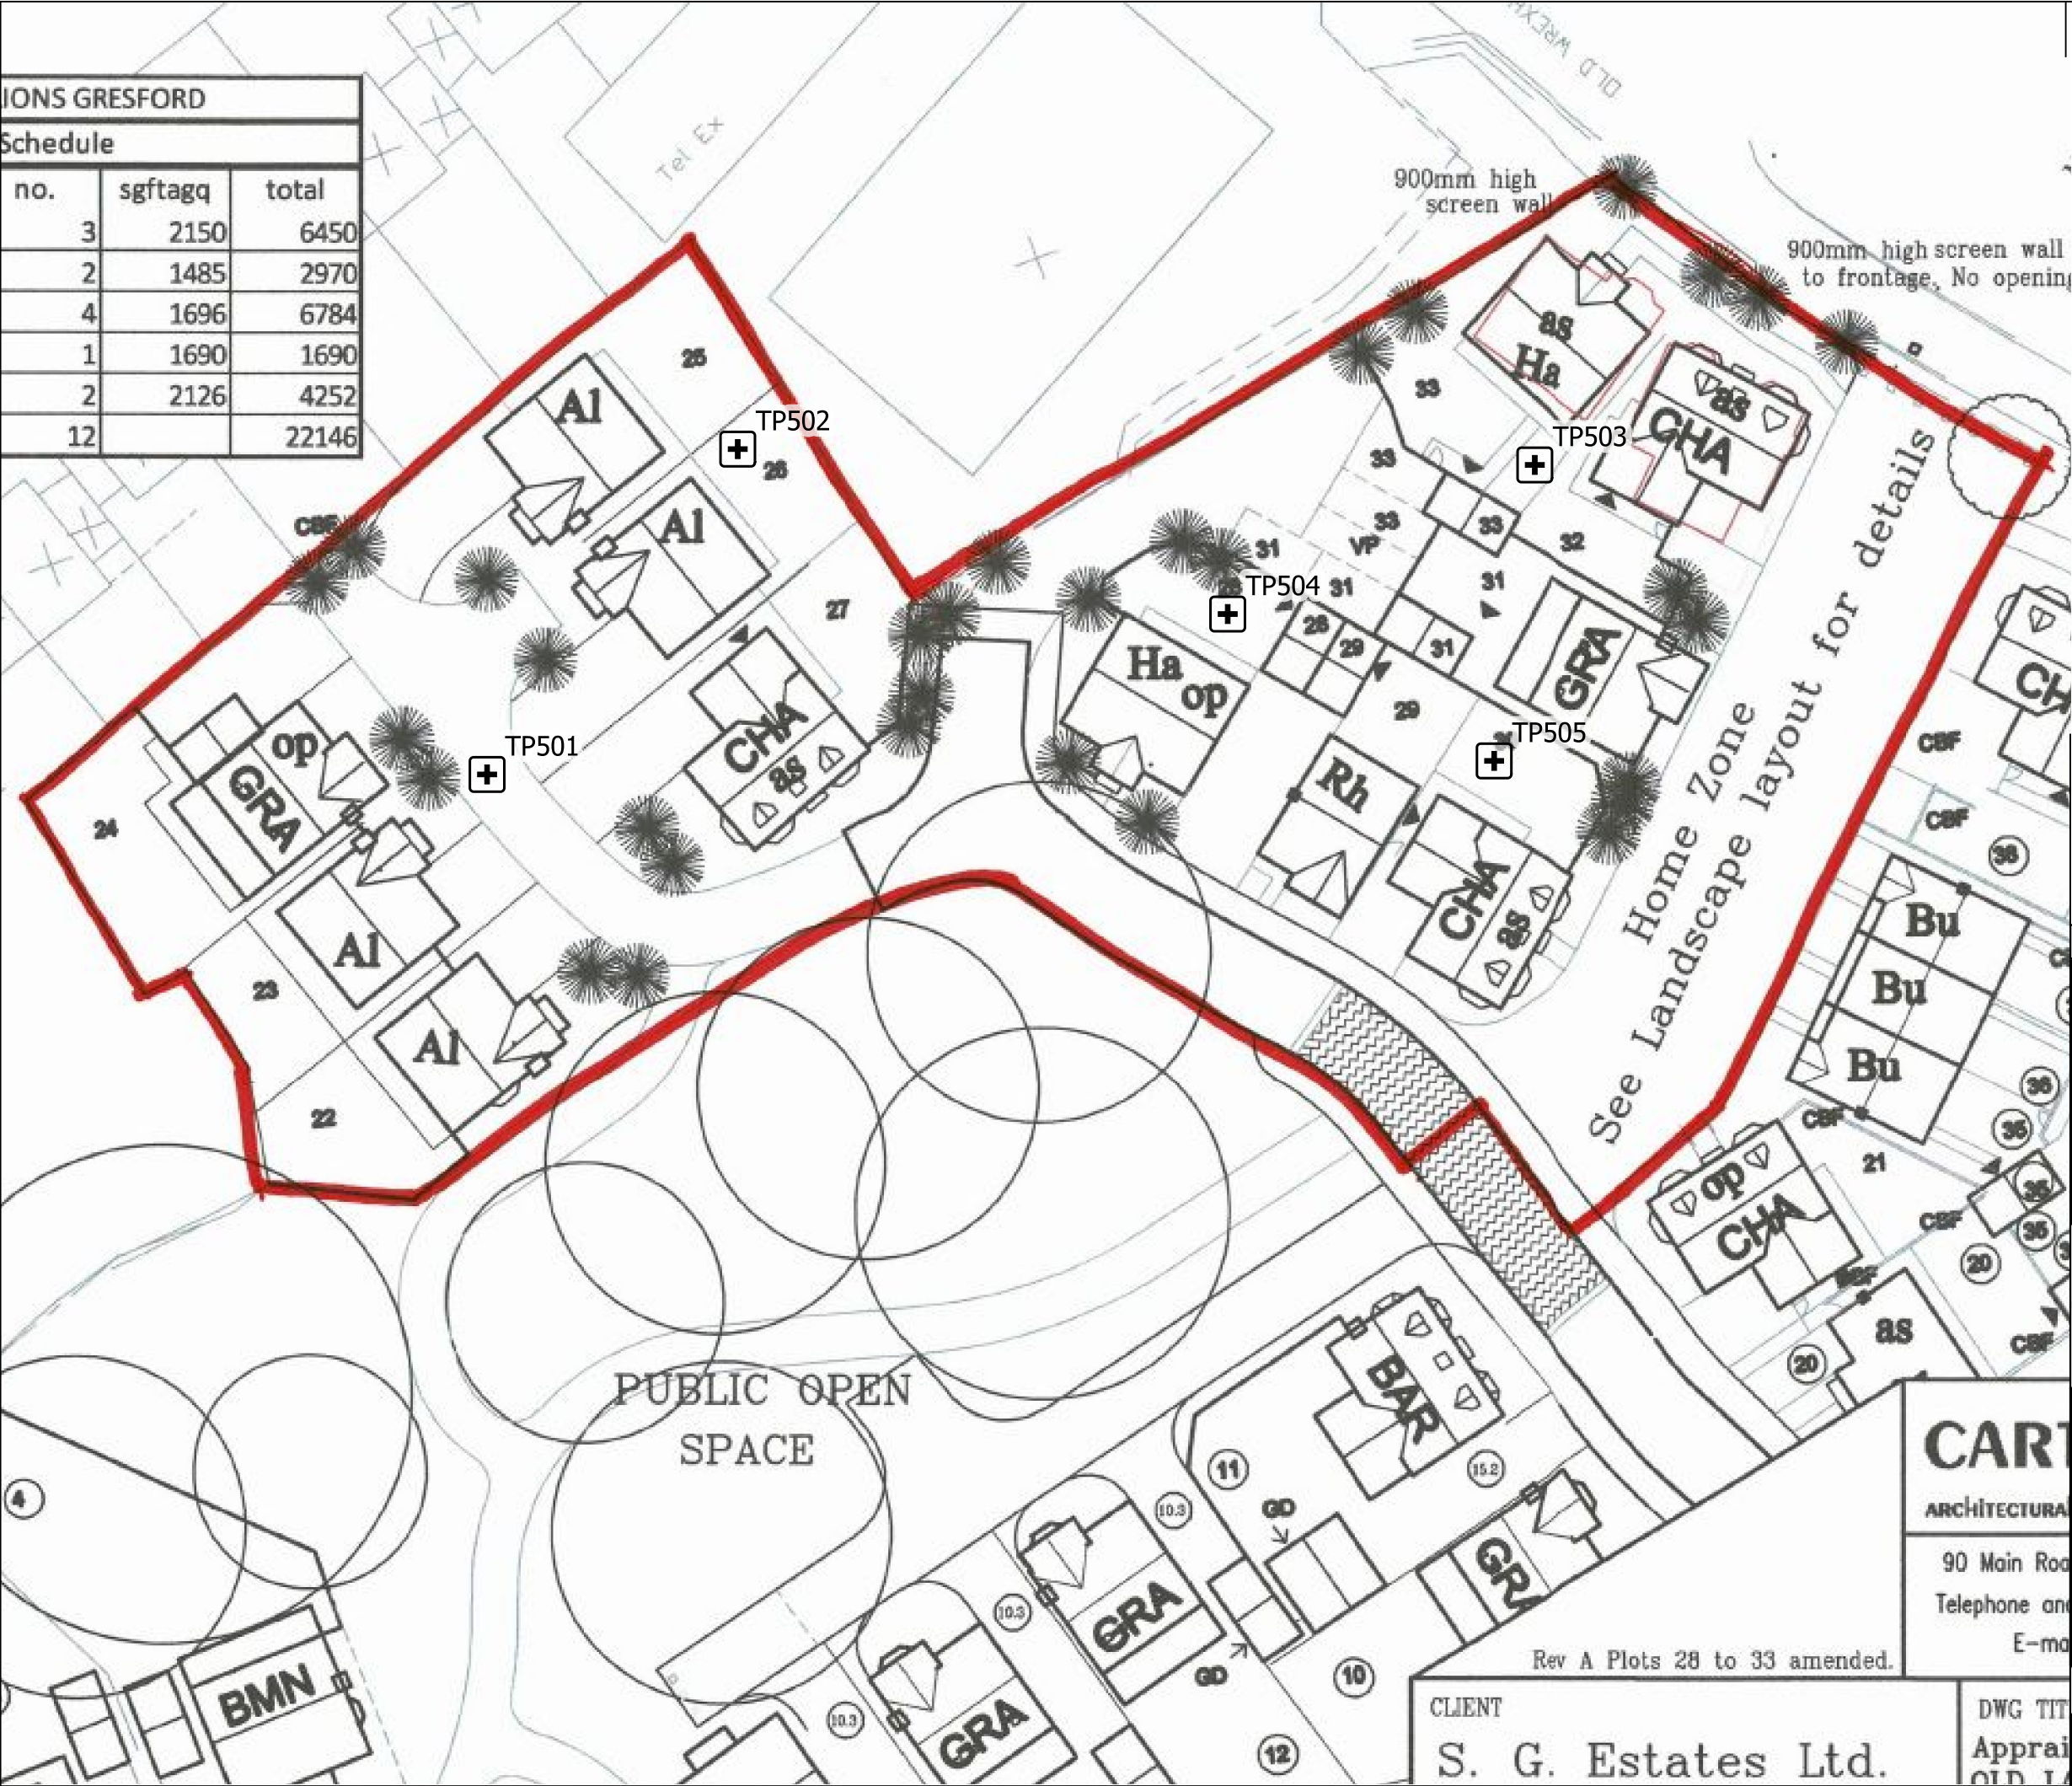
TITLE: EXPLORATORY HOLE LOCATION PLAN

EXPLORATORY HOLE LOCATION PLAN  
SHOWS INDICATIVE LOCATIONS OF TRIAL  
PITS OVERLAIN DRAWING 'APPRAISAL  
LAYOUT PHASE 5 (AREA) OLD LAYOUT REF  
ONLY', No. PH5 SK3A, DATED JULY 2018  
BY CARTWRIGHT.

+ TRIAL PIT

The exploratory hole positions were selected and set out by Betts Geo Environmental (BGE) as shown on the Exploratory Hole Location Plan enclosed with this letter.
