REF: 2165/BGR/ShaftSearch/mjs

## **RE: BRYN GLAS RHOS: MINING STUDY-SHAFT SEARCH**

## 2.0 Site Investigation

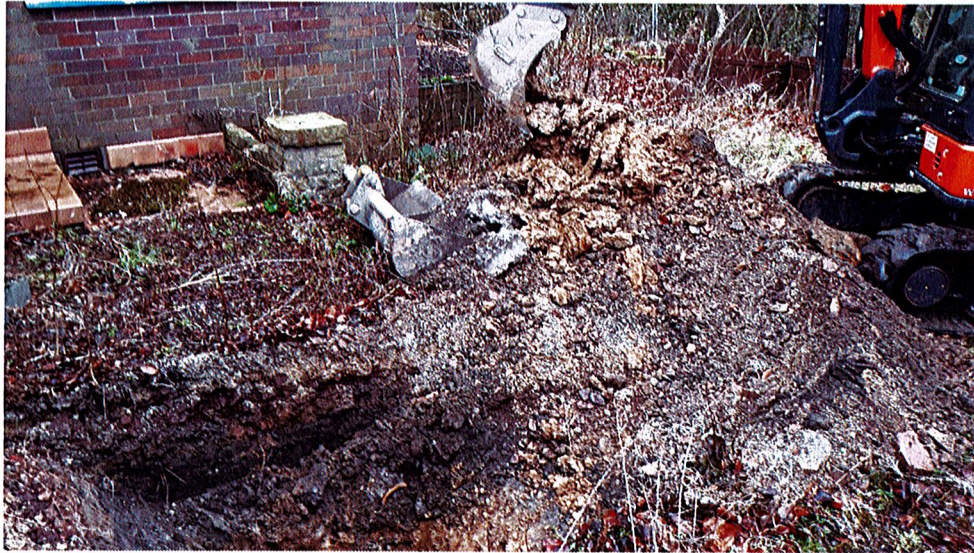
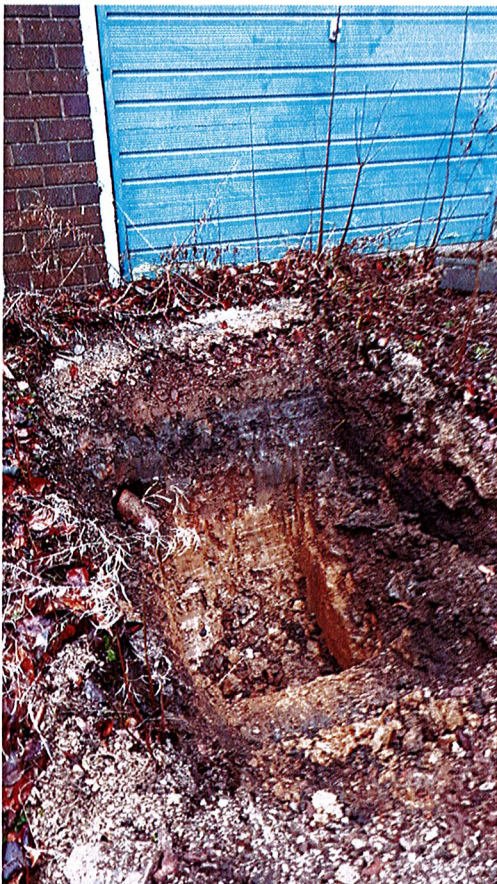
## TRIAL PIT 1

In TP 1 a thin layer of sub base overlay a dark grey to brown, silty clay, with a little gravel and tiles. Roots were also observed, suggesting the sub base had been placed on the previous surface level.

| Depth (m) | Strata |
|---|---|
| 0.00 – 0.10 | Loose cream fine to coarse GRAVEL (SUB-BASE) |
| 0.10 – 0.60 | Dark grey changing to brown silty CLAY with a little gravel, tiles etc, with roots near surface (MADE GROUND) |
| 0.60 – 1.00 | Firm to stiff orange brown silty CLAY with a little to some sub angular to sub rounded fine to coarse gravel (Weathered GLACIAL TILL) |

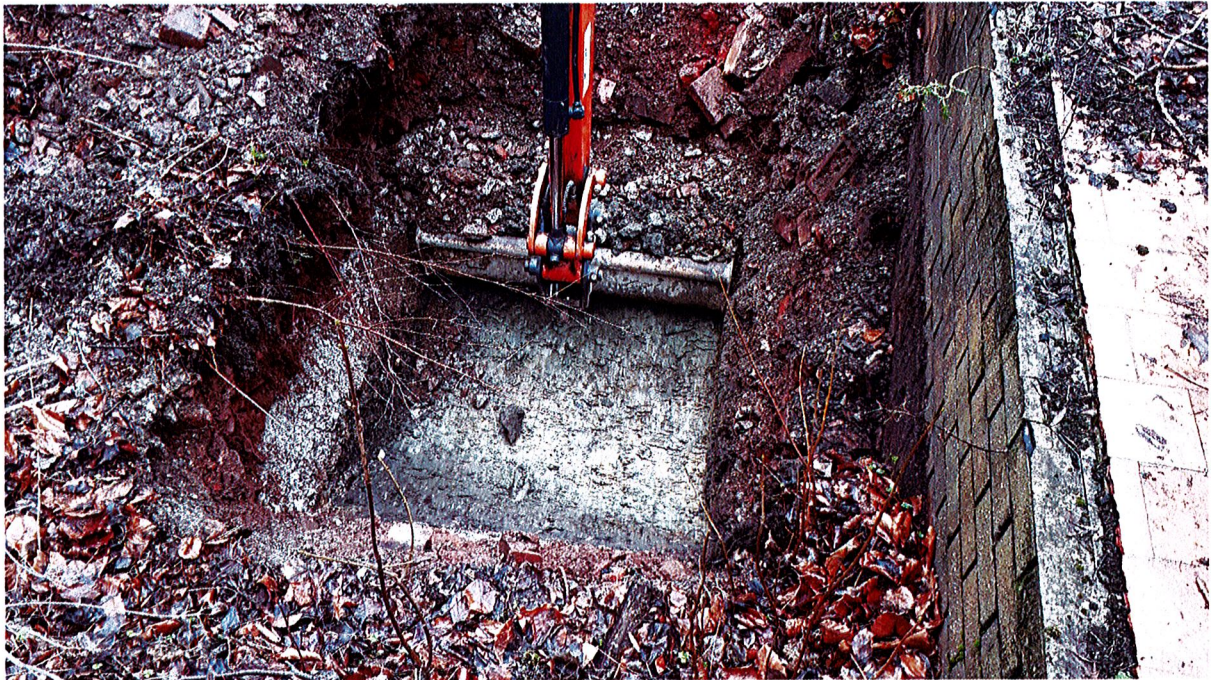
## TRIAL PIT 2

TP 2 was excavated in the raised area at the front of the property. It encountered demolition debris, described as loose, brown and orange, brick and tile fragments, in a sandy gravelly matrix. This layer sat on a thin layer of sub base, resting on the old topsoil layer. This proved conclusively that this fill was placed following construction of the property.

| Depth (m) | Strata |
|---|---|
| 0.00 – 0.75 | Loose brown and orange BRICK & TILE fragments in a sandy gravelly matrix (MADE GROUND) |
| 0.75 – 0.90 | Loose cream sub angular fine to coarse GRAVEL (SUB BASE) |
| 0.90 – 1.10 | Soft brown slightly organic CLAY with traces of old roots and gravel (OLD TOPSOIL LAYER) |
| 1.10 – 1.35 | Firm to stiff orange brown silty CLAY with a little to some sub angular to sub rounded fine to coarse gravel (Weathered GLACIAL TILL) |

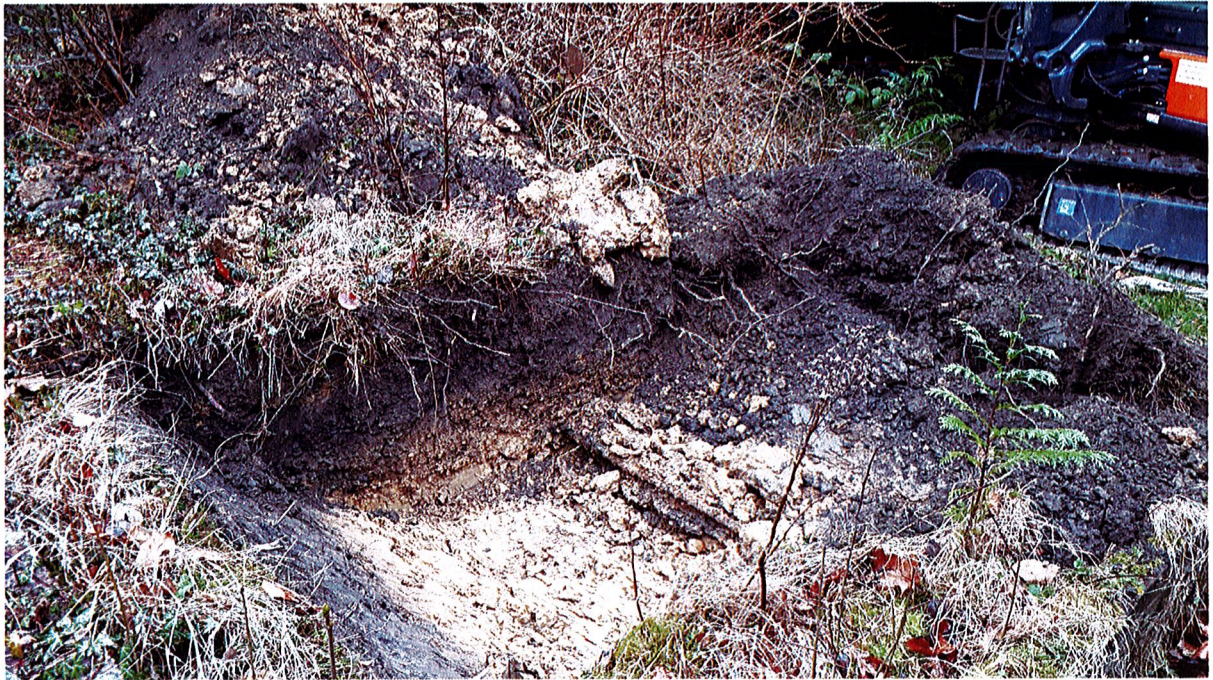
### TRIAL PIT 3

TP 3 and 4 were excavated at the rear of the property and encountered topsoil resting directly on the glacial till.

| Depth (m) | Strata |
|---|---|
| 0.0 – 0.30 | TOPSOIL |
| 0.30 – 0.55 | Firm to stiff orange brown silty CLAY with a little to some sub angular to sub rounded fine to coarse gravel (Weathered GLACIAL TILL) |

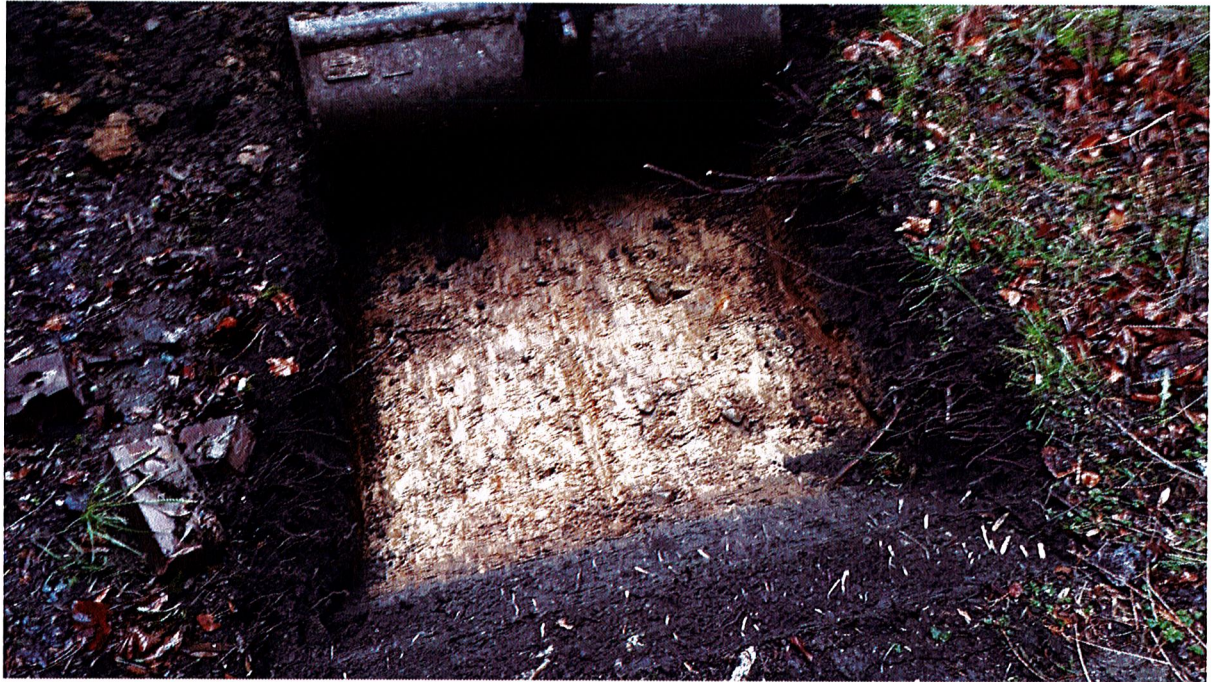
#### TRIAL PIT 4

| Depth (m) | Strata |
|---|---|
| 0.0 – 0.30 | TOPSOIL |
| 0.30 – 0.55 | Firm to stiff orange brown silty CLAY with a little to some sub angular to sub rounded fine to coarse gravel (Weathered GLACIAL TILL) |

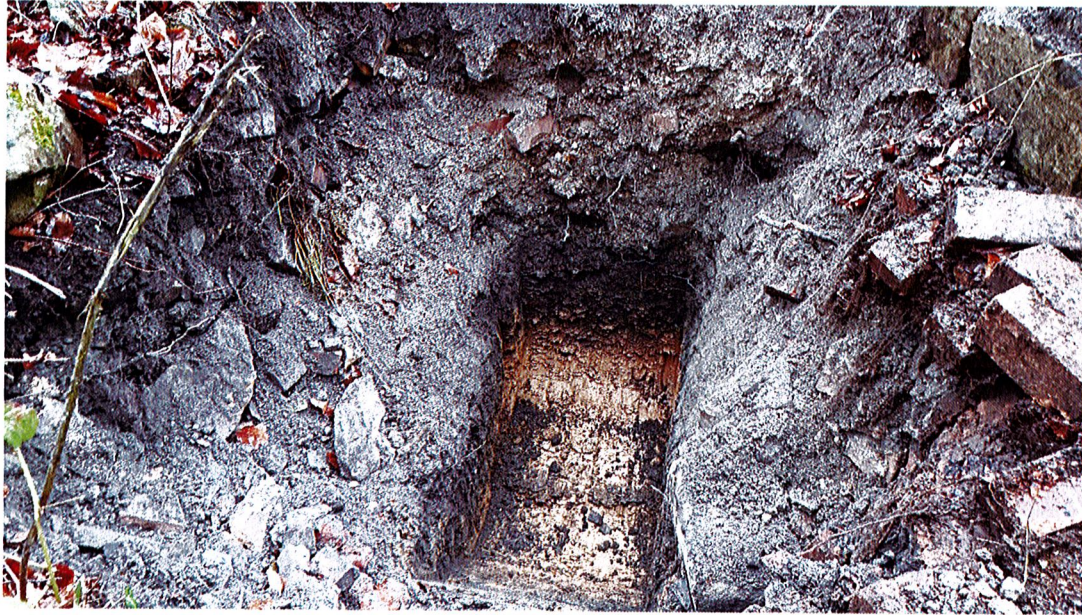
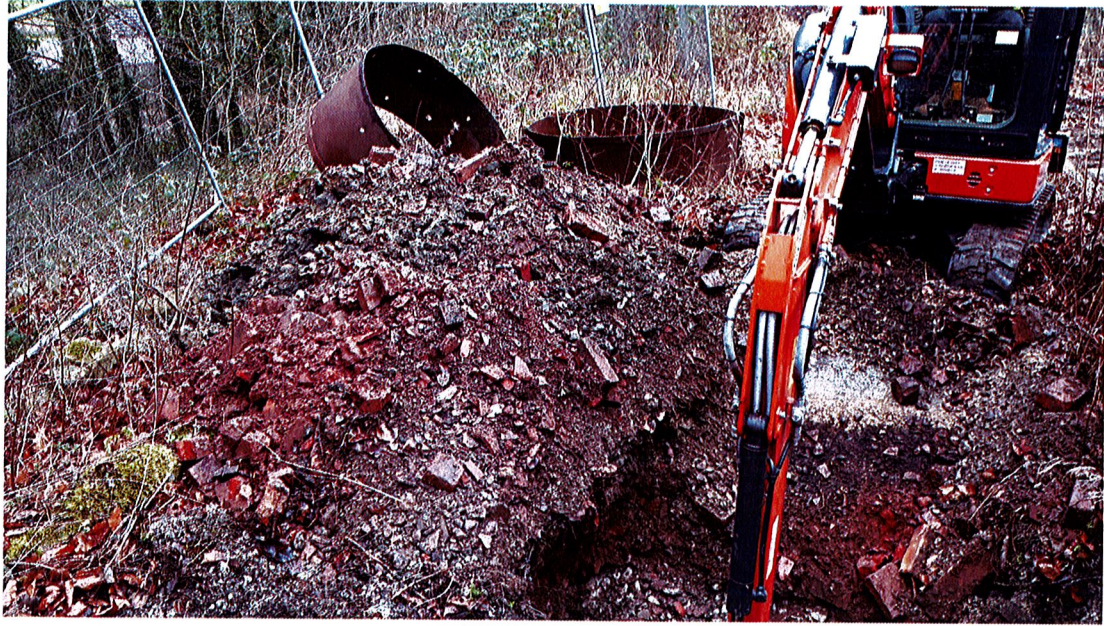
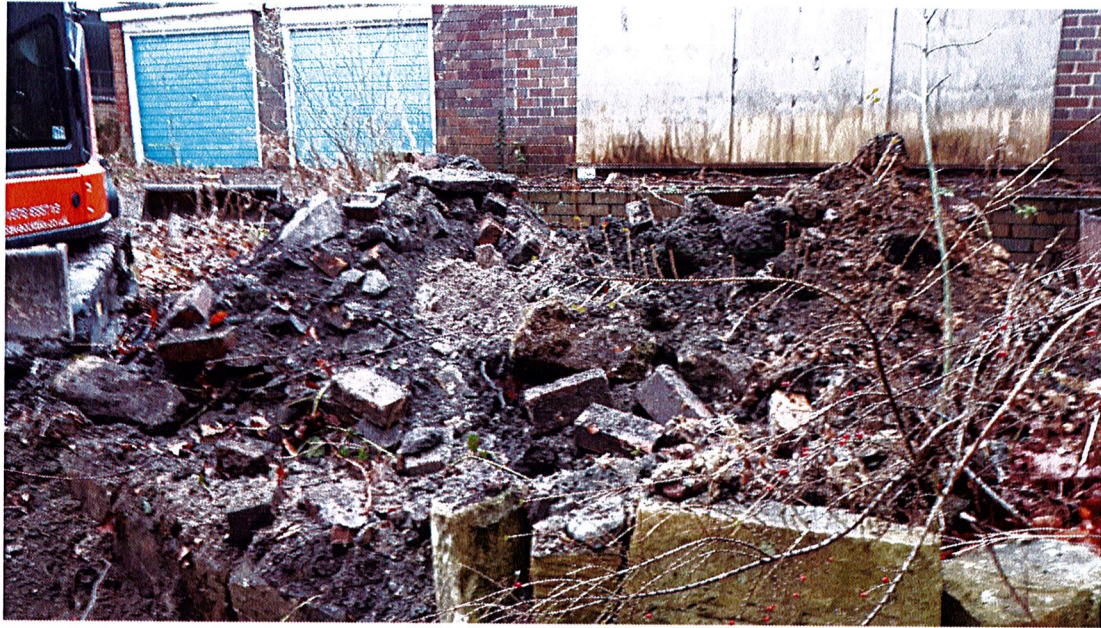
### TRIAL PIT 5

TP 5 excavated at the front of the property, where the fill was thickest, encountered 1.10m of demolition debris, comprising loose, bricks and masonry, overlying the old topsoil layer and the glacial till.

| Depth (m) | Strata |
|---|---|
| 0.00 – 1.10 | Loose BRICKS and MASONRY in a sand gravel matrix (MADE GROUND-Demolition Debris) |
| 1.10 – 1.50 | OLD TOPSOIL LAYER |
| 1.50 – 1.80 | Firm to stiff orange brown silty CLAY with a little to some sub angular to sub rounded fine to coarse gravel (Weathered GLACIAL TILL) |
