MD/17040

21<sup>st</sup> December 2018

### **RE: SUPPLEMENTARY INVESTIGATION WORKS AT GRESFORD RD, LLAY, WREXHAM**

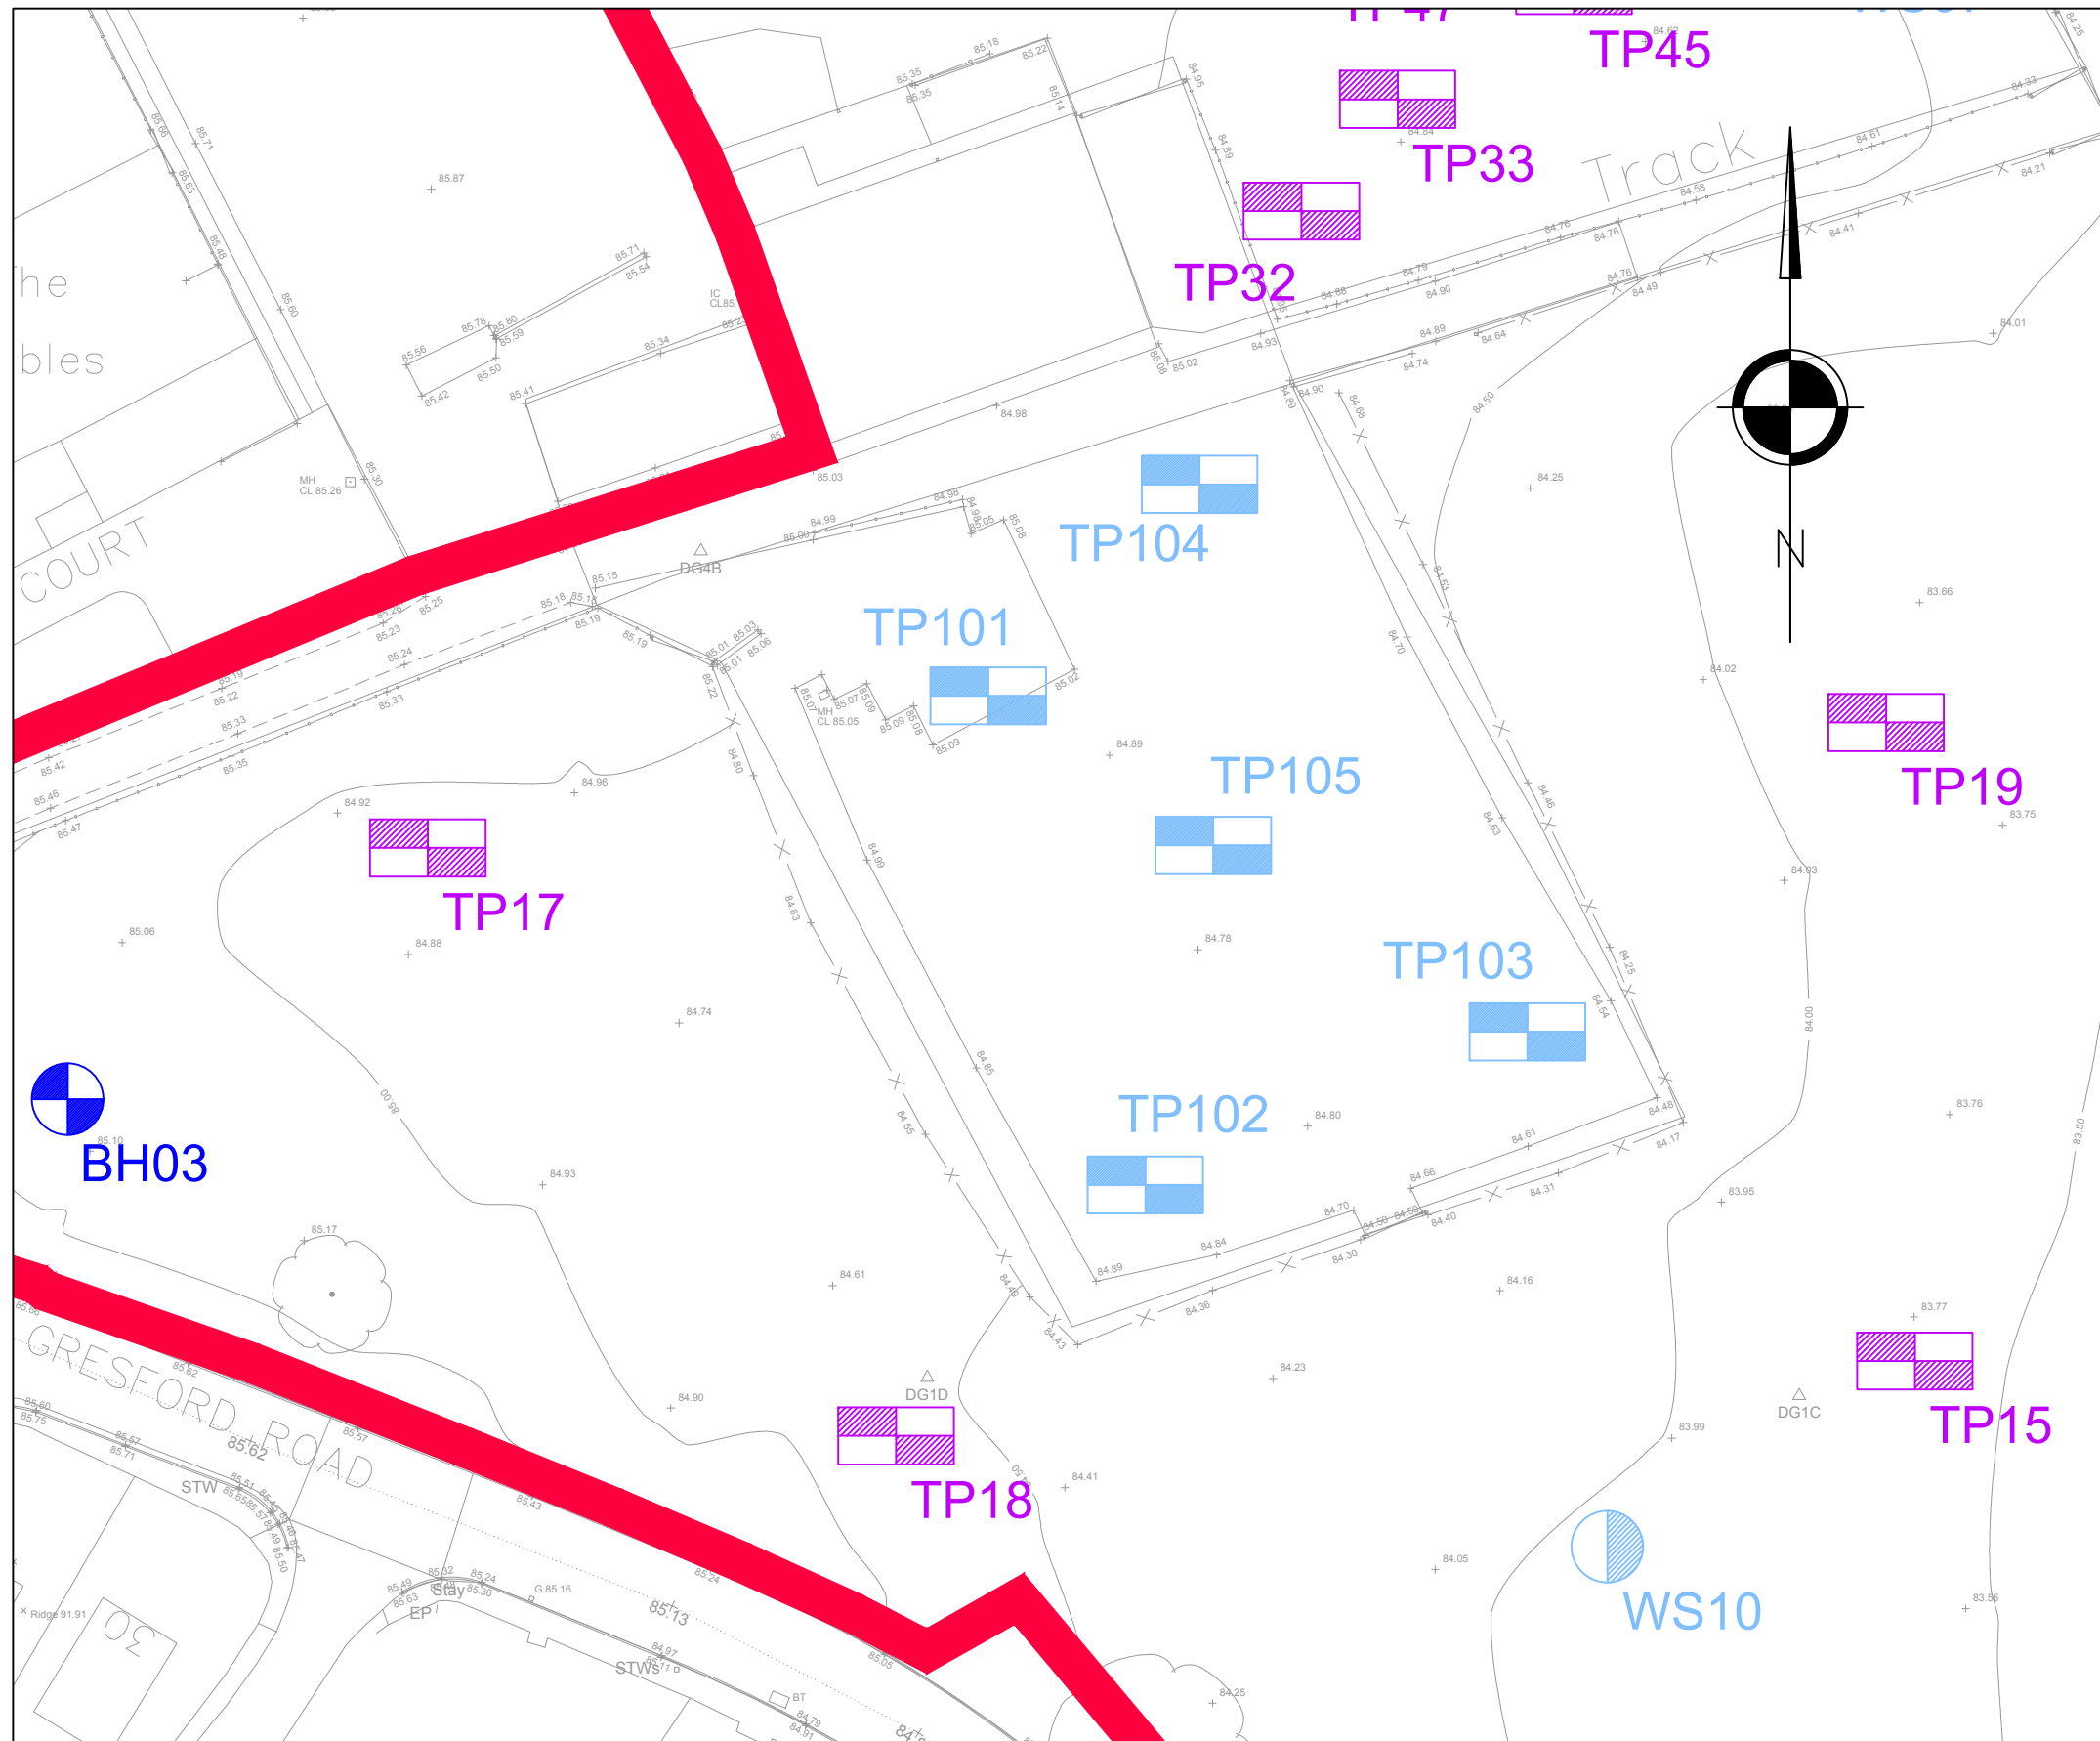
| DRAWING No | 17040/27 | rev |

This investigation commissioned by REFA utilised five (5 No.) trial pits (TP101 – TP105) which were supervised by a REFA engineer. These trial pits were targeted within the area of the existing slab and utilised a pneumatic breaker to break through the concrete slab. These trial pits were excavated to depths between 1.1 – 2.5m bgl. The locations of the trial pits are shown upon the appended exploratory hole plan (17040/27).

**Drawing title**  
Supplementary Site Investigation  
Plan

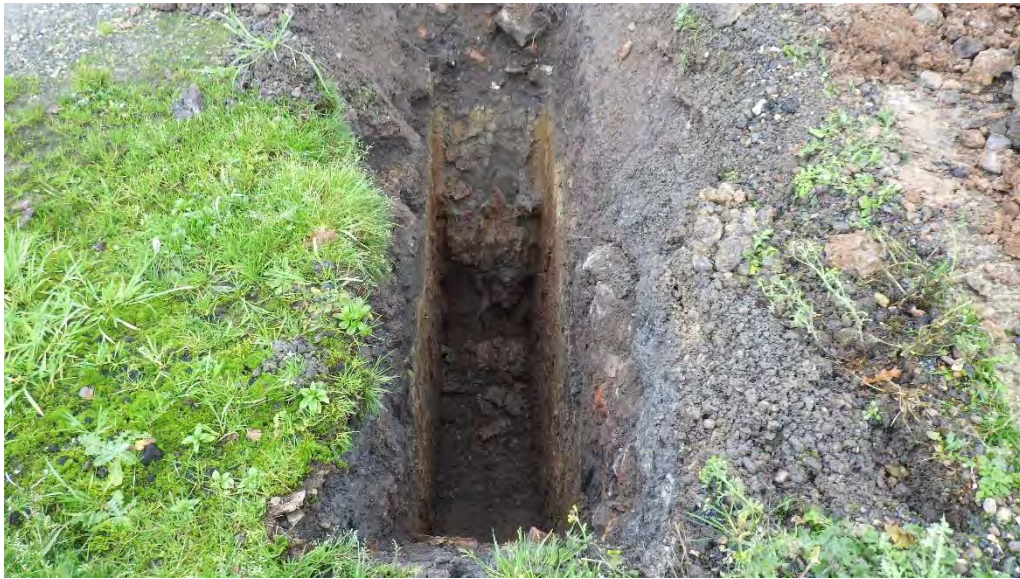
Photo 1 – Trial Pit 101

A majority of locations (TP102 – TP105) have identified concrete present at a thickness of 0.2m. Within position TP101 grass covered made ground comprising of a sub base material of limestone and concrete was identified and proven to a depth of 0.3m bgl.

| Water Strike | Samples & In Situ Testing | | | Depth (m) | Level (m) | Legend | Stratum Description | |
|---|---|---|---|---|---|---|---|---|
| | 0.60 | ES | | 0.30 | | | Grass over MADE GROUND: Dark grey, sandy, fine to coarse, sub-angular to angular gravel of various lithologies including limestone and concrete. Sand is fine to coarse. | |
| | | | | 0.90 | | | MADE GROUND: Dark brown, sandy, slightly clayey, fine to coarse, sub-angular to angular gravel of brick, concrete and limestone. Sand is fine to coarse. Medium cobble content. | |
| | 1.50 | | HVP=92 | | | | Firm to stiff, mottled greyish brown, slightly sandy CLAY. Sand is fine to medium. | 1 |

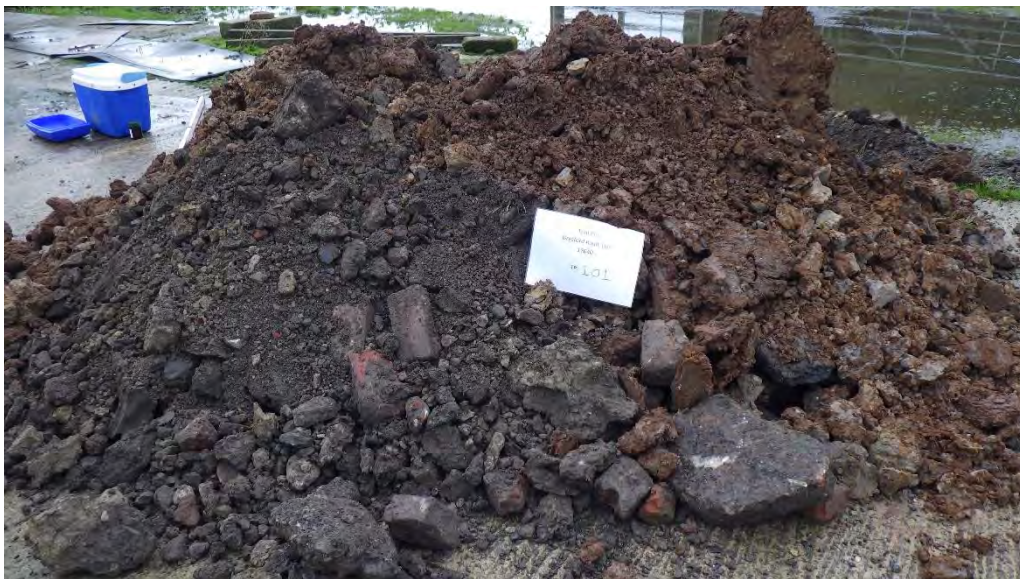
Photo 2 – Arising's from Trial Pit 101

Due to the presence of made ground deposits we have obtained samples for chemical analysis to determine whether the made ground is suitable for retention within the site.

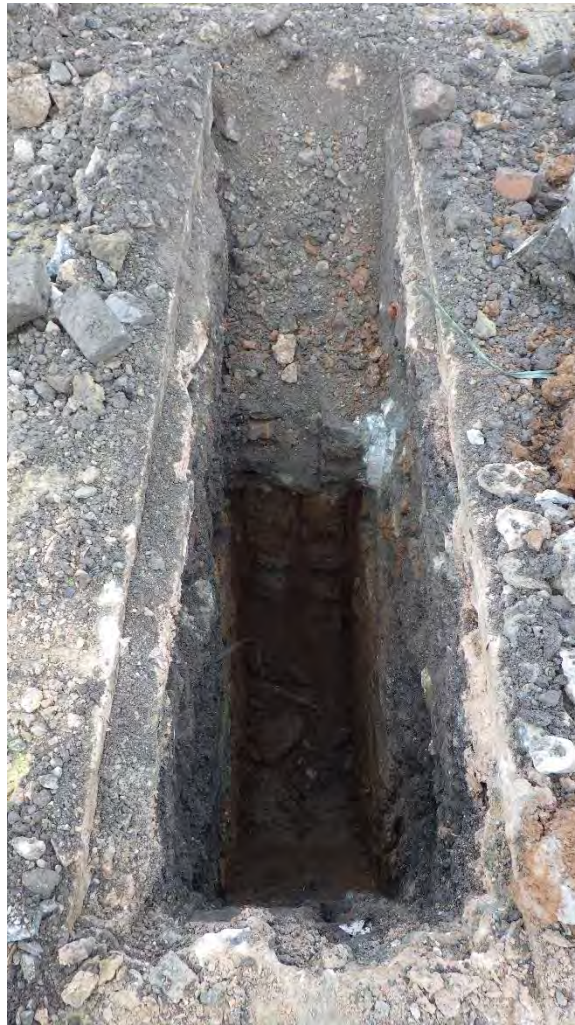
Photo 3 – Trial Pit 102

| Water Strike | Samples & In Situ Testing | | | Depth (m) | Level (m) | Legend | Stratum Description | |
|---|---|---|---|---|---|---|---|---|
| | | | | 0.20 | | | MADE GROUND: Concrete Slab (recovered as light grey, angular cobbly coarse gravel). | |

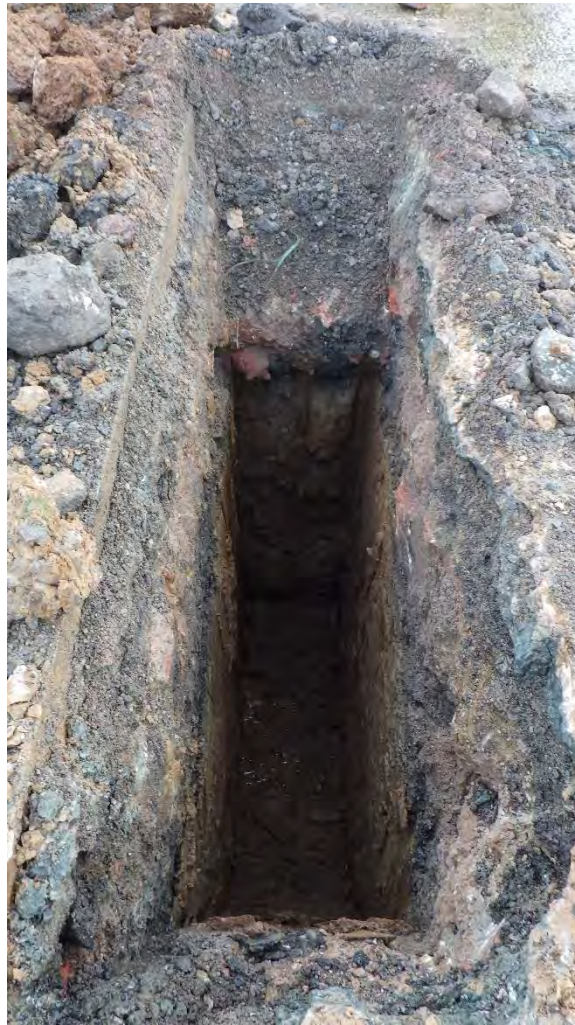
Photo 5 – Trial Pit 103

All samples have been screened for the presence of asbestos fibres and sample TP103 - 0.5m has identified the presence of Chrysotile fibres. Upon identification the fibres have been quantified and recorded a quantity of <0.001%. Based upon this quantity and the lack of visual evidence of ACM's within the made ground it is considered that asbestos fibres do not pose a risk to ground workers or the long term end users of the site. If ACM's or fibres are identified during groundworks then these should be handled and disposed of in accordance with guidance HSG247. The appropriate regulatory authorities should also be notified.

Asbestos screening has identified the presence of Chrysotile fibres within sample TP103 – 0.5m but recorded at a quantity of <0.001%. Therefore asbestos fibres are not considered to pose a hazard to ground workers or the long term end users.

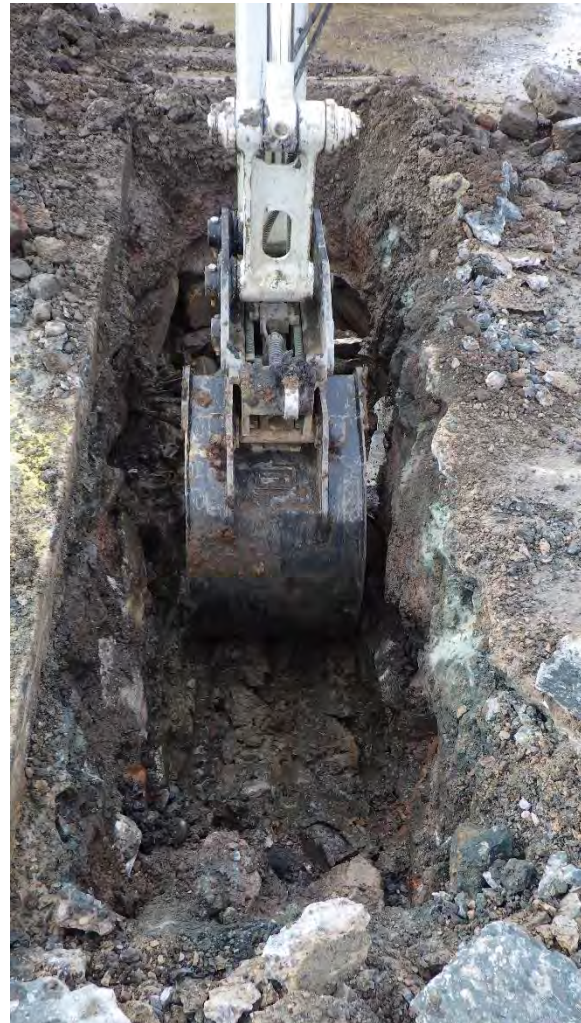
Photo 7 – Trial Pit 104

Position TP104 was terminated at a depth of 1.1m bgl due to the very fast influx of perched water within the made ground material masking the excavation and making it unsafe to continue.

Within position TP104 soft to firm sandy clay was encountered at 0.9m bgl and was proven to 1.1m bgl. It is anticipated that the natural clays within this area are generated by the significant localised perched water in this location. The natural strata in this location should be reviewed following dewatering of perched water.

Remarks: Groundwater ingress at 0.5m. Fast rate of infiltration. Trial pit terminated at 1.1m due to excessive water.

Softer clay deposits were identified within position TP104 at depths between 0.9 – 1.1m bgl and it is anticipated that this is related to the significant amount of perched water in this locality above the natural clays. Following dewatering in this area the natural clay strata in this locality should be reassessed by the foundations engineer.

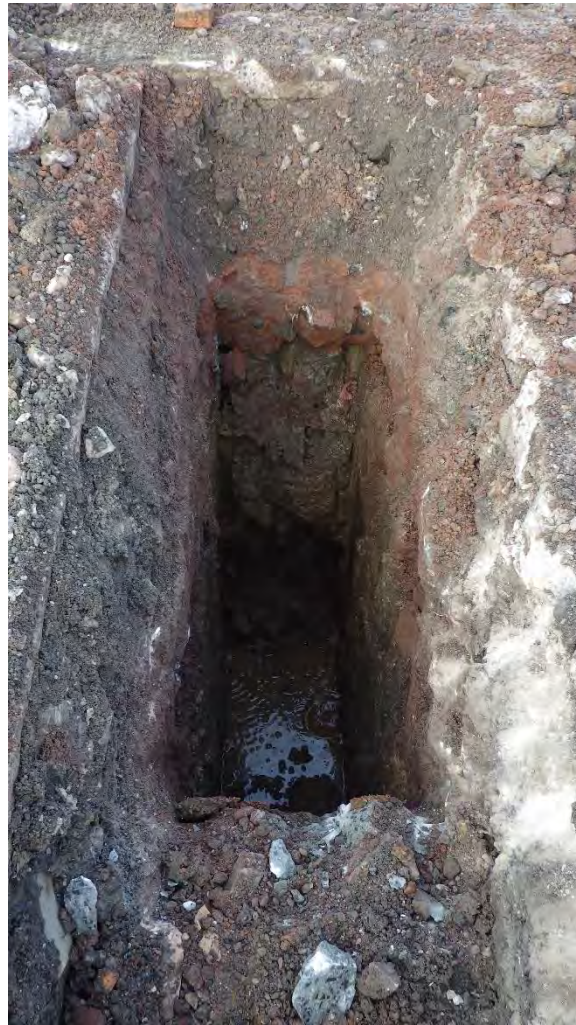
Photo 9 – Trial Pit 105

Remarks: Groundwater ingress at 1.7m. Slow rate of infiltration.
