## BS5837 Tree Survey, Arboricultural Impact Assessment and Method Statement.

Conery Lane Farm, Conery Lane, Bronington, Whitchurch, Shropshire, SY13 3EZ.

January 2018

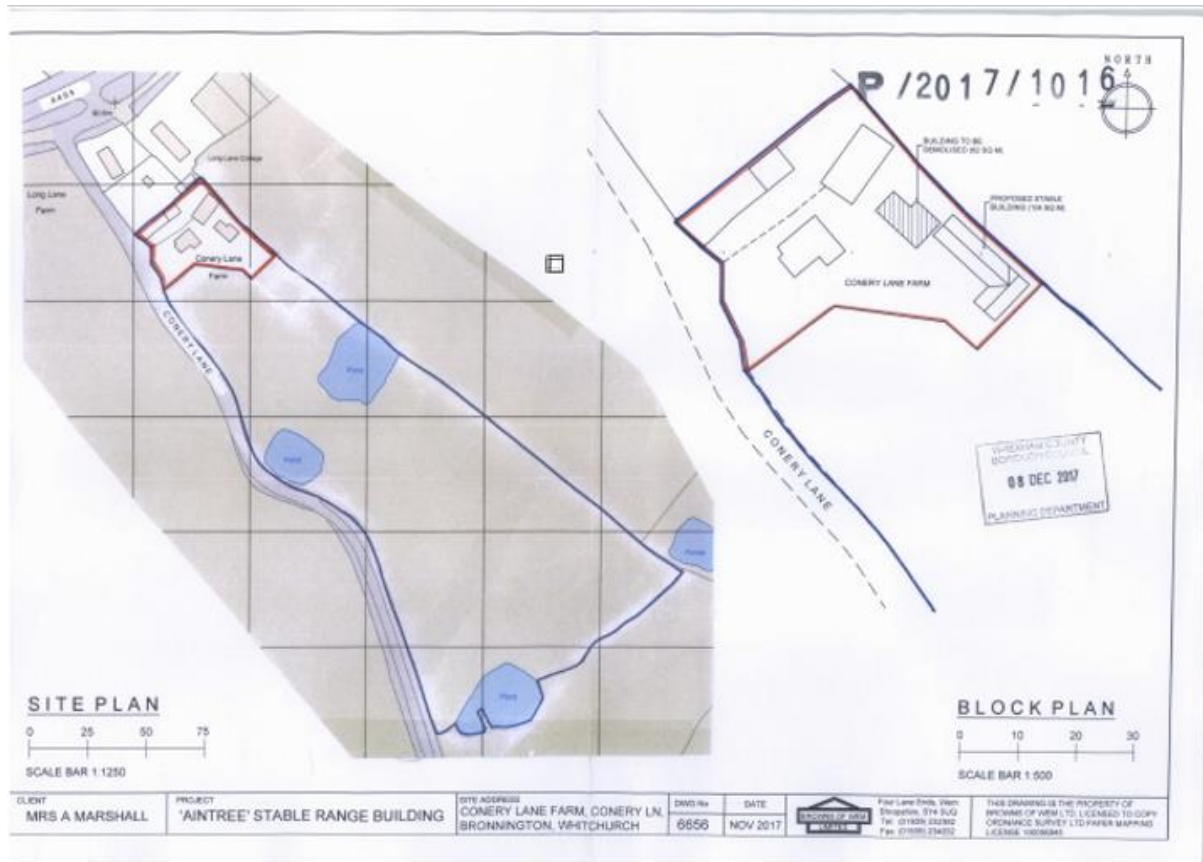
**4. Location of survey:** Proposed stable block to East of Conery Lane Farm.

**5. Tree survey site parameters** are highlighted in red box above.

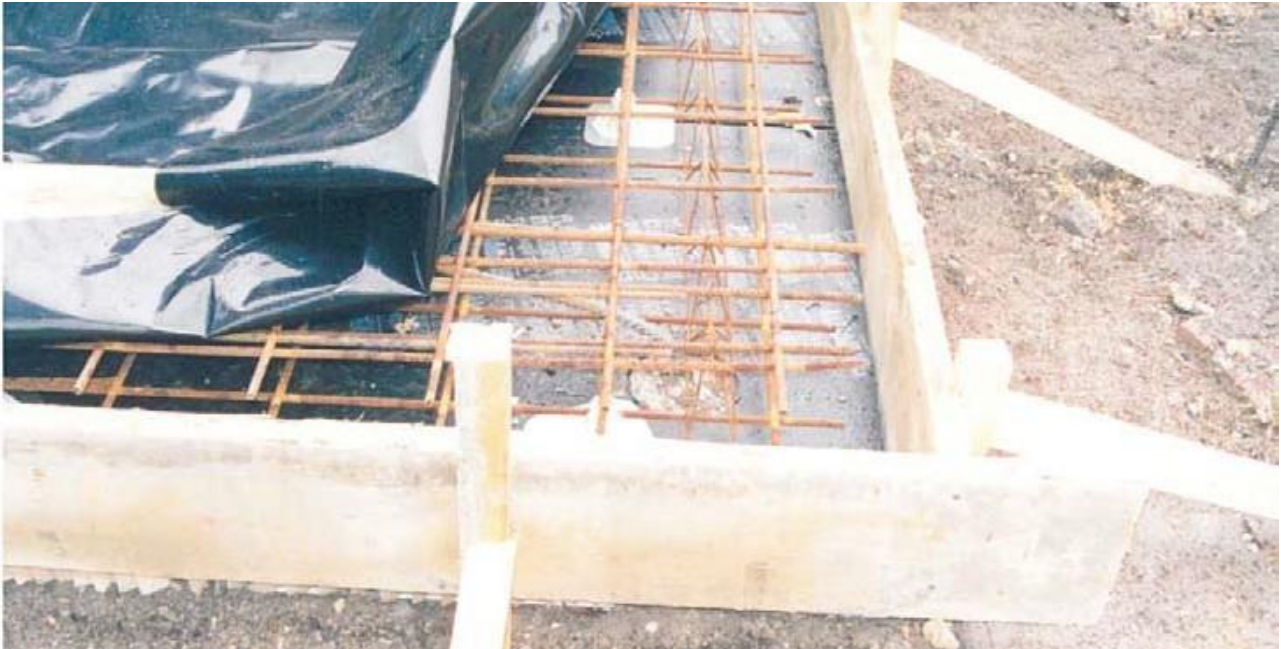
## Appendix 3 figure 3

*Example of shuttering in place and the biodegradable void-former acting as the temporary base. The reinforcing steel links the top of each pile to the main floor ready for pouring concrete*

- 8.5 It is possible to construct new buildings near trees, without adversely affecting their health. If care is taken in the design and installation. This is most commonly achieved by supporting the base of the building just above ground level with a framework of narrow diameter piles that require very little excavation into the soil. Further information of this method is explained in the method statement and pictures appendix 3.

- Engineer shall design a shuttered steel mesh reinforcement pad. This bridges the piles with a biodegradable void former layer underneath. See appendix 3 for pictures.

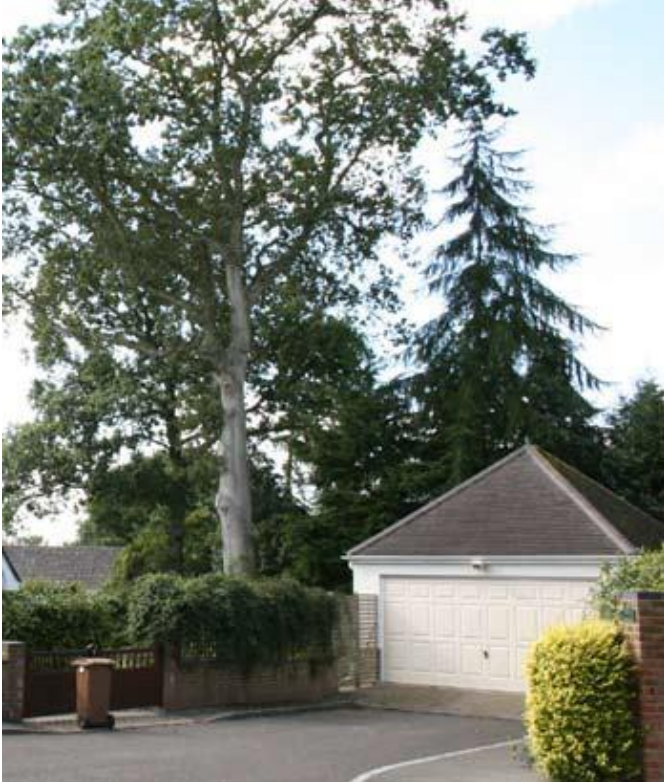
## Appendix 4 figure 4

*Example of an oak in the foreground with a completed double garage using this proposed pile foundation 5 years after completion.*
