# Building Suitability Assessment for Roosting Bats and Nesting Birds

## Graig Wen Cottage

Brymbo Road, Bwlchgwn,  
Wrexham WA7 2HQ

Prepared for ADC  
December 2017

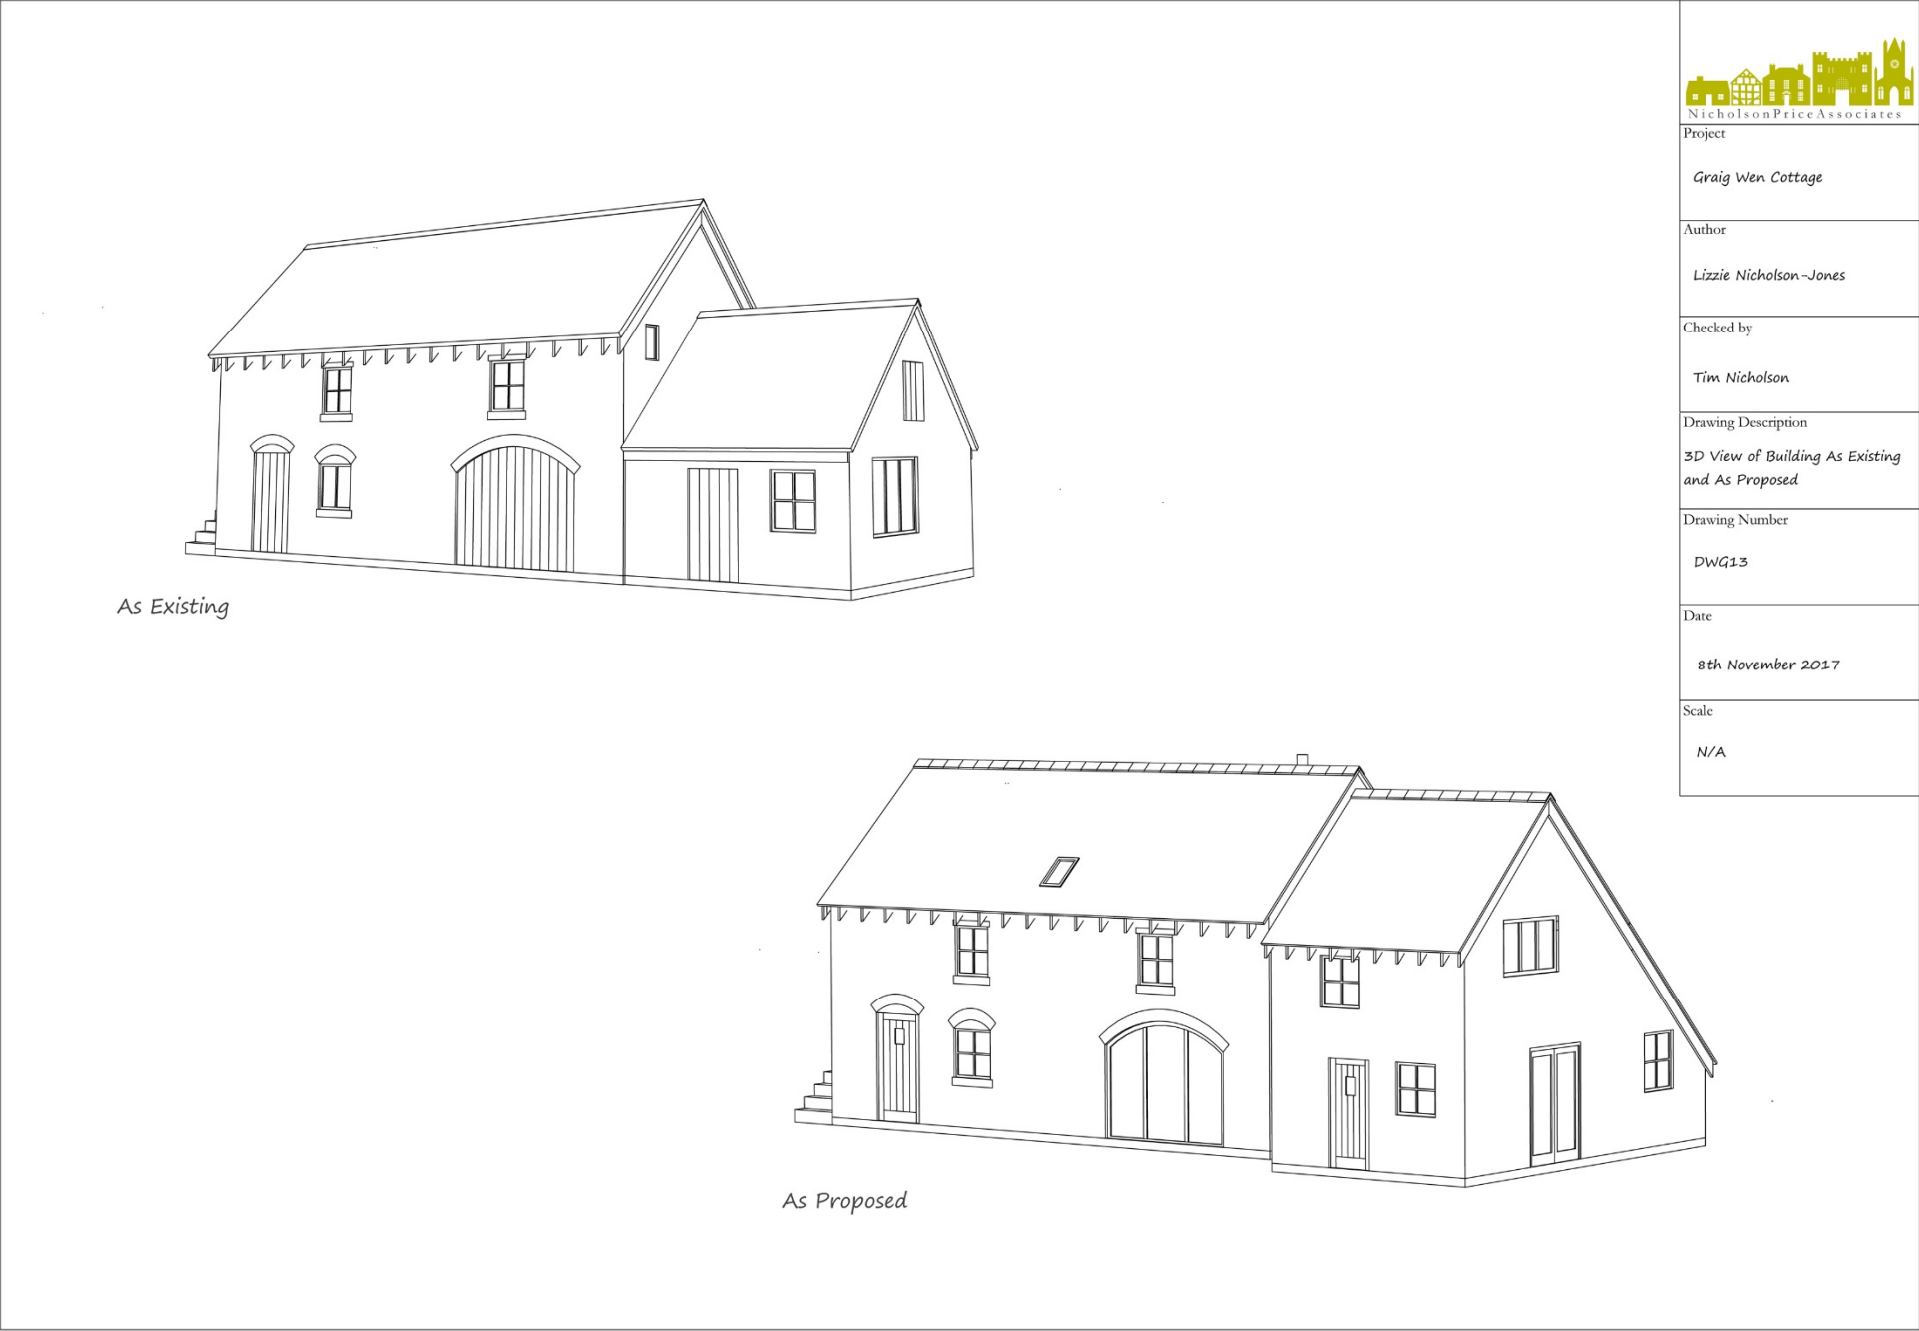
FIGURE 1: 3D VIEW OF BUILDINGS, AS EXISITING AND AS PROPOSED (SE AND NE ELEVATIONS)

- 1.3.1 It is proposed to convert the buildings into one residential dwelling. The main building would have the tin roof sheets replaced with tiles and minor structural works to the exterior of the building, including a small, two-storey extension to the rear; the attached outbuilding would be improved resulting a small increase in height and footprint with new timber-clad walls and a tiled roof. Drawings of the existing and proposed are provided at *Figure 1*.

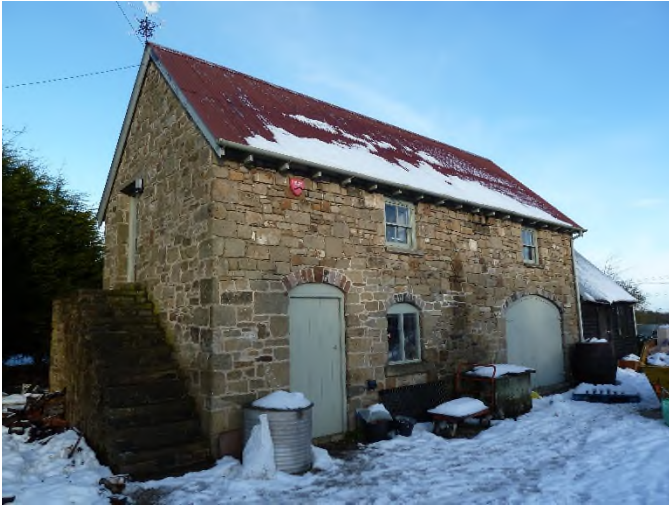
- 1.2.2 The main building (Building 1) was built in 2004. It is a two-storey structure approximately 7 m in height (to the ridge line) and with a footprint of approximately 11 m by 4 m. It has a double-pitched roof covered with corrugated steel sheets laid over a breather membrane and fixed to timber rafters; the eaves are open and the rafter ends exposed. The main structure of the building is formed by concrete blocks but these have been faced with pointed natural stone on the southeast and southwest elevations. The ground floor space currently used as a workshop store with softwood timber doors and a window on the front elevation and a small window on the rear elevation – windows and doors were closed and in good condition. The main room on the upper floor is used as office space, the smaller second room is used for storage. A roof void runs along the length of the building but its height is restricted by the vaulted ceilings below and a substantial amount insulation material used on its floor; the internal structure is complex with many trusses but no ridgeboard.

P1: Building 1 (southwest and southeast elevations).

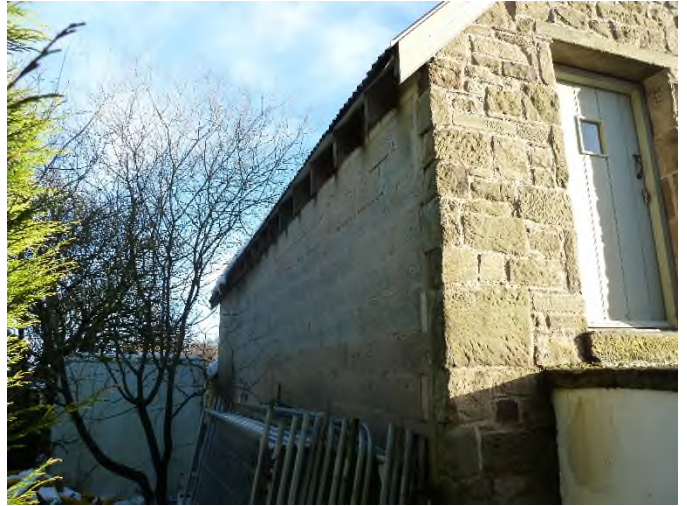
P2: Building 1 (northwest and southwest elevations).

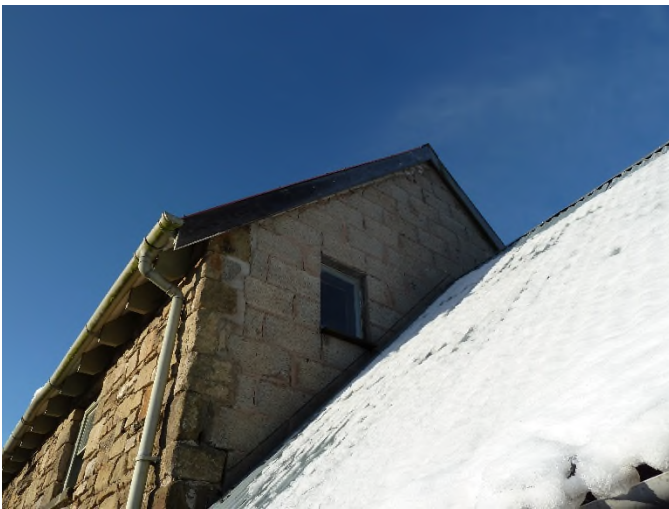
P3: Building 1 (southeast and northeast elevations).

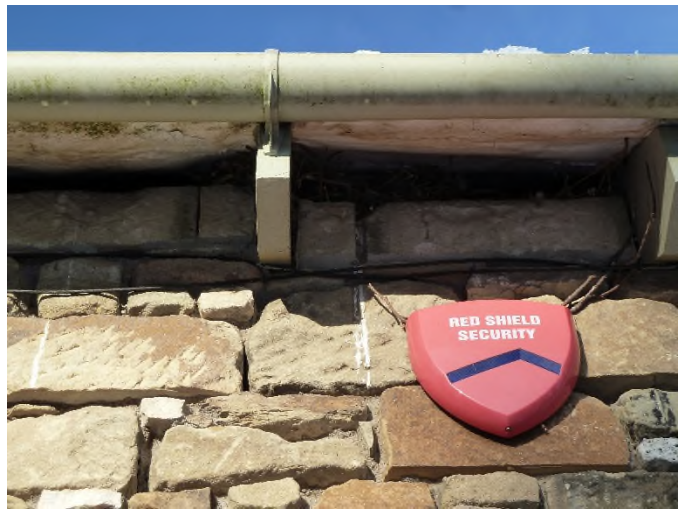
- 3.1.1 The c. 100 mm high openings between each rafter at the eaves on the southeast elevation of Building 1 have been large enough for Jackdaws to enter the roof space. The species has established a breeding colony of up to 16 pairs at this side of the building. No evidence of breeding activity by other species, or obviously suitable nesting sites, were noted on this building, nor was any evidence of nesting birds noted on Building 2.

P4: Open eaves and evidence of Jackdaw nesting at southeast elevation of Building 1

- 5.1 **Recommendation:** The proposed works should be timetabled outside of the main breeding season for birds (March-August inclusive) or, if unavoidable, preceded by a check for active nests by a suitably-experienced ecologist.

- 5.2 **Recommendation:** Measures to prevent Jackdaws entering the roof space of Building 1, e.g. installing wire netting to the eaves, could be employed prior to the start of the nesting season. The netting would need to be secured during daylight hours to prevent trapping any roosting birds.

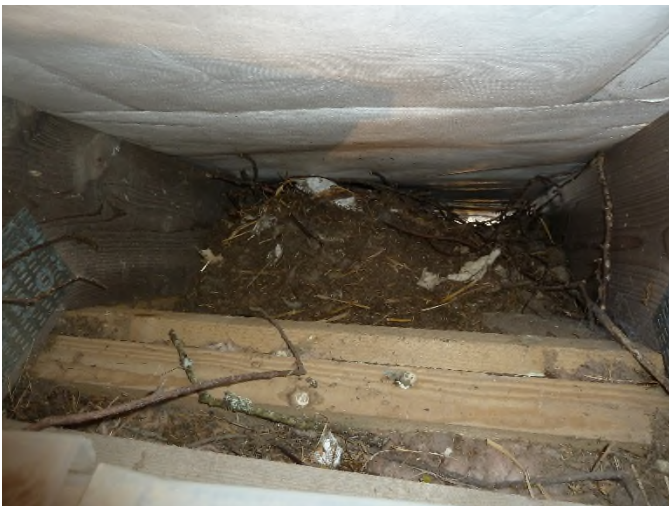
P5: Jackdaw nest in roof space of Building 1.

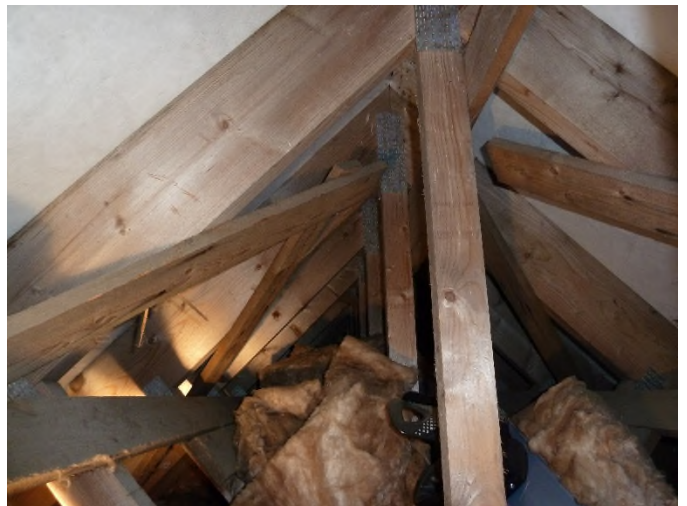
- 3.2.1 No evidence of roosting bats was found on either the interior or exterior of this building. The roof void, although open at the eaves, was narrow and only c. 1 m in height, it was also cluttered (roof trusses, storage boxes and insulating material) and lacked a ridgeboard, thus rendering it unsuitable for species such as Brown Long-eared Bat and Lesser Horseshoe Bat. No suitable roosting features for crevice-roosting species were identified in the internal structure of the space and the metal roof also lacked suitable roost sites and had poor thermal properties to support roosting. The presence of nesting Jackdaws *Corvus monedula* along the entire southwest side of the attic is likely to present a further deterrent to bats in spring and summer. Fascia boards at the gable ends of the building were flush with the masonry work. Pointing around the stonework and blocks that formed the exterior walls was in good condition with no gaps or crevices suitable for roosting noted. All windows and doors were closed and in good condition providing no points of egress into the interior of the building. The suitability of Building 1 for roosting bats was therefore assessed as negligible.

P6: Building 1 roof space.

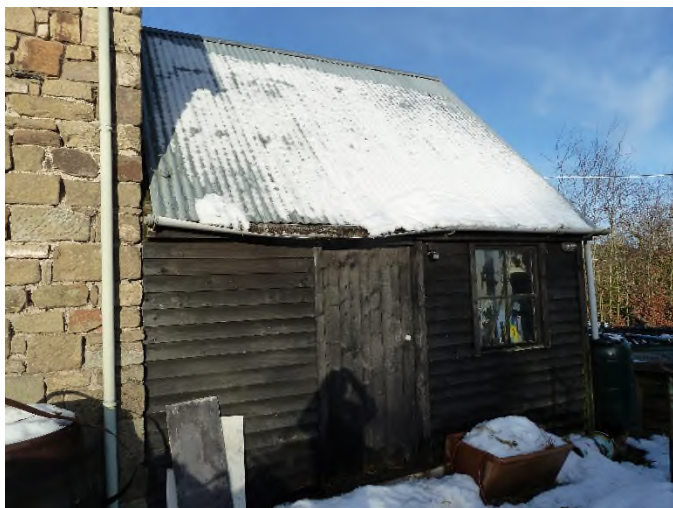
- 3.2.2 No evidence of roosting bats was found on the exterior of this building. The metal roof lacked suitable roost sites and had poor thermal properties to support roosting; the timber cladding fixed directly to the timber frame was in good condition and provided no suitable roosting features for crevice-roosting species. All windows and doors were closed and in good condition providing no points of egress into the interior of the building. The suitability of Building 1 for roosting bats was therefore assessed as negligible.

P7: Building 2 (southeast elevation).

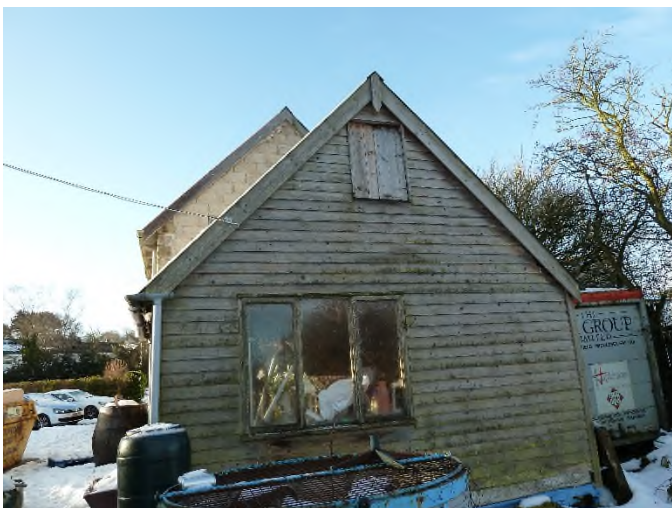
P8: Building 2 (northeast elevation).

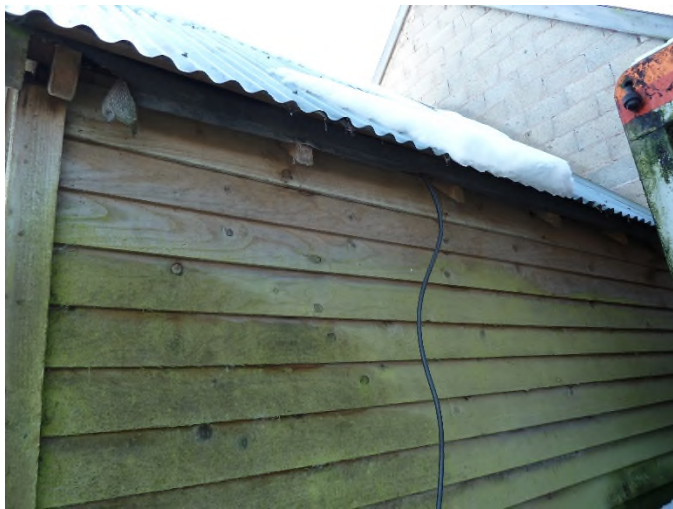
P9: Building 2 (northwest elevation).
