# Chetwynd Grove Cross Lanes

## Outline Bat Mitigation Plan

5 December 2017

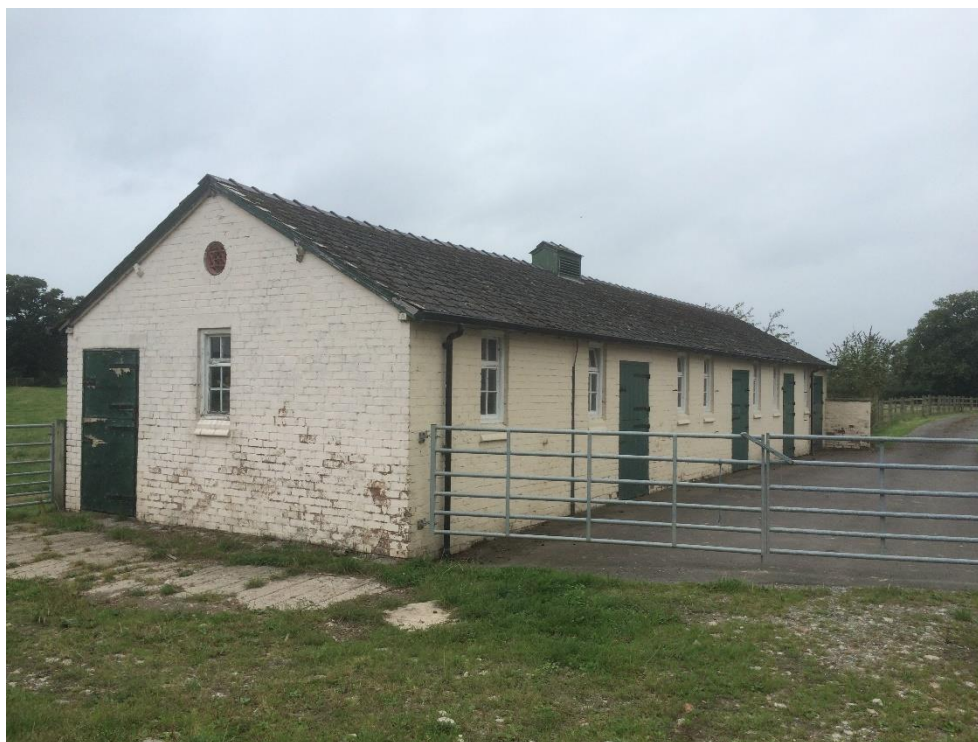
Building 1 comprises of a former pigsty. The building is a single storey, brick-built structure with a pitched, gable ended roof clad in tightly fitted, asbestos tiles.

The external brick work is intact and has been painted in cream paint.

The interior and exterior of the building was observed to be in good condition with no obvious potential bat roosting features identified.

*Photograph 1- Building 1 viewed from east*

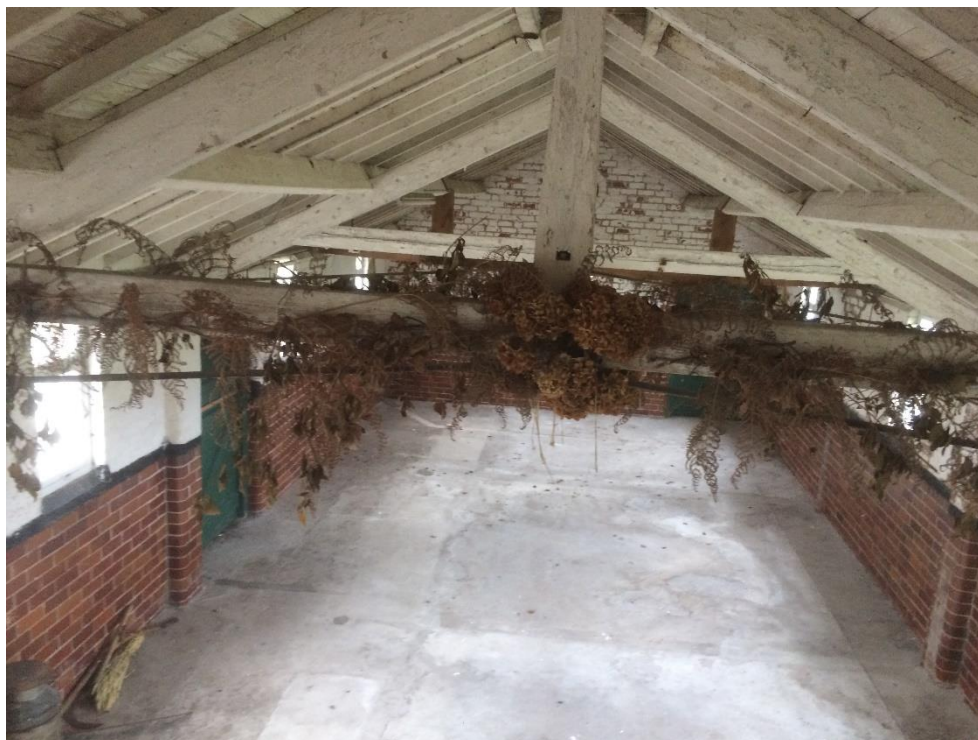
Internally, the building comprises of three adjacent rooms- one room is approximately 15m in length whilst the other two smaller rooms each measure approximately 2.5m in length. There is a 0.5m gap at the tops of the dividing walls between the internal rooms.

The building does not have a separate roof void, with the internal rooms open to the internal face of the roof. The roof is supported on original stout wooden beams and is lined internally with tightly fitting, wooden sarking board. The roof of the building is approximately 4.5m in height. In total, the building measures approximately 20m x 7m in area. The internal walls are partly white washed and part faced with glazed bricks.

The building has glazed windows on its east and west faces and consequently the interior of the building is brightly lit.

No evidence of nesting birds or roosting bats was found associated with the building either internally or externally.

*Photograph 2- Interior of Building 1*

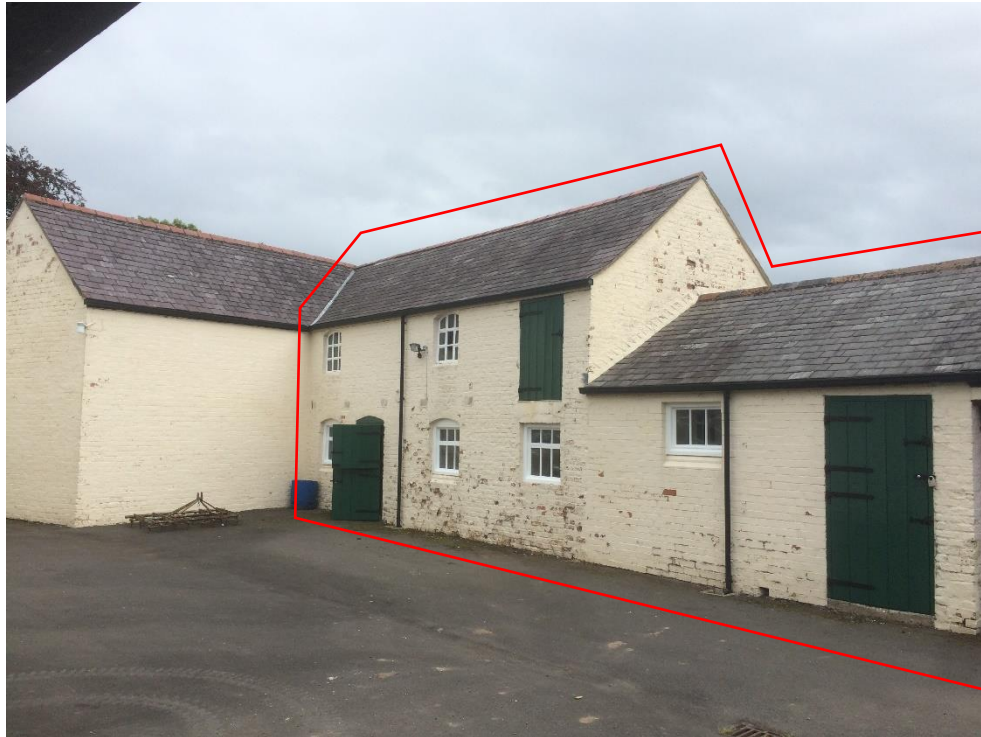
This building comprises of a two storey, brick built outbuilding with a pitched gable-ended roof clad in slate tiles. The building is attached to Building 4 with an internal, open doorway on the building's upper floor providing a link between the upper floors of Buildings 2 and 4. The building has a brick-built single storey section at its southwestern end. One half of the single storey section is linked to the internal ground floor room of the two-storey section whilst the other half comprises of an open garage area.

Externally the building is in very condition with no gaps or obvious potential roosting crevices identified.

The external brick work is intact and has been painted in cream paint.

The roof was replaced approximately 20 years ago and is in good condition with no loose tiles, gaps at the ridge or gaps at the gable ends.

*Photograph 3- View of northwest face of Building 2 (within red line)*

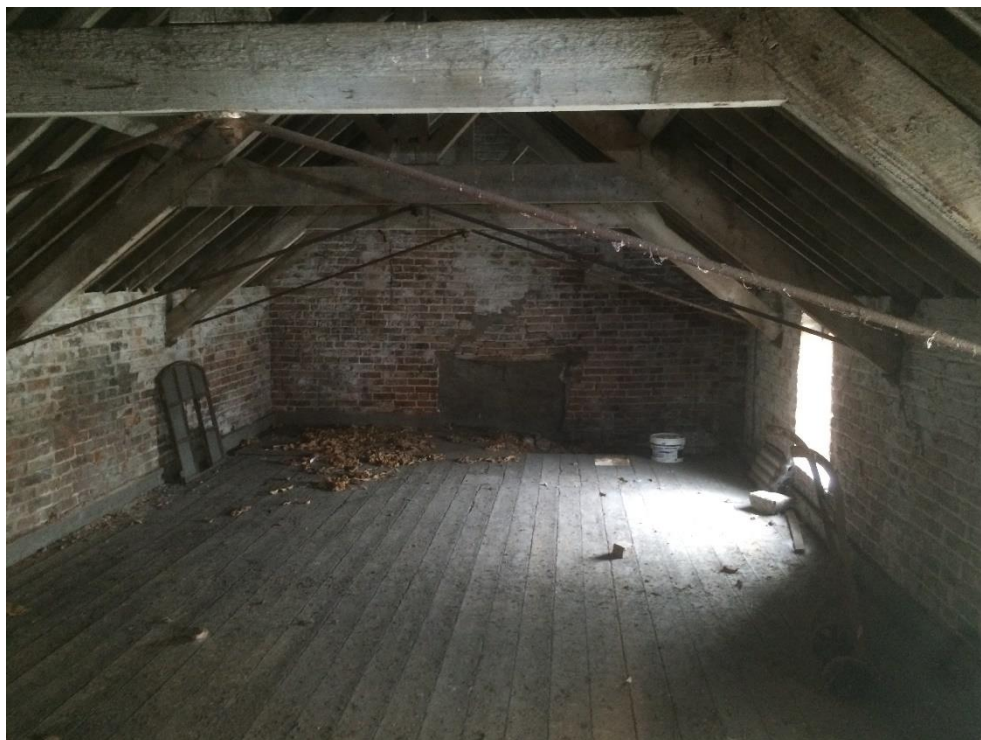
Scattered brown long-eared bat droppings were found on the floor of the upper room of Building 2 (approximately 200 droppings of various ages). Evidence of roosting brown long-eared bat was found within the adjacent upper floor room of the Building 4 (see description below). Roosting bats within Building 4 are able to fly into the upper floor of Building 2 via the open doorway.

No large aggregations of bat droppings were found within the upper floor of Building 2 and it is considered most likely that bats roost within the upper floor of Building 4 but fly within the upper floor room of Building 2 for light sampling etc, prior to full emergence.

No obvious potential roosting crevices were identified within the upper floor of Building 2 but bats may be able to roost between the roof trusses and the roofing felt and above the ridge beam.

As previously mentioned, the upper floor of Building 2 is brightly lit by windows on its northwest face which makes this room less suitable for roosting bats when compared to the adjacent roosting habitat offered within the upper floor of Building 4.

*Photograph 4- Interior of upper floor room Building 2*

Works to convert Building 2 will require the access doorway between Buildings 2 and 4 to be bricked up which could result in a modification of habitats associated with the bat roosts identified.

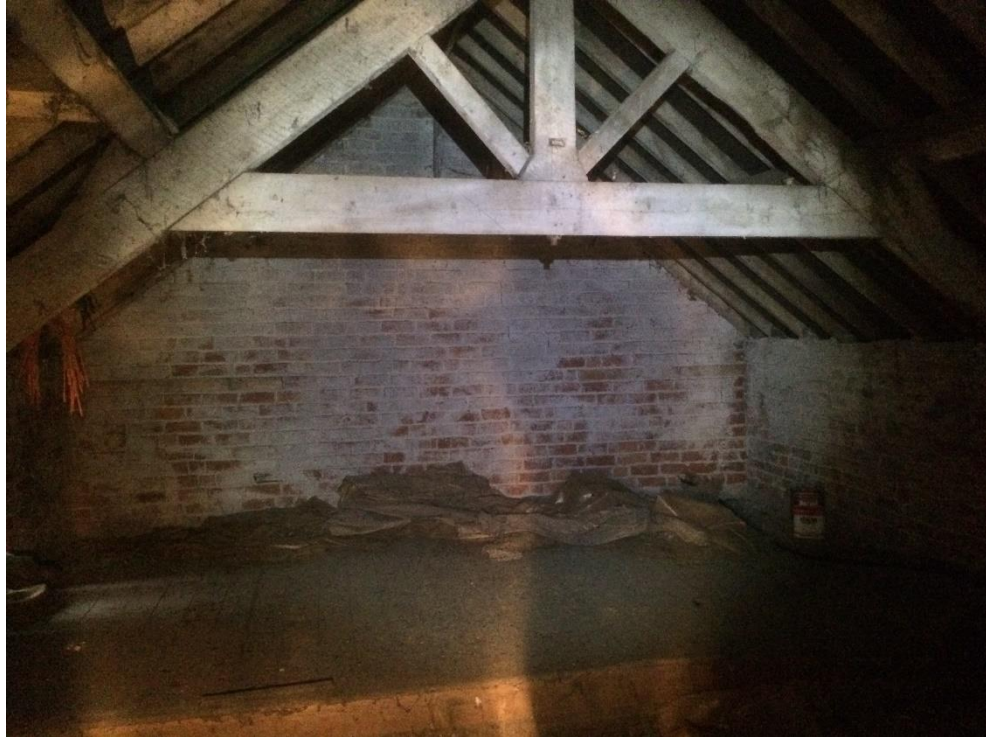
The upper floor of the building does not have any windows and is consequently dark. The upper floor room is approximately 5m x 4m in area and approximately 3.5m in height. The roof of the building is supported on the original stout, wooden beams and is lined internally with bitumastic hessian felt.

Approximately 1000 brown long eared bat droppings of varying ages were identified below the ridge beam near the northeastern end of the upper floor room. A small pile of approximately 10 yellow underwing moth wings was also identified below the ridge beam.

A common pipistrelle bat was also identified roosting between the dividing wall and a roofing truss during the September survey.

*Photograph 5- Interior of upper floor room of Building 4*

Building 4 will not be significantly affected by proposals. However, works will require that the doorway linking Buildings 2 and 4 is bricked up. These works will prevent bats from light sampling/potentially roosting within the upper floor of Building 2.

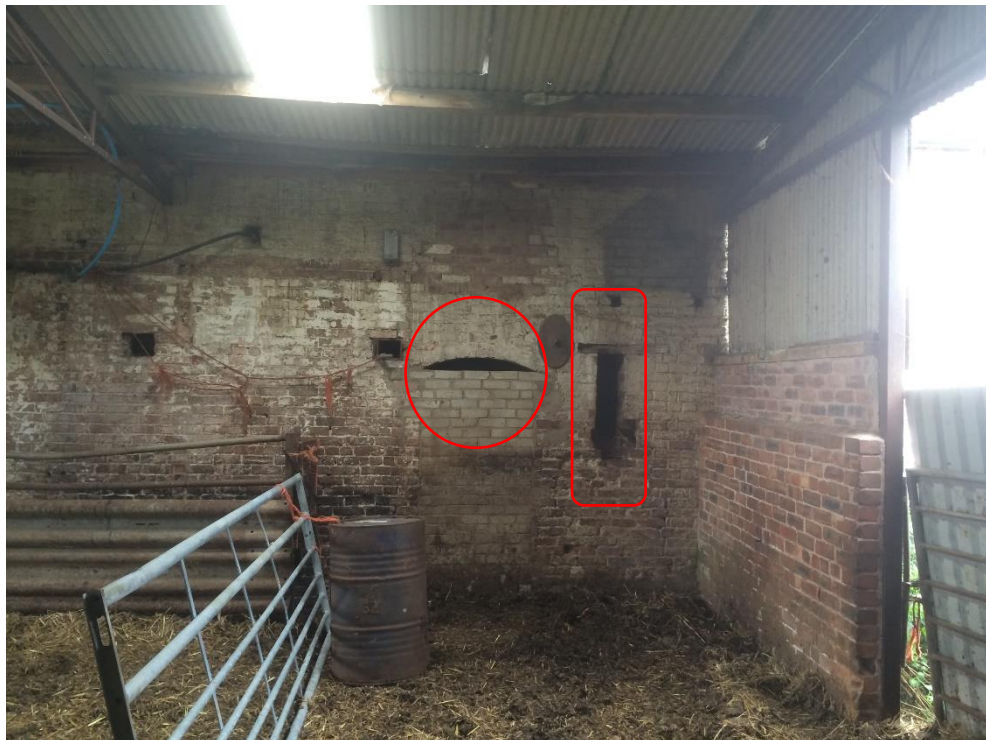
The bat access points comprise of a horizontal gap above a partially bricked up doorway (1m x 15cm) and a vertical ventilation hole (25cm x 50cm) located in the southeast external wall of Building 4. These gaps lead into the ground floor of Building 4 (Potential Roost Access Point 1 on Figure 2, see further description below).

Common pipistrelle bats were identified emerging from Potential Roost Access Point 1 at 22.06 and 22.20 (2 bats in total). A brown long eared bat emerged from Potential Roost Access Point 1 at 22.13.

One brown long-eared bat was identified entering Building 4 via Potential Roost Access Point 1 at 04.14 followed by a further two brown long-eared bats at 04.16. One brown long-eared bat was then observed to emerge at 04.19 and to then fly out of the shed. No other roosting bats were identified.

*Photograph 6- Bat Access Point 1 viewed from interior of Building 3 (circled)*

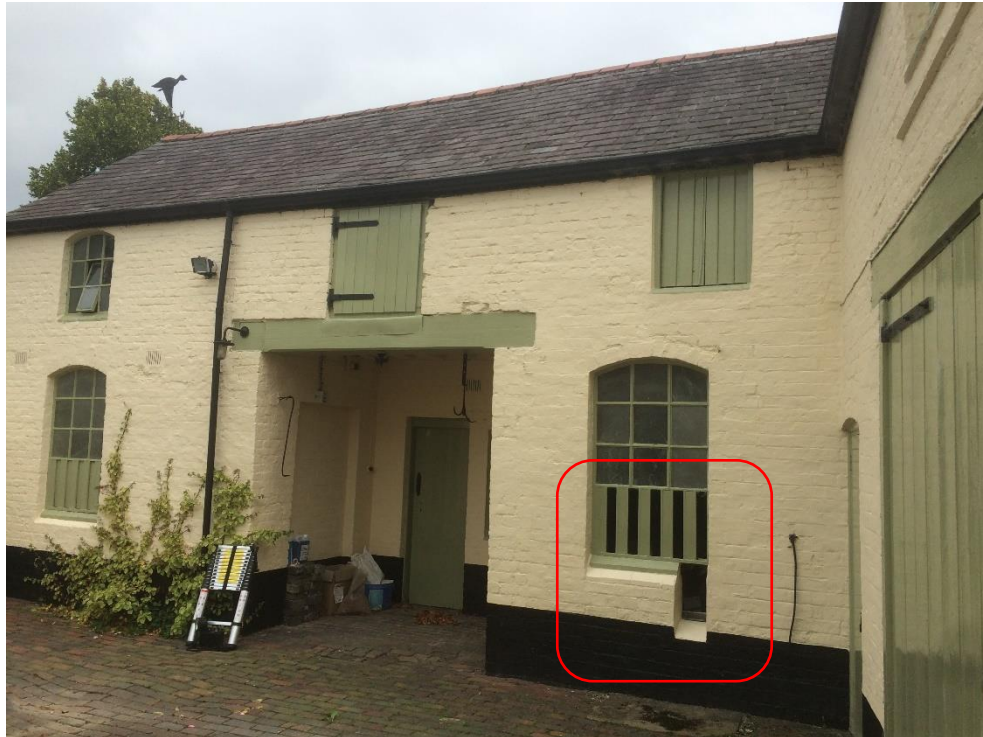
Brown long-eared bat droppings were noted on the ground floor wall adjacent to the access hatch. A further bat access point is located on the building's northwest face where there is are five horizontal gaps measuring approximately 8cm x 50cm located at the base of a ground floor window (Potential Roost access Point 2 on Figure 2).

*Photograph 7- External view of building 4 and Bat Access Point 2 (circled)*
