# **Outbuildings, Overton View**

## **Protected Species Assessment**

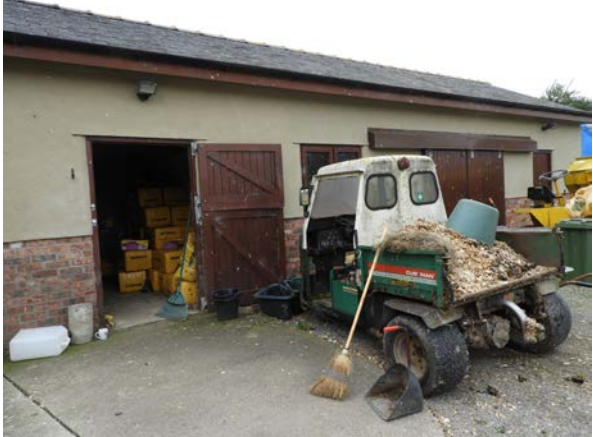
| A photograph showing the main elevation of a barn. The building has a light-colored upper section and a brick lower section. A large open bay door on the left reveals yellow storage boxes inside. A green tractor with a hay trailer is parked in front of the barn. A broom and a shovel are on the ground near the tractor. | <p><b>Plate 1:</b> Main elevation to be converted.</p> <p>Swallows presently use the open storage section on the left for nesting.</p> <p>The building is in a very weatherproof, intact condition; there are no crevices or openings around the barge boards, fascia boards and eaves which bats may use for roosting.</p> |

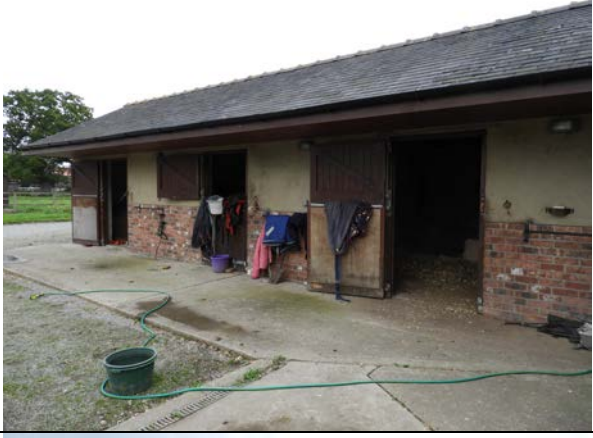
| A photograph showing the side elevation of the barn. It features several bays with open doors. A green hose is coiled on the ground in front of the building. The brickwork is visible at the base of the walls. | <p><b>Plate 2:</b> Barns to be retained and not subject to conversion. Swallow nests are present in all three stables. Retaining these barns as open and in their current use will ensure continued nesting opportunities for swallows.</p> |

- All entrances must be sealed off to swallows before 31<sup>st</sup> March 2018 to avoid use of the buildings for nesting and thus disturbance.
- Doors to the remaining stables should be kept open (as they are presently) to allow nesting in these stables.

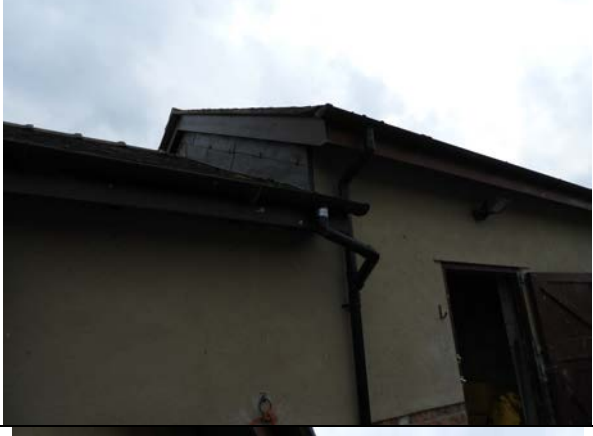
| A photograph showing a close-up of the roofline and eaves of the barn. The roof is dark, and the eaves are visible. A downspout is attached to the side of the building. | <p><b>Plate 3:</b> There is no evidence of use by bats noted within or outside the buildings.</p> |

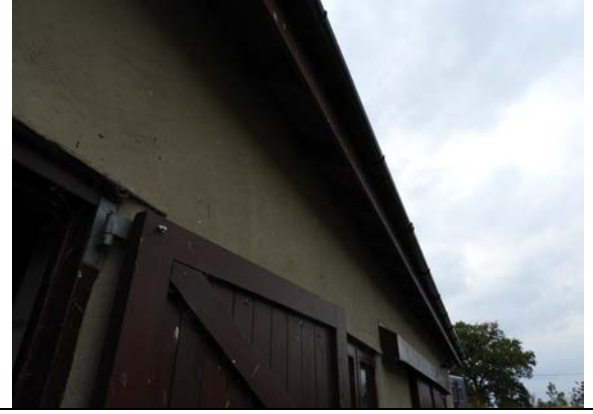
| A photograph showing a close-up of the fascia and bargeboards of the barn. The boards appear intact and sealed, with no visible cracks or crevices. | <p><b>Plate 4:</b> The intact fascia boards and bargeboards do not provide cracks or crevices for bats. They are completely sealed.</p> |

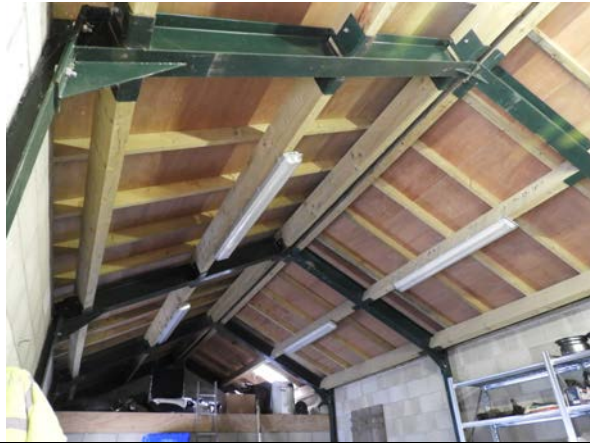
**Plate 5:** The roof space inside the main elevation is open and easily assessed for suitability by bats. It is not suitable pipistrelle bat roosting habitat being draughty and very open. No evidence of use by bats was noted.

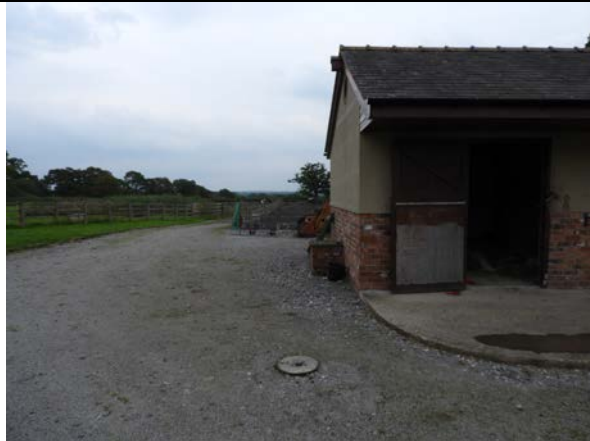
**Plate 6:** A new stable is to be built at the end. This will be of a similar construction and will be suitable for swallows if it is kept open.

- **Vigilance:** If a bat is discovered or suspected during building development all work should cease for consultation with Local Authority and Countryside Council for Wales and the situation assessed by a licensed consultant before work can proceed.
- The applicant is happy to encourage bats and will incorporate bat access into the new roof/ridge slates of the stable and provide two bat boxes on mature trees on the small holding.
