## COAL MINING GROUND INVESTIGATION & RISK ASSESSMENT

Land off Top Road,  
Summerhill,  
Wrexham,  
LL11 4SP

Prepared for:  
Macbryde Homes

Report Ref: 11-780-r2  
Date Issued: July 2017

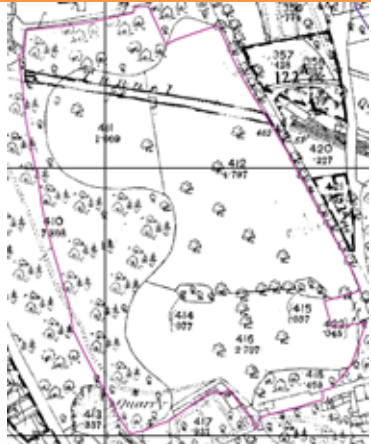
| MAP EDITION | HISTORICAL LAND USE | HISTORICAL MAP EXCERPT |
|---|---|---|
| <b>1873</b><br><b>1:2500</b> | <p>The site is shown to comprise undeveloped agricultural land, containing a series of field boundaries and sporadic trees spread across the site.</p> <p>A tunnel is recorded to run under the northern sector of the site running from east to west, connecting the railway on either side of the site.</p> | |
