| <b>Report Title</b> | <b>Proposed Extension to Fern Villa, Llangollen Road, Acrefair, Wrexham – Preliminary Roost Assessment</b> |
| <b>Date issued</b> | <b>23<sup>rd</sup> January 2017</b> |
| <b>Report Version</b> | <b>C314/ 1.0</b> |

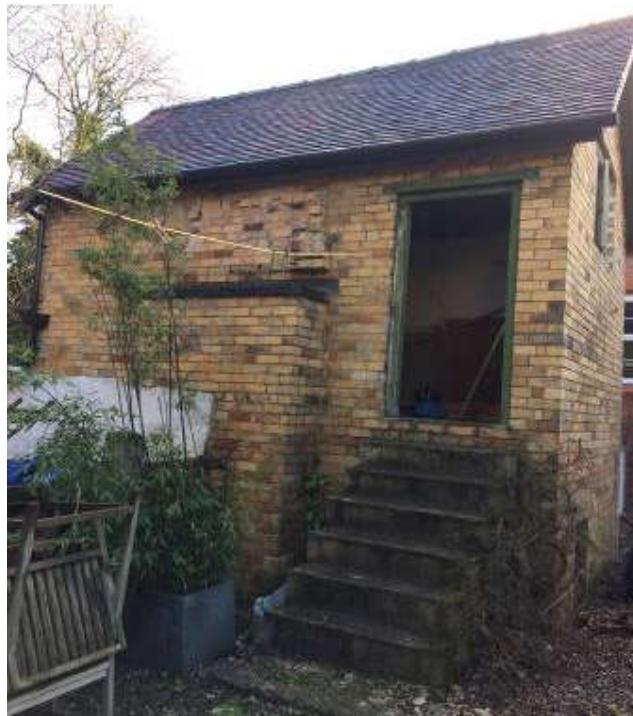
The outbuilding is constructed in brick with a tiled roof. It appears that it has been re-roofed with the addition of an under-slate breathable roofing membrane. Internally it is open to the underside of the ridge beam as the existing ceiling has been removed. As such there is no loft space. This significantly reduces potential breeding opportunities for loft-dwelling species, such as Long-eared (*Plecotus*) or Horseshoe (*Rhinolophus*) despite the habitat in the immediate area being suitable for the specific foraging requirements of both species. It was noticeable however that the original loft would have been relatively shallow and as a result would not have been ideal for Long-eared bats. Furthermore it appears that open access for Horseshoe bats has not previously been available. While the absence of a loft space in a building reduces the breeding potential for loft-dwelling bats they can be used for other roost purposes, e.g. occasional transitional, day roost, 'feeding station' or during the hibernation season.

**Outbuilding proposed for conversion.**

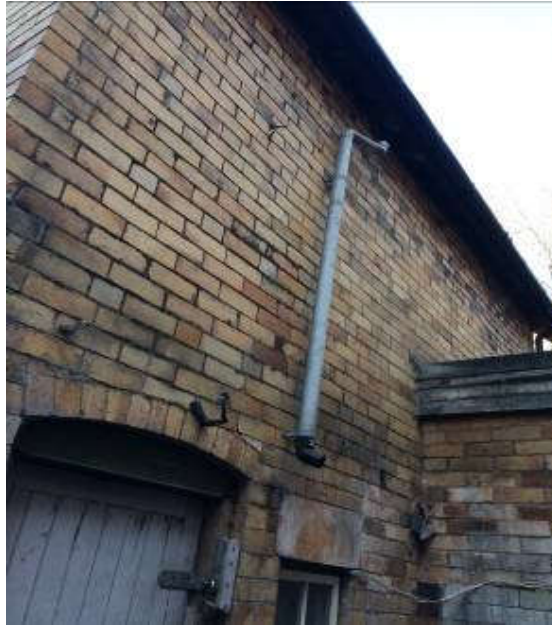
No recent or historic evidence of bat use was located during the internal inspection. Potential roost opportunities such as crevices/cavities were also found to be absent. The eaves are open at wall plate level which creates draughts within the building. As a result internal temperatures will be variable and not conducive to the requirements of bats during the hibernation or breeding seasons.

**Side elevations where eaves are open.**

Due to the presence of a breathable membrane under the roof tiles of the outbuilding it is recommended that during the course of the work all eaves are completely sealed externally (Some bats can access gaps of 10-15 mm) to avoid the possibility of bats coming into contact with this material. The fine claws of bats can, after time, cause fraying of this material which results in bats becoming entangled in the fine fibres.

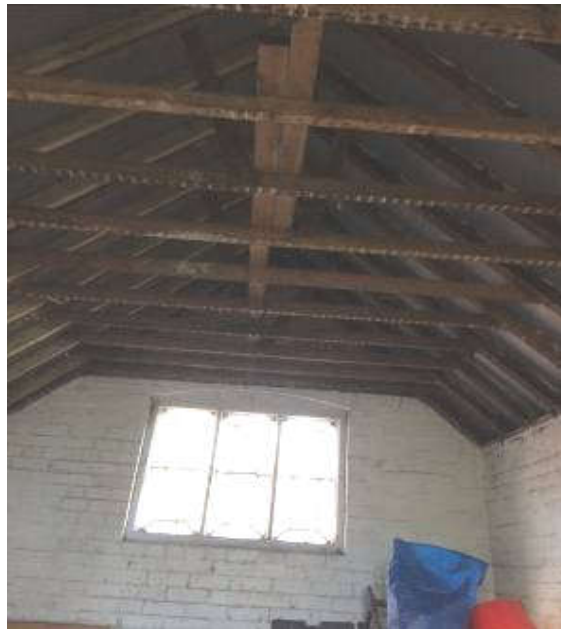
**Interior with ceiling removed and breathable membrane evident.**
