Protected Species Surveys of Two Barns at  
Charity Farm,

Haighton Lane, Bangor on Dee,

## Summary

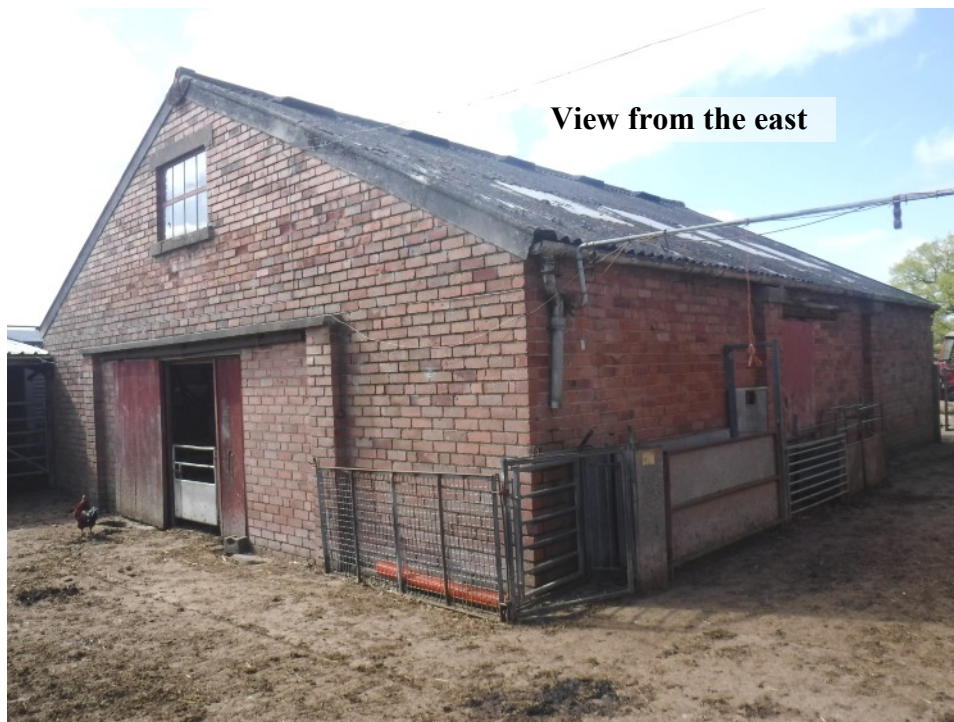
#### Annex 4.1: Photographs of Barn 1 Exterior

The building is one storey and one room. The walls are of double skin brick with no cavity, unlined. Windows are glazed and intact. Doors are of wood and intact but some are left open. The pitched roof is of asbestos, unlined, with overlaps at each gable end and ventilation structures at the apex. The frame is of steel. No evidence of use by bats or birds was found.

View from the east

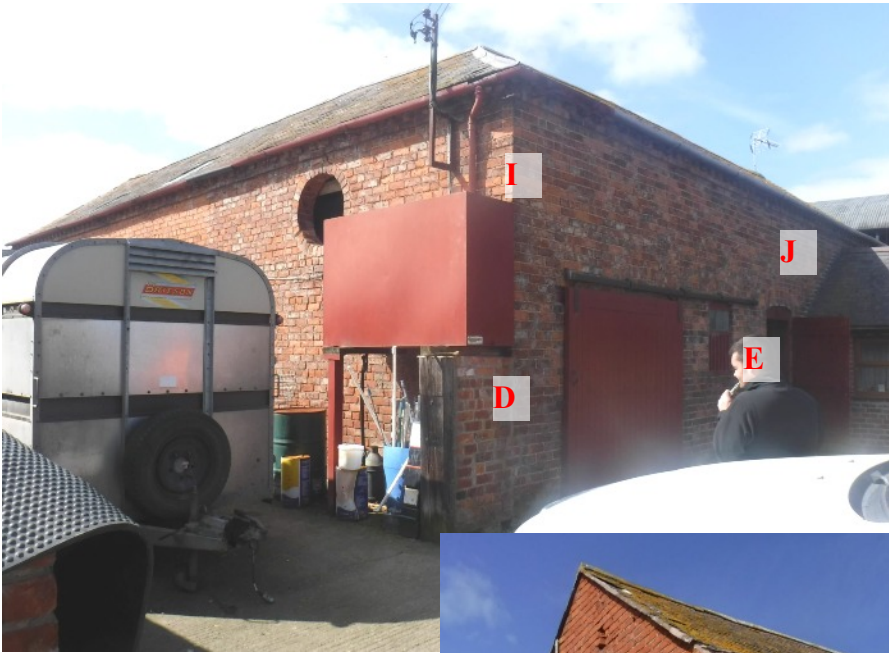
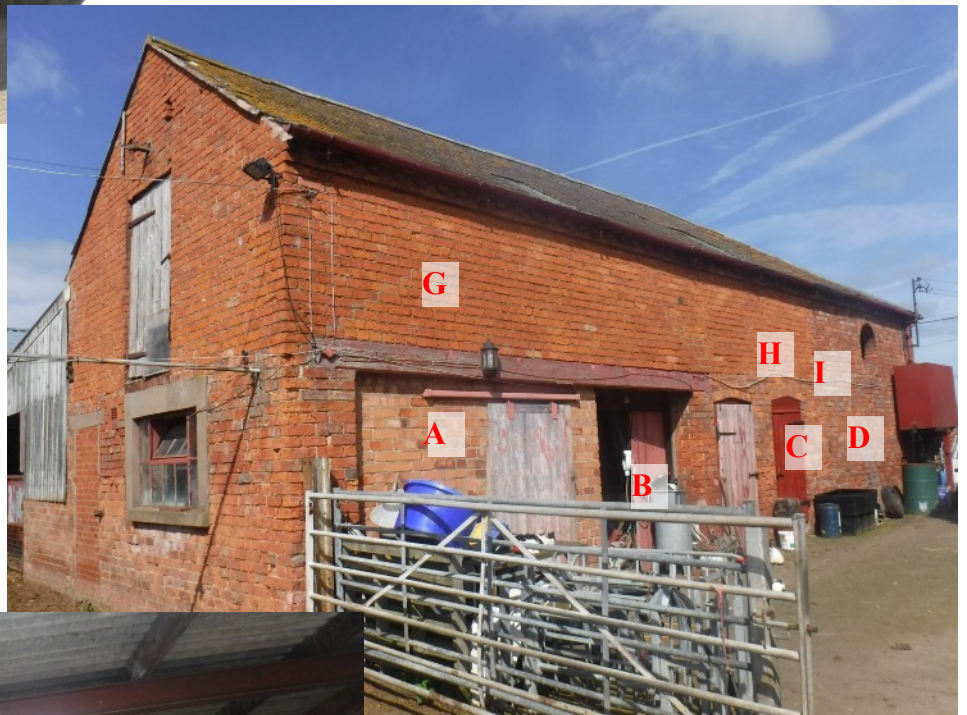
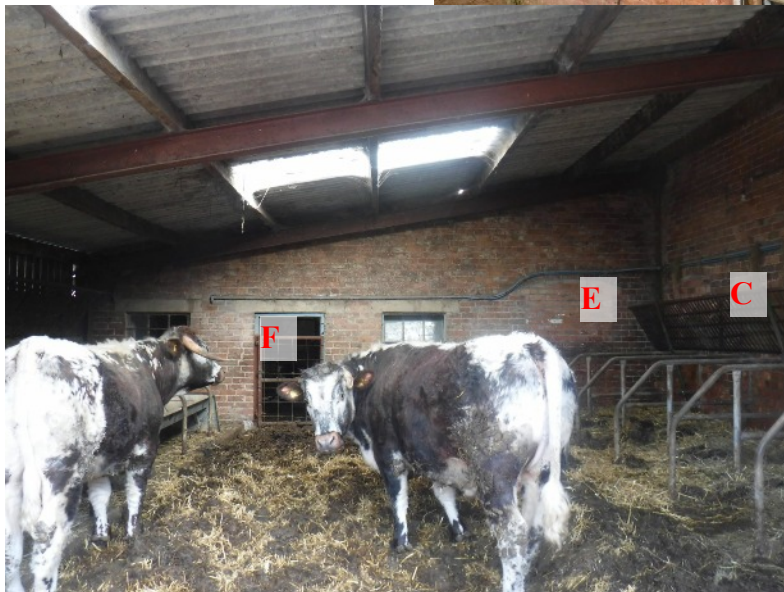
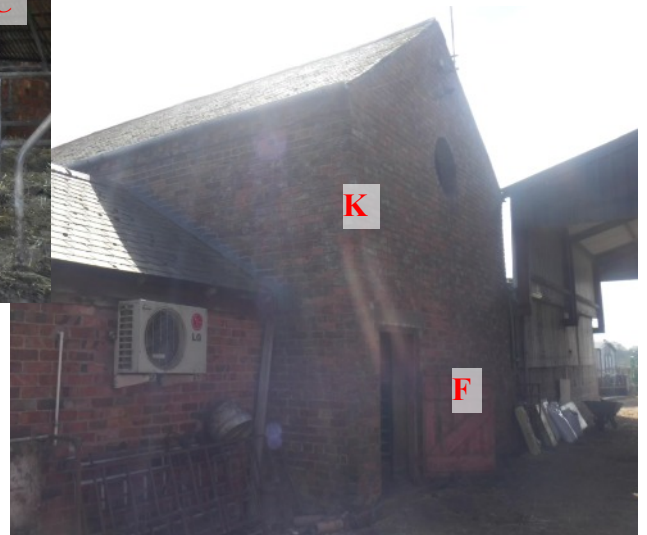
# Annex 4.3: Photographs of Barn 2 Exterior

This is the larger of the two barns and is of two storeys. The walls are of double skin brick with no cavity, unlined. The roof is pitched, tile, partly lined with bitumastic felt with timber rafter and purlin frame. Some windows were glazed and intact while others were not glazed. Doors were of wood. Ceilings/floors were of wood. There were eight rooms including loft spaces. No evidence of use by bats was found There were 3 swallow nests on the first floor.

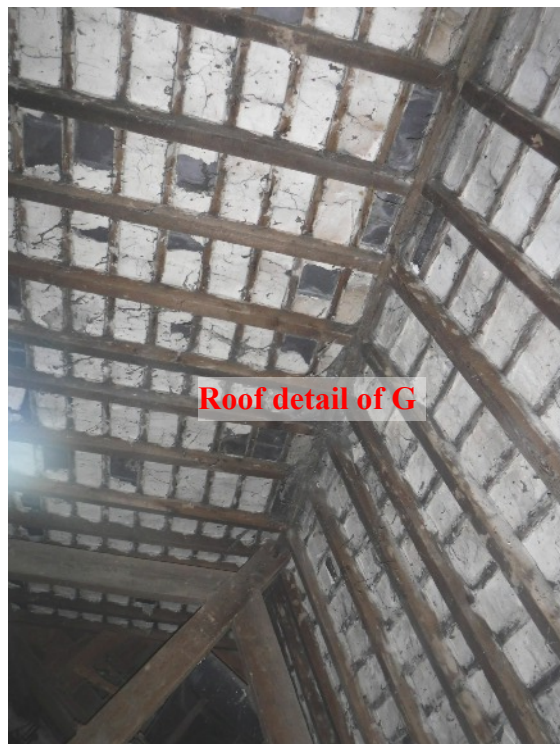
#### Annex 4.5: Photographs of Barn 2 Interior First Floor

Roof detail of G
