# **WREXHAM TECHNOLOGY PARK (PHASE 3) – WESTERN GATEWAY ACCESS ROAD**

## **FINAL COMPLIANCE AUDIT MARCH 2017**

Revision      **00**  
Date          **10/03/2017**  
Made by      **Heather Nickson**  
Checked by   **Jeff Turner**  
Approved by **Jeff Turner**  
Description   **Compliance audit summary report No. 9**

Ref            61034454/AUDIT/09

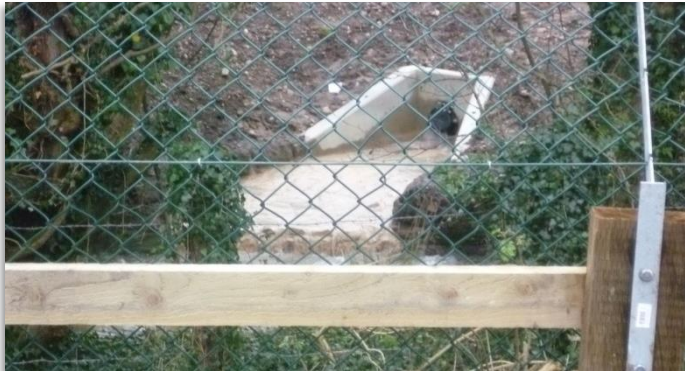
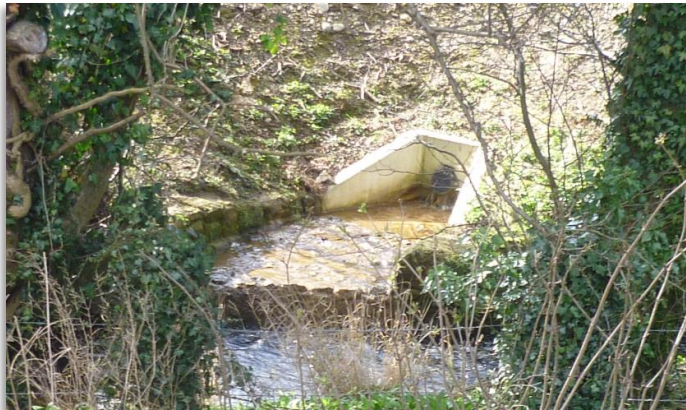
| | Observation May2016 | Action Remaining from Previous Audit | Due* | Closed out by* |
|---|---|---|---|---|
| <b>Drainage and Hydrology</b> | <p>Filter bed outfall from the Moneypenny site is clogged with silt (this was reported on previous audits in December 2015 and January 2016). The Project Manager of the Moneypenny site has been informed (January 2016) and action has been taken to mitigate the release of any silt into the watercourse<sup>2</sup>. Water observed running from the outfall to the River Gwenfro was clear.</p> | <p>Observation March 2017 the filter bed outfall remains clogged with silt however water observed running from the outfall to the River Gwenfro was clear.</p> <p>Sediment release appears to have been controlled and stopped at the source at the adjacent Moneypenny site.</p> <p>Although the sediment does not originate from the AGC Western Gateway site, the location of the outfall is located within the ACG Western Gateway site boundary. Therefore, AGC may be accountable in the event of a pollution incident.</p> | Ongoing by Moneypenny | |

| | Observation May2016 | Action Remaining from Previous Audit | Due* | Closed out by* |
|---|---|---|---|---|
| | | There is a slight risk of an acute discharge of silts in the event of heavy rainfall/high volume of discharge in low flow river conditions. It is Moneypenny's responsibility to maintain this outfall and quality of discharge during the operational phase of the Moneypenny development. | | |

River Gwent is clear with medium flow.  
Filter bed at fall from money penny site remains clogged with silt - medium-low flow from outfall.

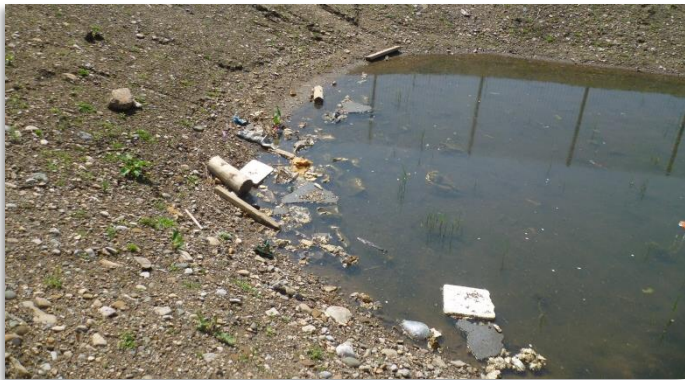
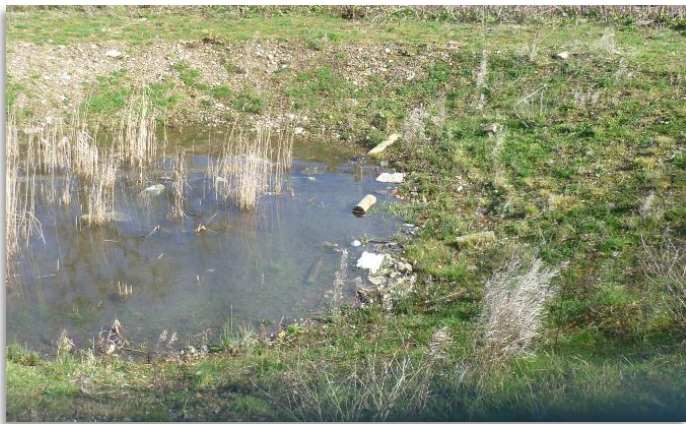
| | Observation May2016 | Action Remaining from Previous Audit | Due* | Closed out by* |
|---|---|---|---|---|
| <b>Waste Management</b> | <p>Site generally tidy with the exception of windblown construction materials found in the southern part of the site near the attenuation lagoon and otter proof fencing south of the River Gwenfro. Generally in the form of plastics, polystyrene (likely to be from adjacent site) and wood.</p> | <p><u>Observation March 2017:</u> Construction litter still present within the attenuation lagoon and to the east of the attenuation lagoon fence generally in the form of polystyrene (likely to be from adjacent site) and wood. In addition to this there is a Heras fence panel on the otter fence to the south of the existing River Gwenfro culvert.</p> <p>Action required to clear all construction litter form the site.</p> | 28/04/2017 | |

Construction litter is still present predominately within the attenuation lagoon, construction litter is to be cleared as part of the ongoing maintenance of the project.

Construction litter on site — within attenuation lagoon  
— south of attenuation lagoon  
by fence  
— marks fence panel south of  
existing culvert.

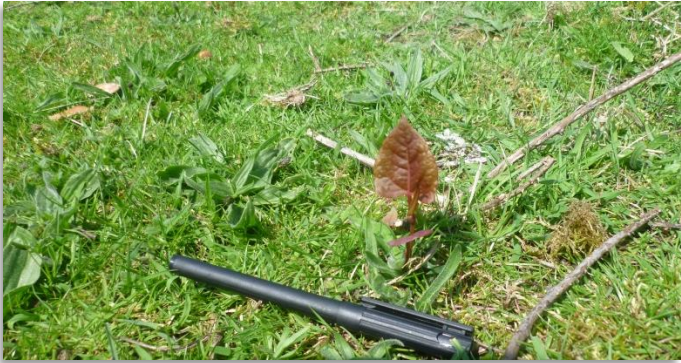
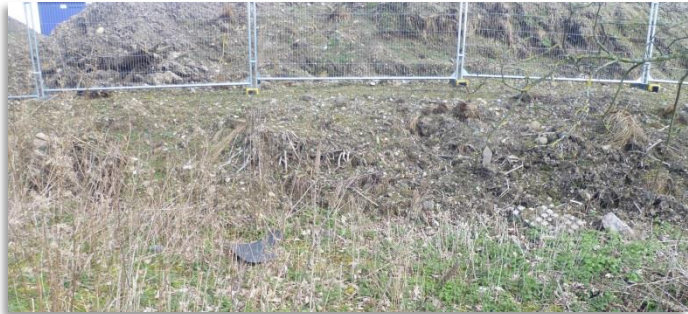
| | Observation May2016 | Action Remaining from Previous Audit | Due* | Closed out by* |
|---|---|---|---|---|
| Wildlife and Natural Features | <p>Japanese Knotweed was identified in two locations as previously recorded on the site:</p> <ul style="list-style-type: none"> <li>To the north of the new access road outside the highway boundary fence; and</li> <li>Within the ecological buffer zone within the otter fence to the south of the River Gwenfro.</li> </ul> | <p><u>Observation March 2017:</u> The area of Japanese knotweed within the ecological buffer was unable to be inspected due to access restrictions. That the area of Japanese Knotweed to the north of the new access road outside the highway boundary fence had been disturbed by adjacent construction works, however no Japanese Knotweed was seen due to the time of the audit.</p> <p>Treatment and management of Japanese Knotweed and other non-native invasive species should be included in the 20 year landscape maintenance and management plan and these areas reviewed as part of the landscape maintenance and management plan</p> <p>Ongoing vigilance for invasive weed species to be maintained throughout the landscape and maintenance period, particularly Japanese knotweed.</p> | 28/04/2017 and ongoing throughout the landscape and maintenance period | |

The landscape design and 20 year maintenance and management plan (Condition No. 13) has not been made available for review by Ramboll. The landscape proposals are required to be reviewed by a suitably qualified ecologist to ensure appropriate cover along the River Gwenfro is included (as part of the otter mitigation proposals). In addition to this the proposals for management and treatment of Japanese Knotweed and other invasive species is to be included within the 20 year maintenance and management plan to minimise its spread.

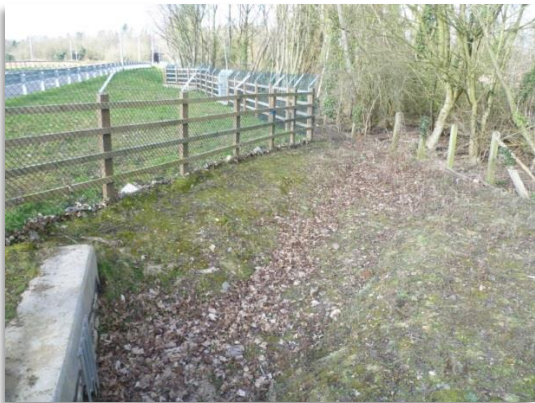
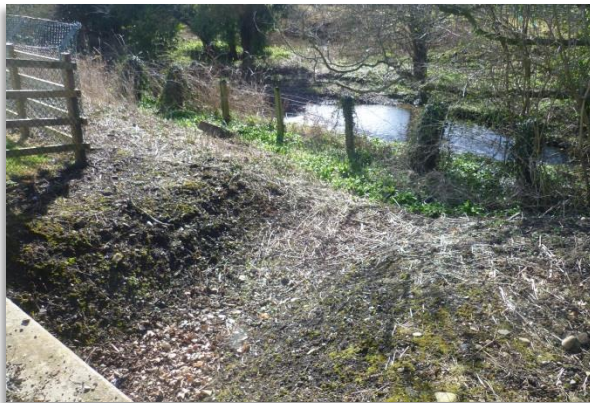
| | Observation | Action Required | Due* | Closed out by* |
|---|---|---|---|---|
| <b>Wildlife and Natural Features</b> | <p>Landscape planting has been undertaken in December 2017 however the landscape design and 20 year maintenance and management plan (Condition No. 13) has not been made available for review by Ramboll.</p> <p>Although a large area have been planted between the attenuation lagoon and the River Gwenfro within the otter fence and will provide good cover when this develops there is not sufficient planting at the entrance and surrounding area to the otter pass, particularly to the north of the road. These areas are currently very open and this is likely to discourage otter from using the pass.</p> | <p>Mature/semi-mature planting should be included in this area and planted at the earliest opportunity to ensure the otter pass is viable. The entrance and surrounding area to the mammal underpass pass is currently very open and this is likely to discourage otter from using the pass. Currently there is a risk that the otter pass will not be used and otter may try to find an alternative way through which could result in fatalities.</p> <p>The landscape proposals are required to be reviewed by a suitably qualified ecologist to ensure appropriate cover along the River Gwenfro is included as part of the otter mitigation proposals.</p> | 28/04/2017 | |

The entrance and surrounding area to the mammal underpass pass is currently very open and this is likely to discourage otter from using the pass. Mature/semi-mature planting should be included in this area and planted at the earliest opportunity to ensure the otter pass is viable. Currently there is a risk that the otter pass will not be used and otter may try to find an alternative way through which could result in fatalities.

Additional planting required around mammal underpass  
this area is very open & could deter others from using  
the underpass. Some bare soils at entrance to site &  
surrounding the outfalls.
