Client. Coleg Cambria

Job No. 16025

**Coleg Cambria, Grove Park Campus  
M Block Window Replacements  
Supporting Statement**

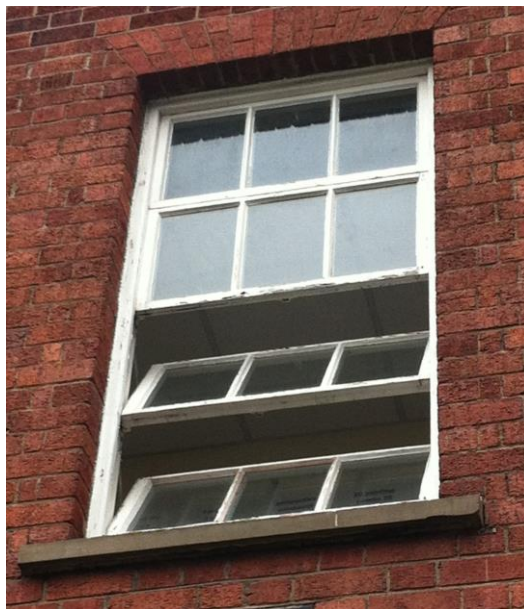
- 2.1 The existing windows are of various styles and arrangement. The majority are casement windows with hopper style inward opening lights. These appear to be original and are located throughout the two wings of the building on the upper floor of the main entrance area. Sash windows are the minority however they are located at ground and first floors to the main entrance area. All windows are single glazed with paint finish generally white in colour.

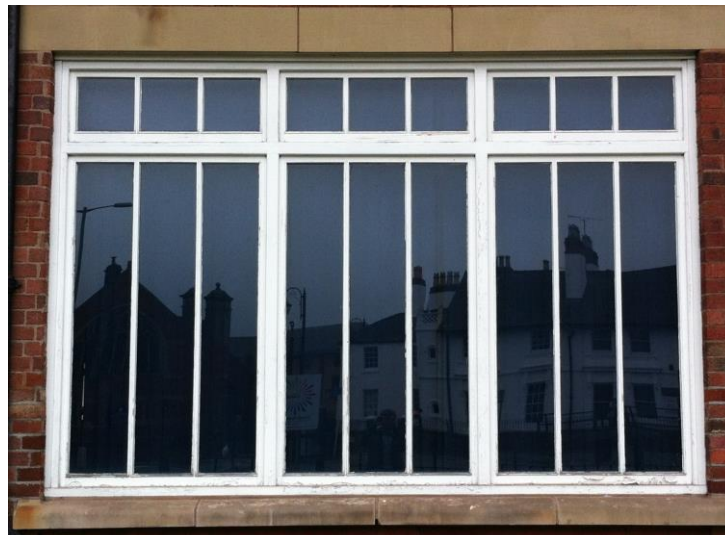
- 2.2 A number of the windows have been replaced with metal frame windows of a style which is not associated with the original building. It is proposed these will be replaced to match the original window style/detail.

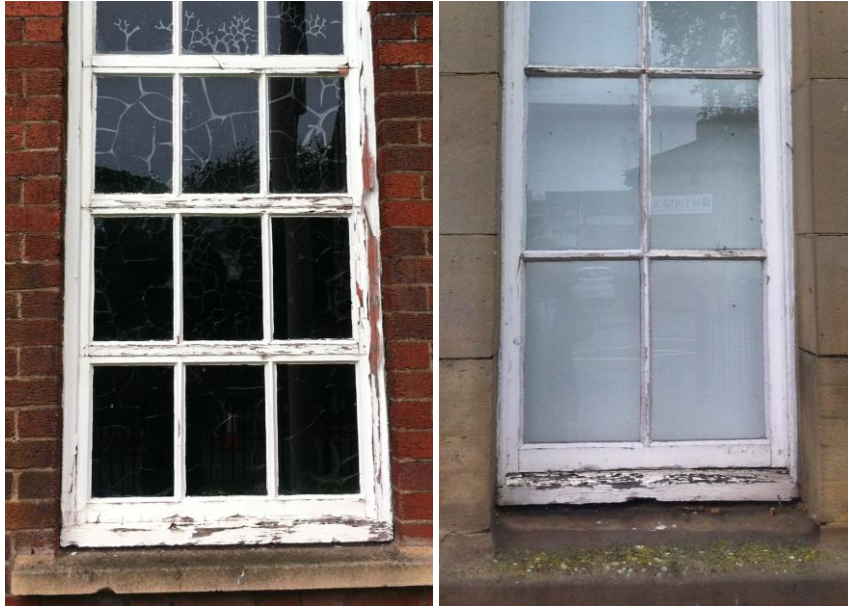
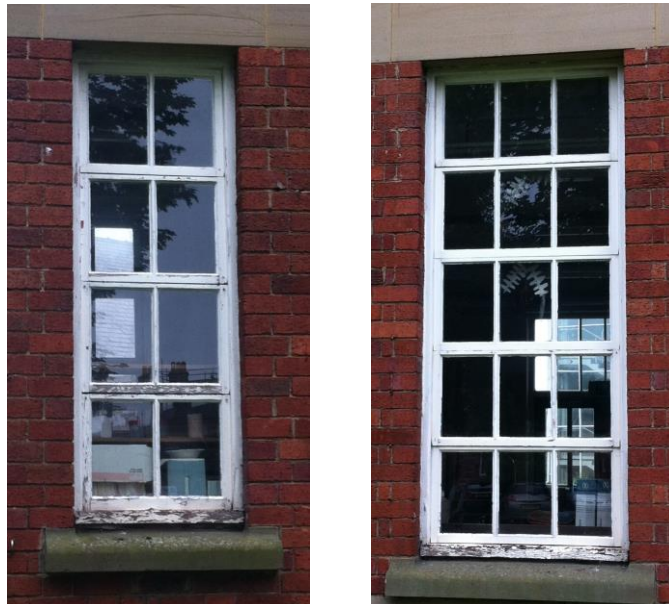
- 2.3 The existing windows are in various conditions of repair and operation. Many are rotten in parts; and seized and are difficult to operate.

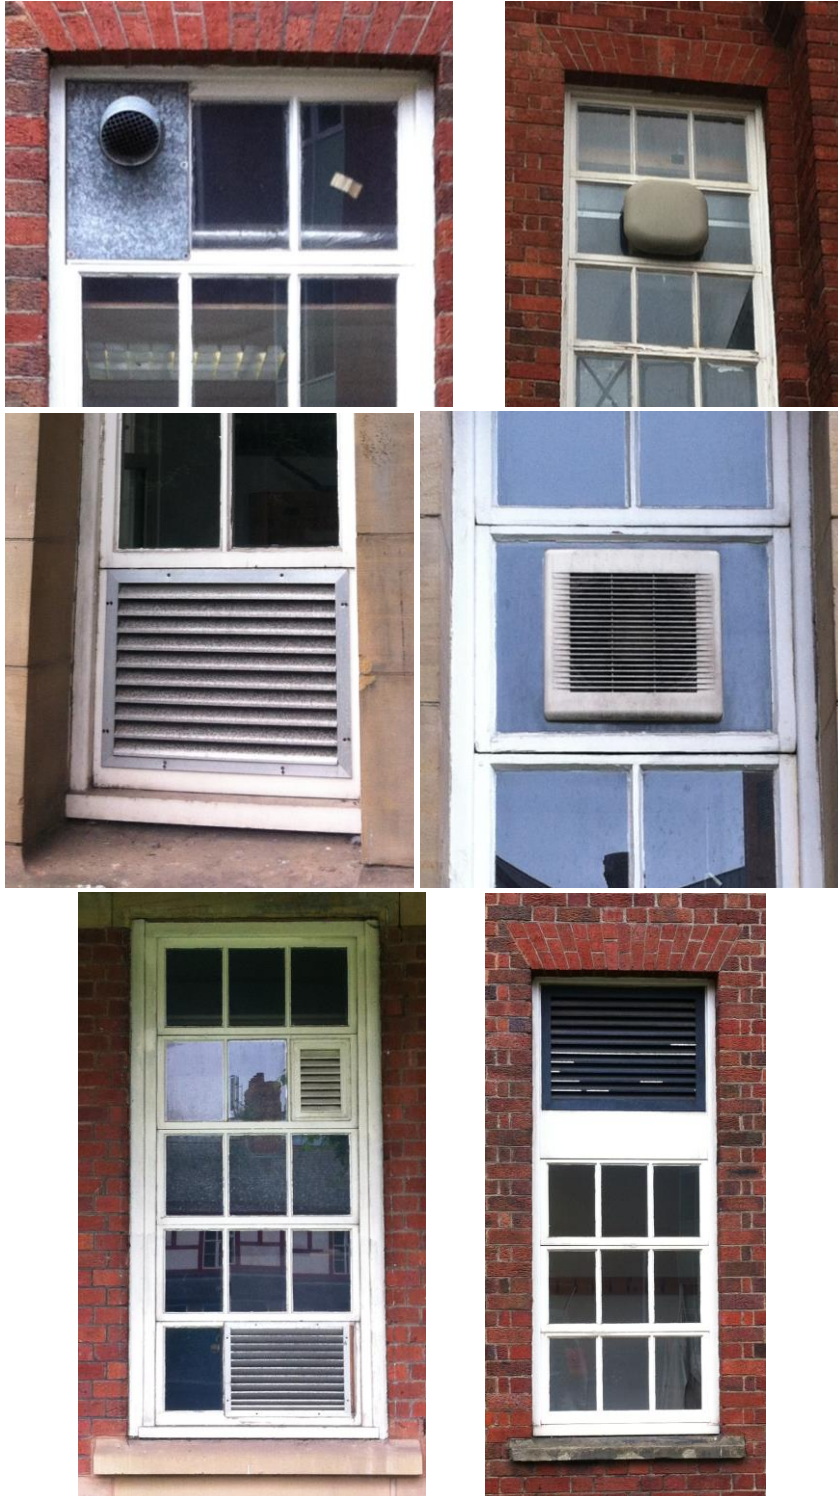
- 2.6 Many windows have been altered and adapted to incorporate fans and louvres. Most are redundant. It is proposed that these will be removed and the replacement windows will be glazed.

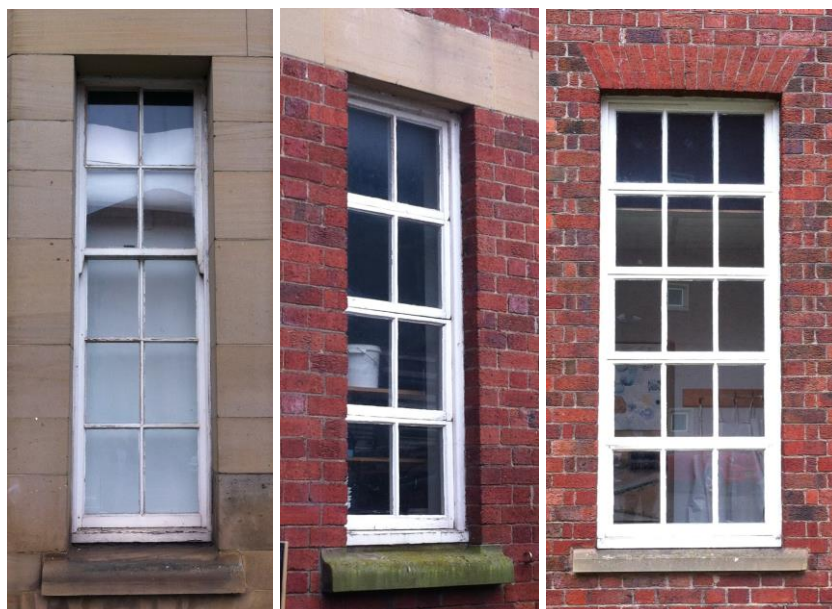
- 2.10 The elevations benefit from existing stone cills, heads, and stone surrounds to feature areas of the main elevations. All cills, heads, reveals and windows surrounds will be retained as existing. These are typically stone on the main elevation. The rear elevation is typically stone cills and brickwork heads.

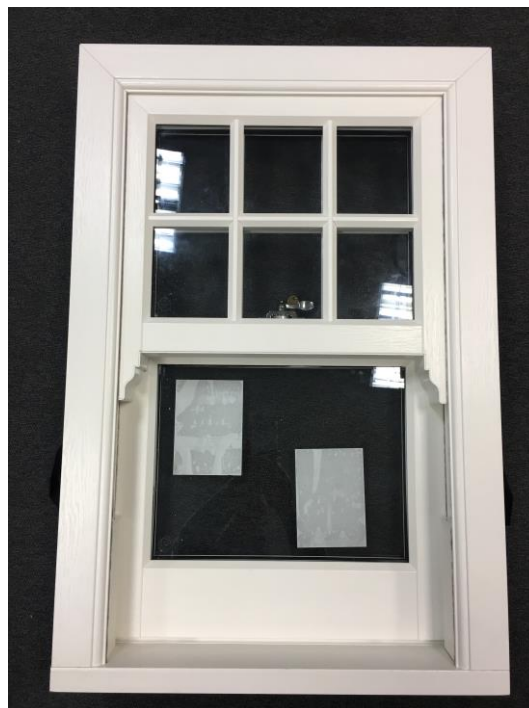
Photos of Sample presented to Planning officer and Conservation Officer:

3.2 Sash windows: -

Masterframe: Vintage range

Operation: vertical slide

All frames to benefit from foil wrap grain textured coating to provide a wood grain finish.

Frame colour: White to match existing, glass clear, except where privacy is required where frosted glass is proposed.

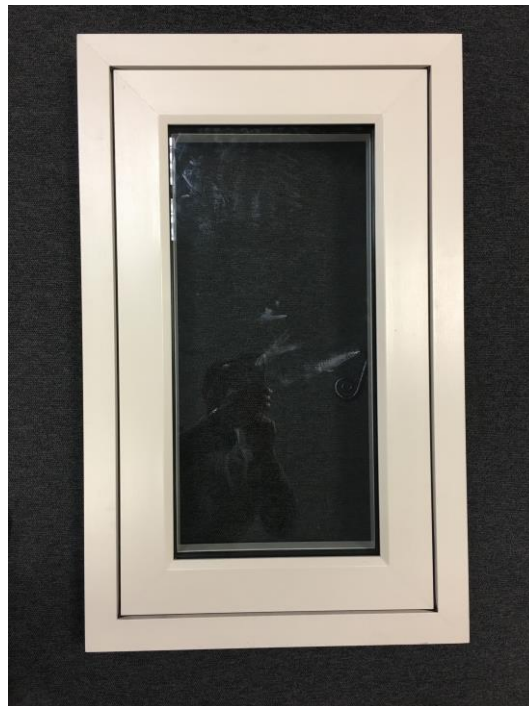
Photos of Sample presented to Planning officer and Conservation Officer:

**3.3 Casement windows: -**

Resident 9: Traditional Flush

Operation: outward opening top swing mechanism.

All frames to benefit from foil wrap grain textured coating to provide a wood grain finish.

Frame colour: White to match existing, glass clear, except where privacy is required where frosted glass is proposed.
