# **WREXHAM TECHNOLOGY PARK (PHASE 3) – WESTERN GATEWAY ACCESS ROAD**

## **COMPLIANCE AUDIT OCTOBER 2015**

Revision      **00**  
Date            **30/10/2015**  
Made by       **Heather Nickson**  
Checked by    **Jeff Turner**  
Approved by   **Jeff Turner**  
Description    **Compliance audit summary report No. 5**

Ref             61034454/AUDIT/05

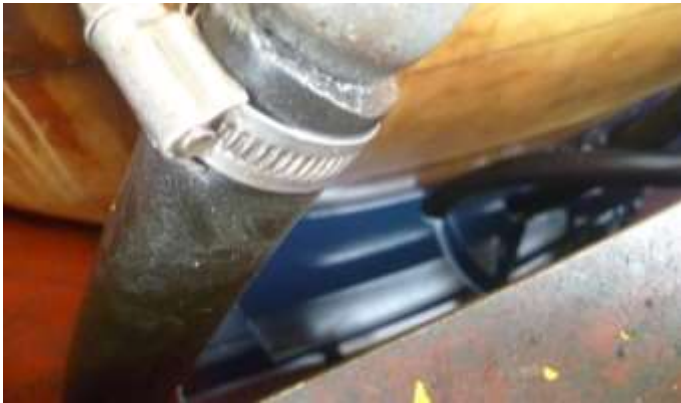
| | Observation September 2015 | Action Remaining from Previous Audit | Due* | Closed out by* |
|---|---|---|---|---|
| Drainage and Hydrology | <p>Mobile fuel bowser has a small amount of fuel within the double skin. No evidence of leaks surrounding the bowser.</p> | <p>Monitor fuel bowser for leaks, consider removal of fuel within double skin to ensure sufficient volume is available in the event of a catastrophic failure. If leaks are present then either repair or replace with bowser that is not leaking.</p> | <p>Next audit</p> | |
| | <p><u>Observation October 2015:</u> This is a small amount of fuel still present within the double skin. No evidence of leaks surrounding the bowser. No change since August compliance audit.</p> | | | |

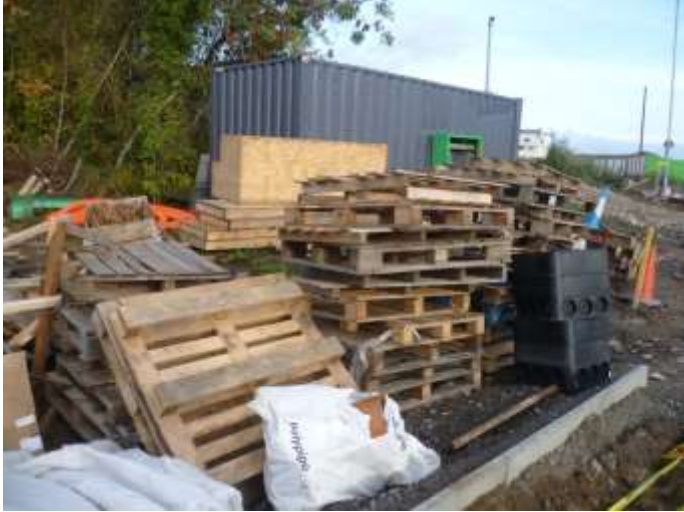
| | Observation | Action Required | Due* | Closed out by* |
|---|---|---|---|---|
| <b>Waste</b> | <p>Developing pile of pallets behind contractors compound.</p> | Opportunities should be sought for to reuse of pallets. | Next audit | |

Wood & pallets piled behind site office area.
