**STAGE 1 and 2 CONTAMINATION  
ASSESSMENT**

**GLAN LLYN, BWLCHGWYN  
WREXHAM**

**R2326-R01-v1**

**Report Title:** Glan Llyn, Bwlchgwyn, Wrexham  
Stage 1 and 2 – Contamination Assessment

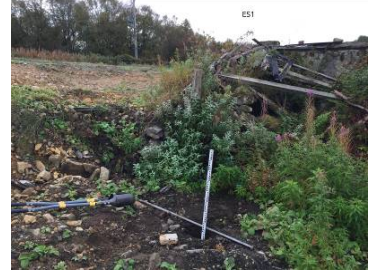
| Sample ES1 | Sample ES2 | Sample ES3 |

5.4.1. Thin topsoil was present in all entries apart from ES5 which was located in an area where the turf had been stripped. Topsoil is represented by blackish dark brown gravelly to very gravelly

slightly clayey sand. Gravel is fine to coarse angular sandstone. Below the topsoil and at formation in the area of ES5 subsoils are a yellowish brown very gravelly sand, gravel is fine to coarse angular sandstone with cobbles and boulders of sandstone (Weatheread Cefn-Y-Fedw Sandstone Formation). Photographs of the entries are provided below:
