## **PROTECTED SPECIES SURVEY**

**REGENT HOUSE**

**REGENT STREET**

**WREXHAM**

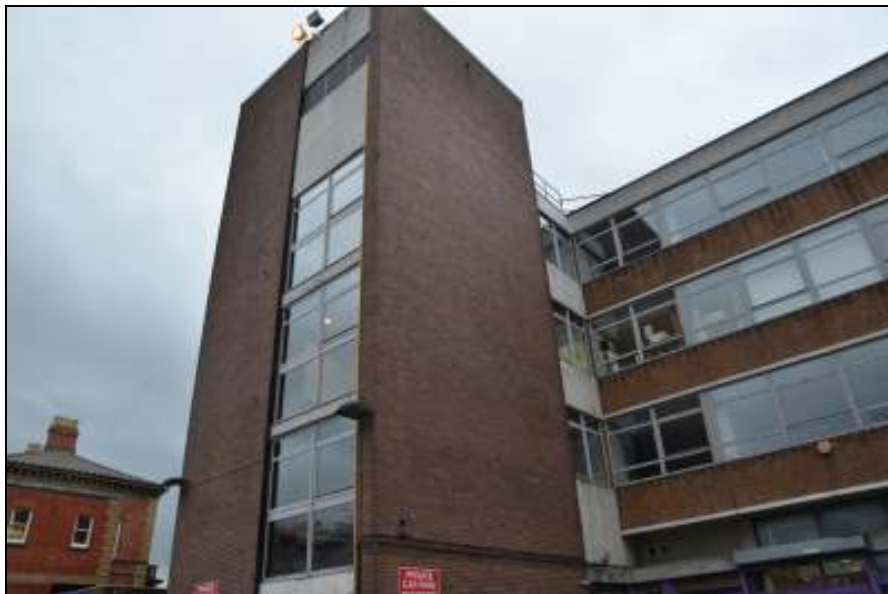
### 4. Rear elevation with lift tower

The four storey building appears to be constructed from a steel frame with brick and block infill walls and a flat concrete roof covered with felt. There is a section at the rear which supports the lift shaft, there is also a small flat roof section at the rear facing the car park.

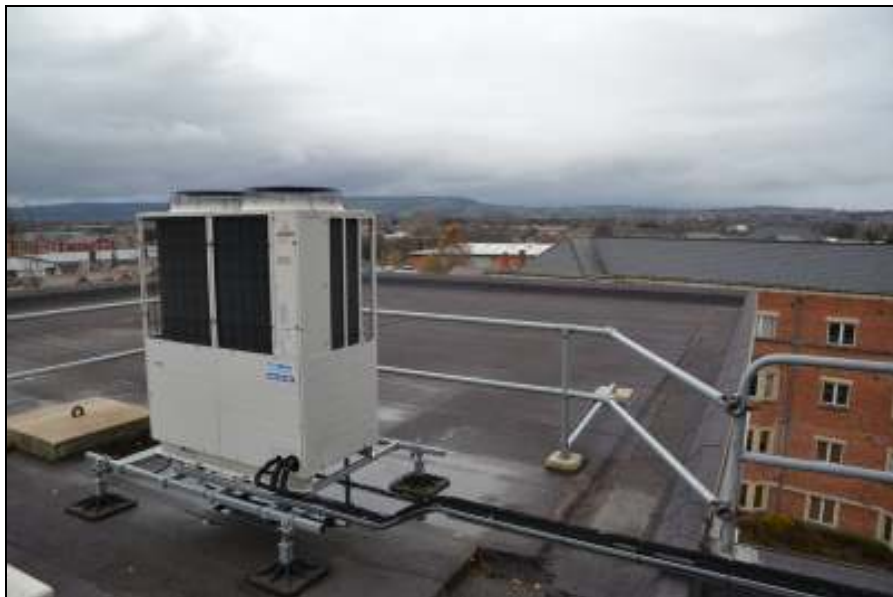
**6. The upper flat roof area**

No evidence of bats was found anywhere inside or outside of the building, no droppings, feeding remains, markings etc. The upper flat roof area can be inspected using the inspection hatch within the upper storey. This section also includes the boiler room and the water tank for the building.

All of the upper roof area to include any fascia sections are well sealed with no potential areas which could be used by bats. The boiler room has a louvre window for ventilation purposes. Internally there is a mesh grill covering the window although there is one small section missing. There is no evidence to suggest that bats have accessed this part of the building.

**No evidence of nesting birds was found anywhere within the structure of the property. The large open flat roof may offer some potential nest sites for gulls but there was no evidence to show that it has been used.**

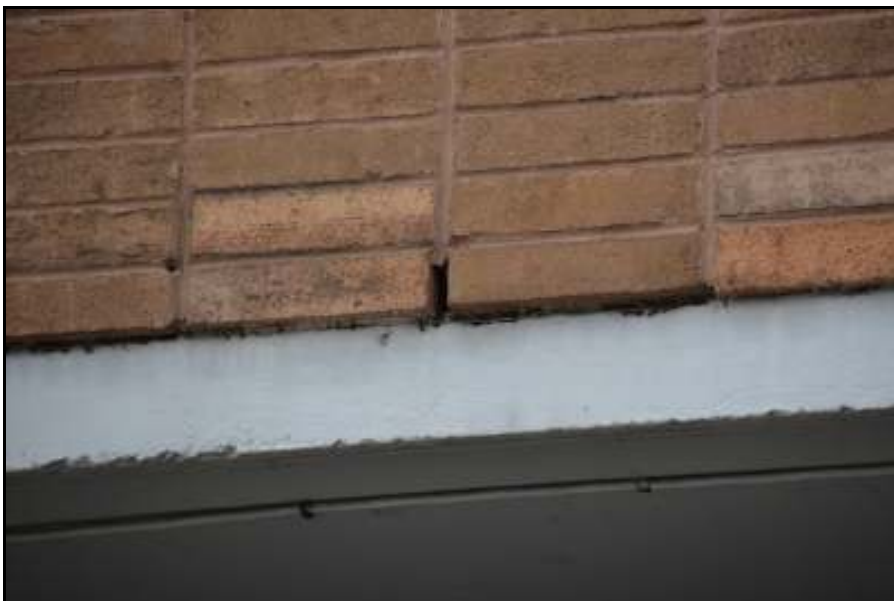
**10. Brick gap example**

At the front of the building and on most levels there are some small cavity gaps in the lower course facing brickwork, some examples of these have been shown in the photos below. If deep enough some of these may offer opportunities for individual roosting bats on an occasional basis.

- **Ensure all gaps within the facing brickwork are retained as existing.**
- **If required, door and window frames should be removed with care to ensure that no roosting, torpid or hibernating bats are injured during the proposed works.**
- **Any structural members, lintel bearings, purlins or wall plates should be removed with care to ensure that no roosting, torpid or hibernating bats are injured during the construction process.**
- **In the unlikely event that bats were found during the construction period then all work should cease and Natural Resource Wales (Buckley office) and/or a licensed bat worker should be contacted for further advice.**
