**DEVELOPMENT AT TALPONCIAU FARM, ACREFAIR, WREXHAM, LL14 1TU**

**STAGE 1 - PHASE 2 – GROUND CONTAMINATION INVESTIGATION AND RISK ASSESSMENT**

**REPORT No. E0761.S1.P2.R2**

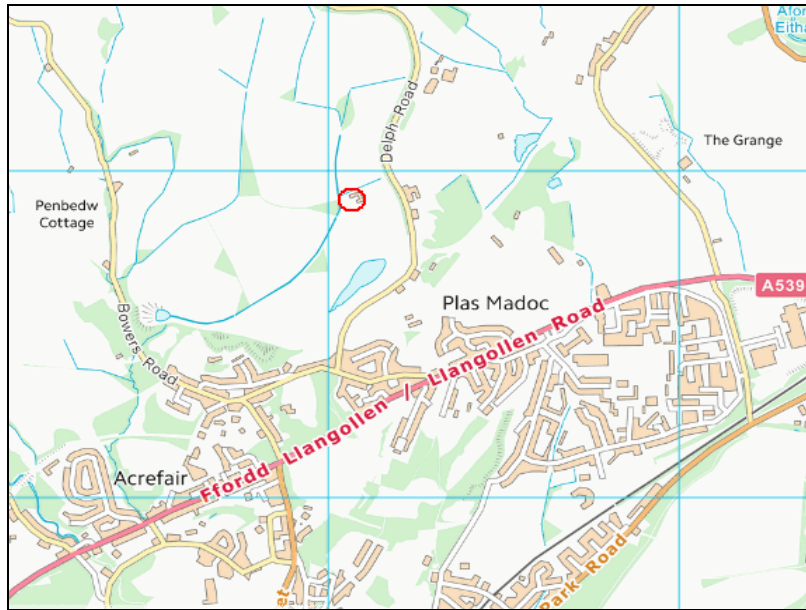
Figure 1 – Site Location

- 2.1.1 The proposed development site (the site) is situated within the farmstead of Talponciau Farm which is located 1km northeast of the village of Acrefair, near Wrexham, as shown on Figure 1. The site is centred at Grid Reference 328070, 343911 and covers a small area to the west of the existing farm buildings as shown on Figure 2.

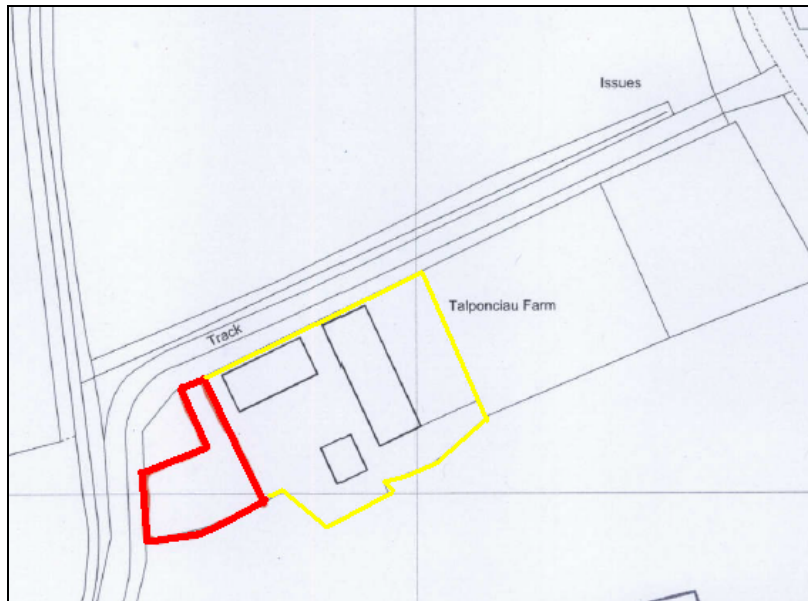
Figure 2 – Development and Planning Application Area

- 2.2.1 The single property development site comprises a small area of gravel surfaced hard standing to the west of the existing farm buildings extending southwards over agricultural land used for grazing. The main farm buildings comprising barns are immediately to the east. The whole site is generally flat and level and at an elevation similar to the surrounding land. To the east of the farm buildings and surrounding the site on all other sides is flat and gently sloping agricultural land used for grazing.

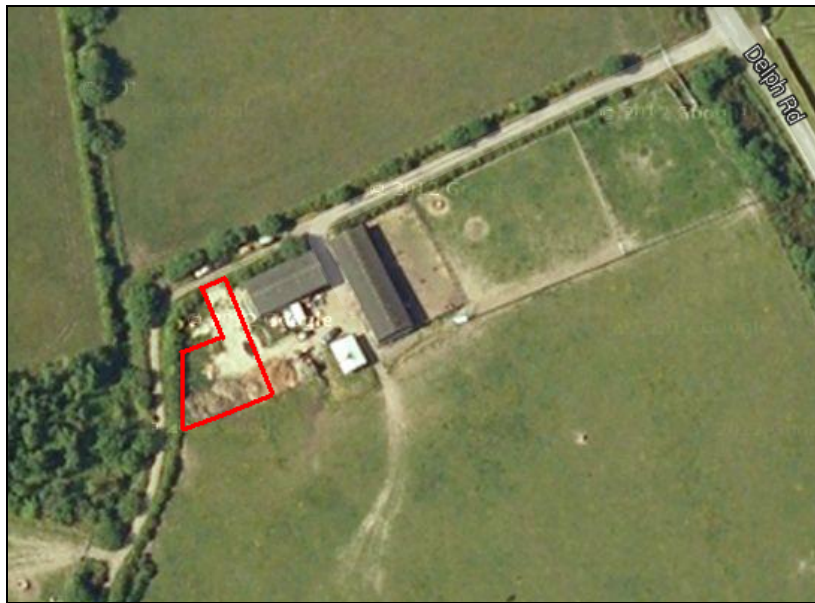
Figure 3 – Aerial Photograph of the Site

The site area is bordered to the west and north by a hedge and farm lane. To the east are farm buildings and grazing land and the southern boundary is marked by a fence and then open grazing agricultural land. An aerial photograph of the site is presented as Figure 3

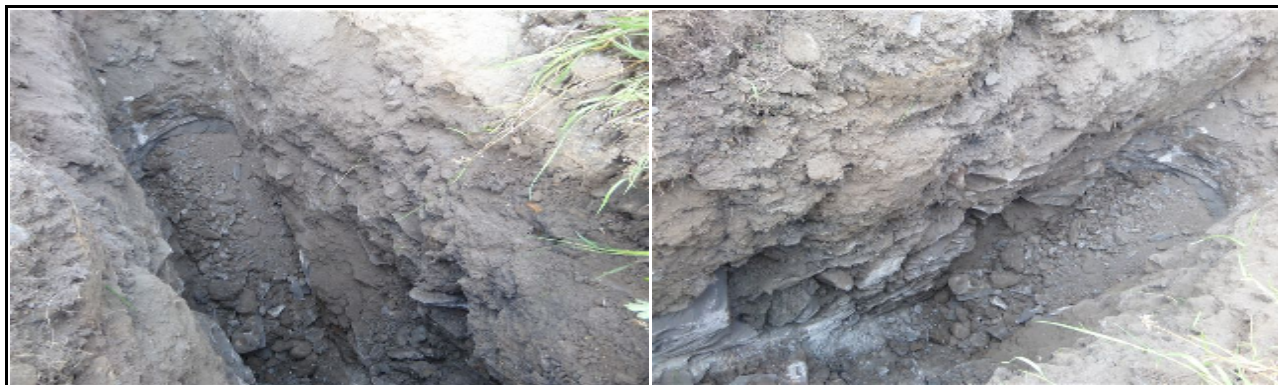
| | | | | | | Trial Pit No: <b>TP 1</b> | | | |
|---|---|---|---|---|---|---|---|---|--|
| TP1 | 0.00 | 0.25 | 0.25 | Stiff medium brown silty Topsoil | | | | | |
| | 0.25 | 2.00+ | 1.75+ | Made Ground - Stiff medium grey gravely silty CLAY with high cobble content and occasional boulder. Gravel is fine to coarse angular siltstone and mudstone | 0.5 | D | 0.35 | | |
| | | | | many cobbles and boulders from 1.20m | 1.5 | | | | |
| <b>Remarks</b><br>Sidewalls : Pit sides stable and vertical<br>Groundwater : None<br>In-situ testing : None<br>Contaminants : None<br>Services : None | | | | | | | | | |

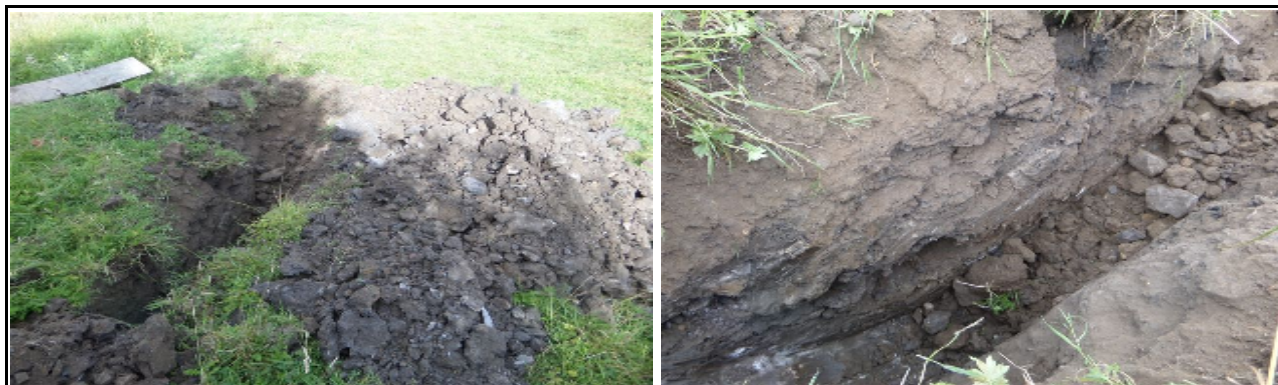
| | | | | | | Trial Pit No: <b>TP 2</b> | | | |
|---|---|---|---|---|---|---|---|---|--|
| TP2 | 0.00 | 0.25 | 0.25 | Stiff medium brown silty Topsoil | | | | | |
| | 0.25 | 0.75 | 0.50 | Made Ground - Stiff medium grey gravely silty CLAY with high cobble content and occasional boulder. Gravel is fine to coarse angular siltstone and mudstone | 0.5 | D | 0.30 | | |
| | 0.75 | 2.00+ | 1.25+ | Made Ground - Boulders and cobbles of siltstone and mudstone in light grey silty clay matrix | 1.0 | | | | |
| <b>Remarks</b><br>Sidewalls : Pit sides stable and vertical<br>Groundwater : None<br>In-situ testing : None<br>Contaminants : None<br>Services : None | | | | | | | | | |

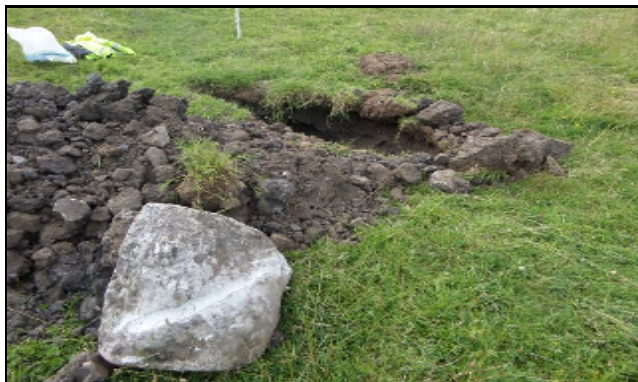
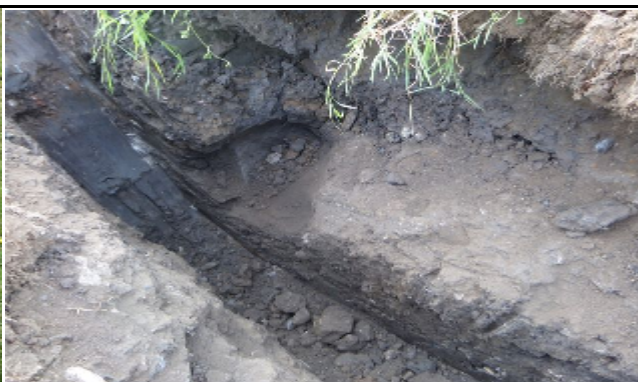
| | | | | | | Trial Pit No: <b>TP 3</b> | | | |
|---|---|---|---|---|---|---|---|---|--|
| TP3 | 0.00 | 0.25 | 0.25 | Stiff medium brown silty Topsoil | | | | | |
| | 0.25 | 2.00+ | 1.75+ | Made Ground - Stiff medium to dark grey gravely silty CLAY with high cobble content and occasional boulder. Gravel is fine to coarse angular siltstone and mudstone | 0.5 | D | 0.15 | | |
| <b>Remarks</b><br>Sidewalls : Pit sides stable and vertical<br>Groundwater : None<br>In-situ testing : None<br>Contaminants : None<br>Services : None | | | | | | | | | |

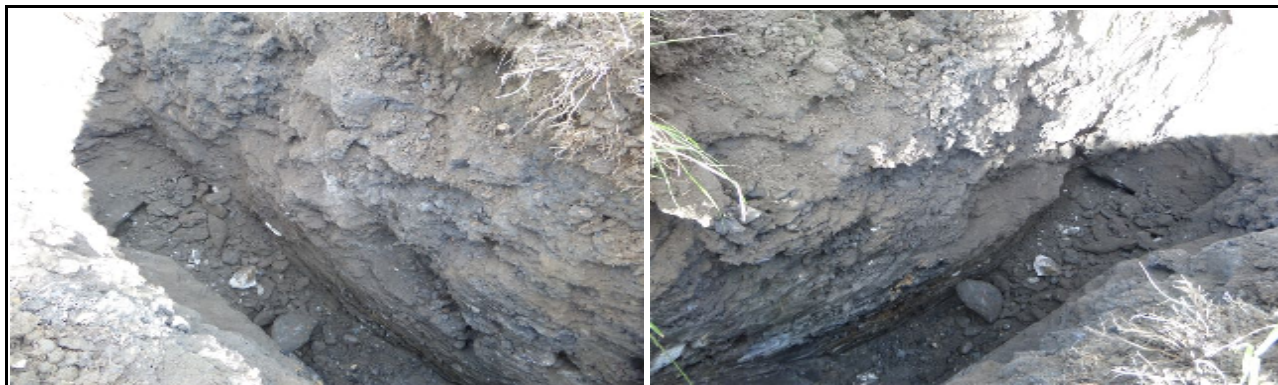
| | | | | | | Trial Pit No: <b>TP 4</b> | | | |
|---|---|---|---|---|---|---|---|---|--|
| TP4 | 0.00 | 0.25 | 0.25 | Stiff medium brown silty Topsoil | | | | | |
| | 0.25 | 2.00+ | 1.75+ | Made Ground - Stiff medium to dark grey gravely silty CLAY with high cobble content and occasional boulder. Gravel is fine to coarse angular siltstone and mudstone | 0.5 | D | 0.50 | | |
| <b>Remarks</b><br>Sidewalls : Pit sides stable and vertical<br>Groundwater : None<br>In-situ testing : None<br>Contaminants : None<br>Services : None | | | | | | | | | |
