**PROPOSED DEVELOPMENT AT  
WALLINGTON FARM, WORTHENBURY,  
WREXHAM**

**BAT METHOD STATEMENT**

**DECEMBER 2015**

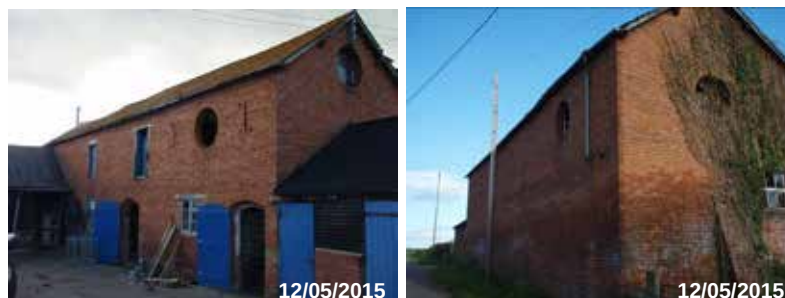
##### *Building 1*

B1 is located approximately 30m above sea-level. The building is a traditional barn which is currently used as storage at Wallington Farm. B1 is a brick built, two storey building with a roof void. The pitched slate roof is unlined and gable ended.

There are open pitching holes at the gable ends and slipped tiles.

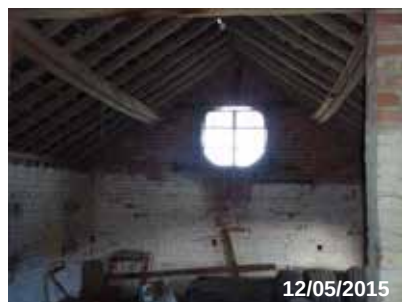
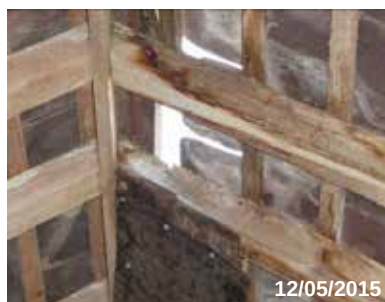
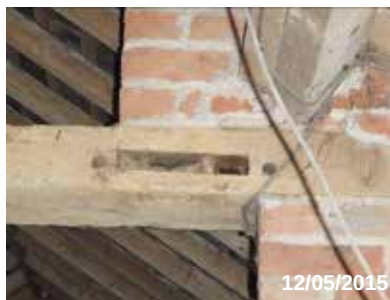
There are a roost site opportunities in these loft areas particularly in timber peg holes, slots, cracks etc.

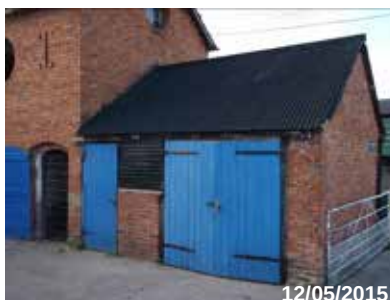
### *Building 1a*

B1a is attached to the eastern gable end of B1. This is a single storey workshop with a pitched corrugated metal roof.

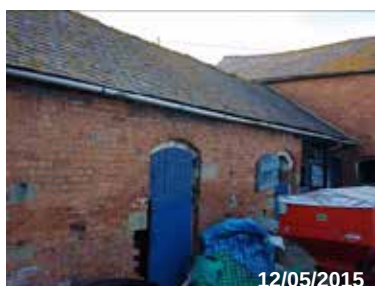
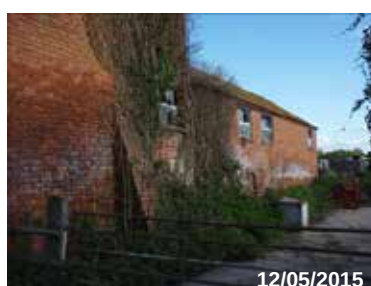
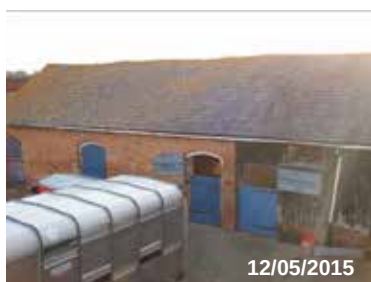
### *Building 2*

B2 forms an 'L' shaped barn with B1. This is a single storey brick storage building with a pitched unlined slate roof. There is no loft void.

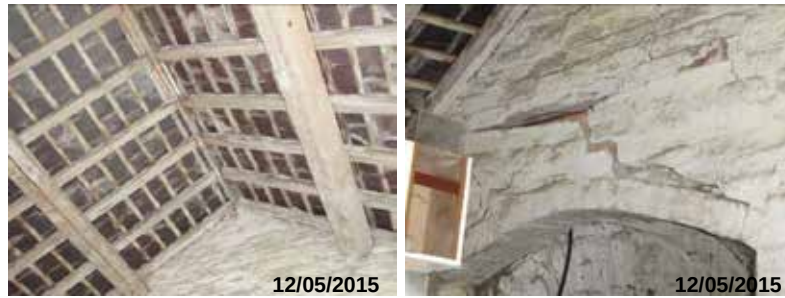
The internal walls are covered in white wash. A number of cracks and crevices were identified.

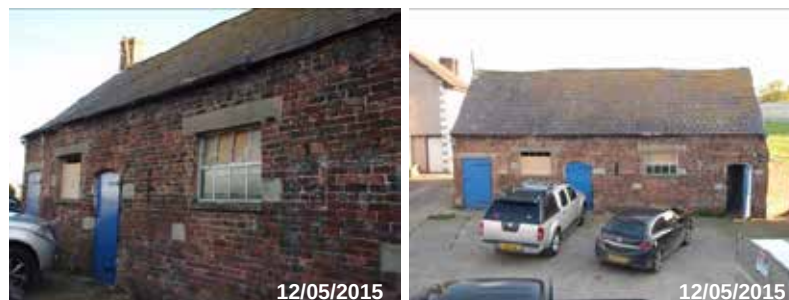
### *Building 3*

B3 is located adjacent to B2 and adjacent the existing farmhouse. This is a single storey brick building with a pitched slate roof. There is no loft void.

There are open pitching holes and slipped slates.

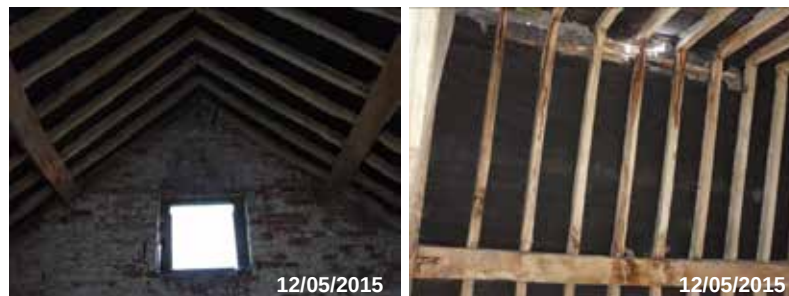
The roof is lined with a bitumen/hessian traditional roofing felt. Therefore there is a potential roost site for bats between the felt and roof slates above. There are a number of tears in the felt. There are roofing timber 'slots' and 'peg-holes' and cracks in internal brickwork.

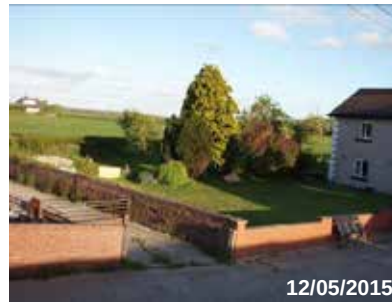
The surrounding habitat comprised predominantly farmland used for stock grazing with interconnecting boundary hedgerows (see Fig. C.4b). Elsewhere on the Wallington Farm site is the existing farmhouse which is being retained and associated landscaped garden.

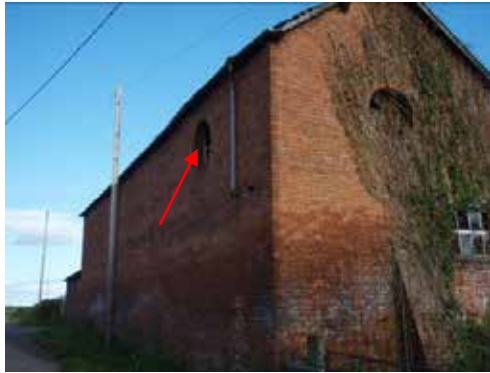
### **Bat access/entry point through open pitching hole on northern aspect of B1**

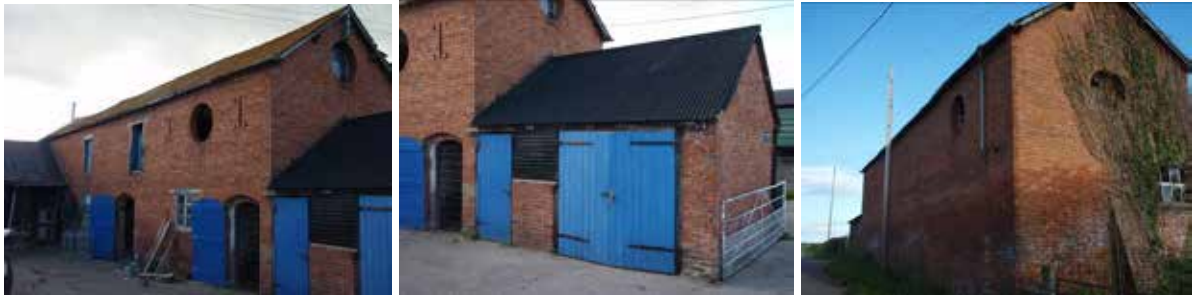
- 1.12 **Building 1 (B1)** was a two storey traditional barn with a single storey corrugated metal roofed attached workshop (B1a). The two storey building had an unlined slate roof.

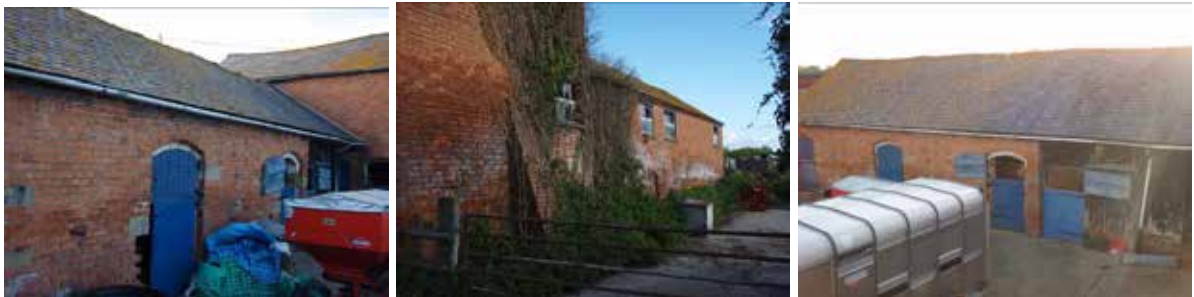
- 1.13 **Building 2 (B2)** had an unlined slate roof, was single storey and there was no roof void.

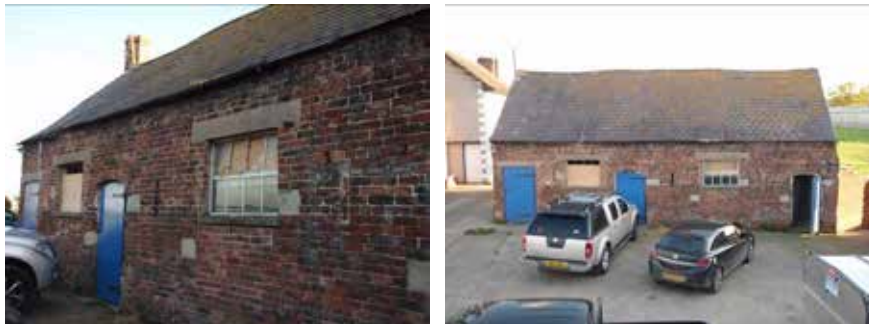
- 1.14 **Building 3 (B3)** had a slate roof lined with bitumen/hessian traditional sarking felt.

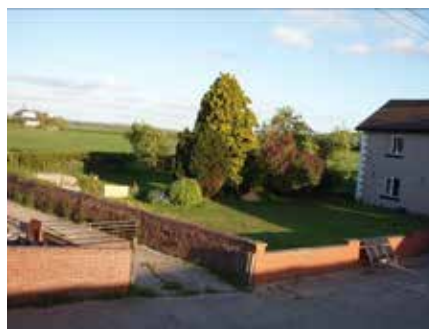
- 1.15 The surrounding habitat is farmland given over mainly to stock grazing.

- 1.16 There were short managed hedgerows with occasional hedgerow trees.

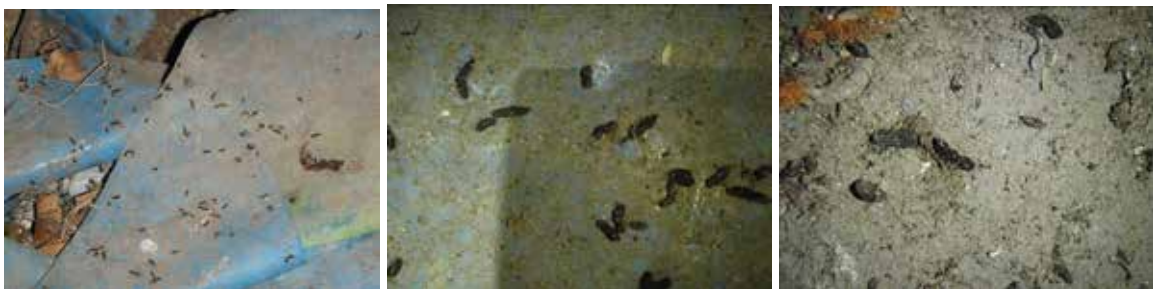
- 7.3 The location of these droppings corresponds to the locations where droppings were found in the September 2014 survey.

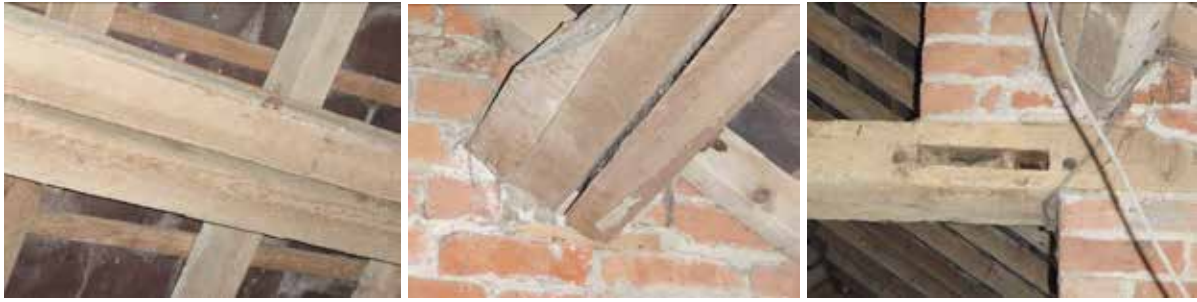
- 7.4 There are a number of potential roost sites in these loft areas particularly in timber peg holes, slots, cracks etc.

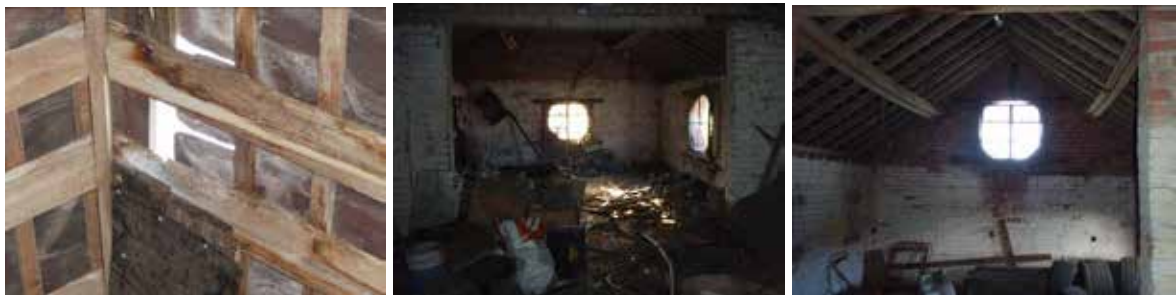
- 7.5 Entry/exit sites are through open pitching holes but also potentially through slipped slates.

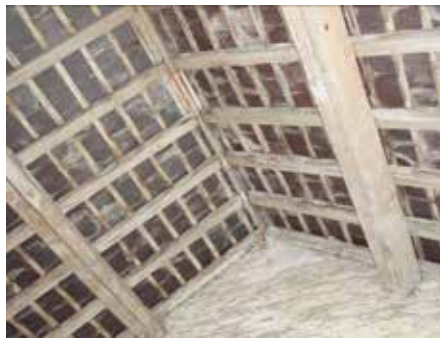
- 7.6 This area has no loft void and an unlined slate roof.

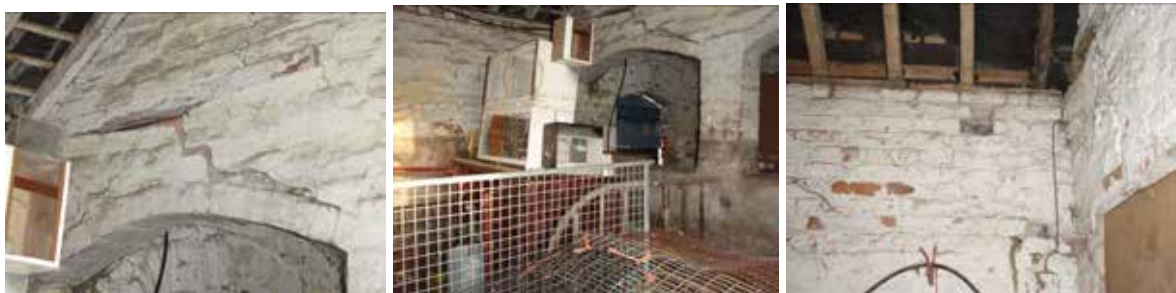
- 7.7 The walls are covered in old whitewash but there are cracks and crevices where bats could potentially roost particularly pipistrelles in winter.

- 7.8 However, no evidence of recent bat usage was found at the time of this daytime survey.

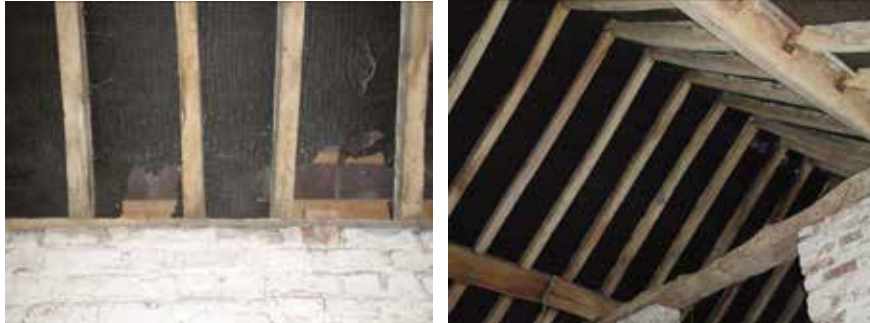
- 7.9 This building has a bitumen/hessian traditional roofing felt and therefore a potential roost site for bats between the felt and roof slates above. There are a number of tears in the felt making potential roost sites for bats.

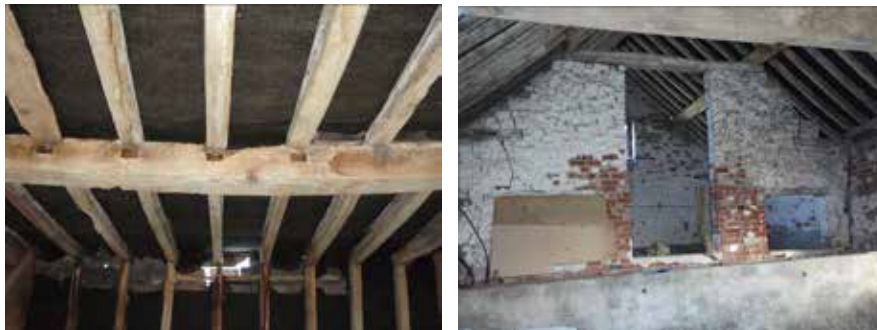
- 7.10 Other potential roost sites were in roofing timber 'slots' and peg-holes' and cracks in internal brickwork.

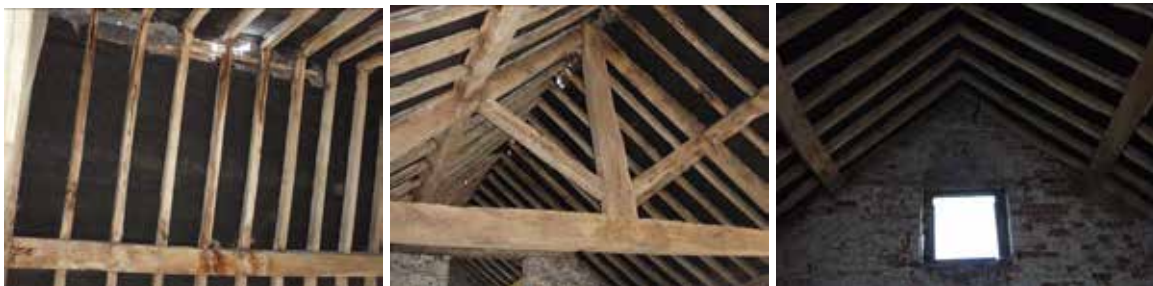
- 7.11 Potential entry points were through open doors and pitching holes and through broken or slipped slates and ridges.

- 7.12 As with B2 however, no evidence of recent bat usage was found at the time of this survey.

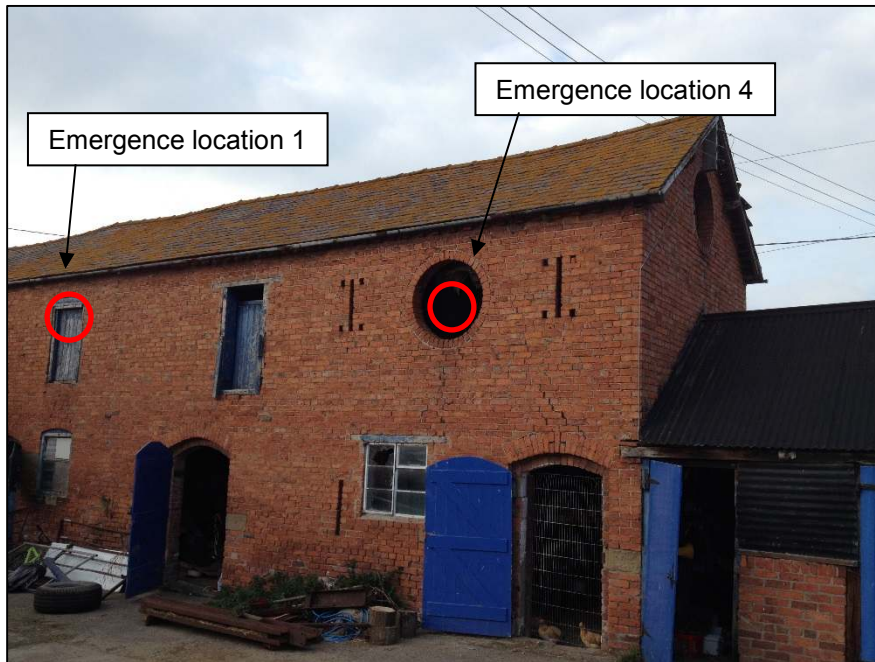
Building B1a is a two storey, red brick barn with three rooms on the ground floor used as storage and livestock sheds, with the upper floor being open plan and used as storage. Evidence of recent bat occupation was observed throughout the first floor of building B1a. At one location (TN1) within the first floor an accumulation of over 50 bat droppings was found beneath potential access points within a brick supporting wall. Another accumulation of around 30 bat droppings was observed in the south eastern corner of the building scattered on a piece of blue plastic (Plate 7). Occasional bat droppings were also observed on the internal walls throughout the upper floor as well as one bat dropping in the gap within a purlin timber. No evidence of bat occupation was found within the ground floor of Building B1a.

| Emergence location | Time | Species | Quantity | Building Number |
|---|---|---|---|---|
| Location 1 | Area above the top of the single blue door on the first floor (Plate 1) | | | |

### A1.1 Plate 1 – Southern elevation of building B1a

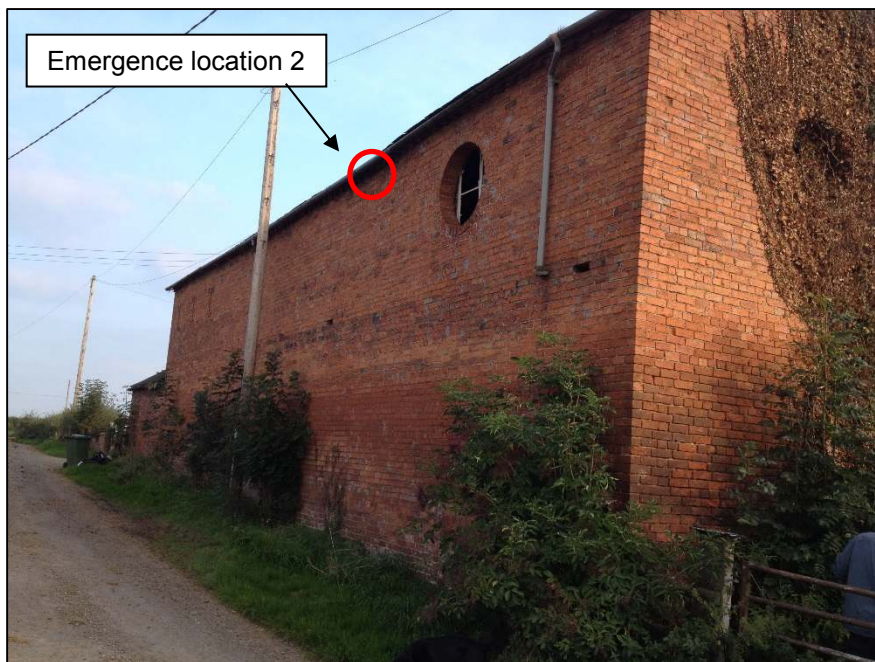
| Emergence location | Time | Species | Quantity | Building Number |
|---|---|---|---|---|
| Location 2 | Behind the guttering (Plate 2) | | | |

### A1.2 Plate 2 – Northern elevation of building B1a

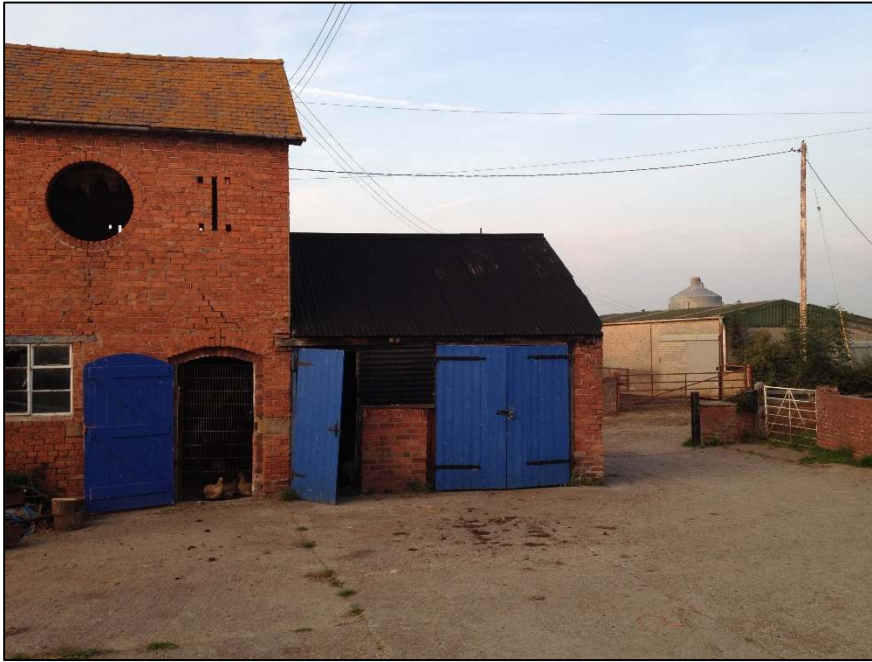
| Bldg.<br>Ref.<br>No. | Building<br>Construction/Description. | Structural Features | | | | | | | | Potential Bat Access<br>Points/Evidence of Bats<br>Observed | Internal Features | Potential as a Bat Roost<br>Site/Comments |
|---|---|---|---|---|---|---|---|---|---|---|---|---|
| B1b | <p>One-storey, double brick wall built outbuilding with tin sheeting roof painted black. Abutting eastern gable end of B1a.</p> <p>Hand sawn timbers throughout roof void</p> <p>Plate 3</p> | ✓ | ✗ | ✗ | ✗ | ✗ | ✗ | ✗ | ✗ | <p>Gaps between the wall plate and the metal roof on the Eastern external wall.</p> <p>Open door.</p> <p>No evidence of bats found</p> | <p>Used as a workshop and tool/machinery store.</p> <p>Double brick wall – potential spaces in between brick work.</p> <p>Height to ridge 3.5 - 4m.</p> | <p><b>Negligible potential to support either a maternity or regularly used roost and low potential to be used as an occasional roost by individual bats.</b></p> <p><b>Negligible potential to be used as a hibernation roost</b></p> <p>Unobstructed southern aspect will allow the outbuilding to heat up during warm weather due to the presence of a black metal roof, lowering the potential for use by bats.</p> <p>Swallows active within the building and nesting throughout.</p> |

A1.3 **Plate 3** – Building B1b southern elevation

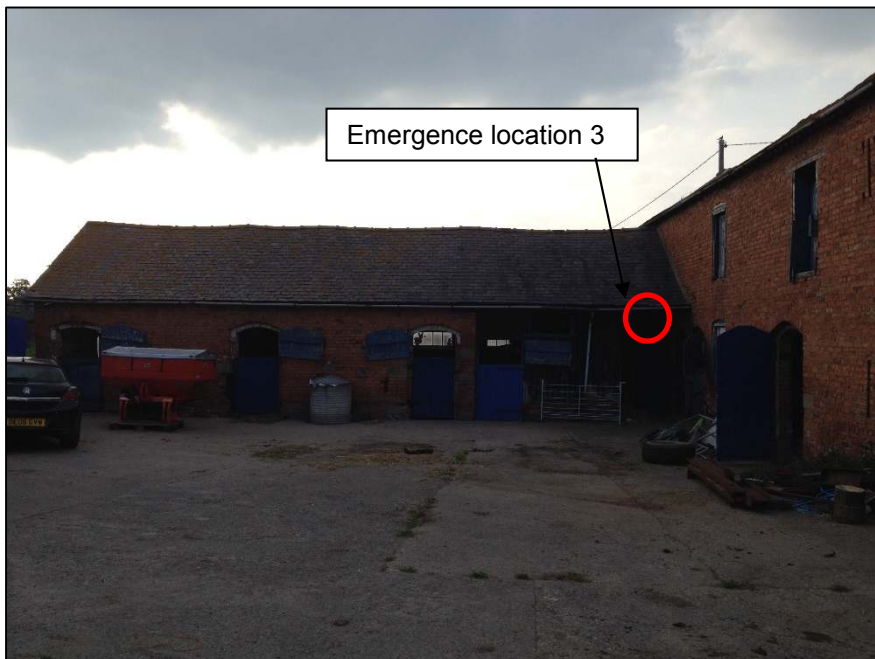
| Bldg.<br>Ref.<br>No. | Building<br>Construction/Description. | Structural Features | | | | | | | | Potential Bat Access<br>Points/Evidence of Bats<br>Observed | Internal Features | Potential as a Bat Roost<br>Site/Comments |
|---|---|---|---|---|---|---|---|---|---|---|---|---|
| B2 | <p>One-storey, double brick wall built outbuilding with pitched slate tiled roof.</p> <p>Hand sawn oak timbers throughout.</p> <p>Abutting the south western corner of building B1</p> <p>Plates 4, 9 &amp; 10</p> | ✓ | ✗ | ✗ | ✗ | ✗ | ✗ | ✗ | ✗ | <p>Holes in external brick work under guttering and on the wall plate where.</p> <p>Access into the rooms via open stable doors.</p> <p>Open and/or smashed windows on the western elevation of the building</p> <p>Scattered bat droppings present on internal walls.</p> | <p>Double brick wall – potential spaces in between brick work.</p> <p>Open roof void with large timbers, gaps between timbers</p> <p>Gaps where rafters meet purlins in roof void.</p> <p>Underfelt present providing gap beneath tiles.</p> <p>Height to ridge 3.5 - 4m.</p> | <p><b>Moderate potential to support a maternity bat roost or regularly used roost.</b></p> <p><b>Moderate potential to be used as an occasional roost by individual bats.</b></p> <p><b>Low potential to be used as a hibernation roost</b></p> <p>Eight bat droppings found scattered on internal walls (TN 3 &amp; 4)</p> <p>Some light ingress due to windows in each room.</p> <p>Numerous sparrows and swallows observed and nesting in the building</p> |

| Emergence location | Time | Species | Quantity | Building Number |
|---|---|---|---|---|
| Location 3 | Behind timber cladding above doorway where it joins the roof (Plate 4) | | | |

A1.4 **Plate 4** – Eastern elevation of Building B2

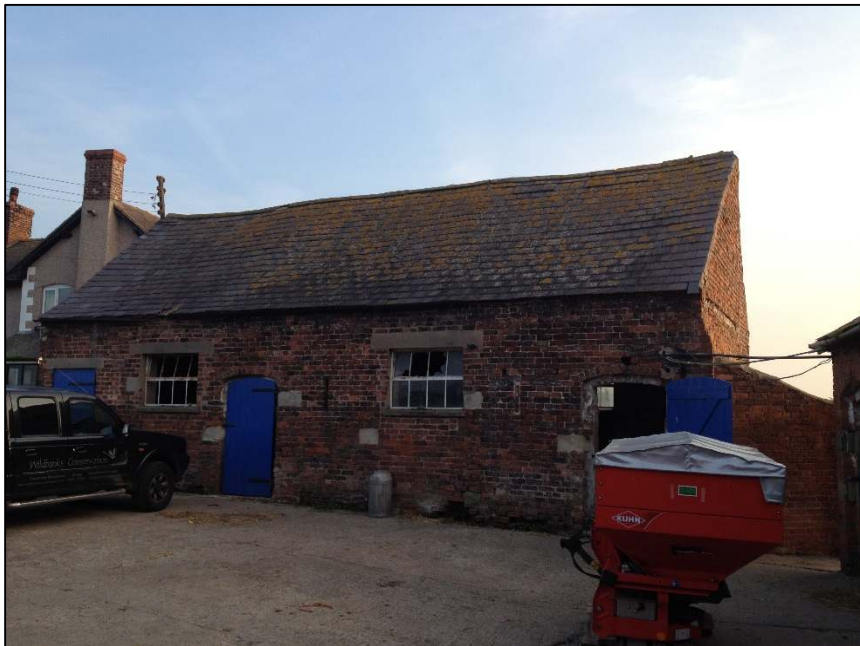
Building B3 is a red brick outbuilding with a slate tiled roof. Large oak trusses hold up the roof and underfelt is present (Plates 11 and 12). Three bat droppings were found on the external window frame and window ledge of building B3 (TN5). The glass is missing from the windows, allowing access and they are located on the northern aspect of the building, facing in to the courtyard.

| Bldg.<br>Ref.<br>No. | Building<br>Construction/Description. | Structural Features | | | | | | | | Potential Bat Access<br>Points/Evidence of Bats<br>Observed | Internal Features | Potential as a Bat Roost<br>Site/Comments |
|---|---|---|---|---|---|---|---|---|---|---|---|---|
| B3 | <p>One-storey, double brick wall built outbuilding with pitched slate tiled roof.</p> <p>Hand sawn oak timbers throughout roof void with large truss structure and underfelt present.</p> <p>Plates 5, 11 &amp; 12</p> | ✓ | ✗ | ✗ | ✗ | ✗ | ✗ | ✗ | ✓ | <p>Holes in external brick work under guttering and under the underfelt in the roof void.</p> <p>One large window smashed entirely on northern aspect.</p> <p>Three bat droppings found externally on the smashed window frame and window ledge.</p> | <p>Double brick supporting wall in the middle of the building with opportunities for bats in between the brick work and mortar.</p> <p>Large oak timber truss supporting roof with gaps in wood joins.</p> <p>Gaps where rafters meet purlins in roof void.</p> <p>Mice heard running between underfelt and slate tiling in roof void.</p> | <p><b>Moderate potential to support a maternity bat roost or regularly used roost.</b></p> <p><b>Moderate potential to be used as an occasional roost by individual bats.</b></p> <p><b>Low potential to be used as a hibernation roost</b></p> <p>No evidence of bat use inside, but some bat droppings found near open window externally (TN5).</p> <p>Numerous swallows observed and nesting in the building</p> |

A1.5 **Plate 5** – Northern elevation of Building B3

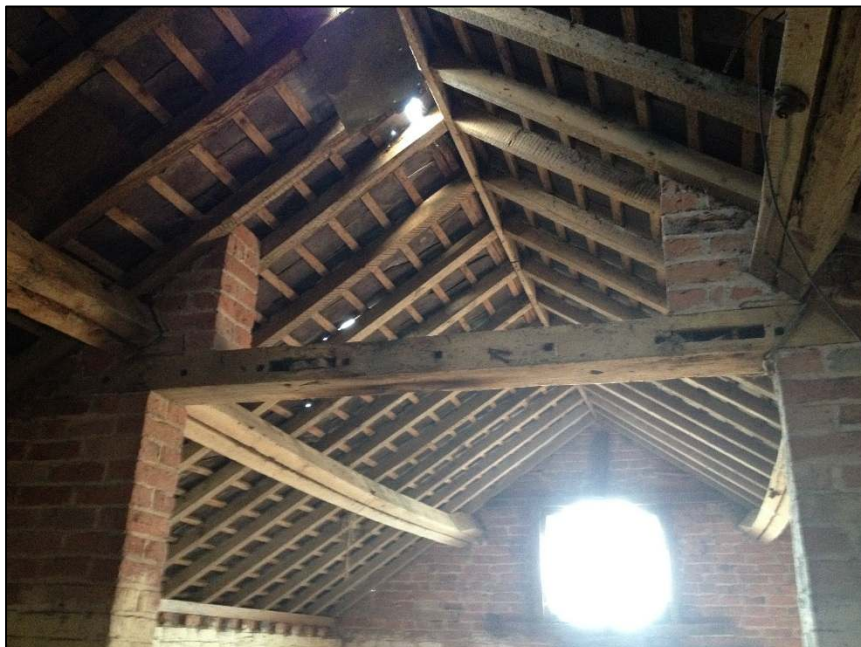
| Bldg.<br>Ref.<br>No. | Building<br>Construction/Description. | Structural Features | | | | | | | | Potential Bat Access<br>Points/Evidence of Bats<br>Observed | Internal Features | Potential as a Bat Roost<br>Site/Comments |
|---|---|---|---|---|---|---|---|---|---|---|---|---|
| B1a | <p>Two storey double brick wall built outbuilding with pitched slate tiled roof.</p> <p>Hand sawn oak timbers throughout roof void.</p> <p>Floor between storeys constructed from machined timbers.</p> <p>Used for storage</p> <p>Plates 1, 2, 6 &amp; 8</p> | ✓ | × | × | × | × | × | × | × | <p>Gaps beneath ridge tiles and beneath occasional raised slate tiles allowing access in to the first floor.</p> <p>Feature holes built into brickwork.</p> <p>Two large circular window holes with no glass present.</p> <p>Cracks in external brickwork and masonry and around second storey doors.</p> <p>No evidence of bat presence observed externally.</p> | <p>The upper floor is one open area with four windows and numerous holes present allowing a lot of light to penetrate. No underfelt or sarking was present on the roof and 90 % of the underside of the slate tiles could be inspected. Brick walls extend to support the roof</p> <p>Purlins run the length of the roof and are double beams with gaps in between.</p> <p>Gaps where rafters meet purlins in roof void.</p> <p>Height to ridge 3.5 - 4m.</p> | <p><b>High/moderate potential to support a maternity bat roost or regularly used roost. High potential to be used as an occasional roost by individual bats.</b></p> <p><b>Low potential to be used as a hibernation roost</b></p> <p>Bat droppings were observed in two large accumulations (TN 1 &amp; 2) within the first floor as well as scattered throughout internal walls and on artefacts stored on the floor.</p> <p>Numerous roosting opportunities exist within the walls and in and around the timbers of the roof</p> <p>Numerous swallows nests were present and sparrows were also observed</p> <p>Some light ingress was present into the first floor due to four windows</p> |

A1.6 **Plate 6** – Building B1a, first floor roof structure

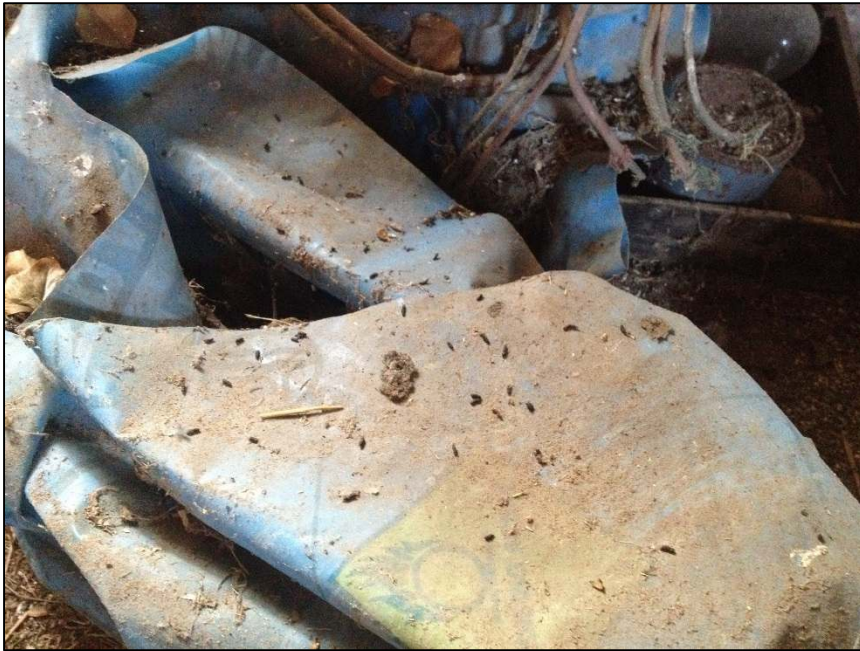
A1.7 **Plate 7** – Bat droppings at TN2 within Building B1a

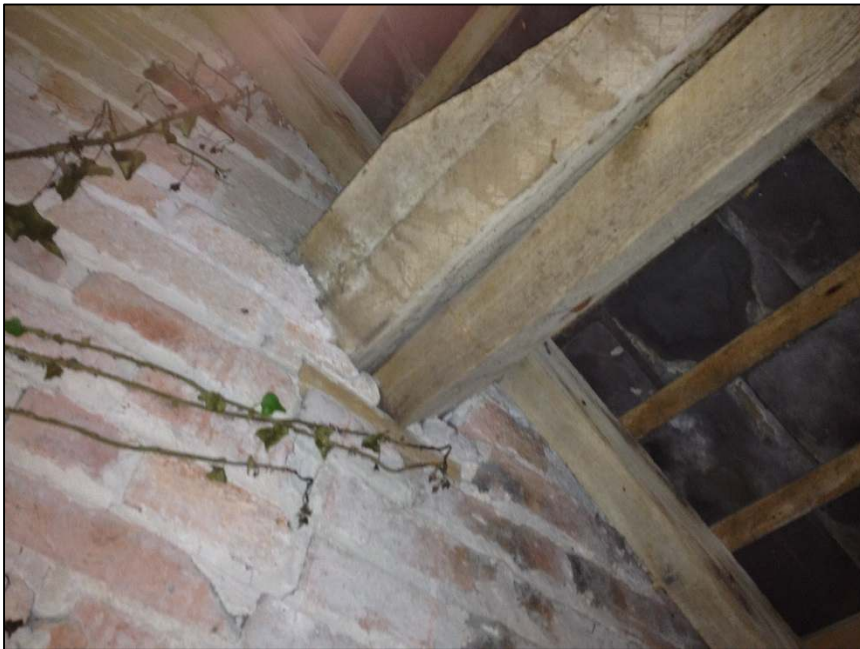
A1.8 **Plate 8** – Example of potential roost location within Building B1a

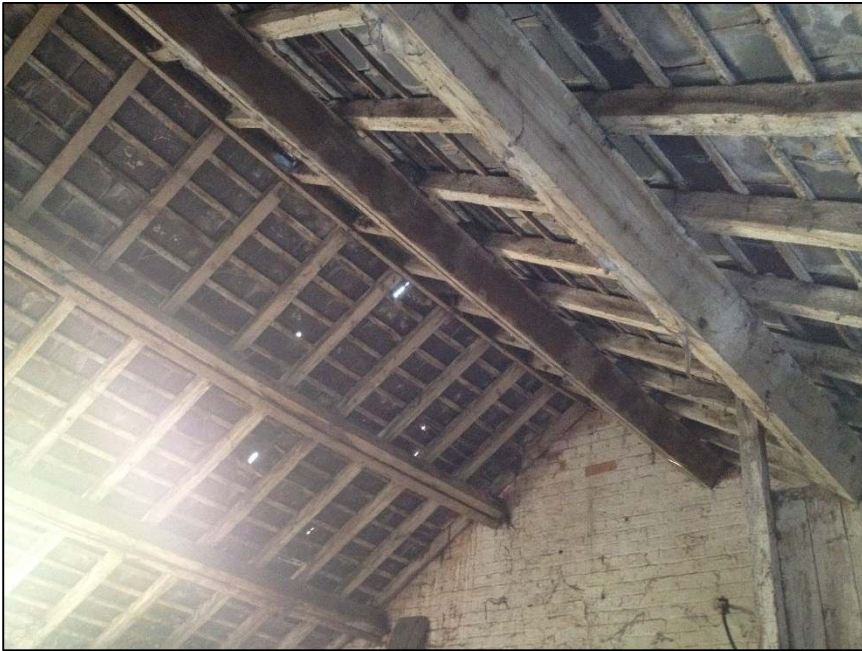
A1.9 **Plate 9** – Building B2, roof structure

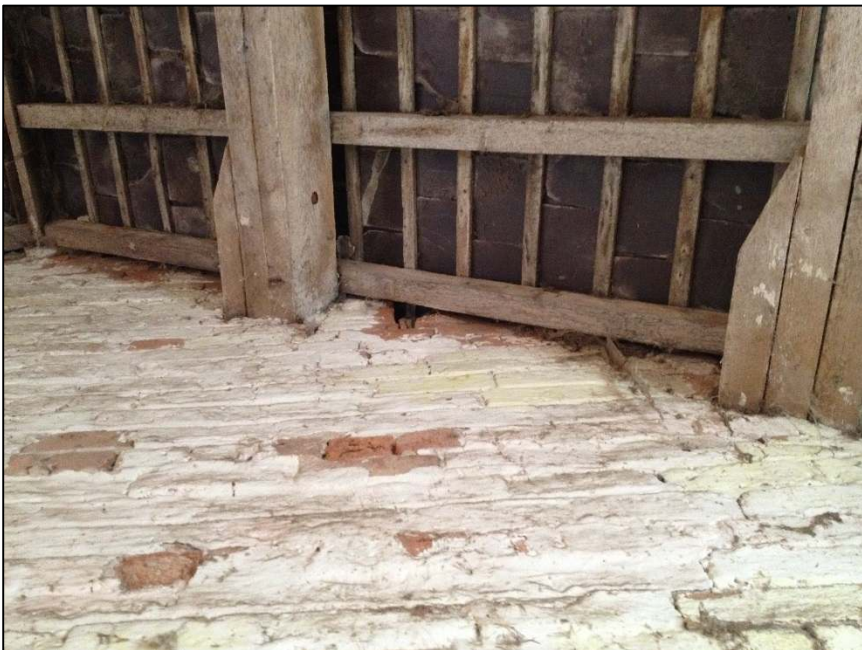
A1.10 **Plate 10** – Potential roosting opportunities within Building B2

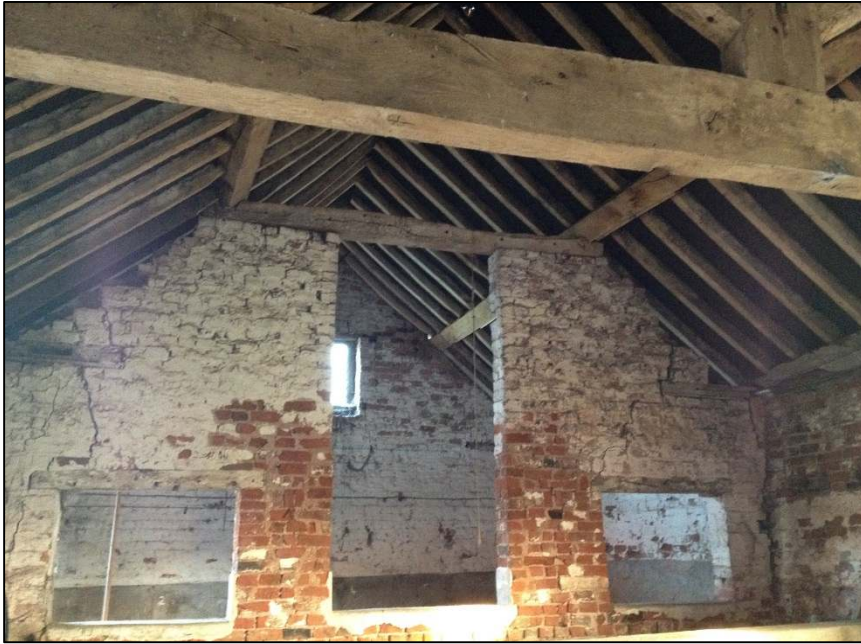
A1.11 **Plate 11** – Building B3 roof structure

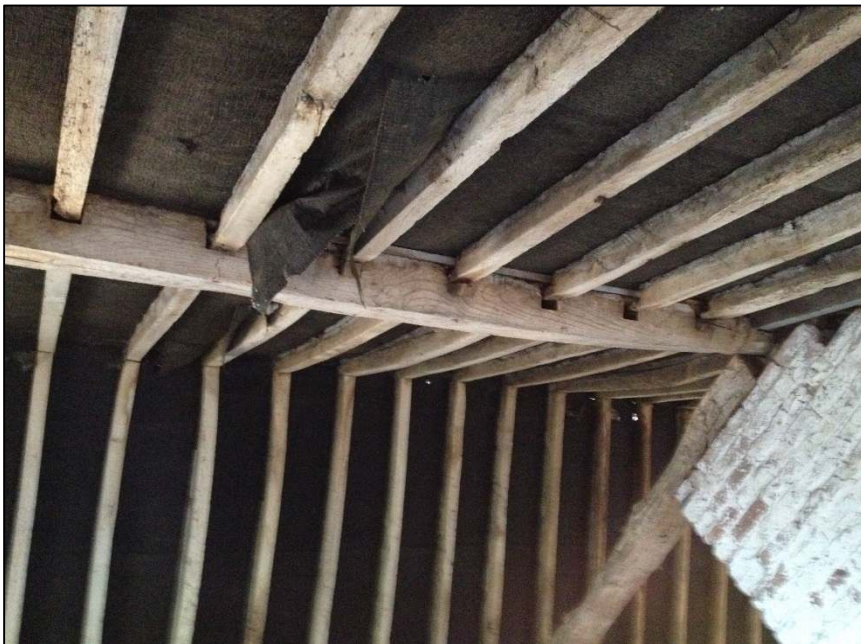
A1.12 **Plate 12** – Building B3 Roof structure and potential roosting features
