***Penyllan House***  
***3 Penyllan Street, Overton-on-Dee,***  
***Nr. Wrexham LL13 0EE***

***Bat Survey with Mitigation Plan***

July 2015 (Revised October 2015)

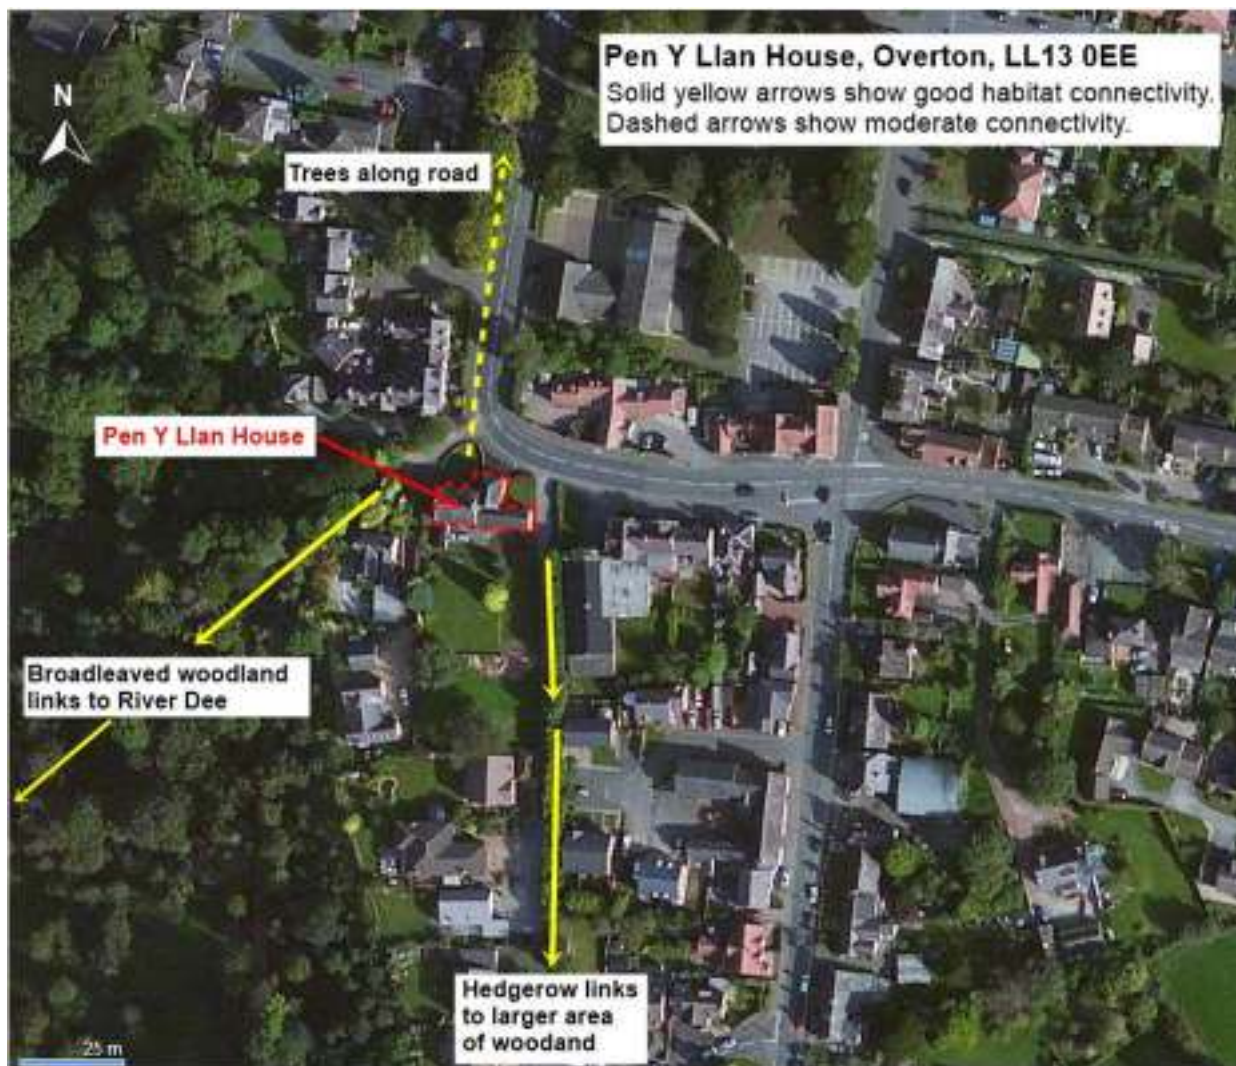
Features of the landscape around the site are shown on the aerial photograph below. Solid yellow lines indicate good habitat connectivity (i.e. vegetation links). The best links were to the south and south west with moderately good connectivity north along a line of street trees but this area was very well lit by streetlamps.

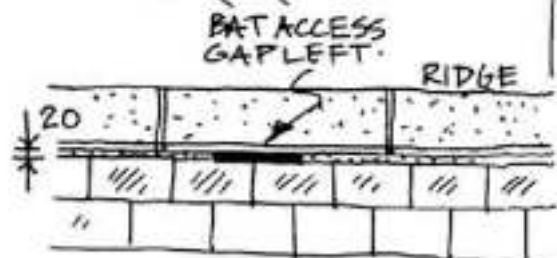
# RIDGE TILE ACCESS DETAIL 4A

~ OPTION A ~

ROOF RIDGE SET ON TOP  
OF GENERAL RIDGE TILES  
TO FORM BAT ACCESS GAP.

~ OPTION B ~

MAINTAIN 20MM MORTAR  
GAP. & LEAVE A SECTION  
OUT.

- (vii) To the underside of the rafters on both pitches fix 6 number rough sawn battens, about 25mm x 25mm in dimension, the length of the building. The highest placed within 100mm of the apex beam and the other 5 at approx. 200mm spacing down the roof pitches. The lower parts therefore have no underside battens.
- (viii) Three evenly spaced ridge tiles (more on buildings longer than 5m) will be "notched" to their lower edges to provide a slot 100mm long and an effective depth, when the ridge tile is in situ, of 20mm (and no larger or smaller) to both lower edges to provide access for bats under the ridge tiles, with a cavity left inside at this point. The ridge will be a mortared not "dry system" ridge. See Detail 4A below.
