## **PROTECTED SPECIES SURVEY**

**16-18 GROSVENOR ROAD**

**WREXHAM**

**27<sup>th</sup> September 2015**

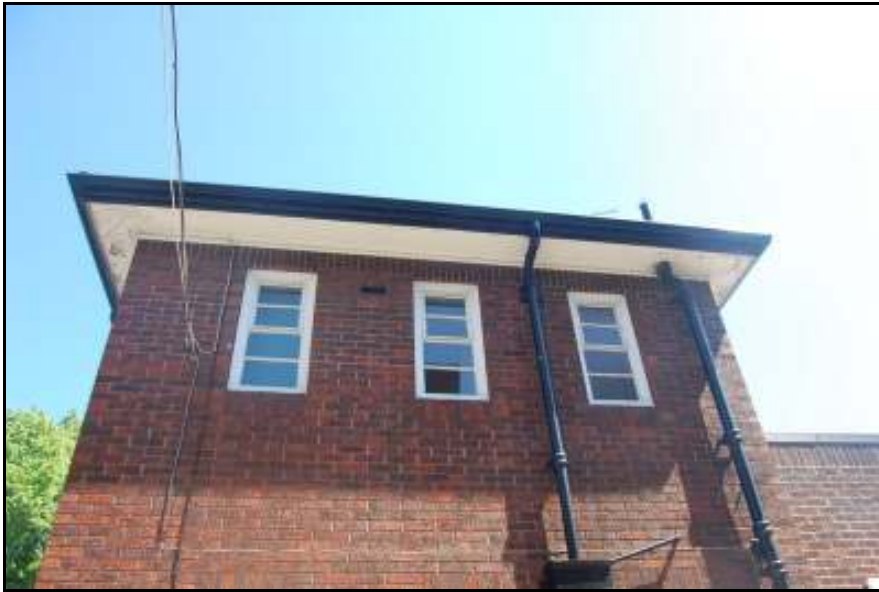
**3. All soffit areas of number 18 are well sealed**

No evidence of bats was found anywhere inside or outside of this building. No droppings were apparent on the floor, roof and wall areas and there were no signs of feeding perches. The internal roof timbers are exposed but they do not support any features suitable for roosting bats. The loft space is generally quite dusty and covered with cobwebs, there are no signs of disturbance. The presence of these cobwebs would have the advantage of catching any droppings from past roosting bats. There are no obvious changes from the situation found during the previous survey.

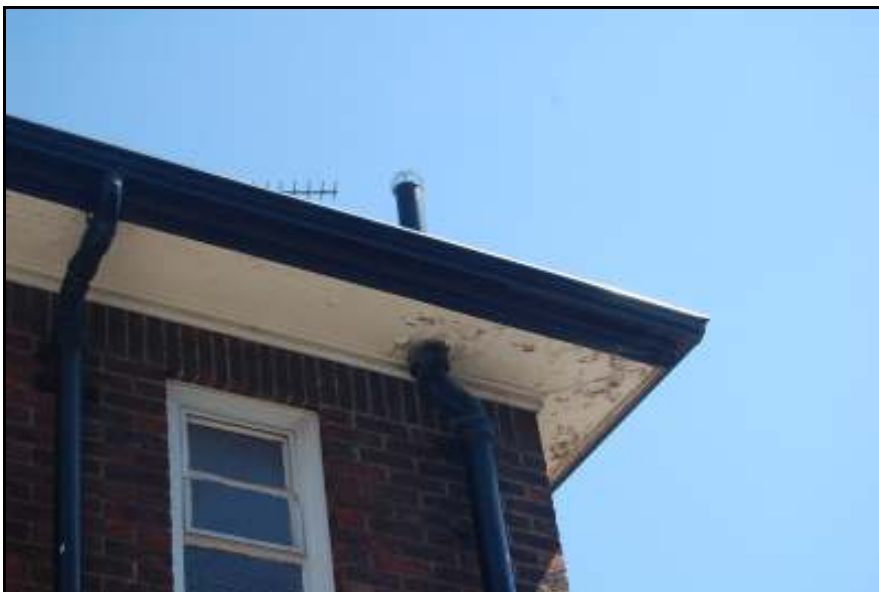
**4. Intact soffits**

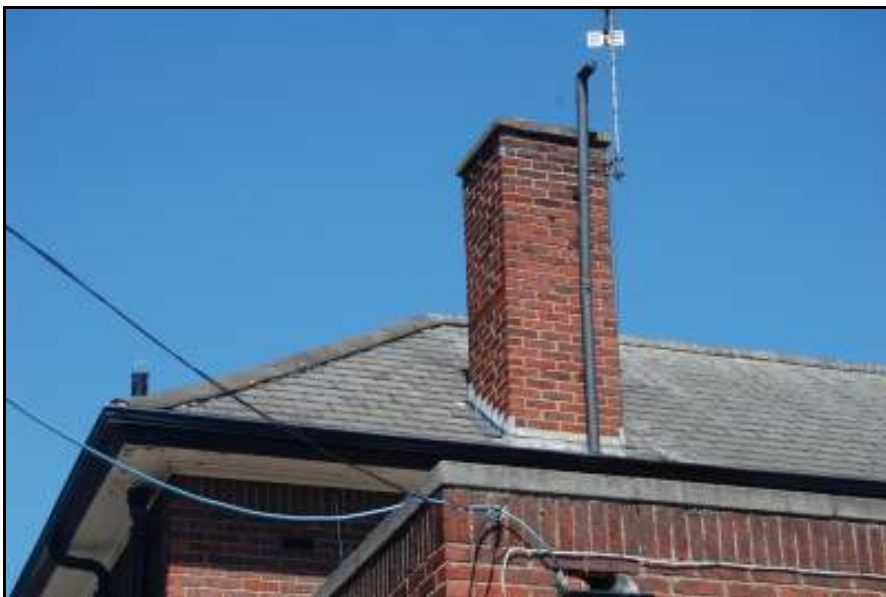
**6. Roof areas of number 18 all intact with no missing tiles, gaps etc**

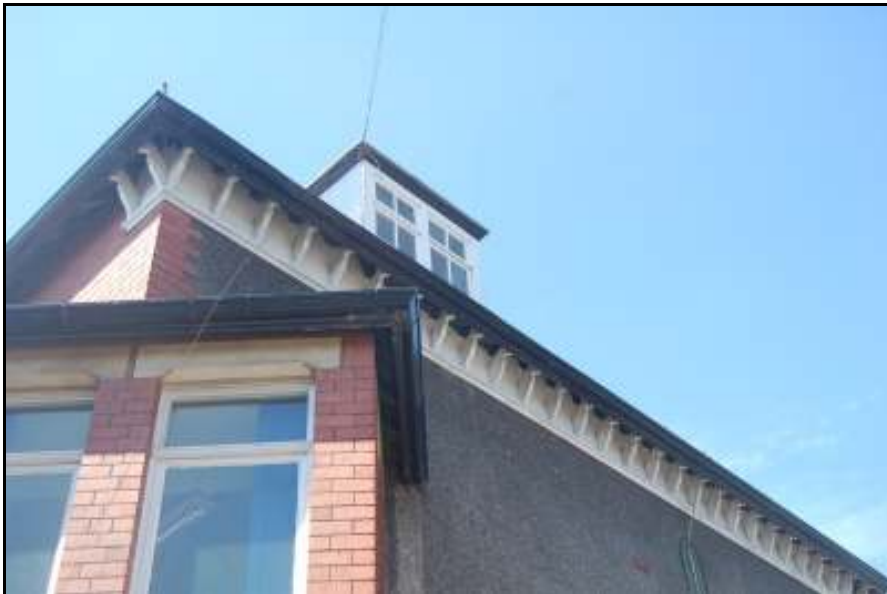
**8. Roof area of number 16 with rooms extending into the roof**

No evidence of bats was found anywhere inside or outside of the building. No droppings were apparent on the floor, roof and wall areas and there were no signs of feeding perches. The internal roof timbers are exposed but they do not support any features suitable for roosting bats. The two loft spaces are generally very dusty and covered with cobwebs. The presence of these cobwebs would have the advantage of catching any droppings from past roosting bats.

Externally the main building appears to be well sealed around the roof area with intact roof tiles and lead flashing. The eaves do offer some potential points of access and light can be seen when inside the roof voids. However, no evidence of bats was found on this occasion (or the previous occasion which was mid-summer) and all areas can be viewed down to the wall plate. Internally the fireplaces are all sealed and it looks like the chimney pots have been blocked or sealed.

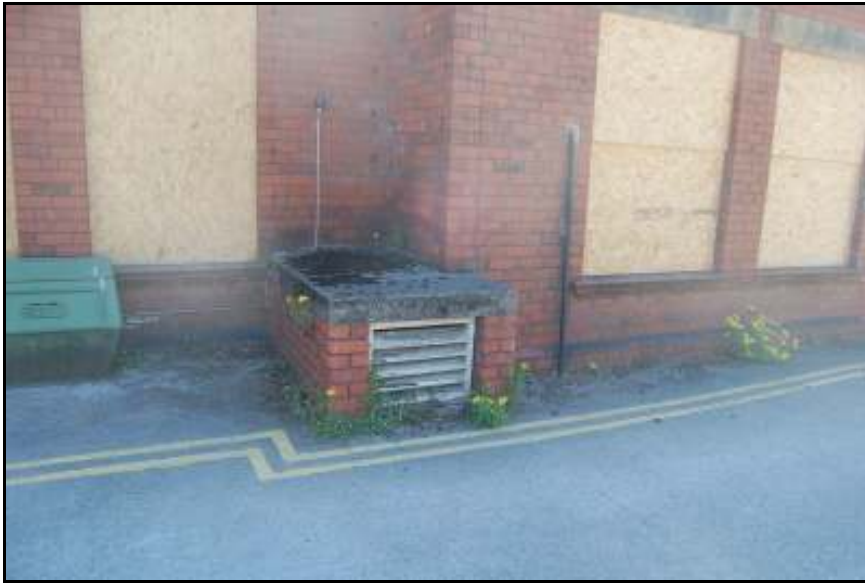
The basement area was inspected and no evidence of bats was found although the cool conditions could be used for hibernation if the building remains unused for a period of time. Access is still available from the louvre entrance at the front as shown in the photo below.

**9. Louvre entrance into the cellar/basement area**

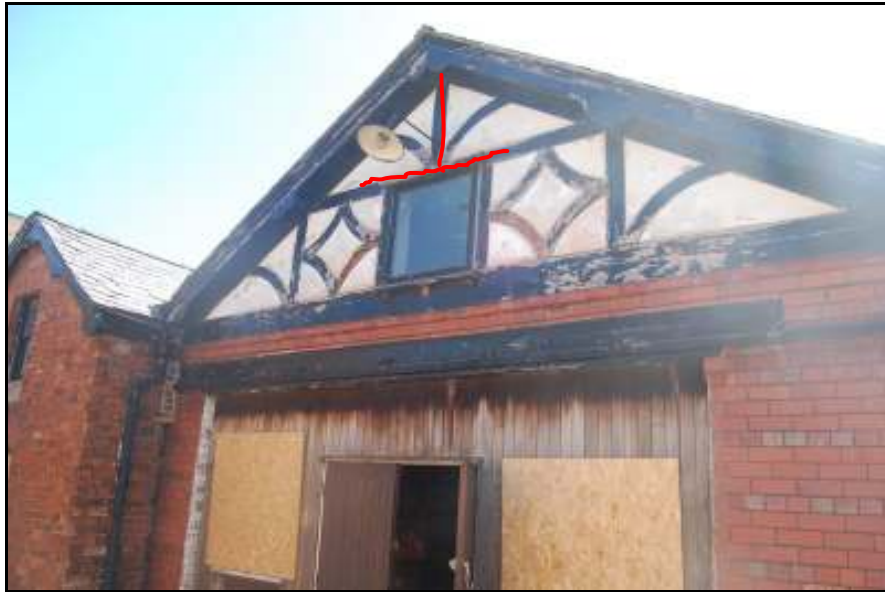
**13. Front elevation of the coach house – roof void shown**

The coach house is a larger building which is quite light internally from the window on the front elevation. An inspection hatch was cut into the roof during the previous visit to access the small void which is less than one metre in height. The void was inspected and as before it appears that there has been no disturbance in this area for a long period of time. The cobwebs are dense and hanging from the roof timbers suggesting no movement by bats or any other species. There is no underfelt or insulation which allows all areas to be viewed. There is some limited potential for bats to roost on top of the wall plate but given that there is no visual evidence inside or outside of the building the potential is low.

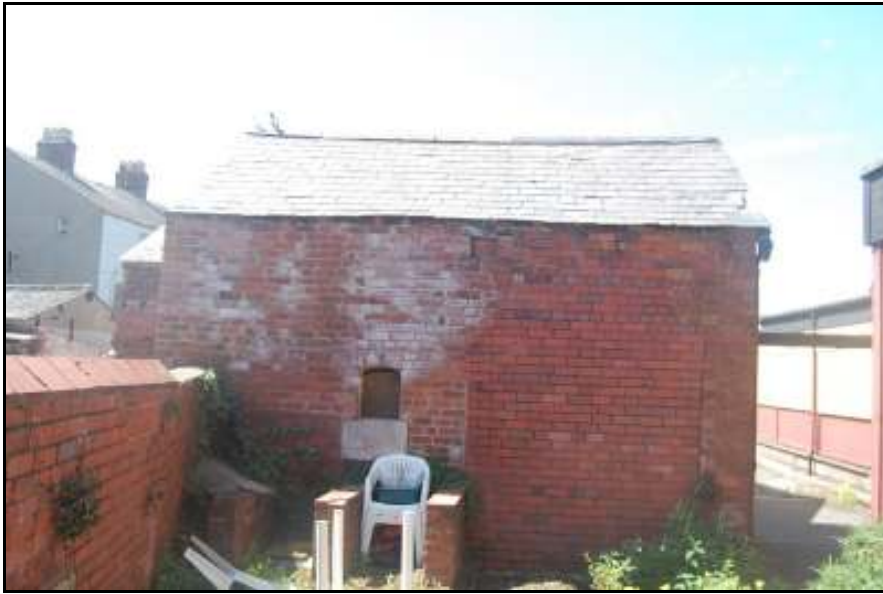
The smaller building adjoining the coach house is boarded up at the front. Internally the building is quite open and light and there is no evidence to suggest that bats are present. This section was previously used by a large number of pigeons and doves although at the time of this visit no birds were present. Evidence suggests that they had nested in there quite recently though.

**15. The small brick/shed/store adjoining the coach house**

No evidence of nesting birds was found in and around the two main buildings although there is some potential for birds under the eaves of number 16. The small brick building adjacent to the coach house previously supported a large number of doves/pigeons. This species can nest outside of the normal nesting season, especially in urban locations.

Other bird species have also nested in this building so any works should be undertaken between October and February to avoid any potential disturbance. If a nest was found (or in the course of being made) then all work should cease until the young have fledged – this applies to all bird species including pigeons and doves. Any removal of ivy from the coach house should also be undertaken during the winter months.

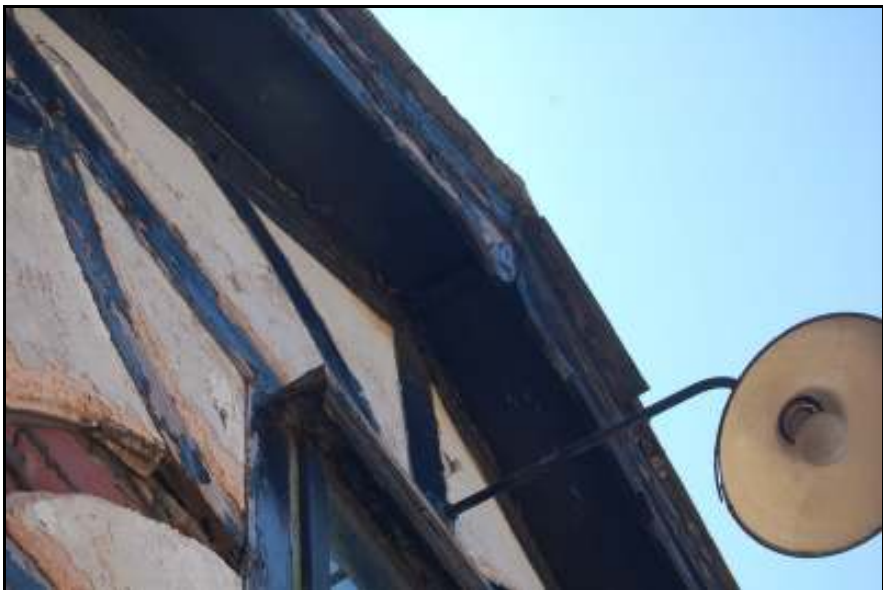
**16. Sealed areas under the front gable of the coach house**

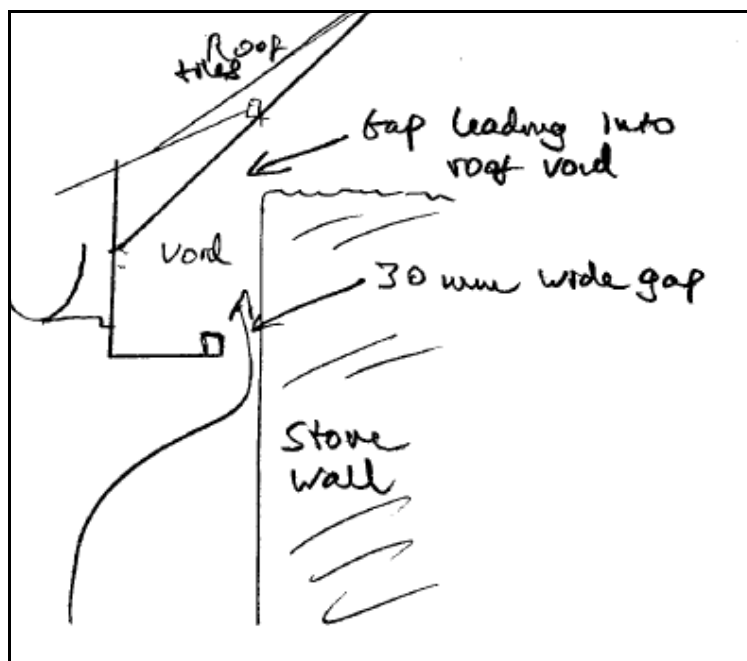
A backing board can be used to prevent access into the roof void/living area if desired.

- Install four Slateline bat access tiles to the south or west facing roof elevations (positioned above the attic areas). These will provide direct access into the roof voids.
- Create/retain some access under the eaves to the space leading into the roof void from the wall plate, a gap of 25-30mm is all that is required.
- Ensure any timber treatment is carried out using chemicals which are safe for bats (Natural England list). A certificate should be obtained as required.
- Where possible ensure any external lighting is low level and directional towards the ground.
