The Garage

The Connery, Connery Lane, Bronington

**Method Statement to facilitate the  
development of a garage into a residential property  
with regards to bat species**

August 2015

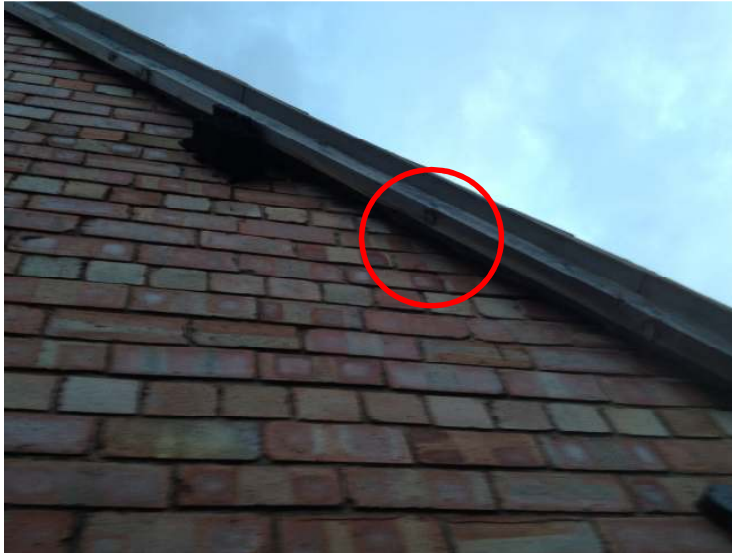
### ***Roost 1***

The roosting site was located within a gap under the eave on the southern gable end of the building. This roost site can be maintained by leaving an appropriate sized gap under the eave in the same location.

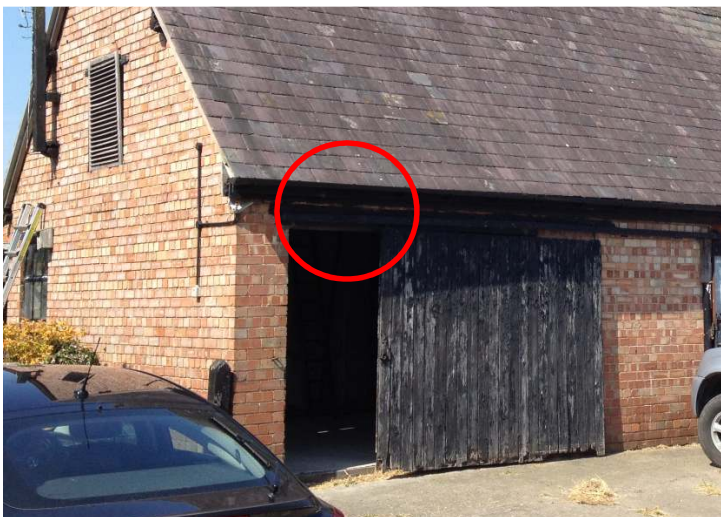
### ***Roost 2***

The roost was behind the fascia board located above a wooden door to the building on the eastern aspect. This roost site can be maintained by leaving an appropriate sized gap behind the new fascia board in the same location.

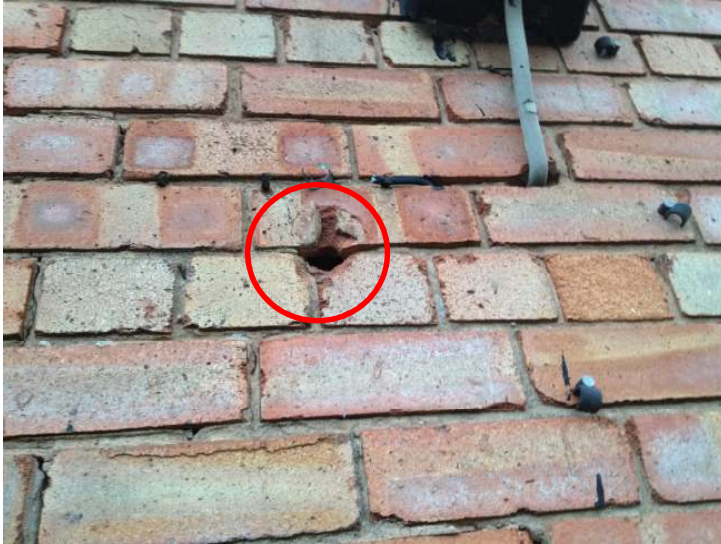
### ***Roost 3***

The third roosting site was a small hole located in the brickwork on the southern gable end. This should be left 'as is' and so the roost will not be affected in any way.

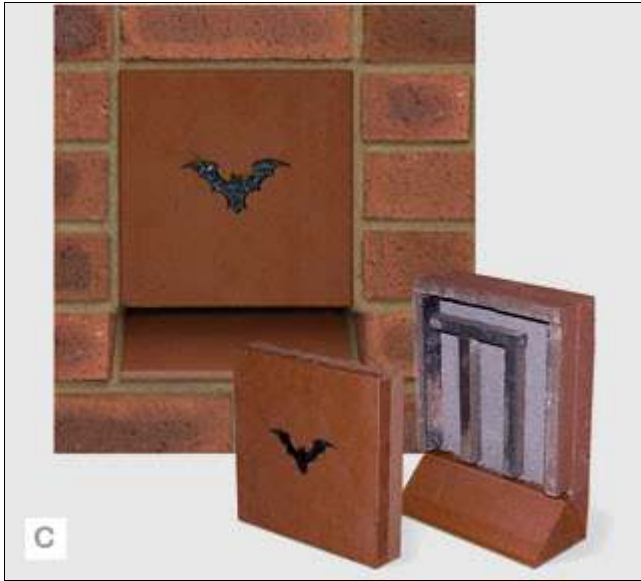
#### Details of additional roosting features installed at location R4

Bat boxes that can be built into the walls of buildings are designed specifically for crevice dwelling species such as Common pipistrelles. It is recommended that an Ibstock enclosed bat box is installed. Its dimensions are 215mm x 290mm x

During the Visual Assessment two accumulations of bat droppings were recorded on the north-eastern corner of the building beneath the eaves and the western elevation. A new roosting site can be created by installing an 'Ibstock enclosed bat box' in the gable end of the northern elevation.
