**Protected Species Survey Report  
Gredington Arms, Holt Road, Wrexham**

**Planning Application Number: P/2014/0651**

**Grid reference SJ 3676 5188**

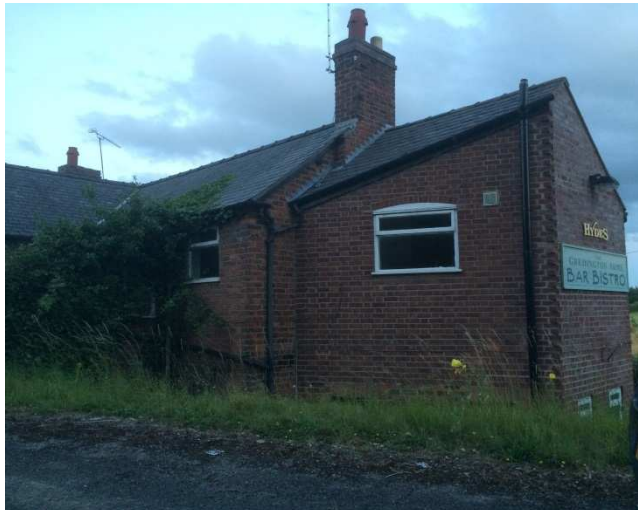
**Photograph 2. Gredington Arms – rear of pub**

There is a bird nest behind the soffit on the east side of the chimney on the rear extension of the pub.

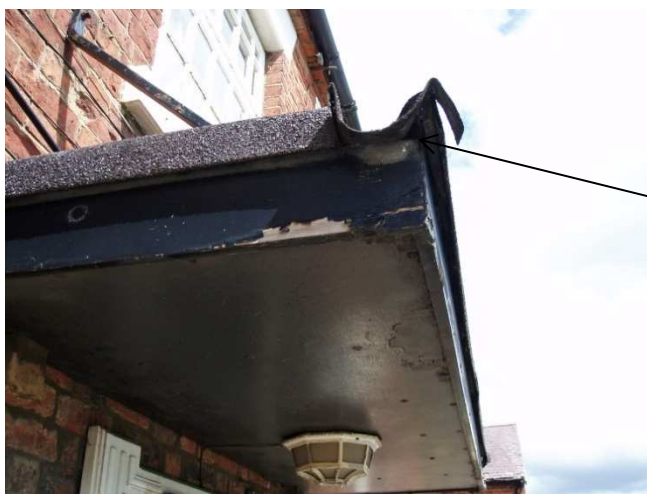
**Photograph 3. Gredington Arms – porch over front door**

Gaps under the edge of felt roof

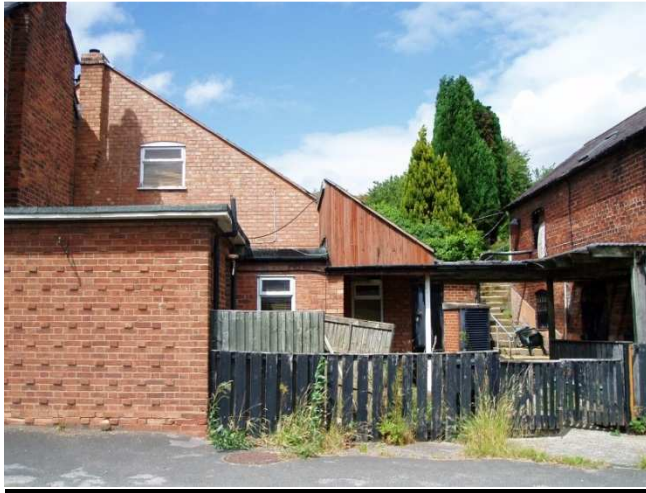
**Photograph 4. Gredington Arms – extensions to pub**

The pub is a two storey building of red brick construction with a pitched slate roof, there are numerous extensions attached to the pub with a combination of flat felt roofs and single pitch slate. There are gaps behind the wooden soffits, under slates and lead flashing. There is ivy and bramble growth of sections of the rear of the building. The roof voids in the building, which are felt lined, have a lot of cobwebs throughout.

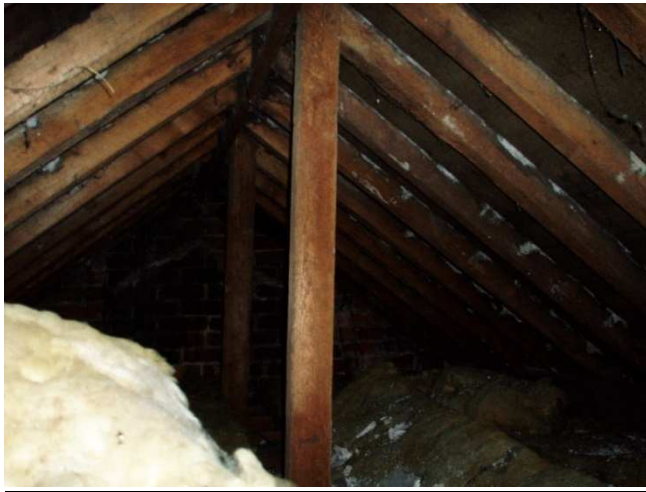
**Photograph 5. Gredington Arms – pub roof void**

The roof voids of the pub buildings were checked for bats and evidence of use by bats, although none was found and the voids had a lot of cobwebs in them

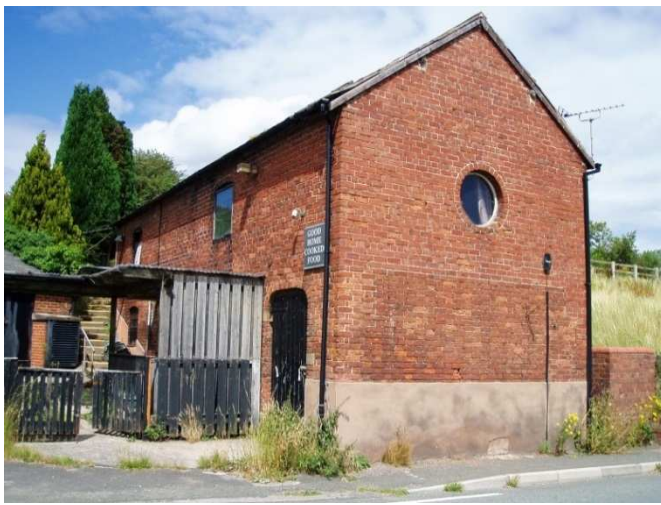
**Photograph 6. Gredington Arms – south end of the barn**

The barn is a two storey building also of red brick construction with pitched slate roof. There is no roof void in the building, with the first floor being open to the beams. There are multiple gaps under the bottom layer of slates, many of which have slipped.

- 4.1 I understand the buildings are due to be converted into residential accommodation. As part of this work the length of the barn will be reduced by moving the southern gable end of the barn approximately 1/2m north, to allow for better sighting along the road.
- 4.2 I understand that an additional planning permission has already been submitted regarding the building of houses on the land at Gredington Arms and that this application had its own ecological surveys carried out.

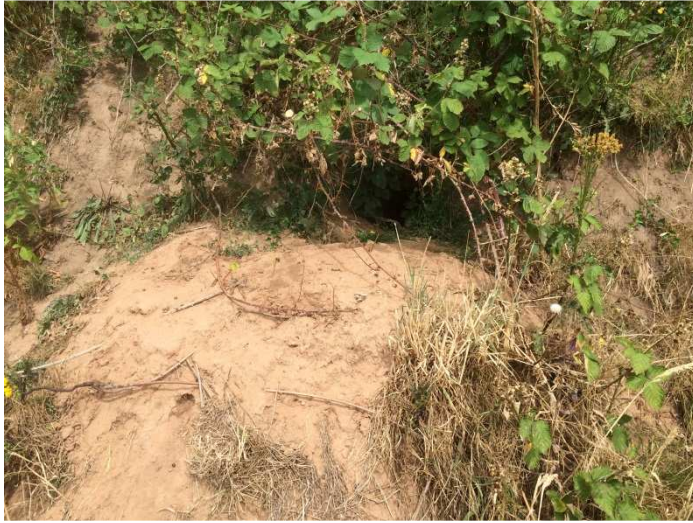
There is a large amount of rabbit activity on the site, with many burrows. One borrow at approximate grid reference SJ 36823 51923 had been enlarged and a badger hair was found in the spoil from the hole. To the west of the hole there is an obvious mammal track into the scrub up the bank which has visible claw marks see photo numbers 7 and 8.

**Photograph 7. Gredington Arms – Enlarged rabbit burrow with Badger hair in spoil**

- 6.2 As the COFNOD search shows both badger and great crested newts nearby the site, caution should be taken if any trenches or pits have to be dug. These should not be left open or uncovered overnight unless some means of escape is provided for both species, for example a wooden plank.

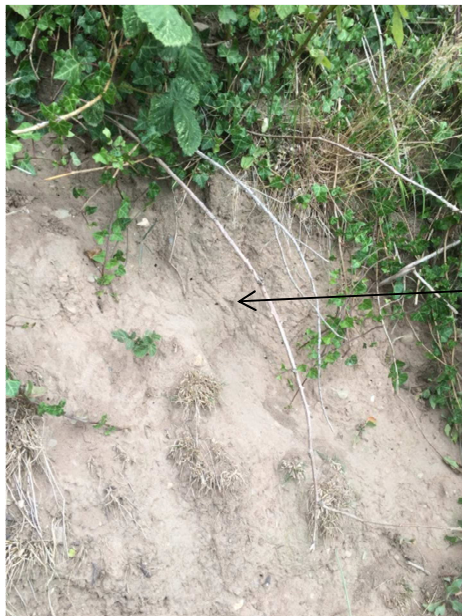
**Photograph 8. Gredington Arms – Claw marks on mammal run above photograph 7**

Claw marks
