Gas Membrane Installation  
Validation Report  
Anthony Eden Drive,  
Wrexham

## Verification of gas protection measures

| <b>Site name:</b> | <b>Anthony Eden Drive,<br/>Wrexham</b> | <b>Units/ plots checked:</b> | <b>Plots 1-8 (Perimeters<br/>Only)</b> |

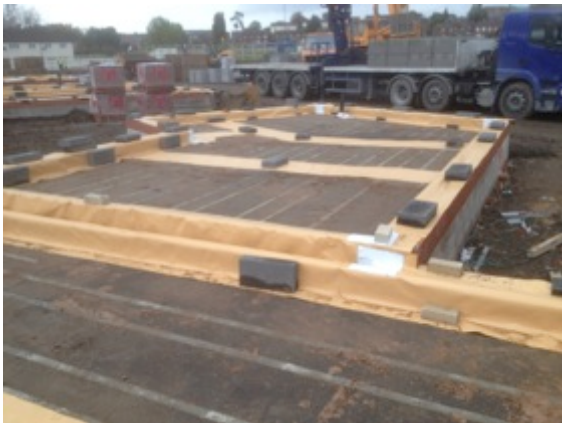
| No. | Description | No. | Description |
|---|---|---|---|
| 1 | General Membrane Overview. | 10 | General Membrane Overview. |

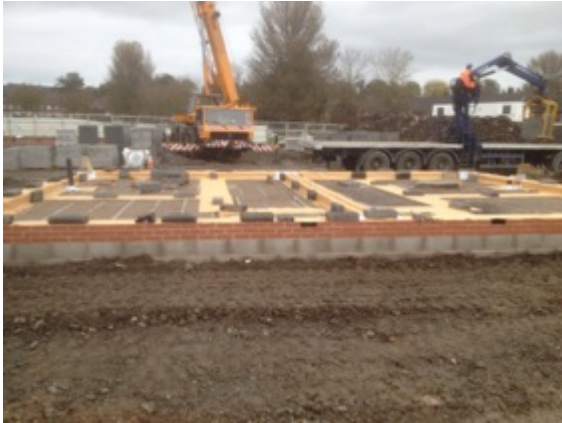
| No. | Description | No. | Description |
|---|---|---|---|
| 2 | General Membrane Overview. | 11 | General Membrane Overview. |

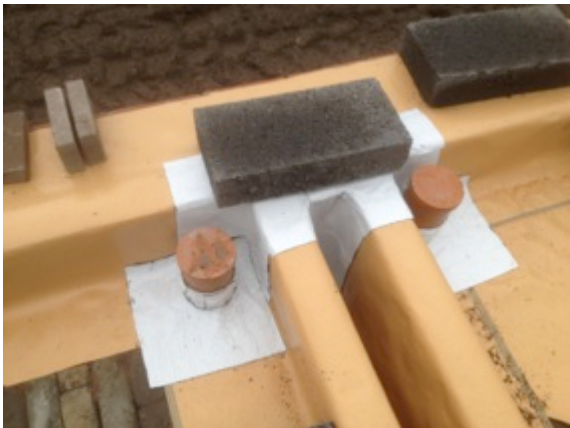
| No. | Description | No. | Description |
|---|---|---|---|
| 3 | Typical Sealed Pipe Penetrations. | 12 | General Membrane Overview. |

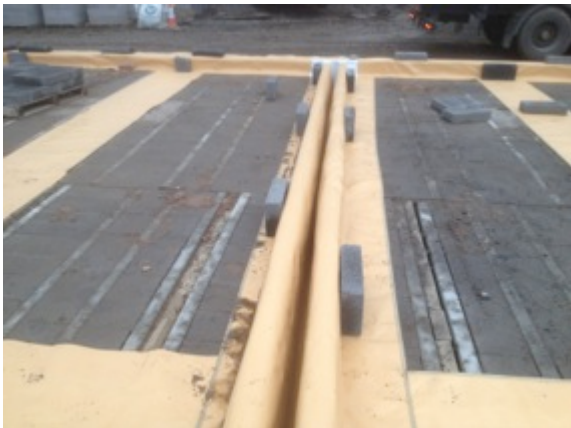
| No. | Description | No. | Description |
|---|---|---|---|
| 4 | General Membrane Overview. | 13 | Typical Sealed Pipe Penetration. |

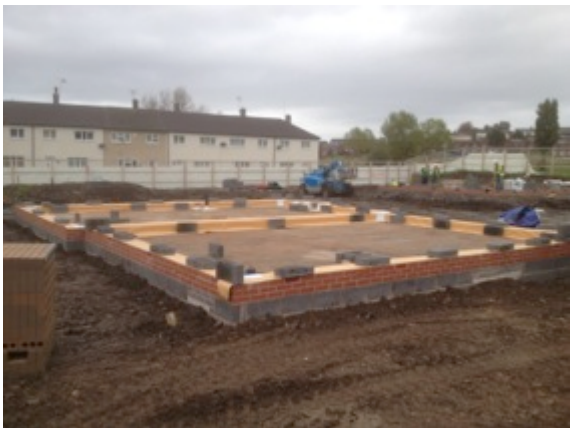
| No. | Description | No. | Description |
|---|---|---|---|
| 5 | General Membrane Overview. | 14 | General Membrane Overview. |

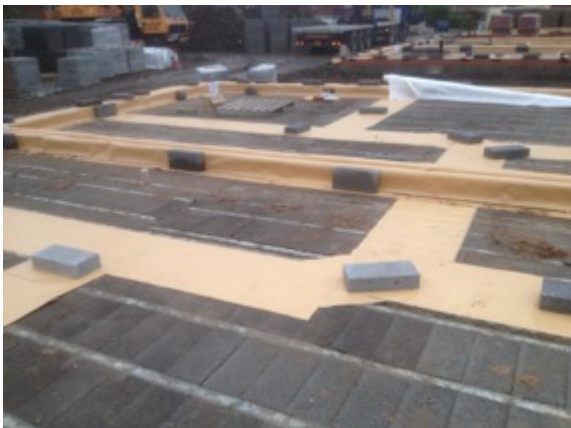
| No. | Description | No. | Description |
|---|---|---|---|
| 6 | General Membrane Overview. | 15 | General Membrane Overview. |

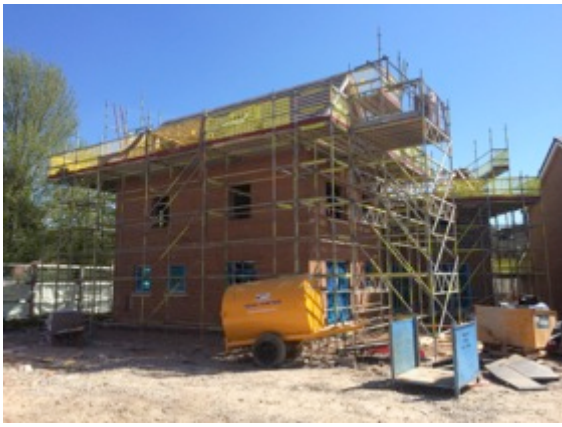
| No. | Description | No. | Description |
|---|---|---|---|
| 7 | General Site Overview. | 16 | Typical Sealed Pipe Penetrations. |

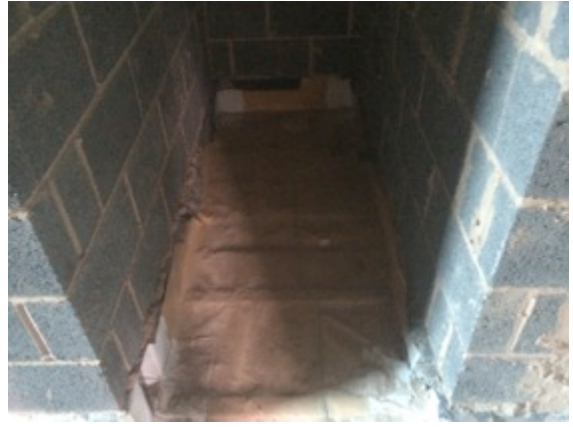
| 8 | General Membrane Overview. | 17 | |

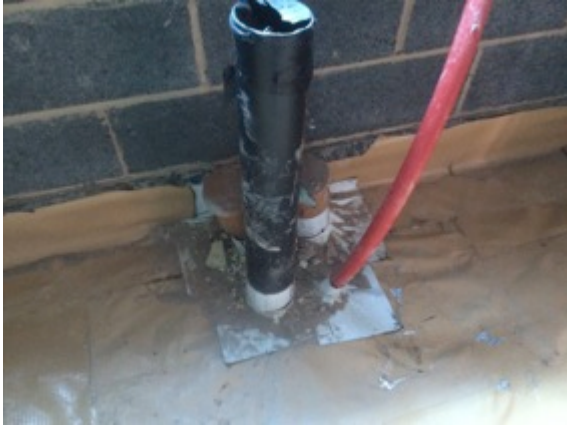
| 9 | Typical Sealed Pipe Penetrations. | 18 | |
