**REASONABLE AVOIDANCE MEASURES  
METHOD STATEMENT  
BATS AND BIRDS**

**REDUNDANT BARN  
OLD HALL FARM  
ERBISTOCK  
WREXHAM  
LL13 0DD**

**JULY 2015**

**777 003MS**

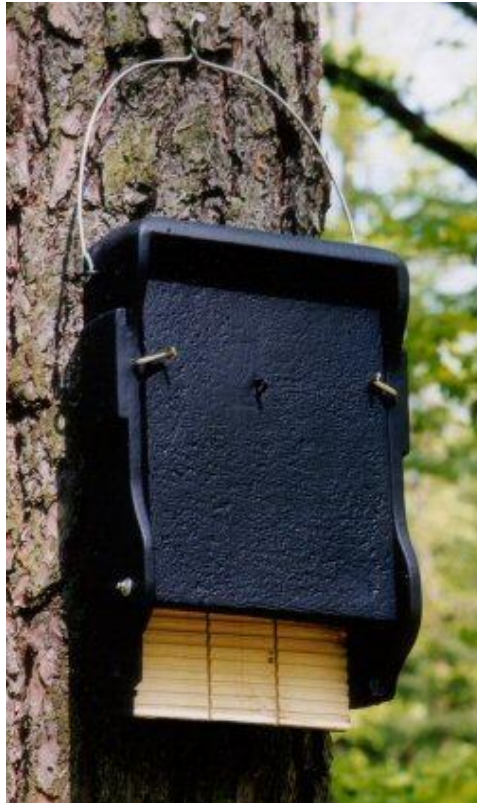
**Figure 2. Schwegler 1FF bat box**

1. It is recommended that provision will be made for roosting opportunities for bats with the erection of two Schwegler 1FF bat boxes on the building and a bat loft as indicated in the approved plans. The bat boxes will be erected at a height of 3-4m and in a southerly, westerly or easterly facing direction on trees in the grounds of the building.

1. The ECW will provide a toolbox talk for all workers to inform them of the potential to find bats and outline safe working practises and emergency procedure should a bat be located
2. The developer will erect two external bat boxes, these will include at least two Schwegler 1FF boxes. They require placement on south-facing aspects of buildings or trees and must be in place for a minimum of three months before commencement of work and will be placed at a height of 3-4m.

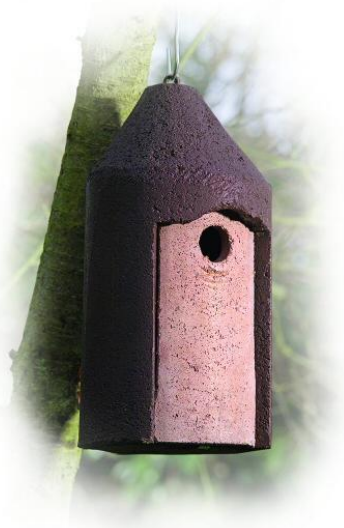
| Schwegler 1b | Schwegler 9b |

15.2 Schwegler bird boxes will be erected on the site, a Schwegler 1b suitable for tits and other birds, and a house martin nest (Schwegler 9b) on the eastern eaves of the new garage.
