Document type  
**Compliance Audit**

# **WREXHAM TECHNOLOGY PARK (PHASE 3) – WESTERN GATEWAY ACCESS ROAD COMPLIANCE AUDIT JUNE 2015**

Revision      **00**  
Date            **29/06/2015**  
Made by       **Heather Nickson**  
Checked by    **Jeff Turner**  
Approved by   **Jeff Turner**  
Description    **Compliance audit summary report No. 1**

Ref             61034454/AUDIT/01

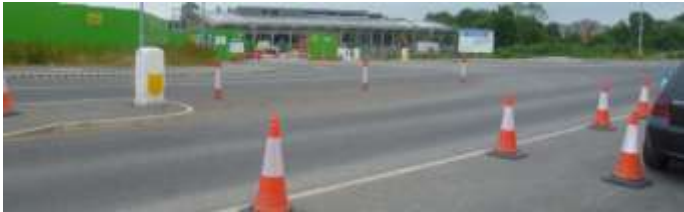
| | Observation | Action Required | Due* | Closed out by* |
|---|---|---|---|---|
| <b>Dust, Emissions and Odours</b> | <p>AGC not commenced import of fill materials, entrance to site access roads generally clear, some debris on road thought to be from adjacent WAST construction site. Continue to monitor.</p> | Maintain vigilance with regard to airborne dusts and road mud particularly during earthworks. | Ongoing | |

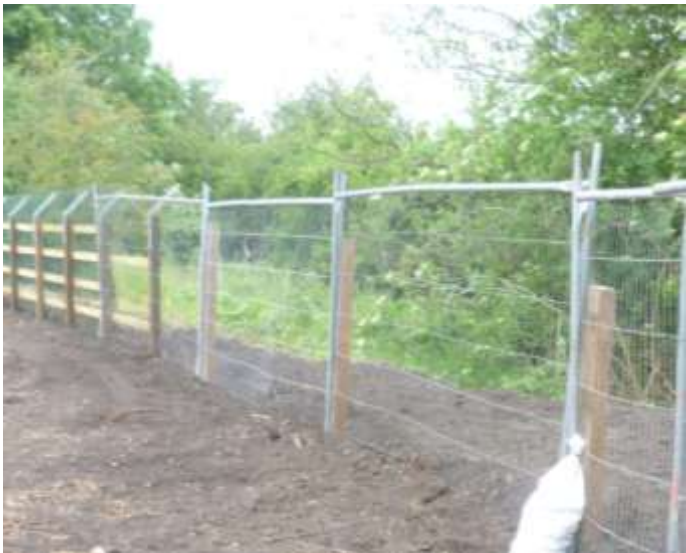
| | Observation | Action Required | Due* | Closed out by* |
|---|---|---|---|---|
| <b>Wildlife and Natural Features</b> | <p>Temporary otter fence (Heras fence buried in ground c.100-300mm).</p> | Temporary sections of the otter fence need to be inspected first thing each day for any breaches. Any holes/damage to the fence shall be fixed immediately. | 29/06/2015 | |
