**MAELOR WORKS, WREXHAM (SITE CODE 138S)**

### **METHOD STATEMENT AND SPECIES PROTECTION PLAN: GREAT CRESTED NEWTS**

13627-REP-008

February 2015

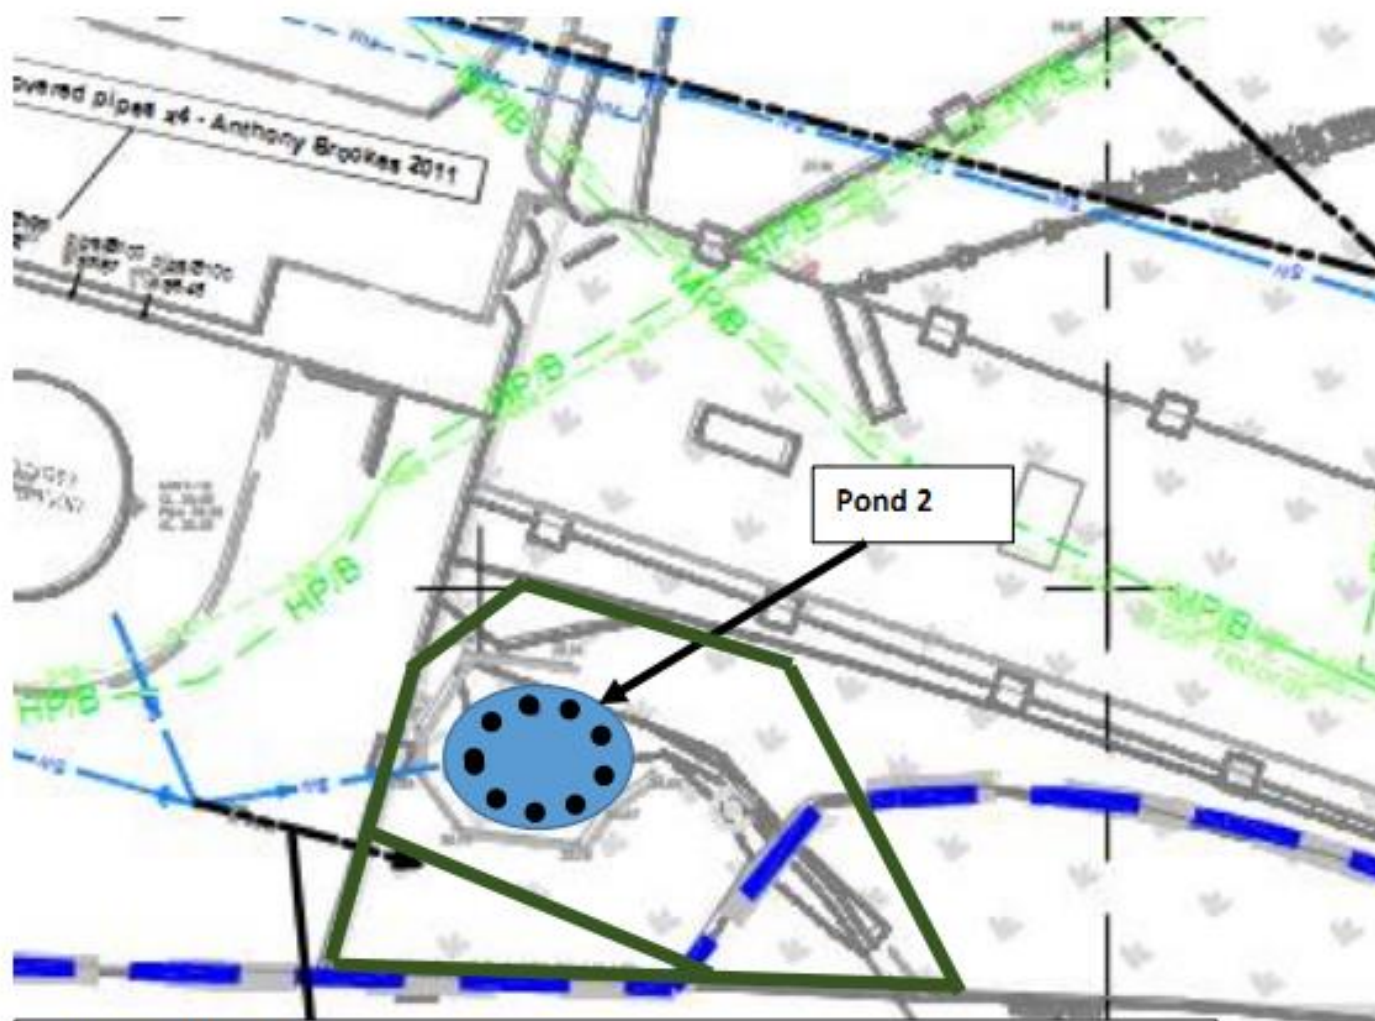
**Figure 6**  
**Detailed Map Mitigation Site 2**

Mitigation Site 2 Fencing Design,

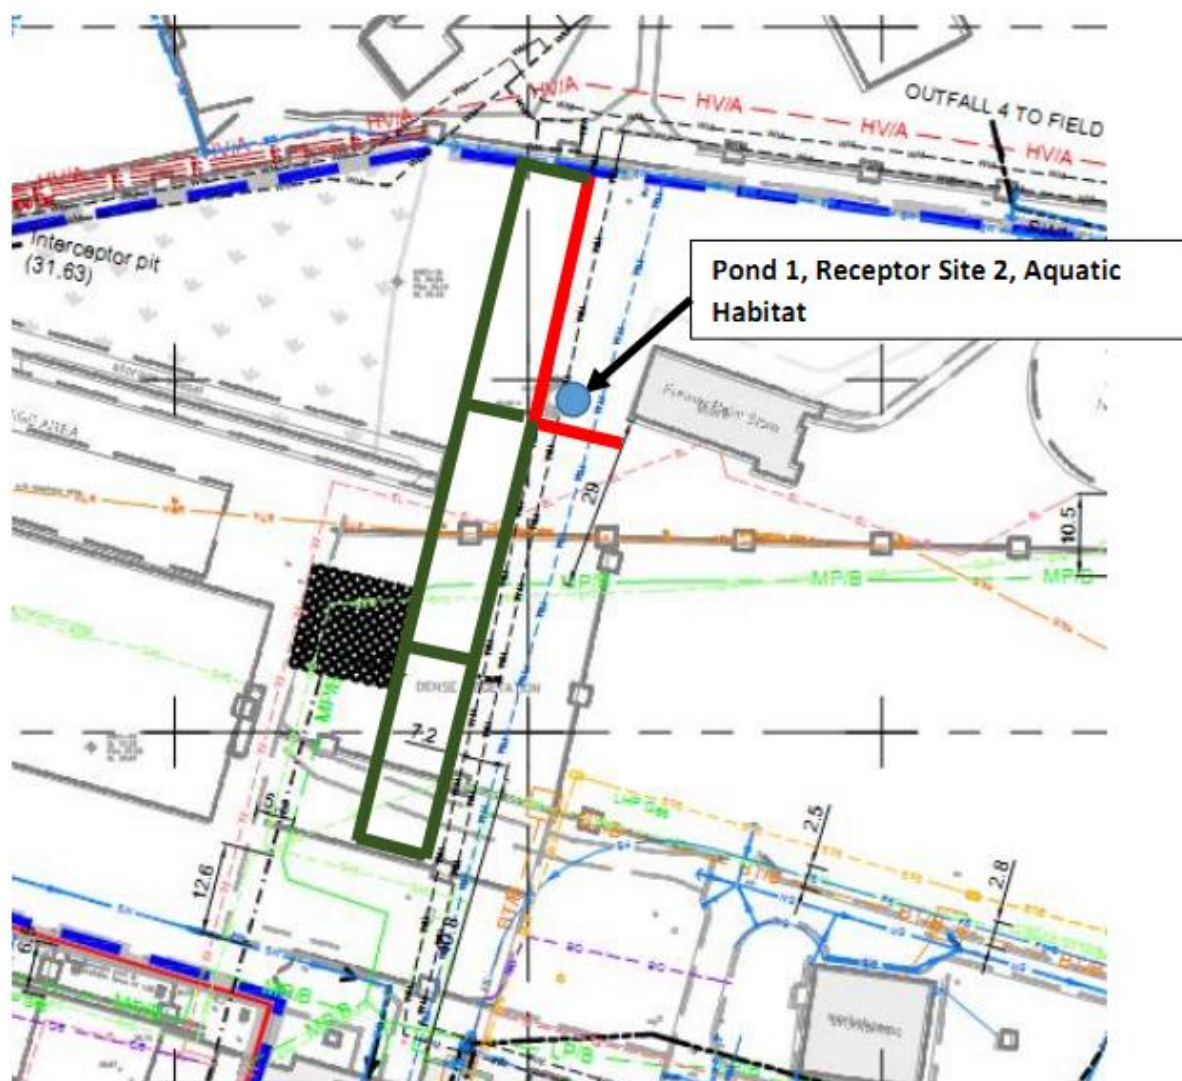
**Figure 7**  
**Detailed Map Mitigation Site 3**

### Mitigation Site 3 Fencing Design

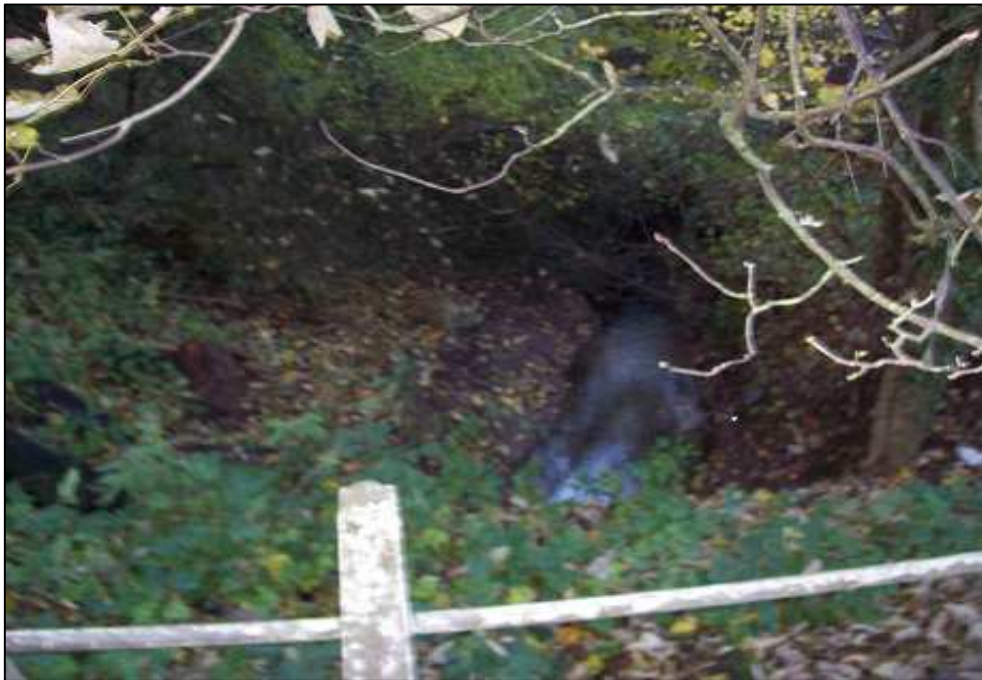
**Figure 10:** A view of the running water course that cuts through the site. The steep embankments can be observed to either side, particularly to the left in this image.

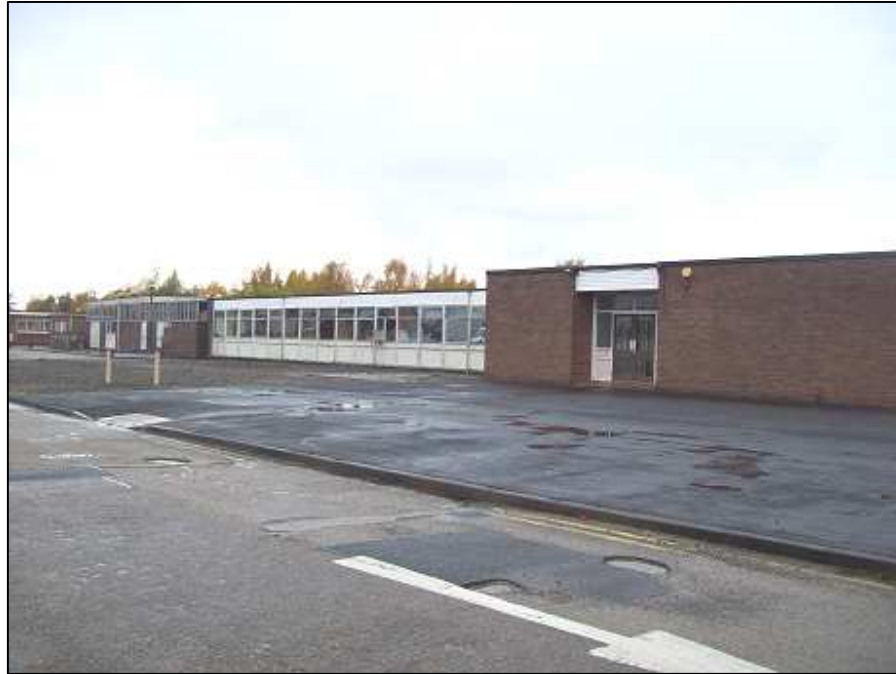
**Figure 11:** Building 1 (B1) and some of the hard standing from a south-eastern viewpoint.

The second building inspected (B2) located to the east of the pond, was of similar construction to B1, but on a much smaller scale. It was a flat roofed building with no fascia/soffit boards, but it had one noticeably broken window, which would be large enough to allow entry for birds up to the size of a Barn Owl (*Tyto alba*). As the building was locked, it was not possible to gain entry to the inside, but as it is not likely to be affected by the trial pits/boreholes, this should not be an issue. With regards to bats, although they would be able to gain access through the broken window, there would be no suitable areas inside to roost within (due to the lack of a roof void, roofing felt and roof tiles). Overall, it would appear that this building is of moderate potential for bird species, but low for bats.

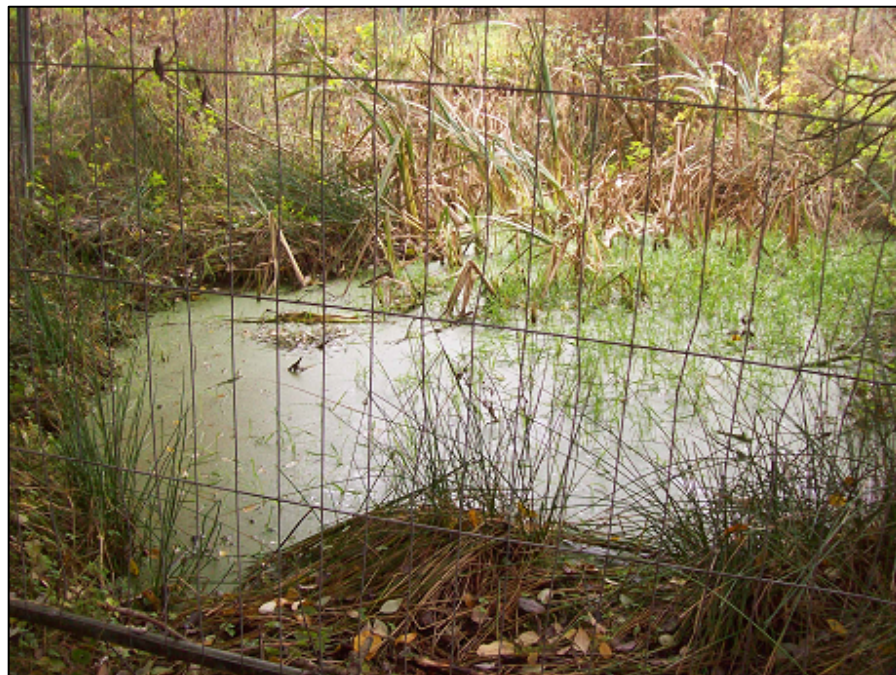
A close up of the pond, which has low potential for housing breeding GCN during the optimal survey period.

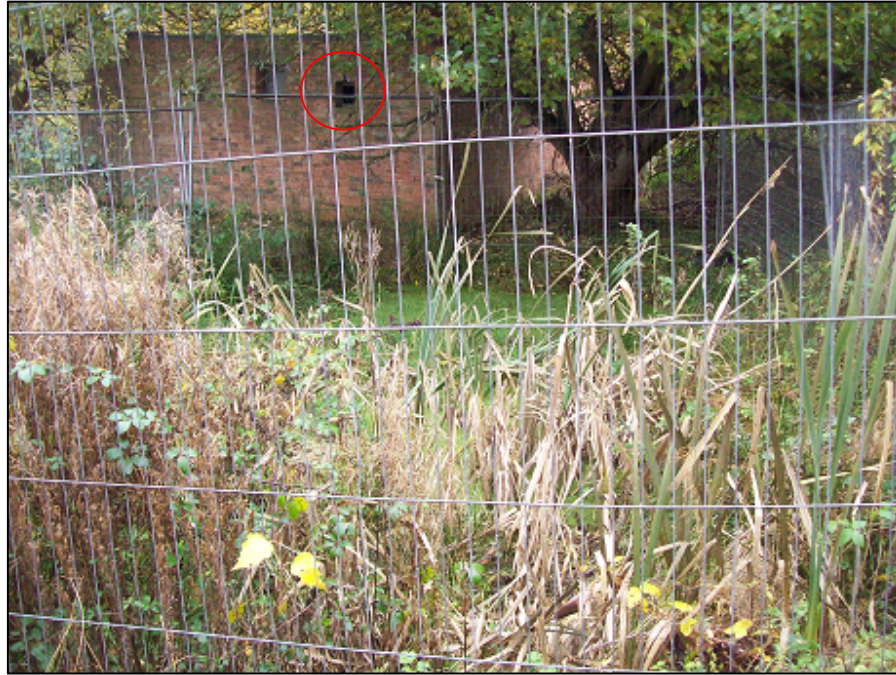
The pond located outside the development zone, with the adjacent building in the background. The broken window which may allow bird access is indicated by the red circle.

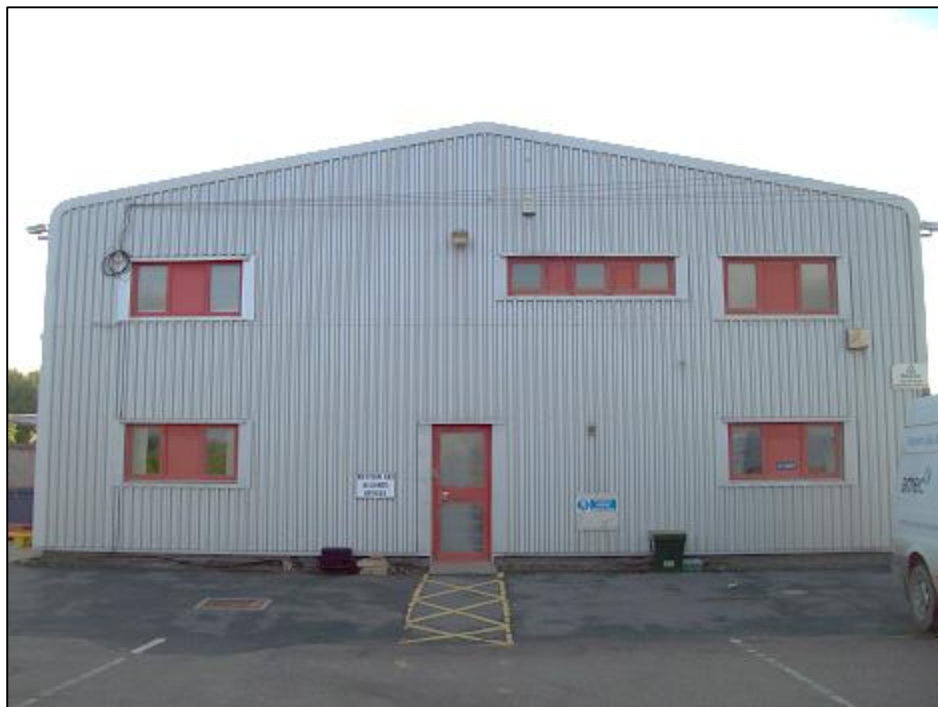
**Figure 4:** A view of the front of B1 from an eastern viewpoint.

B1 was investigated first, and it was found to be of corrugated steel construction with intact [and new] windows and doors. In addition to this, the building possessed no fascia or soffit boards (which can often be used as potential access points into a building) and ultimately possessed minimal utilizable features. The only identifiable gaps were where the front corrugated panels meet the 'bargeboard' at the front of the building. However, it is anticipated that, even if bats could get beneath these gaps there would be nothing for them to 'grip' onto, as the corrugated material is too smooth. With this being the case, it is considered that B1 is of minimal roosting interest to local bat species, and as such, no further surveys will need to be conducted on this building. This conclusion also includes nesting birds.

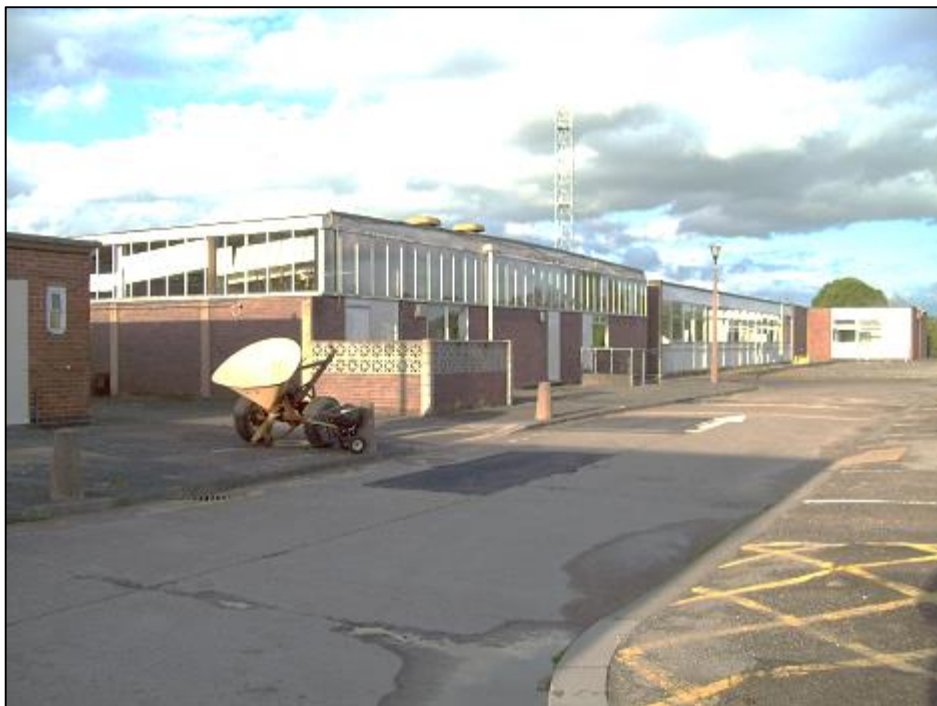
**Figure 5:** This photograph illustrates the size and layout of B2 as taken from a south-western viewpoint.

The second [and final] building to be inspected was B2 (again, see figure 1 for the precise location of this building). This building was derelict, single storey and of cavity brick wall construction. Although derelict buildings with cavity brick walls often provide ideal roosting opportunities for bats, the fact that the building is single storey with

intact windows and doors [and where not intact, they have been boarded up], means that there are minimal access opportunities into the building and ultimately limited flight and roosting space (which would be abundant within a pitched roof building). With regards to the fascia/soffit boards, they are of wooden construction and are again largely intact, however, a few areas along the northern elevation do present large enough gaps for bat access. Bearing all of the information in mind, it is anticipated that [although relatively low] the building does house some potential for roosting bats. With this being the case, it is anticipated that at least one (possibly two) dusk emergence surveys be required in order to determine bat presence/absence within this building.

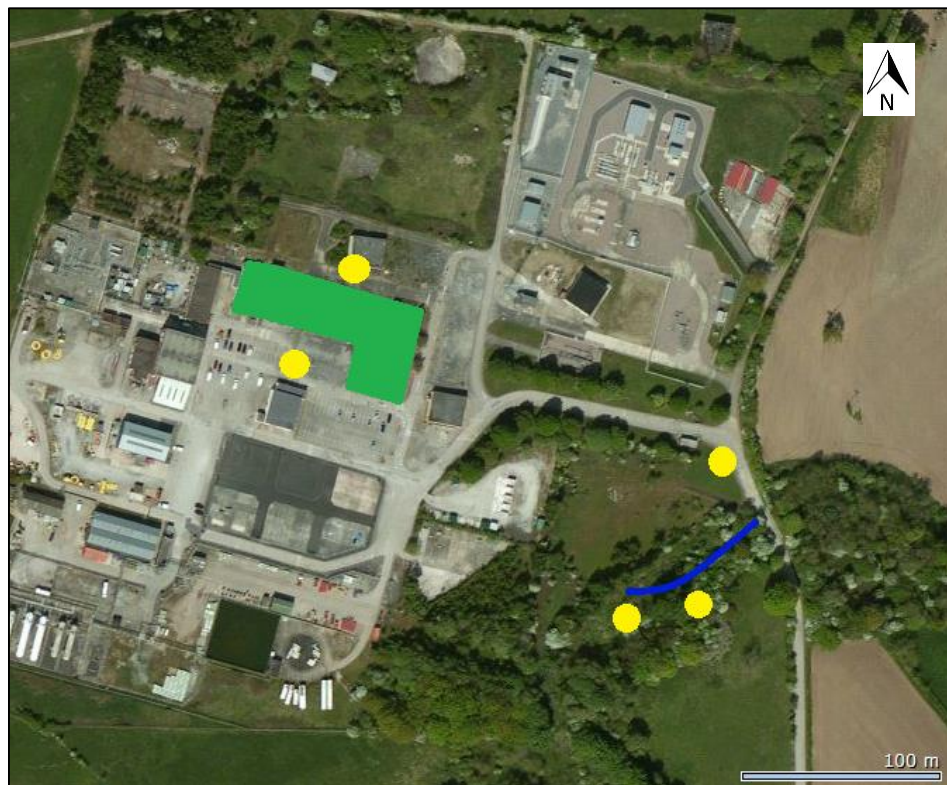
**Figure 6:** This image illustrates the approximate locations of the surveyors during the dusk emergence surveys of the eastern woodland area and B2. The yellow circles indicate the locations of the surveyors, the green outline represents B2 and the blue line illustrates the rough location of the brook.

Please see figure 6 for a map illustrating the approximate locations of the surveyors during the dusk emergence surveys of the brook corridor and B2.

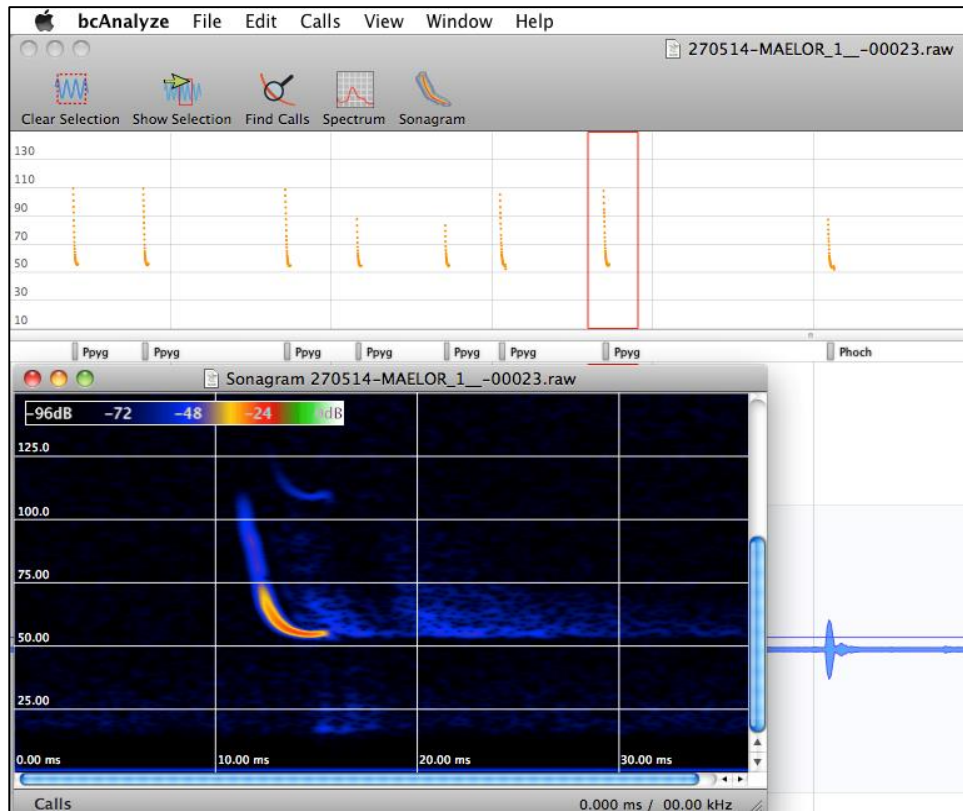
**Figure 6A:** A sonogram of a soprano pipistrelle - Ppyg (*Pipistrellus pygmaeus*) which was detected during one of the dusk surveys, with a 95% CL (confidence interval of accuracy).

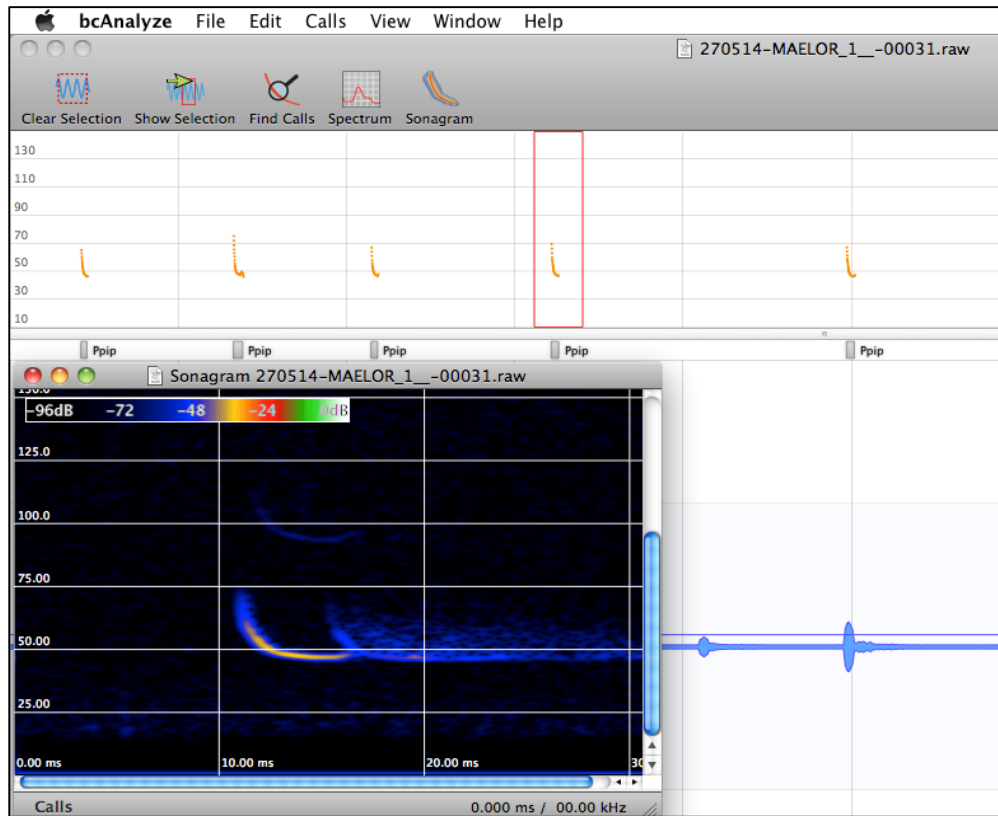
**Figure 6B:** A sonogram of a Common Pipistrelle - Ppip (*Pipistrellus pipistrellus*) which was detected during one of the dusk surveys, with a 100% CL (confidence interval of accuracy).

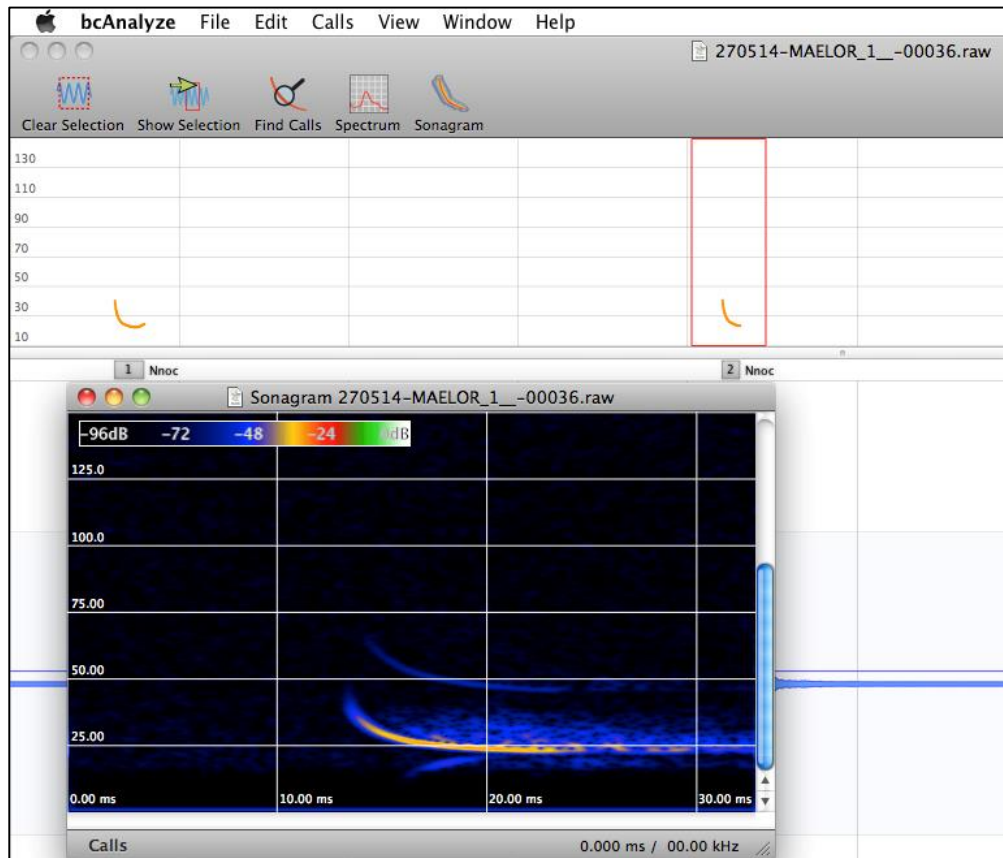
**Figure 6C:** A sonogram of a noctule (*Nyctalus noctula*) - Nnoc (*Pipistrellus pipistrellus*) which was detected during one of the dusk surveys, with a 100% CL (confidence interval of accuracy).

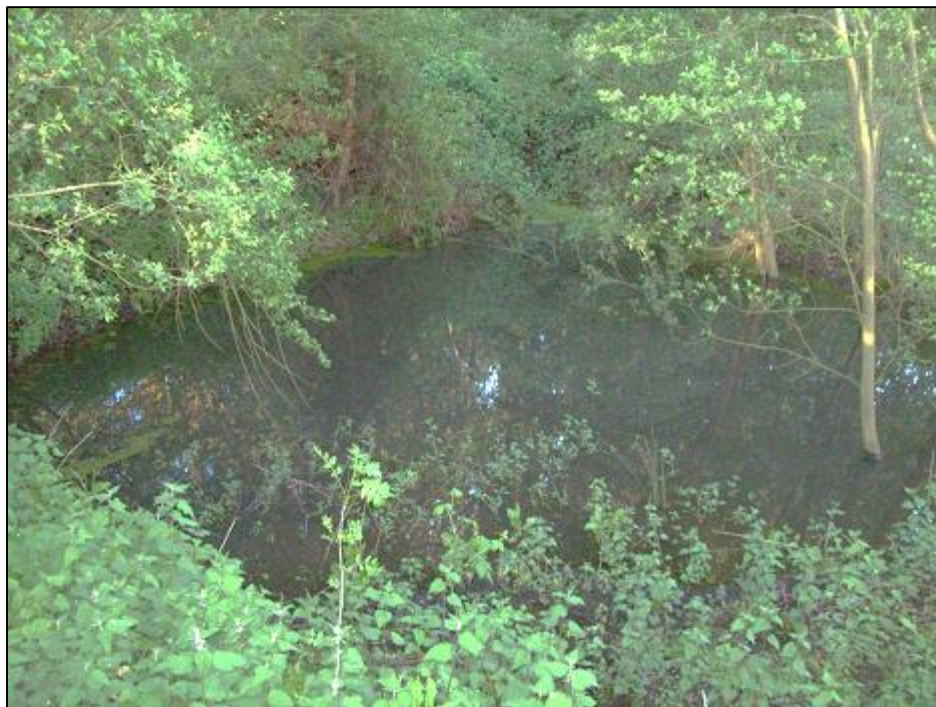
**Figure 7:** A photograph which illustrates the relatively overgrown nature of the pond of interest. This has subsequently meant that the majority of the pond is devoid of emergent aquatic vegetation, with the exception of a small area located to the south-west. The remainder of the pond was colonized by aquatic floating plants (i.e. duckweed species - *Lemnoideae*) in varying densities during each survey visit.

A Habitat Suitability Index (HSI) was also conducted on the pond in order to establish its suitability to support great crested newts. Please see Table 4 on the next page.

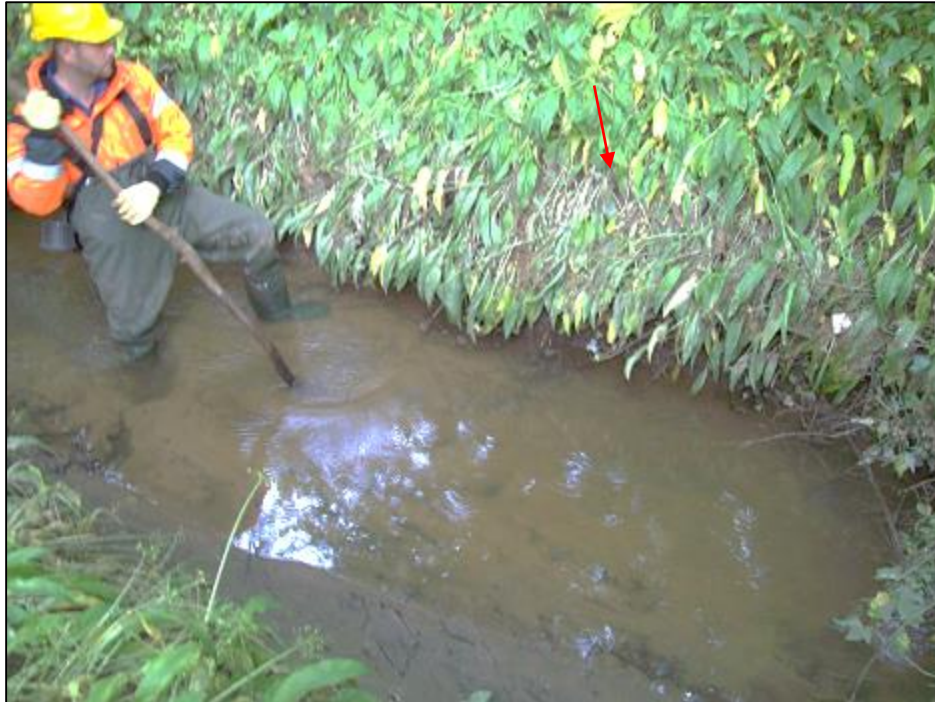
**Figure 8:** This image illustrates the water level within the brook at the time of the survey, in relation to the water levels which have been reached in the recent past (as indicated by the mud upon the leaves of the overhanging ramsons (*Allium ursinum*) plants – red arrow).

Due to the shape and structure of the brook, it is anticipated that it has undergone some sort of human interference in the past. This could be in the form of a sluice gate [or something similar] further upstream which could restrict water flow and could ultimately explain the high variability in the water levels. In addition to this, further up- (to the west) and down- (to the east) stream, the water flow appears to be natural with pebble stone beds and meandering channels. This is in contrast to the area to be impacted, which has a bed made of clay/silt-like substances and is a largely straight continuous channel (which is not likely to occur naturally – especially when considering the layout of the brook further up and down stream).

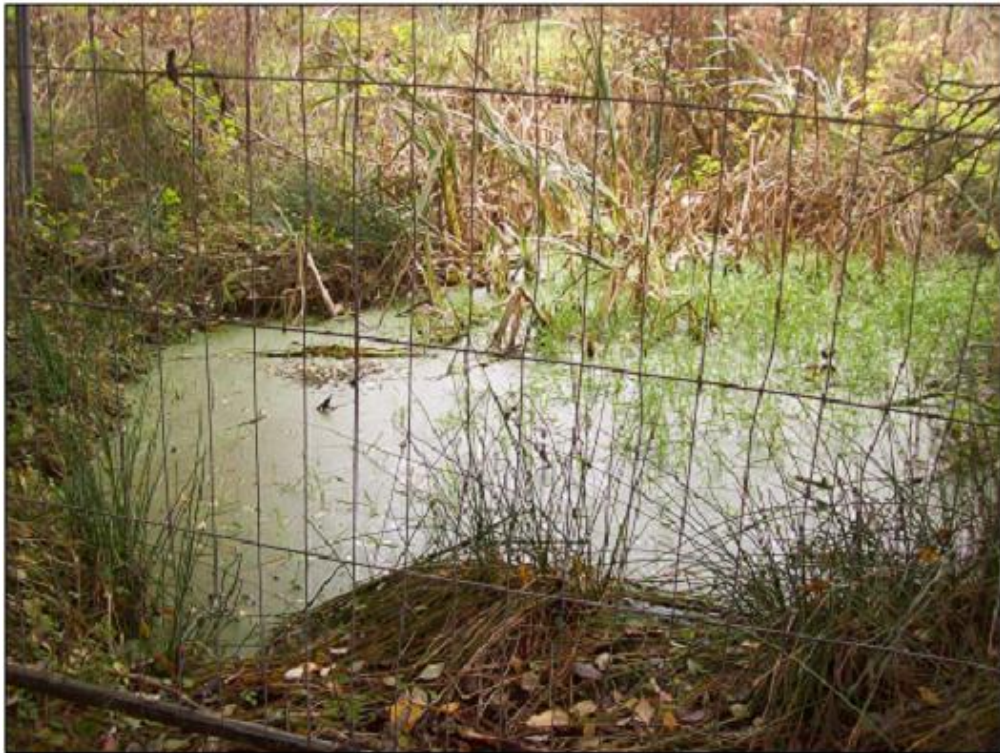
***Photograph 1: Pond to the north of the site***

The standing water body located in the northern part of the site (Pond 1, Photograph 1, Appendix D) will not be directly affected by the proposed works although the water main replacement works will go through suitable habitat in the vicinity of the pond. The second pond situated in the southern part of the site (Pond 2, Photograph 2, Appendix D) will be drained to remove contaminated sediment. On completion of these works it is proposed that the pond will be refilled and enhanced (removal of overhanging trees, to increase the daylight), which should ultimately improve this habitat for GCNs.

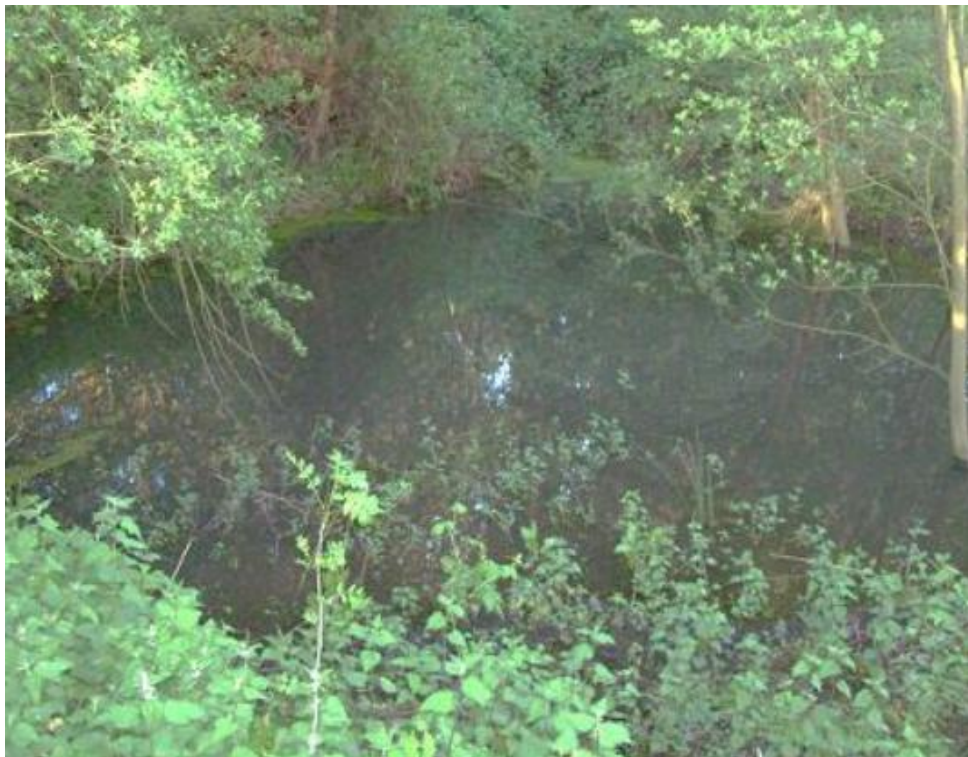
**Photograph 2: Pond to the south-east of the site**
