# Preliminary Risk Assessment: Former Firestone Site, Wrexham Industrial Estate

| <b>Report reference:</b> | 60895R1 |
| <b>Date issued:</b> | December 2012 |

**Confidential**  
**Prepared by**  
**ESI Ltd**

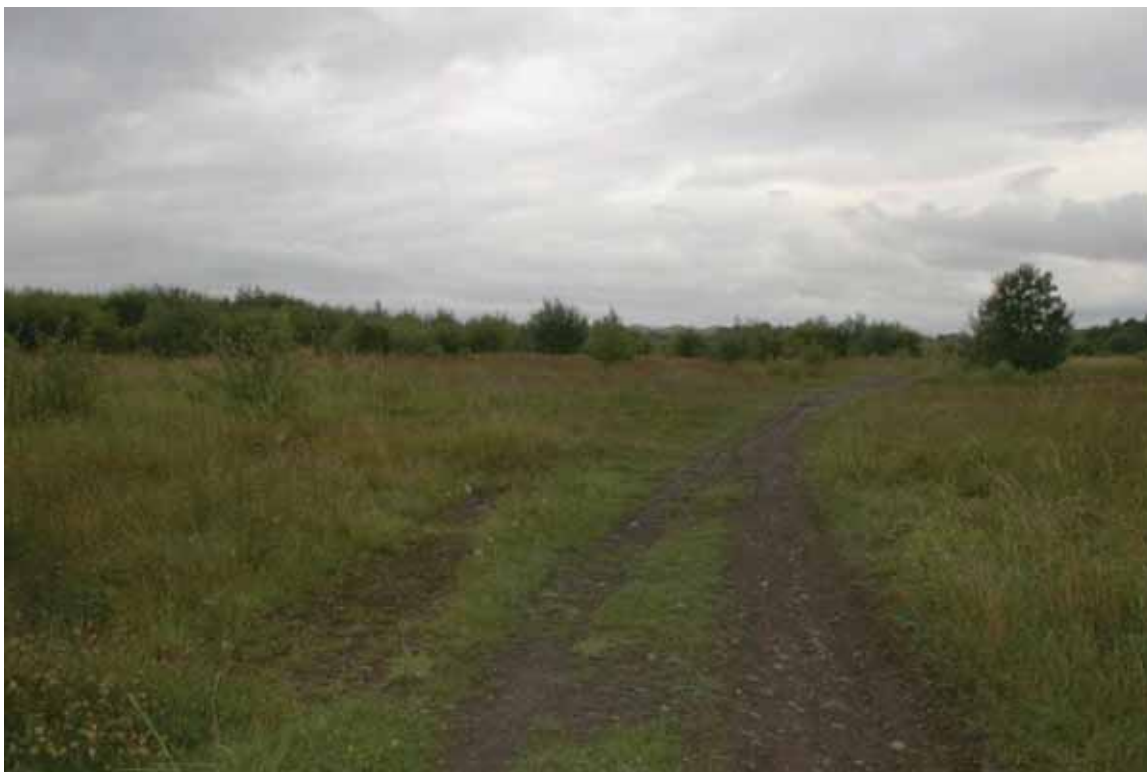
| 2.2 CONCEPTUAL UNDERSTANDING (POTENTIAL SOURCE OF CONTAMINATION) | | | | | |
|---|---|---|---|---|---|
| Current land use | <p>The Site was cleared in the early 1990s and since this time has been left vacant.</p> <p>From observations made during the site visit (06/08/12) it is evident that the Site is routinely used by members of the public. There was evidence of dog-walking and that motorised vehicles (both motorcycles and four-wheel vehicles) had recently accessed the Site. The Site was essentially litter free and no evidence of fly-tipping was observed.</p> | | <p><b>No obvious sources of gross contamination</b> have been identified in relation to the existing land use.</p> <p><b>Potential minor or localised contamination</b> may however relate to the unauthorised use of the Site by the public (e.g. minor fuel spills; disposal of waste, etc.).</p> | LOW | |

**Photo 1 General view of Site showing tracks used by members of public**

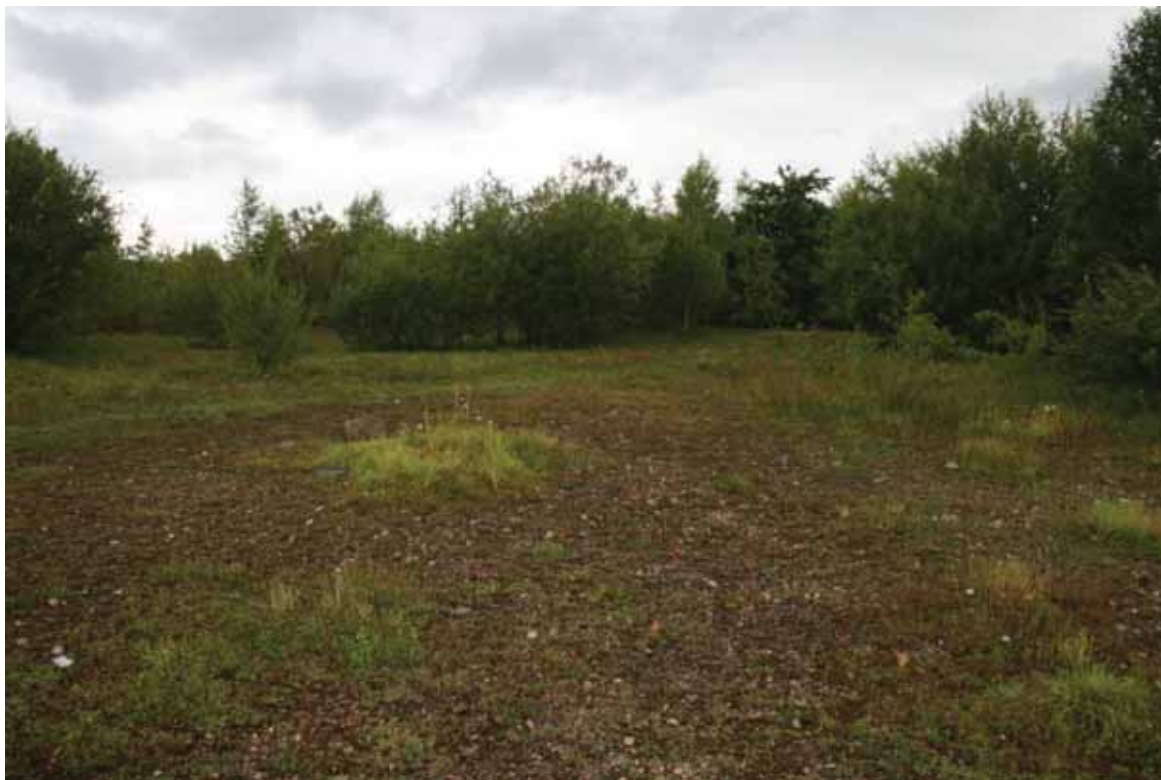
**Photo 2 General view of Site showing mixed surface cover**

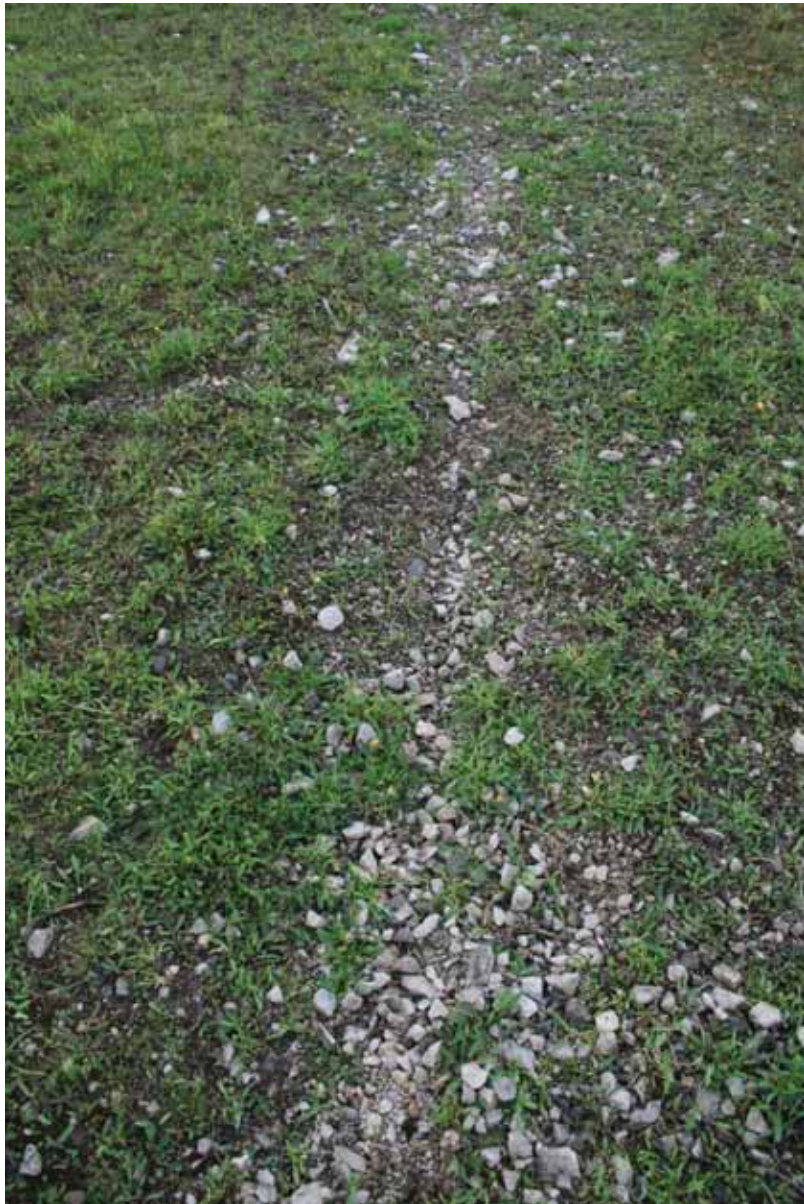
**Photo 3 Exposed surficial soils (containing crushed concrete)  
evident at ground surface**

It is therefore recommended that a proportionate programme of intrusive site investigation and monitoring works is undertaken in order to confirm the nature of the Made Ground materials that are still present, characterise their composition (including the potential for ground gas generation) and assess their significance as a potential contamination source.

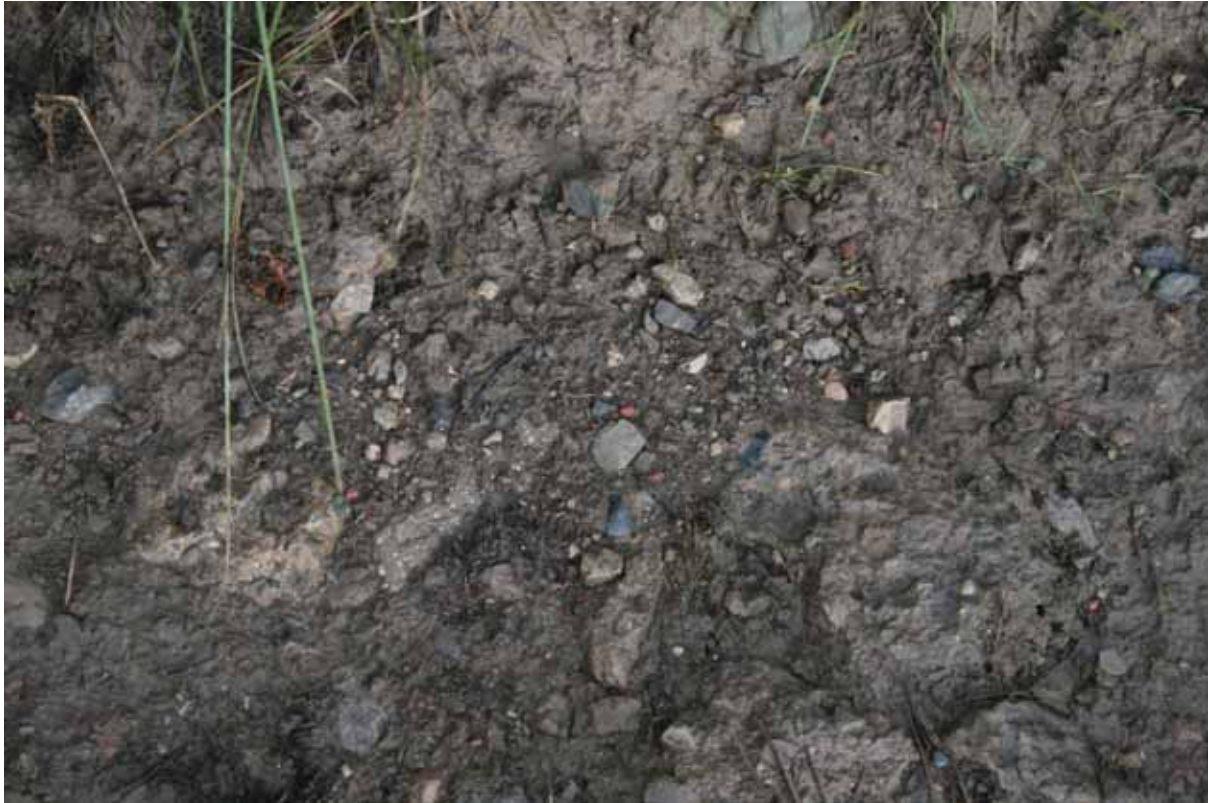
**Photo 4 Close up of exposed surficial soils (containing fragments of brick)  
evident at ground surface**

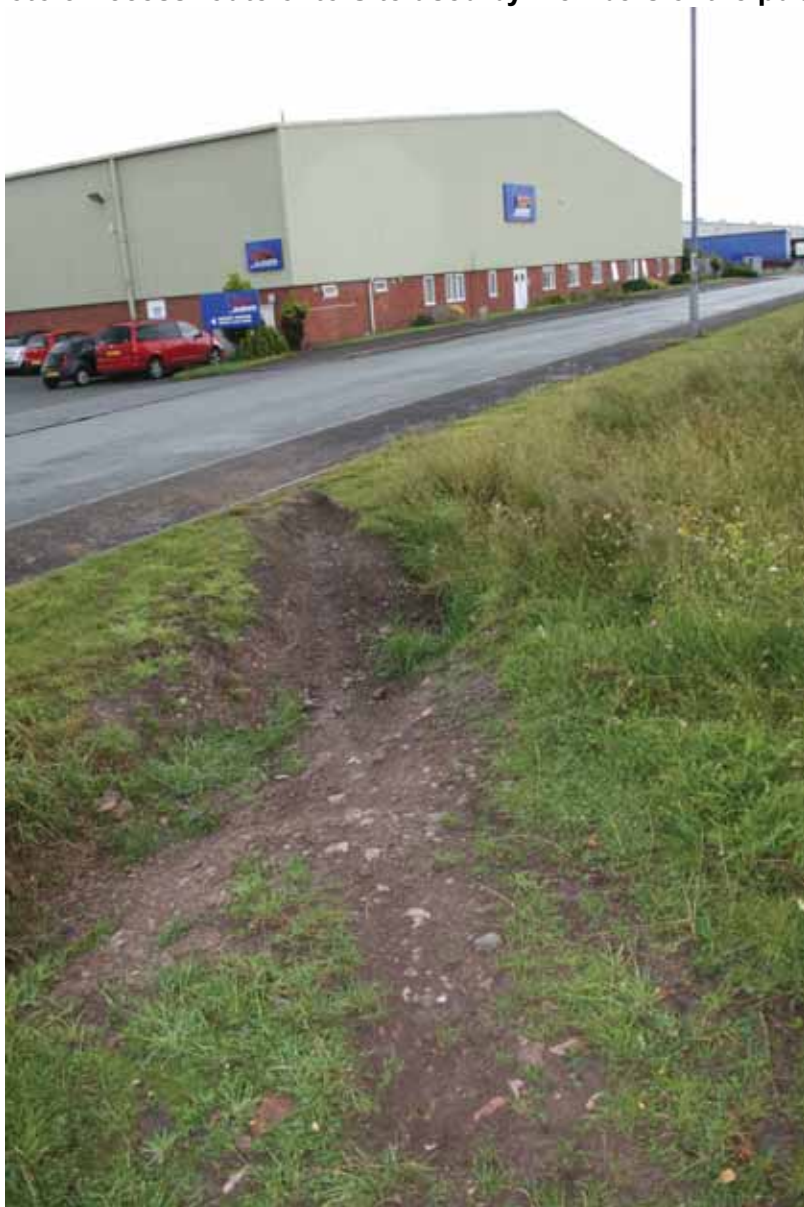
**Photo 5 Access route onto Site used by members of the public**
