**MOUNT PLEASANT, PLEASANT VIEW**

**FRONCYSLLTE, WREXHAM**

**BAT MITIGATION REPORT**

**15<sup>th</sup> July 2014**

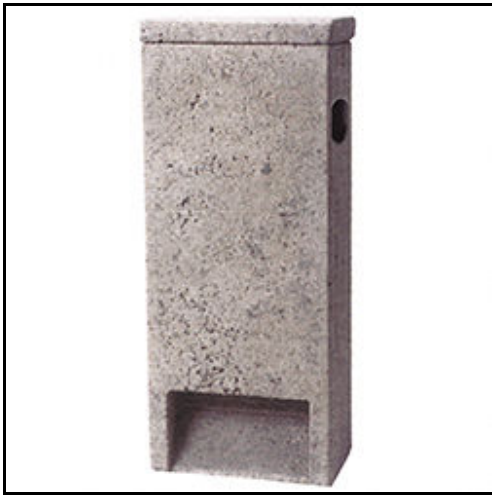
**6. Schwegler 2FR bat box to be installed within the gable end wall of the house**

- Install two “Slateline bat tiles on the rear, west facing elevation elevation of the house to allow bats access to the space between tile and felt.
- A Schwegler 2FR bat box will be installed on the south facing gable end somewhere below the ridge. The box can either be installed onto the wall or built in flush with just the entrance being visible.
- Four of the ridge tiles on the new house will have access under the tile using example A or B as shown below.
- The eaves of the new house will be open as shown in the example below to permit bats to access the space above the wall plate (as per the existing arrangement). A gap of 25-30mm is suitable to permit bats to land on the wall and crawl up into the cavity.
- A gap of at least 20mm will be available under the gable end fascia boards of the new house with access leading up and onto the top of the wall.

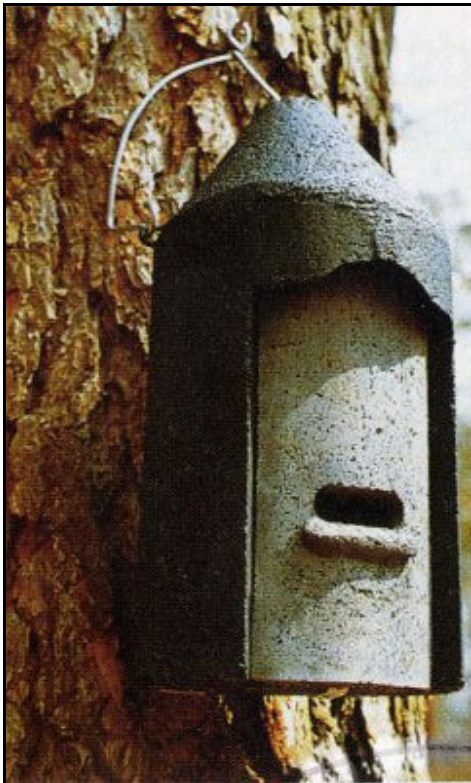
**7. Schwegler 2F bat box (general purpose) to be installed on the wooden pole**

- A wooden post will be erected (at least 15ft high) south of the existing cottage but within the garden boundary.
- A 2F Schwegler bat box will be installed near the top of the post facing approximately south-east. This will provide some temporary roost space before during and immediately after demolition.
- The post and box can be removed after the new house is complete or it can be left where it is. If it is due to be removed then it will need to be taken down and inspected by a licensed bat worker in case it is occupied. Removal will need to take place between mid September and March inclusive.
