**Cheshire Ecology Ltd.**

**RHOSROBIN, WREXHAM  
GREAT CRESTED NEWT SURVEY**

## EXECUTIVE SUMMARY

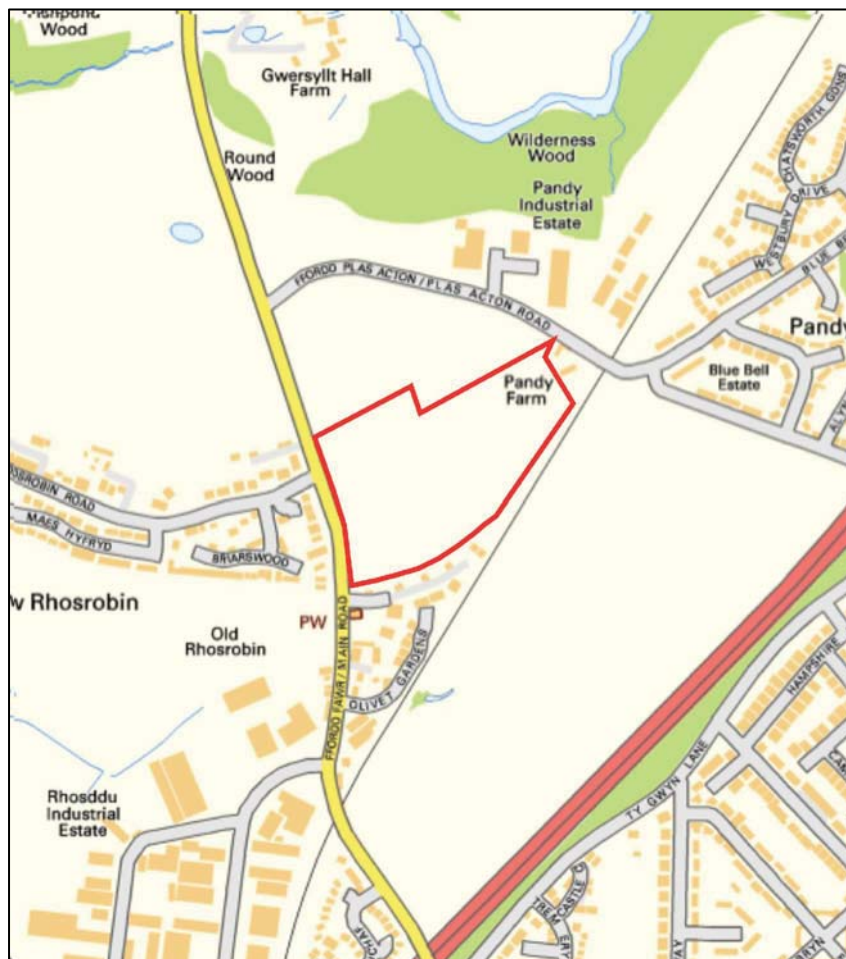
**Figure 1: Site location**

- 1.2.1 The site is bounded to the north by Plas Acton Road (Ffordd Plas Acton) and to the west by Main Road (Ffordd Fawr). A new cemetery lies to the north and to the southeast a railway line. The southern boundary is formed by a recent housing development, known as 'Churchlea'. The site boundary is shown on Drawing CE119-1.

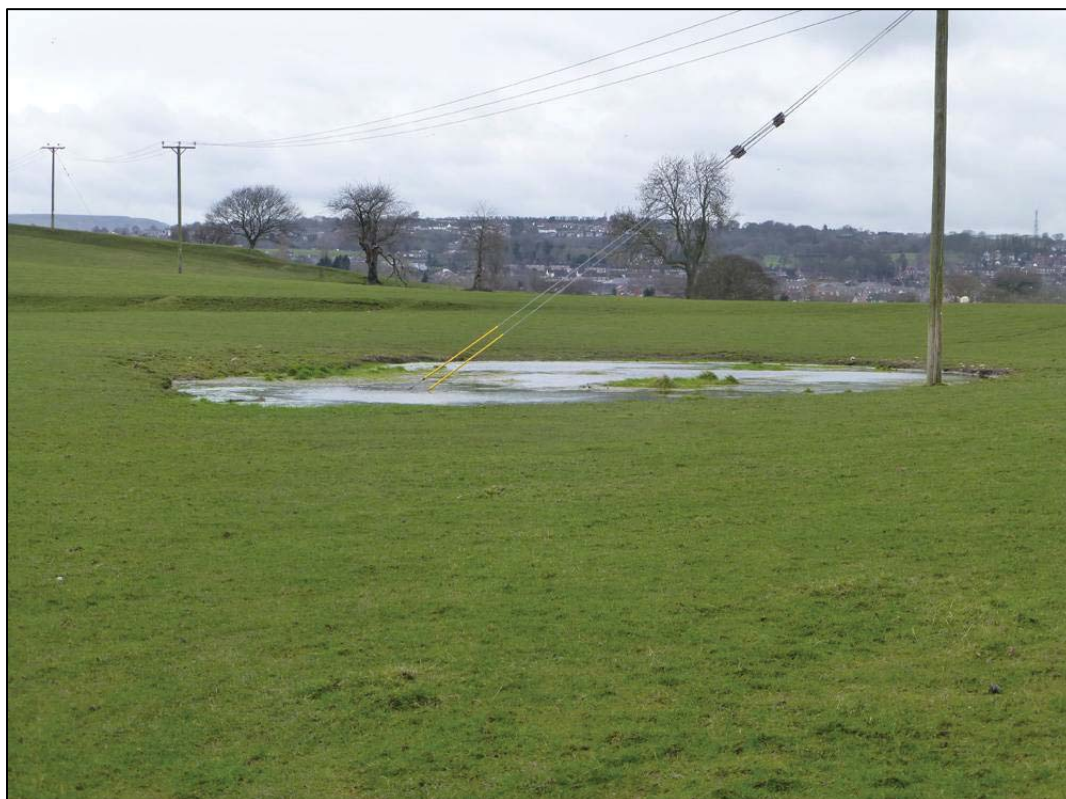
Photograph 1: WB1 is situated in the middle of a field. The photograph was taken before a herd of bullocks was introduced.

- 1.5.2 Water-body 1 (WB1) is located approximately 280m from the site boundary and is situated in a cattle-grazed field. The water-body is roughly oval in shape and measures approximately 550m<sup>2</sup> in extent. There were no aquatic plants present and the margins are badly poached by the cattle. Vegetation was limited to patches of sweet grass *Glyceria fluitans* and creeping bent *Agrostis stolonifera*.
- 1.5.3 The water was extremely turbid throughout the survey period and badly polluted with manure. A small number of invertebrates were present including tubifex worms *Tubifex sp.*, water boatmen *Corixa sp.* and great diving beetles *Dytiscus marginalis*.

- 3.1.6 Water-body WB1 is the only one that had an existing record for great crested newt. This was recorded twenty-two years ago in 1992 (Cofnod, 2014). It is impossible know how the field was managed at the time, but it may have been less intensively than now.
- 3.1.7 The water-body is quite shallow and the surrounding soil is badly poached by cattle. Cattle were observed standing in the water-body and trampling would probably kill any newts that were in the water. Great crested newts are quite tolerant of polluted conditions, but the presence of tubifex in shallower water suggests that it is badly polluted and unsuitable for newts. The water-body has an HSI of 0.47 (poor).

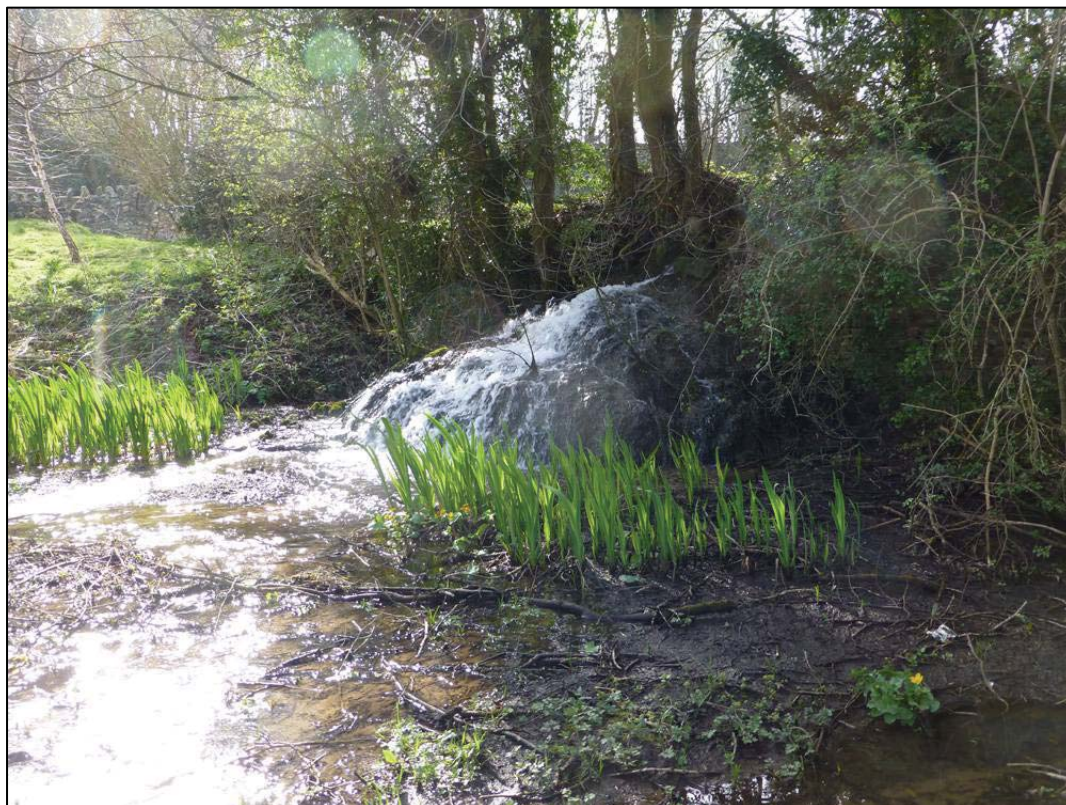
Photograph 2: Flowing water in WB2 made it unsuitable for GCN.

- 1.5.4 WB2 is roughly oval in shape and is located to the west of Gwersyllt Hall Farm, approximately 460m from the site. The water-body is fed by a fast-flowing stream, which passes over a roughly made concrete cascade (see Photograph 2) and then exits at the eastern end. It then flows through a culvert and eventually empties into the River Alyn (see Photograph 3). The water-body had an unpleasant odour and appears to be regularly flooded by sewage. The bed of the water-body is scoured by the stream and was considered unsuitable for great crested newts. It seems likely that the water flow used to be controlled by a sluice gate and that it was originally much higher than it is now.
- 1.5.5 The water-body has a clump of alder trees *Alnus glutinosa* growing in the middle of it and there are several clumps of marsh marigold *Caltha palustris* and yellow flag *Iris pseudacorus*.

- 1.12.2 Water-body WB2 was considered unsuitable for great crested newts because of the fast-flowing water. There was evidence that the water had scoured the bottom of the water-body and any amphibians that found their way into it would be washed downstream into the River Alyn. The stream was badly polluted with sewage during the second visit and it was considered unsafe to net. The water-body was torched on four occasions, but no netting or bottle trapping was carried out for reasons of health and safety. It was obvious from the pieces of discarded toilet tissue caught in the tree branches and roots that the stream is regularly polluted.

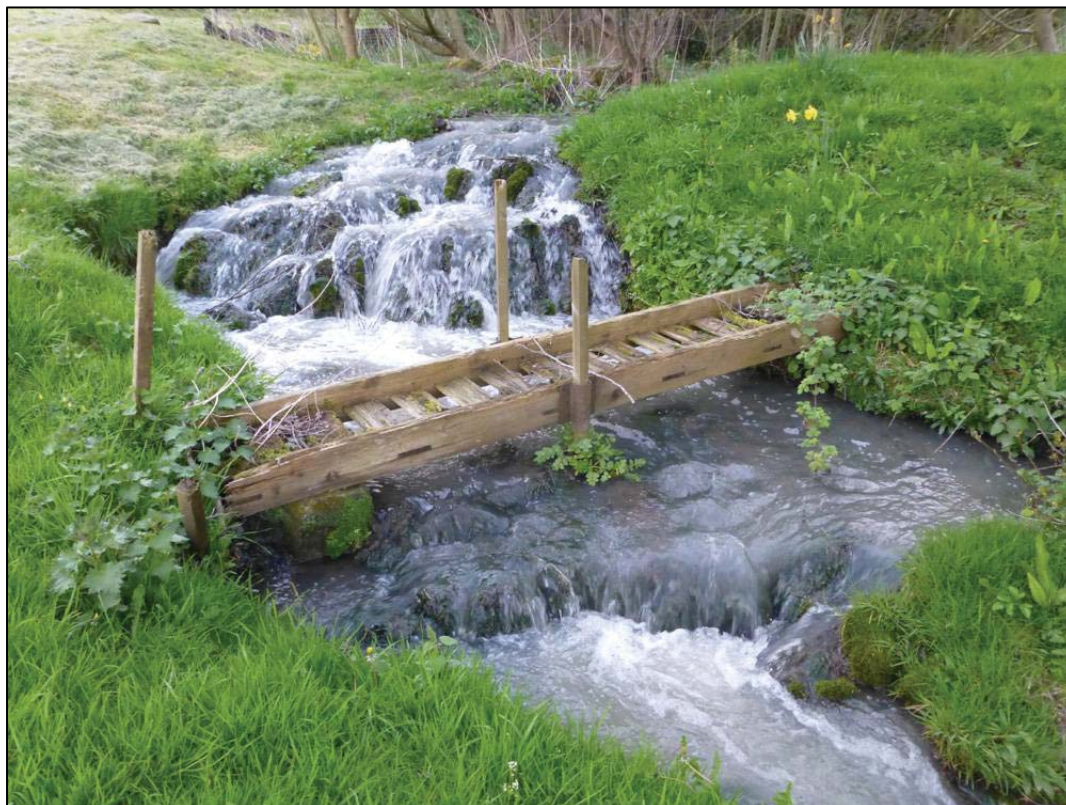
Photograph 3: The stream was badly polluted by sewage on 18<sup>th</sup> May 2014.

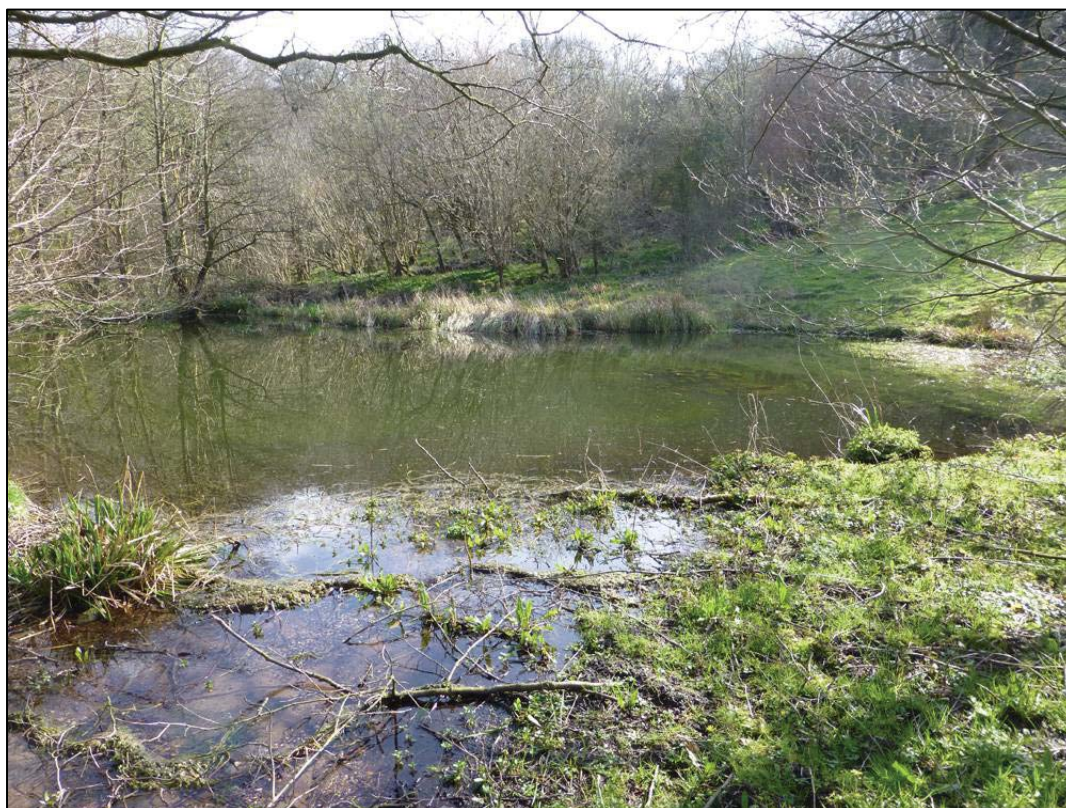
Photograph 4: WB3 is a disused millpond. The water-body is surrounded by emergent vegetation and has clear, unpolluted water.

- 1.5.6 Water-body 3 is a disused millpond and is situated next to the River Alyn (see Photographs 4 and 5). It is approximately 330m from the site. The western bank is fringed by yellow flag and has extremely clear water. Two streams maintain the water level, with the excess flowing into the River Alyn. The water-body has a variety of invertebrate life and is immediately next to the river.

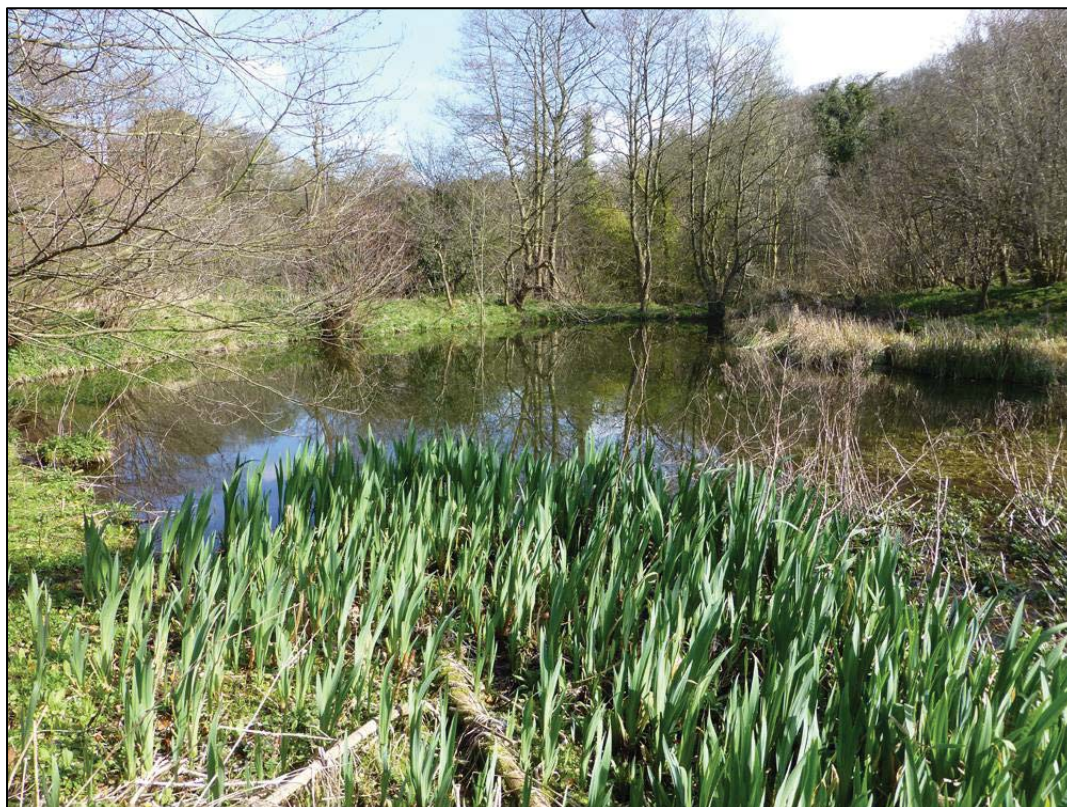
Photograph 5: The water-body is located next to the River Alyn.

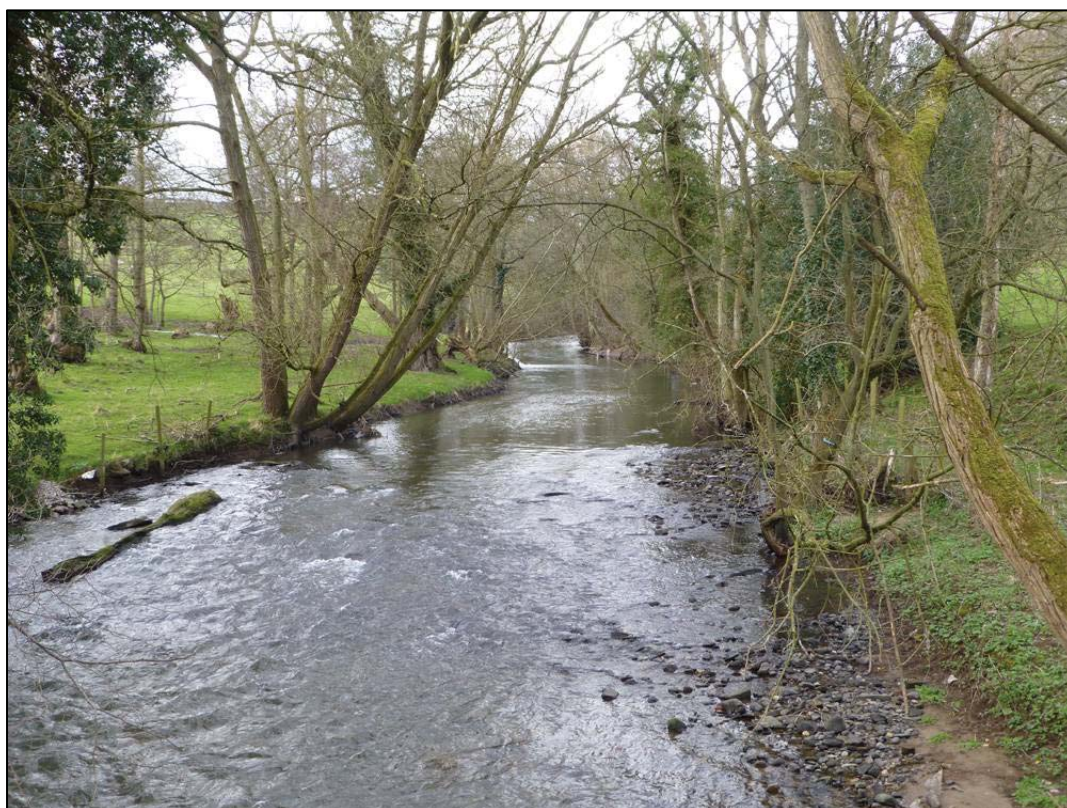
Photograph 6: The River Alyn is fast flowing and unsuitable for GCN.

- 1.5.7 The River Alyn is located approximately 260m to the north of the site. The river is fast flowing and was considered to be unsuitable for GCN (see Photograph 6).

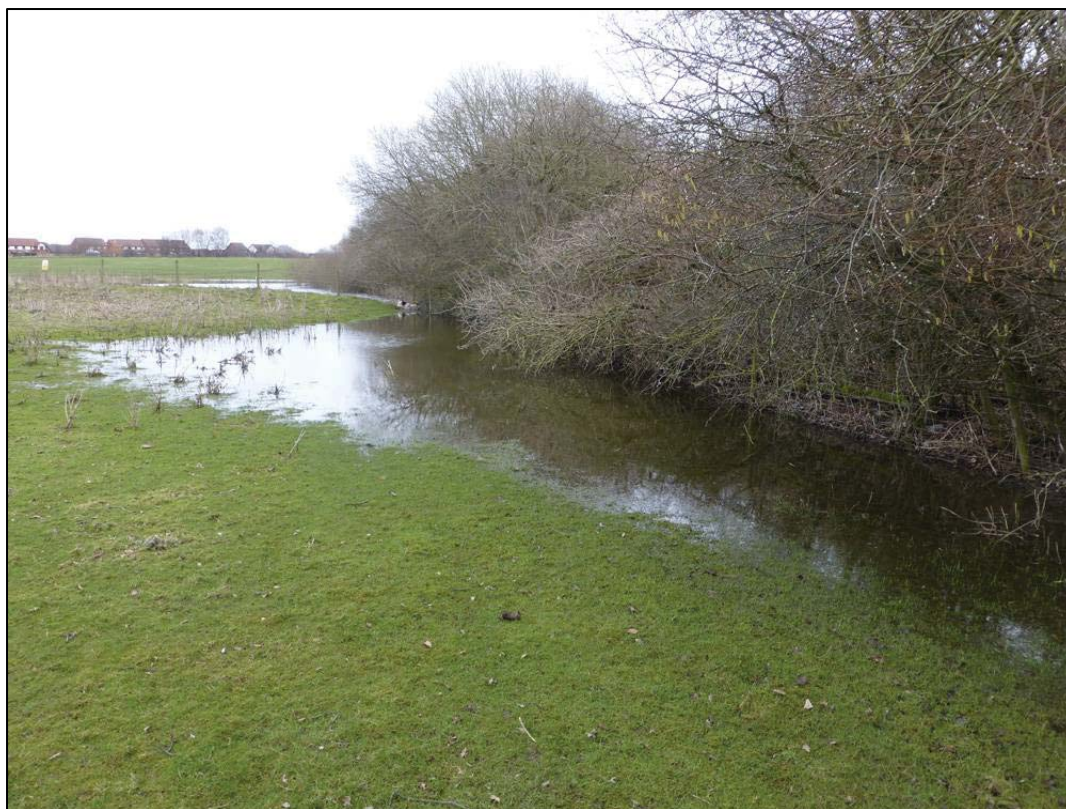
Photograph 7: WB5 had dried up by the time that the GCN surveys started.

- 1.5.8 This seasonal body of water was located to the north of Rhosddu Industrial Estate (see Photograph 7). It is situated approximately 400m from the site. The water-body was roughly triangular in shape and had no aquatic vegetation. It was dry before the GCN survey commenced.

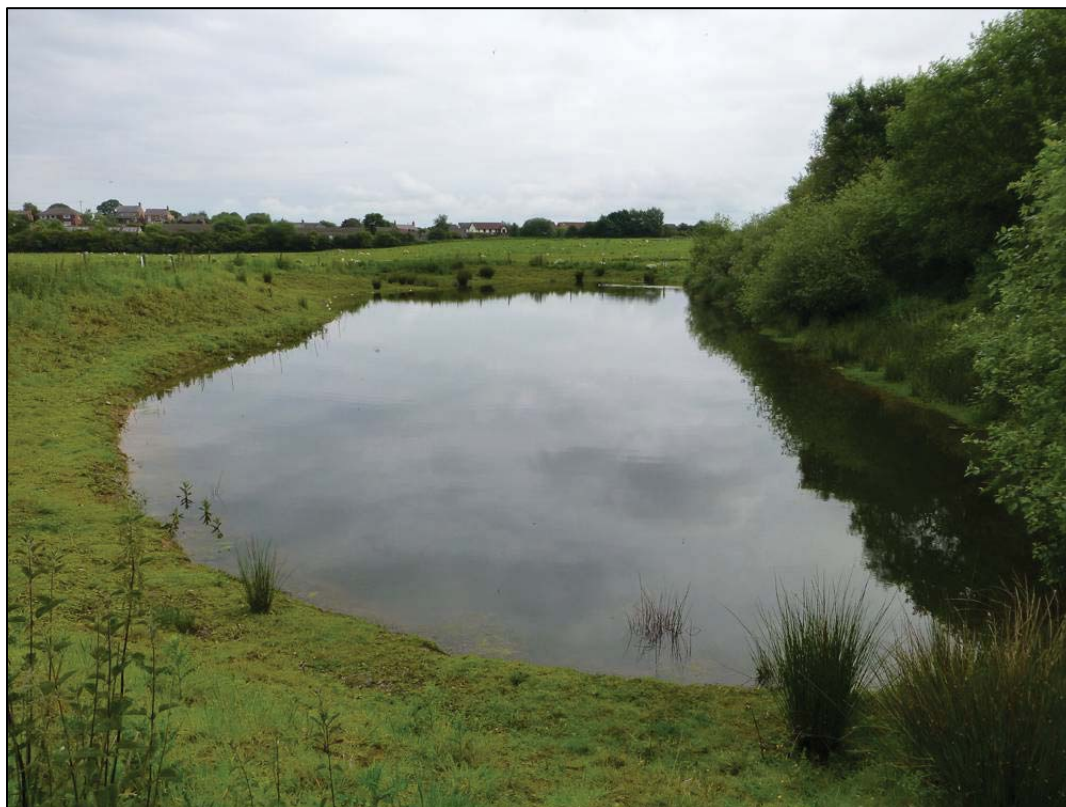
Photograph 8: Great crested newts were present in WB6

- 1.5.9 This is a deep pool, measuring approximately 1800m<sup>2</sup> in extent (see Photographs 8 and 9). The water body has steep sides and is located to the north of the Rhosddu Industrial Estate. The depth of the water-body is uncertain but it appears to be at least 2m deep. There is no emergent aquatic vegetation, but submerged vegetation could be seen when the water level dropped in early May 2014. The denuded margins of the water-body suggest that it is probably colonised by Canada Geese in the winter months. It is located 366m from the site.
- 1.5.10 A rush-filled ditch connects water bodies 6 and 7. The ditch was dry when the GCN surveys were started but had filled with water by the time that the 5<sup>th</sup>

- 3.1.14 At first sight this lake should be unsuitable for GCN. The lake has submerged vegetation, but there is little emergent and the banks have been denuded of vegetation by wildfowl. The water-body also has a relatively low HSI of 0.44 (poor), but it was teeming with newts. Reasonably large numbers of adult GCN were recorded and both eggs and efts were found during the June surveys.

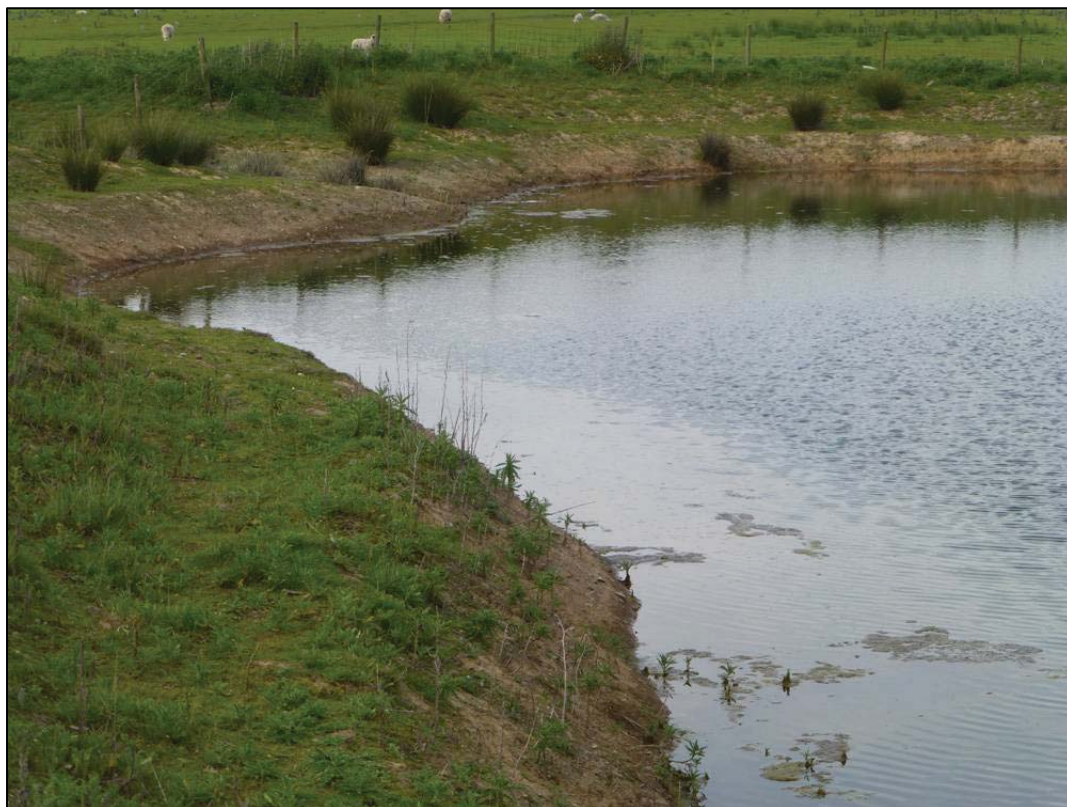
Photograph 9: The water level dropped considerably during May 2014.

- 1.12.4 The depth of WB6 fluctuated considerably during the survey season. At one point it was estimated that the water level had dropped approximately 100cm below the surrounding land. The water-body was surveyed on one occasion using bottle-traps on long lines.

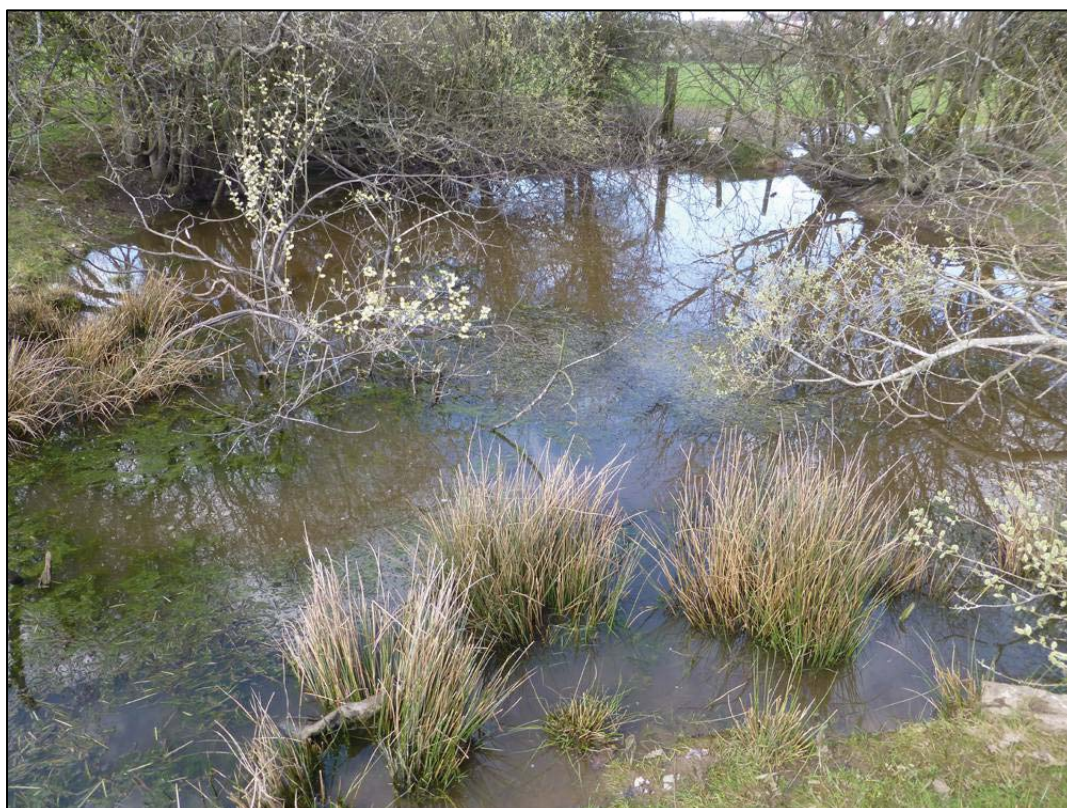
Photograph 10: WB7 is very turbid and had a small population of GCN.

- 1.5.11 This is a small, irregularly shaped water-body, located approximately 420m from the site (see Photograph 10). The water-body is of uncertain depth and has had blocks of concrete dumped in it. The water-body is surrounded on three sides by hawthorn *Crataegus monogyna* and grey willow *Salix cinerea* trees and only the southern quarter was accessible. The water was usually very turbid and polluted with sheep manure. A dead sheep was found on the last survey. The ditch is connected to WB 6 by a rush-filled ditch (see photographs 11 and 12).

- 3.1.19 Water-body WB7 is shown on all of the historical Ordnance Surveys maps of the area and is obviously a long-standing feature. Unfortunately the water is badly polluted by sheep manure and is very turbid. Lumps of concrete have been dumped in the water-body, making surveying hazardous. An old willow tree has collapsed into the water and mature hawthorn trees surround the northern part of the water-body. The water-body has an HSI of 0.50 (below average).

- 3.1.20 WB7 has clearly been neglected. It acts as a sump for polluted water and would benefit from having the broken concrete removed. It is heavily shaded, which prevents an aquatic flora from developing.

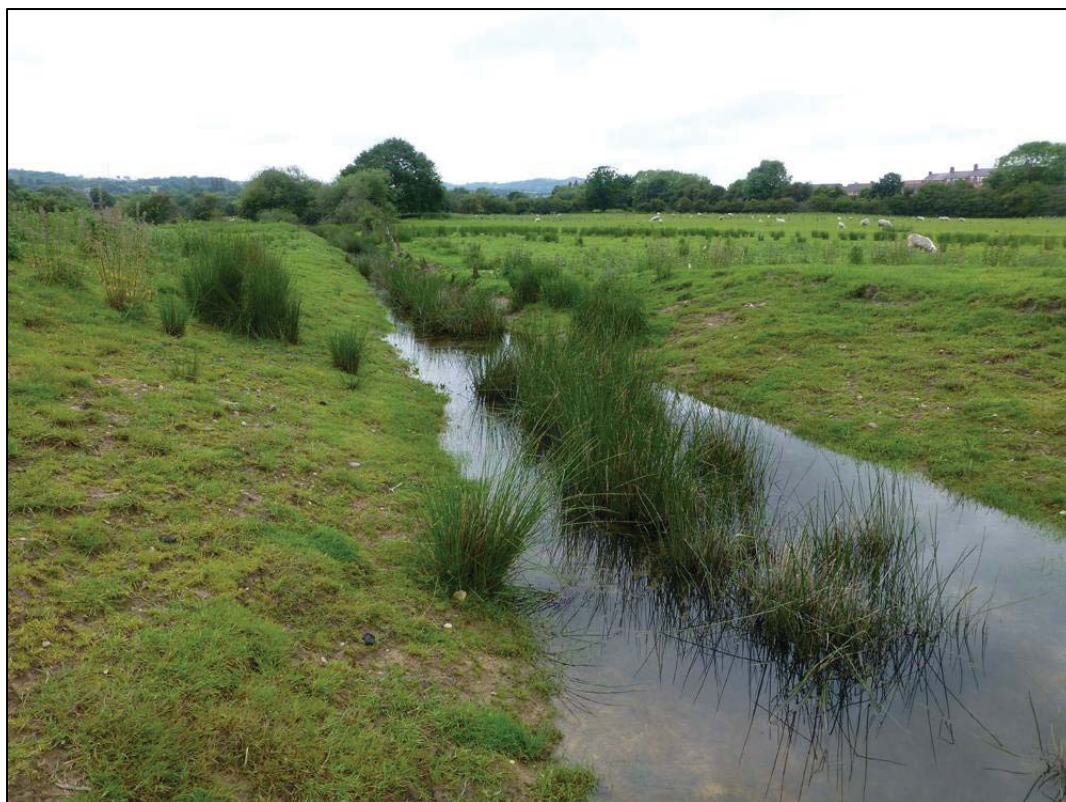
Photograph 11: A rush-filled ditch connects WB6 and WB7. It was completely dry for the majority of the survey.

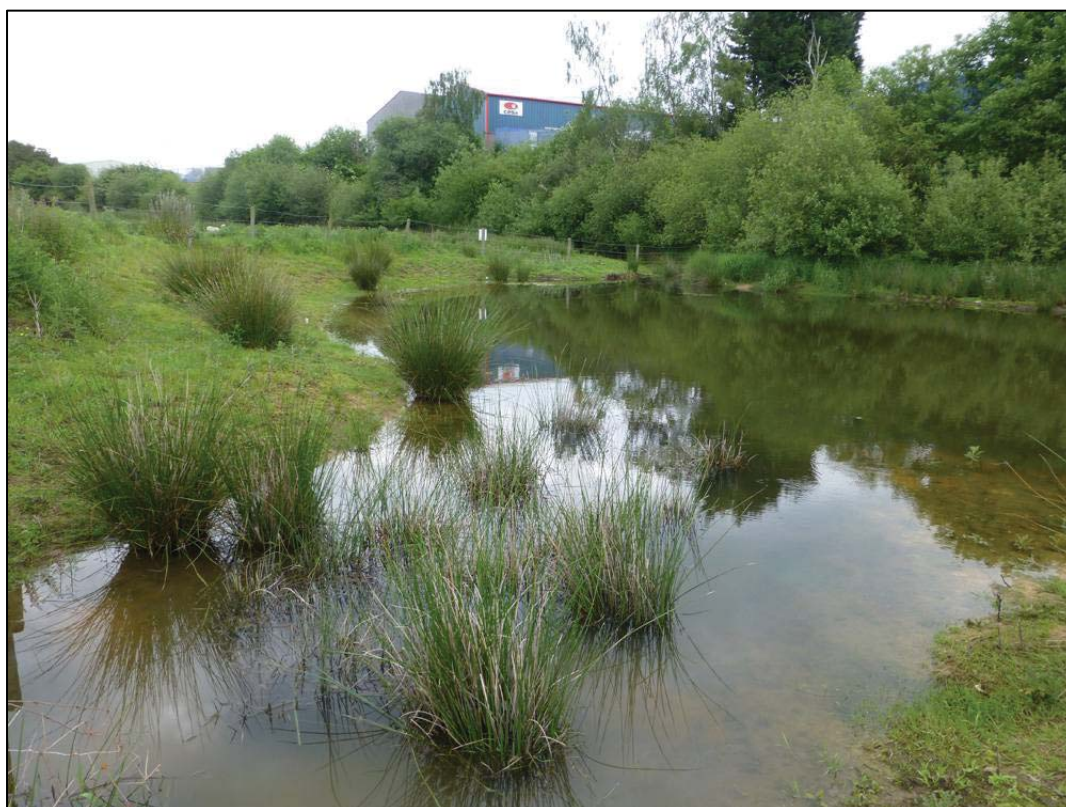
Photograph 12: Great crested newt eggs were found at the end of the ditch.

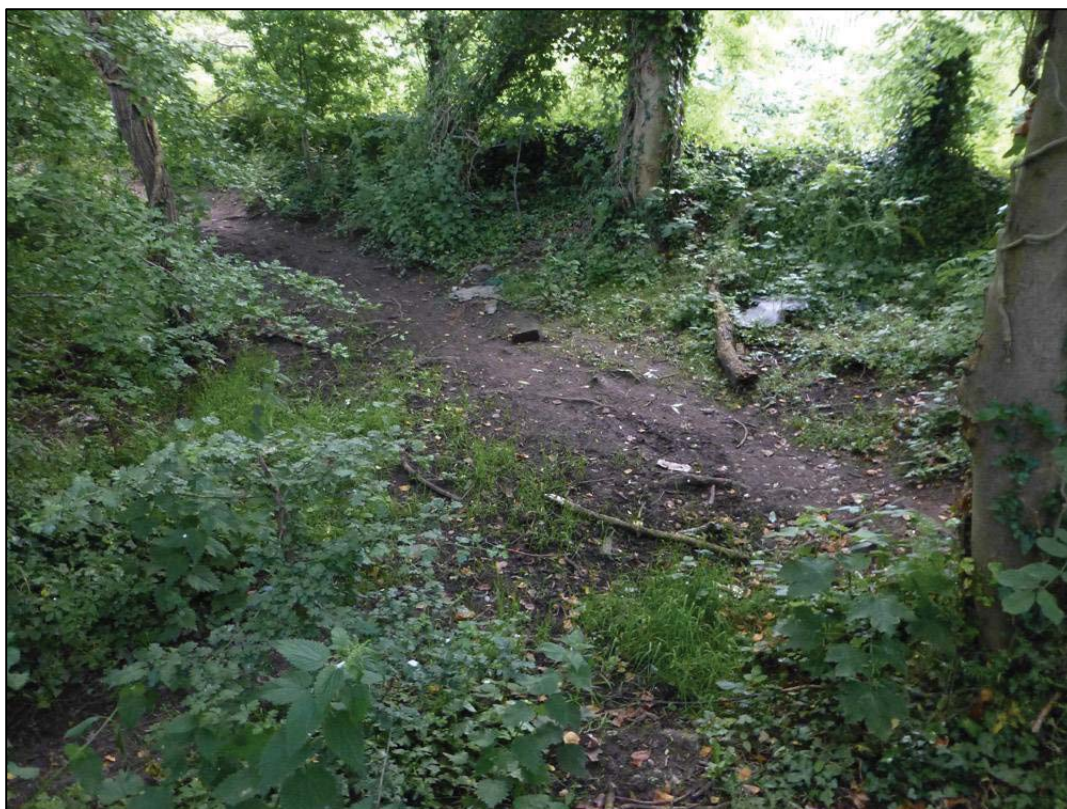
Photograph 13: WB8 no longer retains water and was completely dry.

- 1.5.12 This disused water-body is located on the opposite side of the railway line, approximately 150m from the site (see Photograph 13). The water-body was dry at the time of the survey, but it appears to have been constructed by building a raised bank at the end of a deep ditch. The ground was covered with a film of dead filamentous green algae when the water-body was surveyed in May 2014. The former water-body is heavily shaded and has no GCN potential.

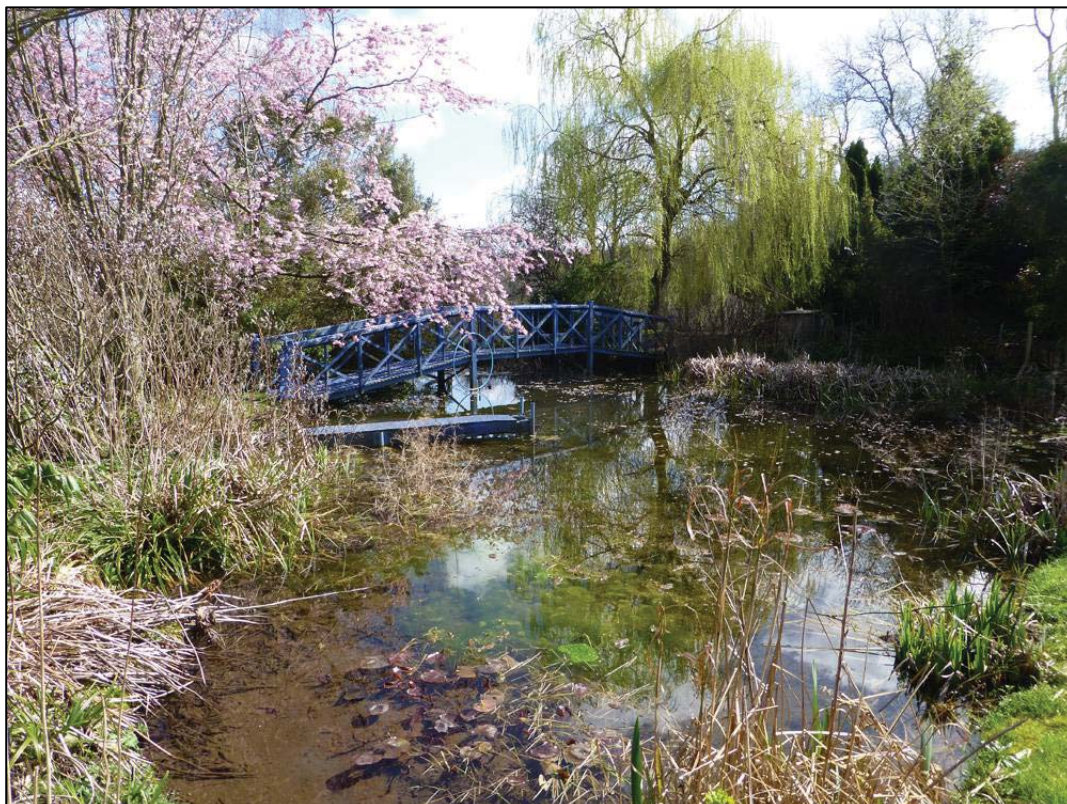
Photograph 14: WB9 is an ornamental water-body, with crystal clear water.

- 1.5.13 Anecdotal evidence suggests that this water-body was constructed by the previous house owner and has always been for ornamental purposes (see Photograph 14). It is crossed by a wooden bridge and has crystal-clear water, with plenty of submerged vegetation. The water-body is fed by two small streams and drains away at the eastern end. It had potential for GCN when it was originally surveyed. It is located approximately 350m from the site.

- 3.1.25 WB9 is an attractive ornamental water-body with a blue-painted wooden bridge. The water-body already seems to offer optimum conditions for GCN and we cannot explain why they are absent. It had an HSI of 0.99 (excellent), the highest of any of the water-bodies surveyed.

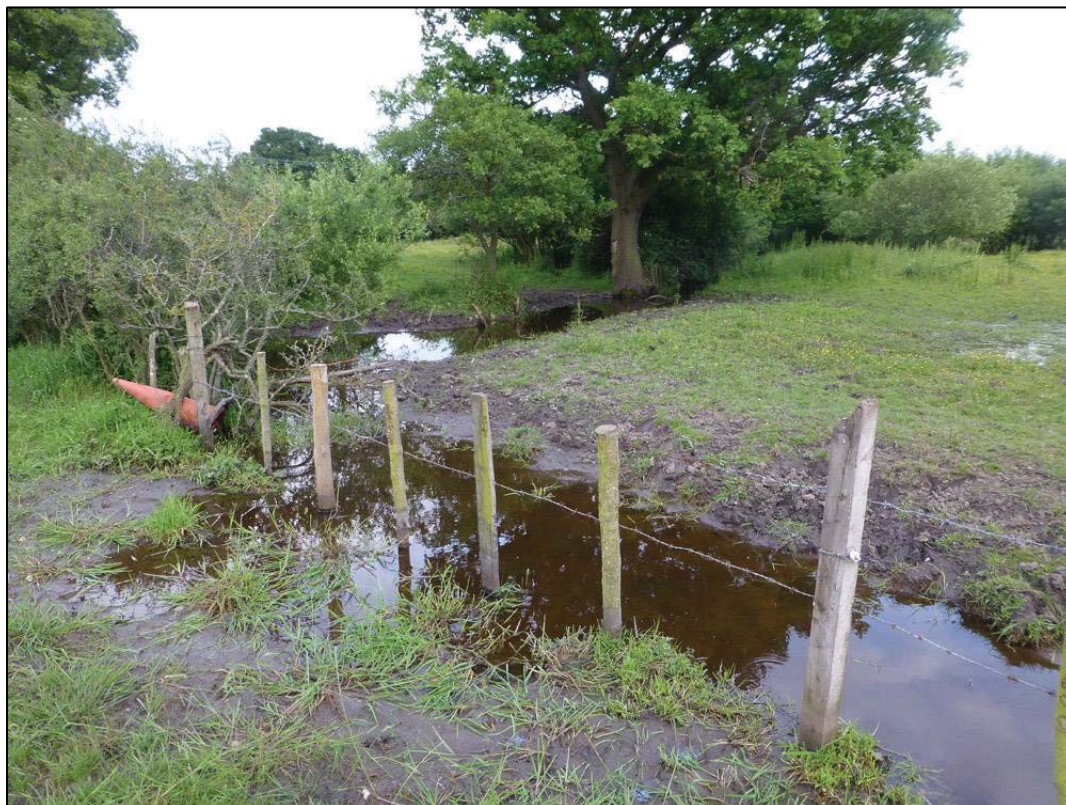
Photograph 14: WB10 is a turbid, unpleasant ditch.

- 1.5.14 WB10 is a flooded ditch between two horse-grazed fields and is located approximately 150m from the site (see Photograph 15). The ditch was covered by filamentous green algae and was very turbid. The margins are badly poached and covered with sparse *Glyceria fluitans* and *G. declinata*. The water-body has low potential for GCN.

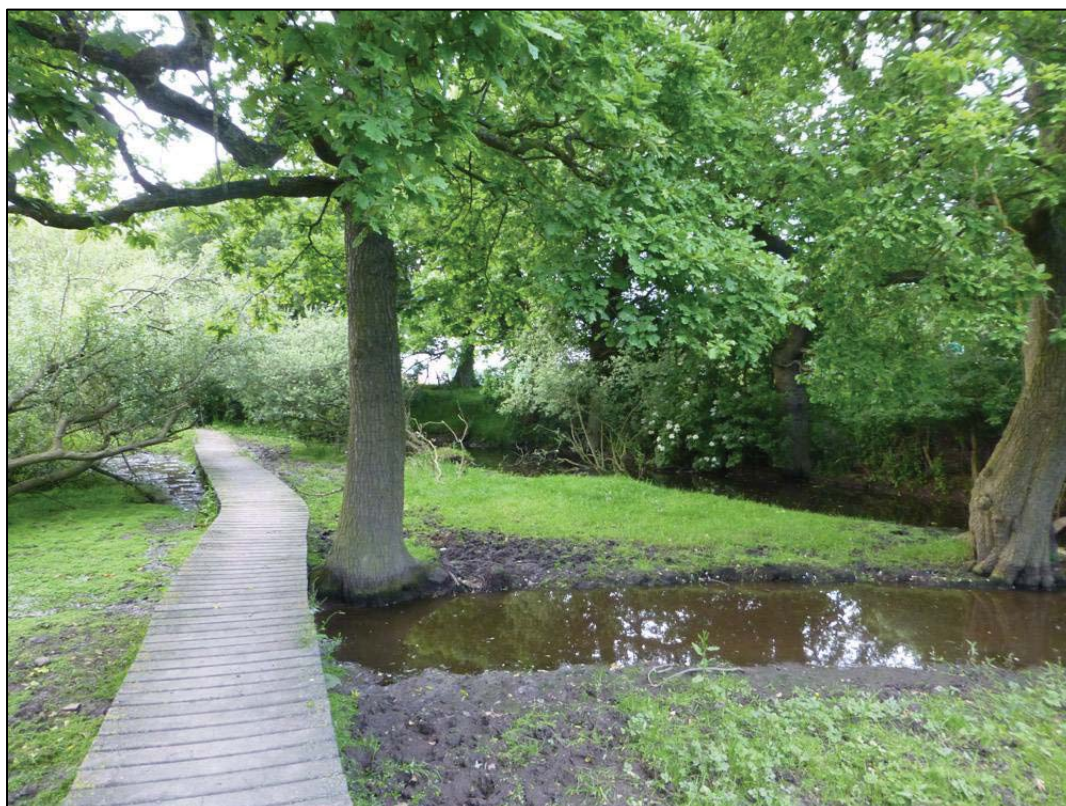
Photograph 15: WB11 is turbid and was badly poached by horses. It has potential for enhancement however.

- 1.5.15 Water-body 11 is a flooded ditch, located near the A483. It is located approximately 290m from the site (see Photograph 16). The ditch may be part of Watt's Dyke, which forms the eastern bank of the water-body. The water is shallow and the margins badly poached by horses. There was little aquatic vegetation at the start of the survey, other than a small patch of common water-starwort *Callitriche stagnalis*, but this had become quite extensive by the time that the survey was completed in early June 2014. This water-body was assessed as having low potential for GCN.
