## **ADDITIONAL BAT REPORT**

**CEFN BYCHAN CHAPEL**

**NEWBRIDGE, WREXHAM**

**20<sup>th</sup> March 2013**

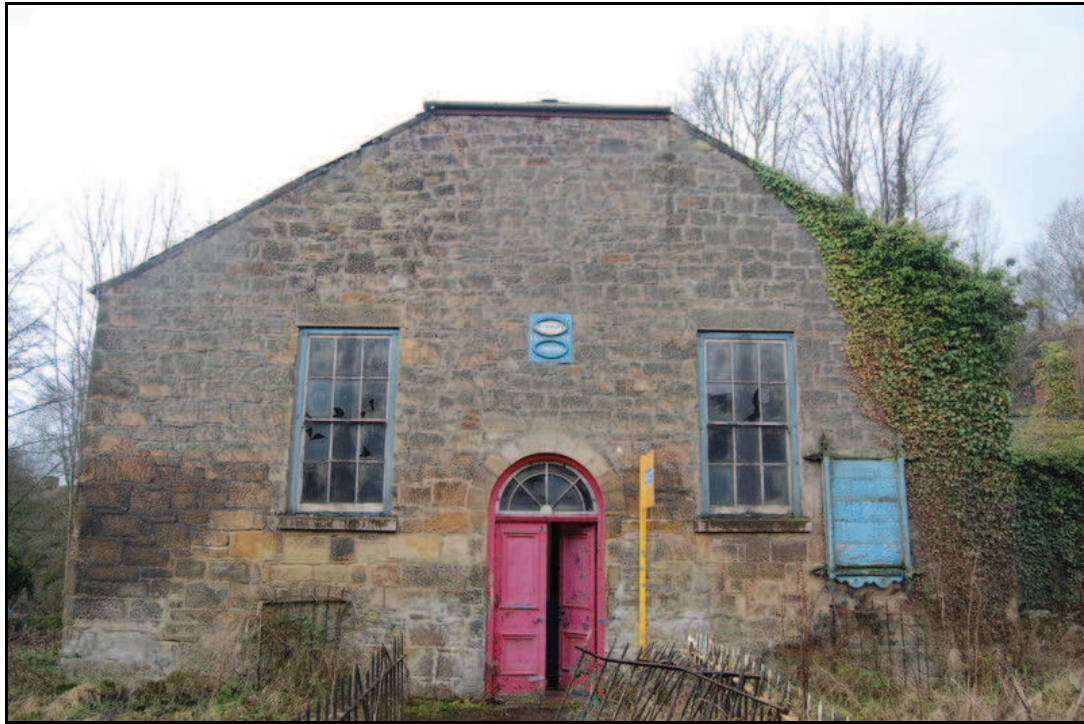
### 1. Front elevation

No evidence of bats was found anywhere within the building and it apart from the changes it seemed to be the same. There was no evidence of droppings or any other evidence to suggest bat presence. The roof is untouched apart from a few repairs to leaks and the cobwebs are still present suggesting no movement in that area. All areas beneath the roof can be viewed because there is no underfelt.

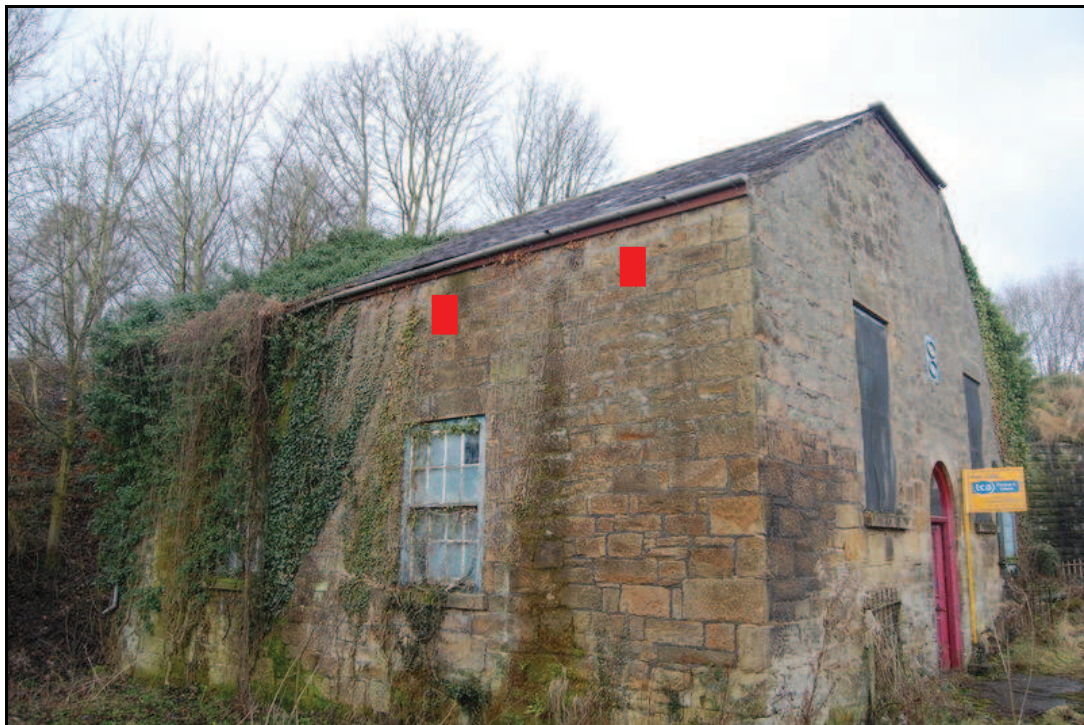
### 2. Side elevation facing south-east – two Schwegler 1FR bat boxes to be installed

- Install ten of the ridge tiles using option A or B in the attached example to allow bats access to the space below the tiles.
- Fix three Schwegler 1FR bat boxes to the external walls. Two should be fixed to the south-east facing wall and one to the north-west facing wall as shown in the photo below. Each box should be installed approximately one metre below the eaves. They can either be installed against the wall or sunk into the wall although that may not be possible with the existing wall structure.
- Ensure all timber treatment is undertaken using chemicals shown to be safe for bats, a certificate should be obtained.

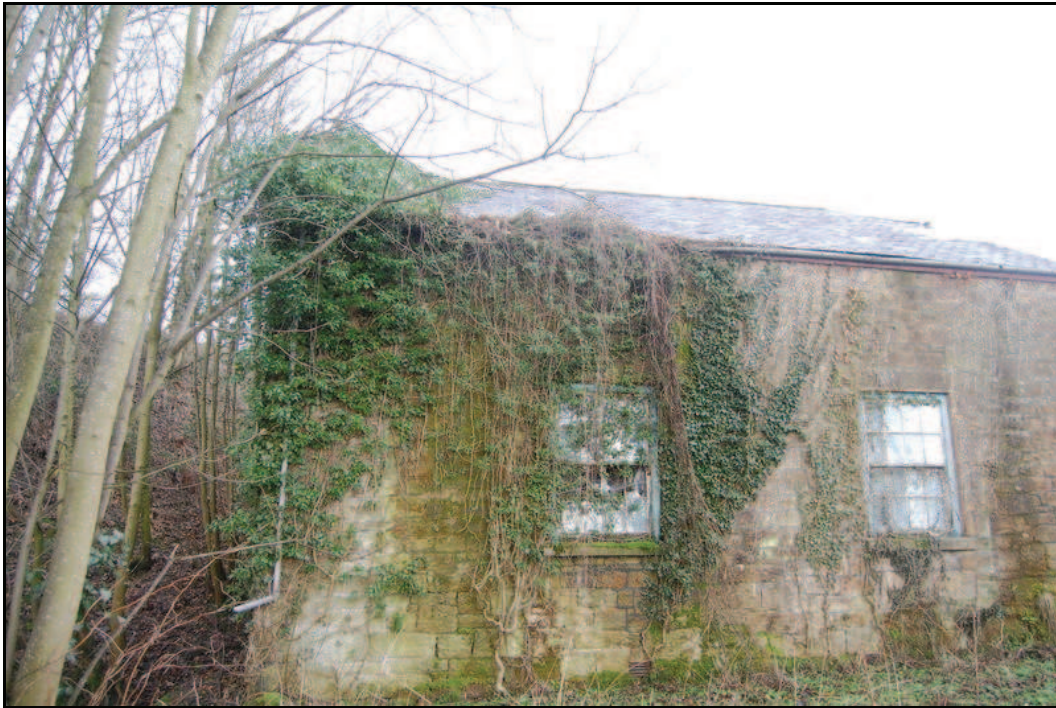
**3. Side elevation with view to rear**

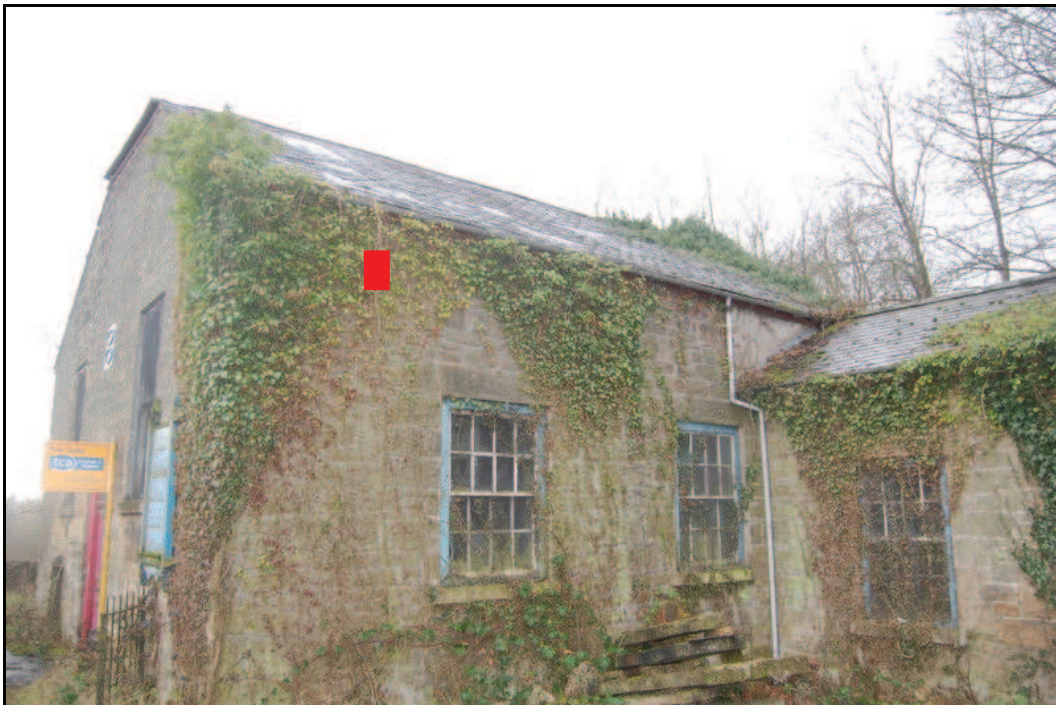
**4. Side elevation including schoolroom facing north-west with single Schwegler 1FR bat box to be installed.**

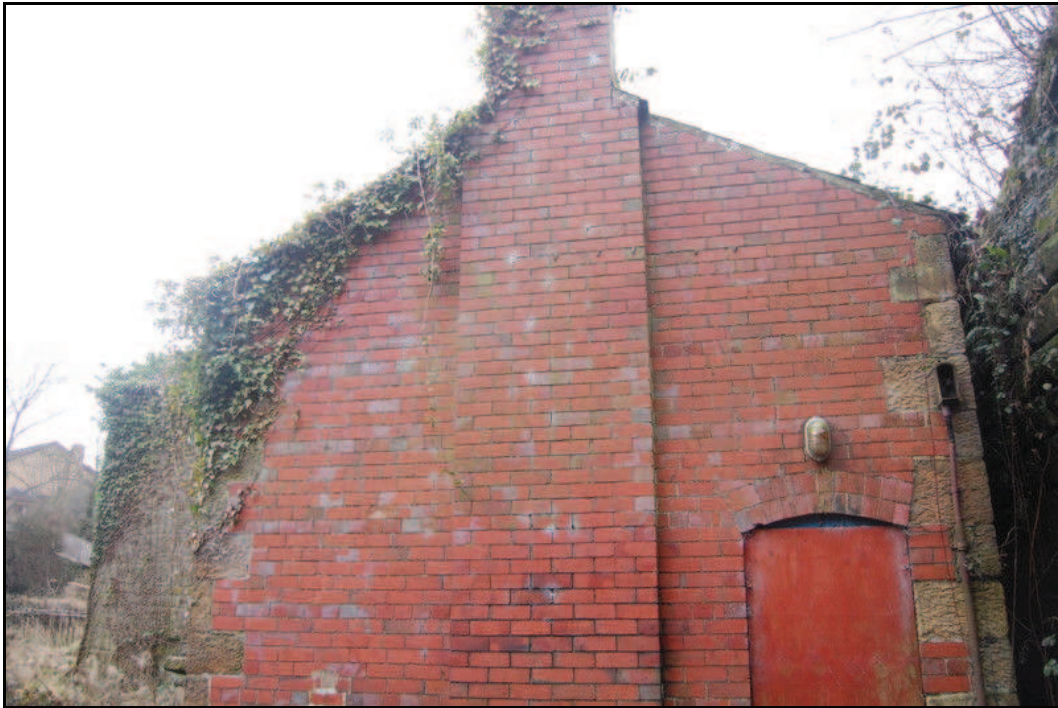
## 5. Schoolroom

The small schoolroom is constructed from brick and also has a slate roof which does not have the benefit of underfelt. Dense ivy had developed to the rear of the chapel and partially along the side walls; in places the ivy had penetrated the interior of the building. Much of the ivy has now been treated or removed to avoid any further damage to the roof and walls.
