## North Wales Prison

Remediation Strategy and  
Method Statement, Area 1  
(Outline Planning Permission Ref  
P/2013/0671)

Hydrock Ref: R/14656/003

**Title:** Remediation Strategy and Method Statement, Area 1

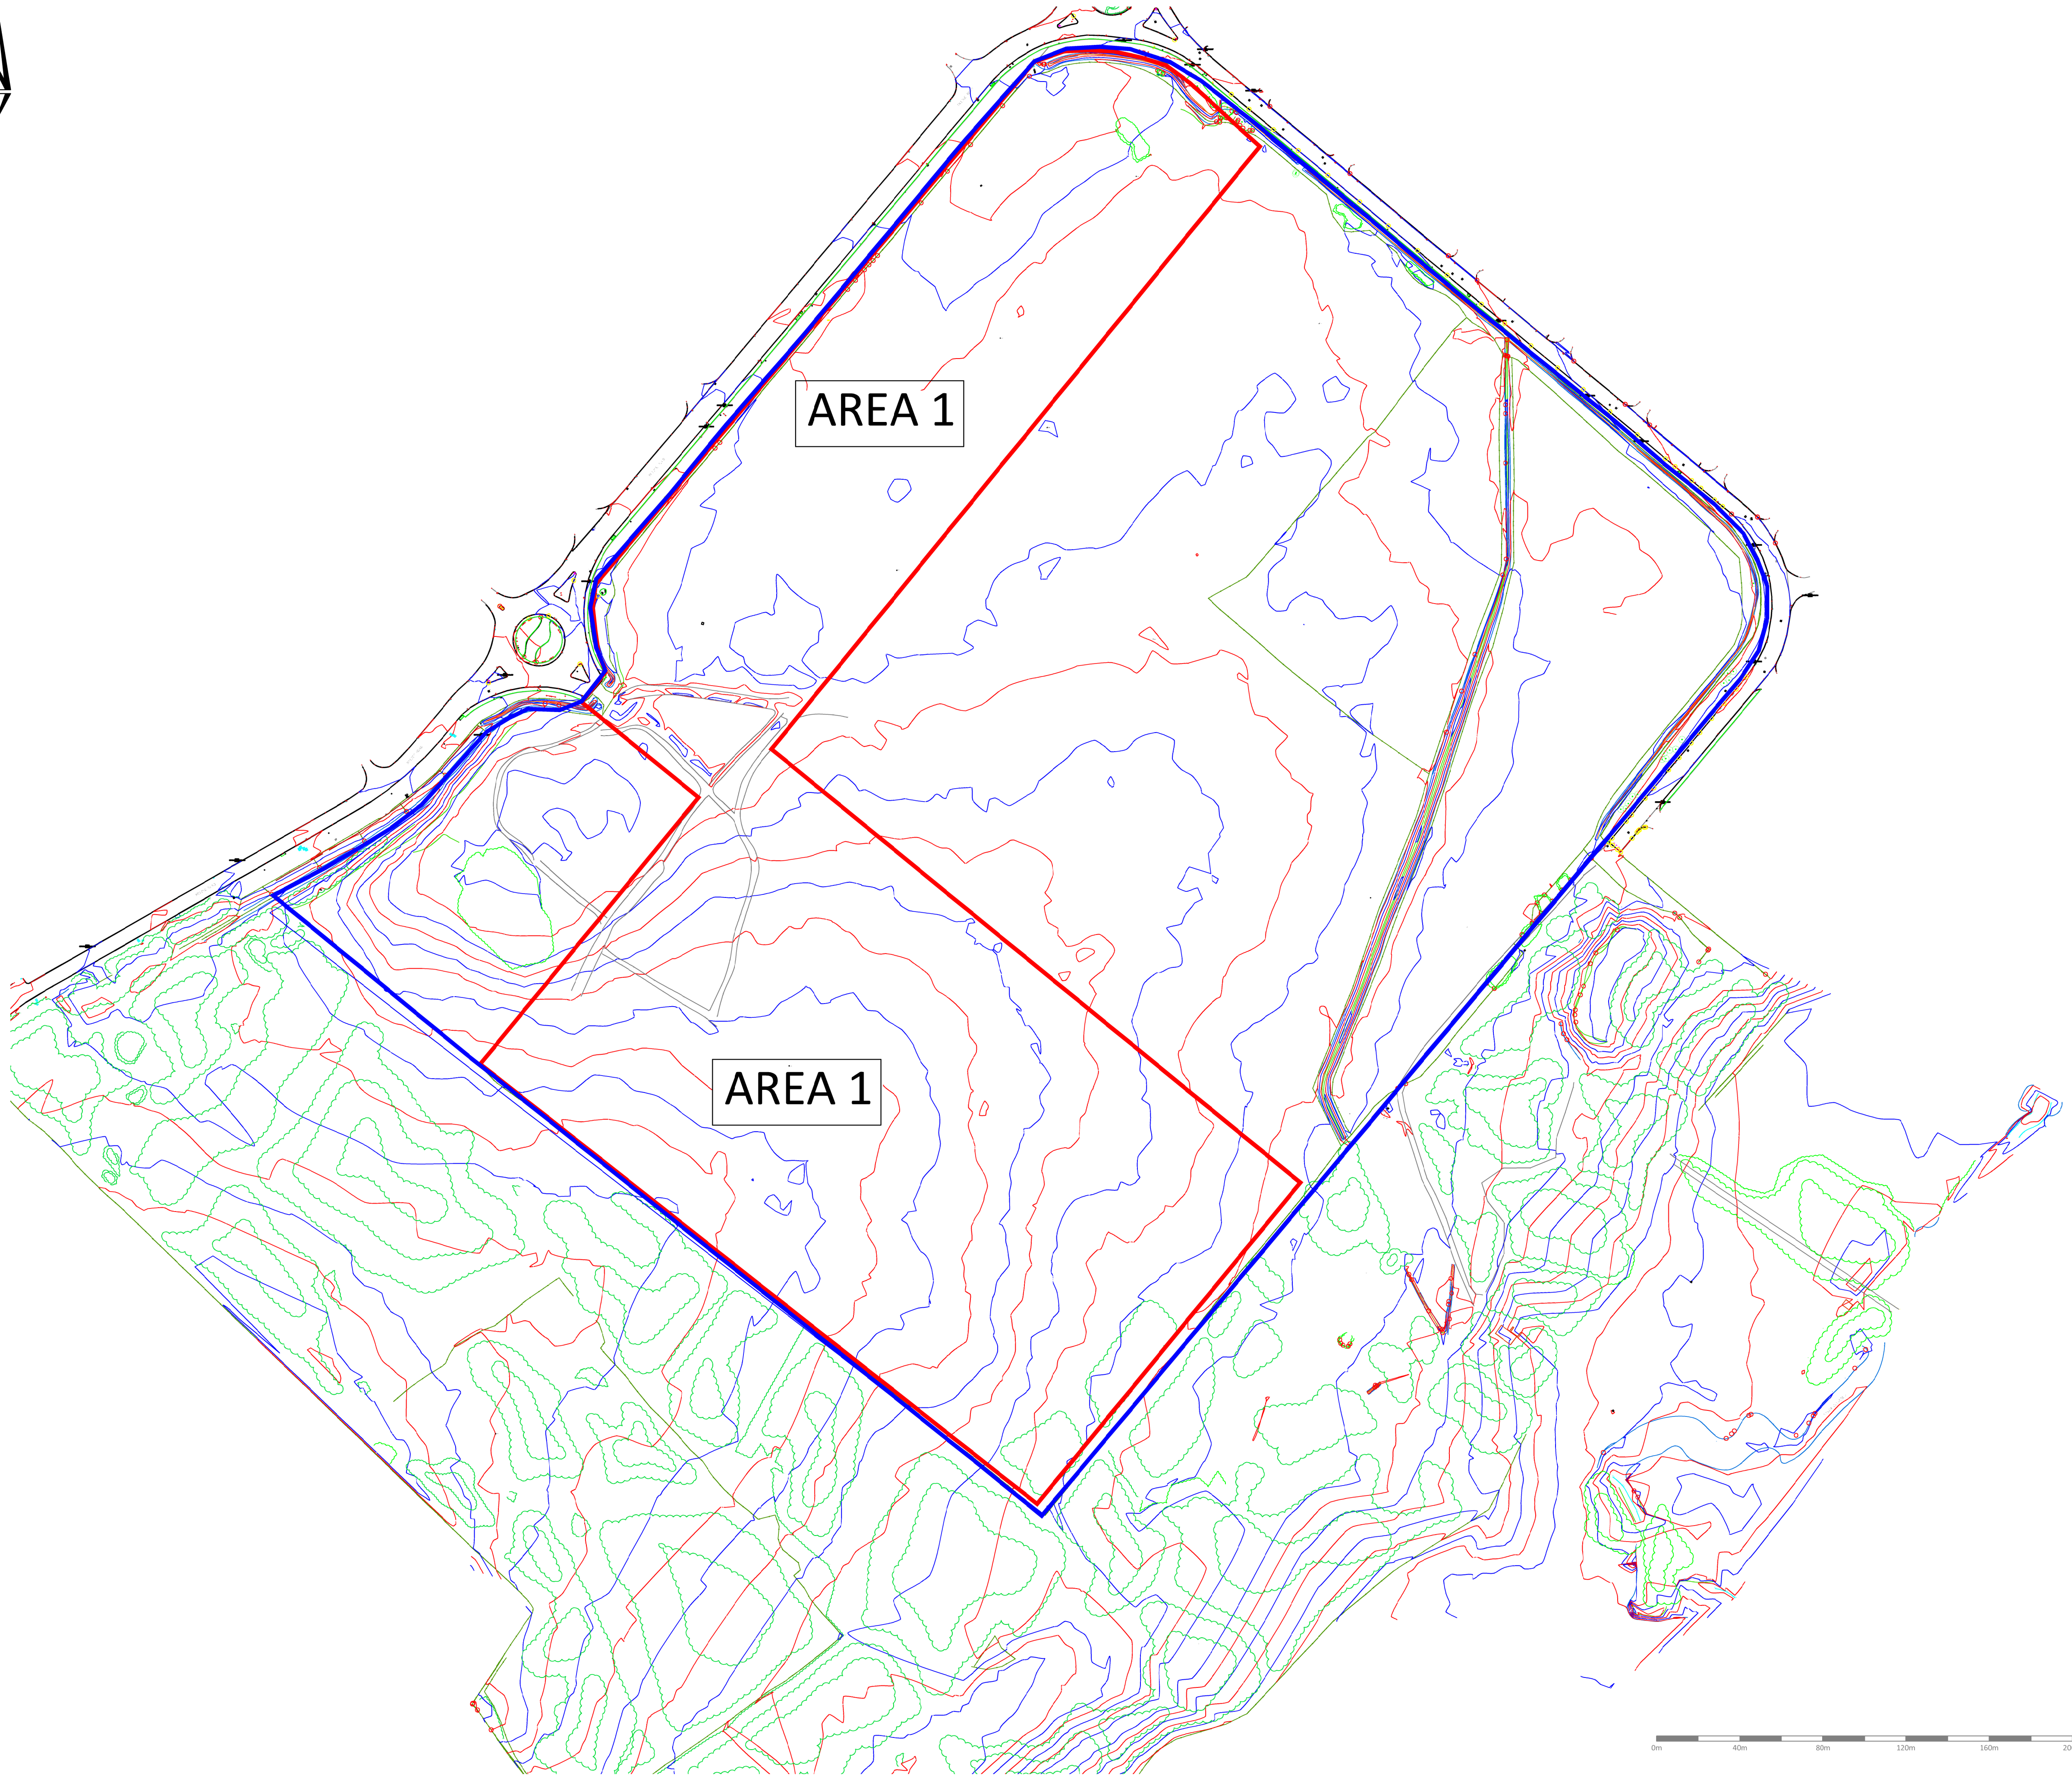
| Rev | Date | Description | By | Ckd |
|---|---|---|---|---|
| 14656/D002 | | | | - |

A site location plan (Drawing 14656/D001), a site survey plan (14656/D002) and a proposed development layout (14656/D003) are presented in Appendix A.

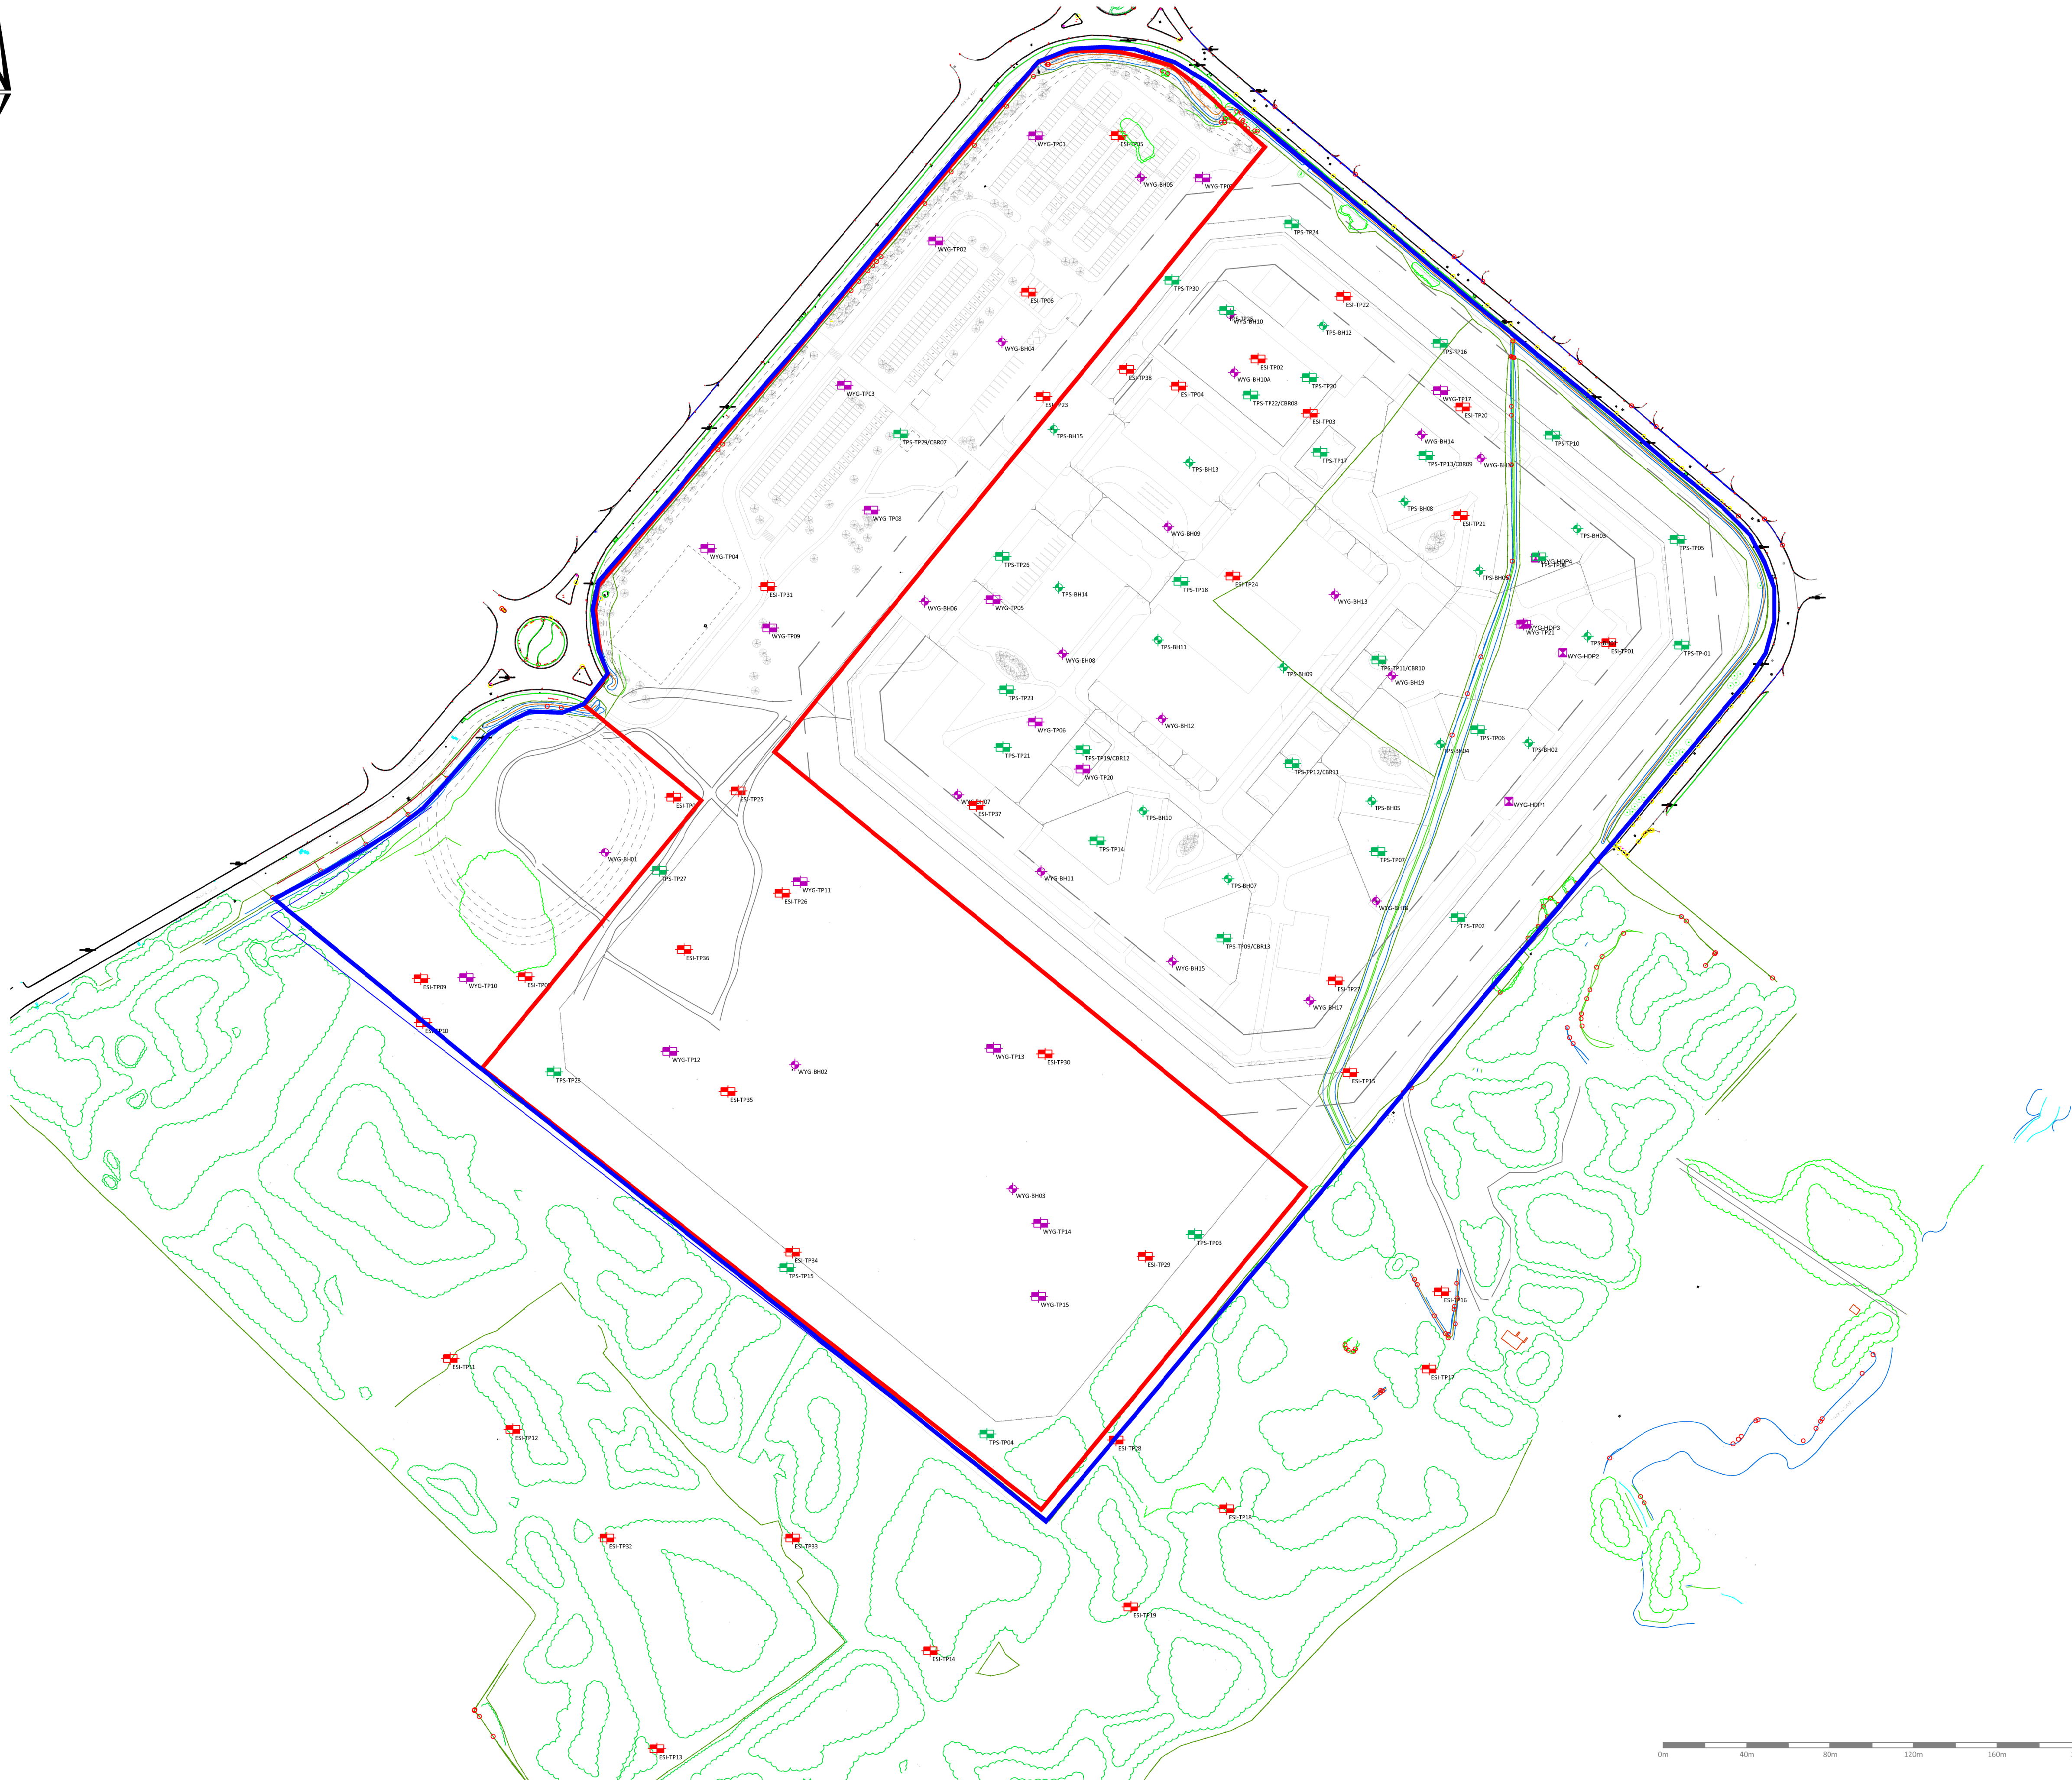
- Notes:
- DEVELOPMENT FOOTPRINT AREA
  - AREA 1
  - TPS-TP05
  - TPS-TP05/CBR01
  - TPS-BH07
  - WYG-TP17
  - WYG-HDP2
  - WYG-BH13
  - ESI-TP30
  - TPS HYDROCK BOREHOLE 2014
  - TPS HYDROCK BOREHOLE 2014 AND CBR LOCATION
  - TPS HYDROCK BOREHOLE 2014
  - WYG TRIALPIT 2013
  - WYG HAND-DUG PIT 2013
  - WYG BOREHOLE 2013
  - ESI TRIALPIT 2012

In Area 2 of the development area, asbestos containing materials or loose asbestos fibres were recorded in a number of the soil samples, as summarised in Table 2.6. The locations are shown on Drawing 14656/D004 in Appendix A.
