## **SURVEY RESULTS, RE PROTECTED SPECIES**

**Site:** Former Fields Farm  
Old Wrexham Road  
Gresford  
Wrexham  
LI12 8TY

**Job No:** 0659

**Report Ref: 0659/FF/-r2-v1**

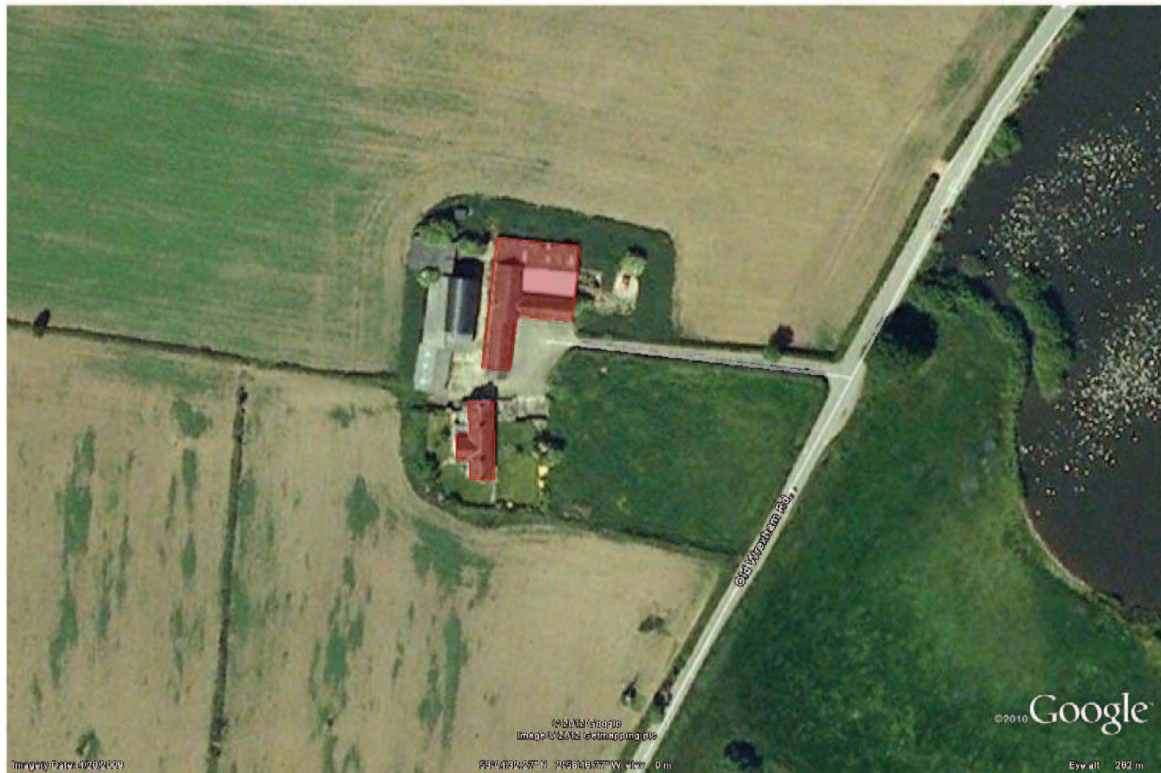
The main building is formed by three traditional masonry barns and a pitched portal framed attached shed. The buildings have been erected at different periods. The layout of the buildings can be seen on fig 1.

*Fig 1: Aerial Photograph of the Site*
