## **PROTECTED SPECIES SURVEY**

**CROSS STREET, PENYCAE**

**WREXHAM**

**24<sup>th</sup> September 2012**

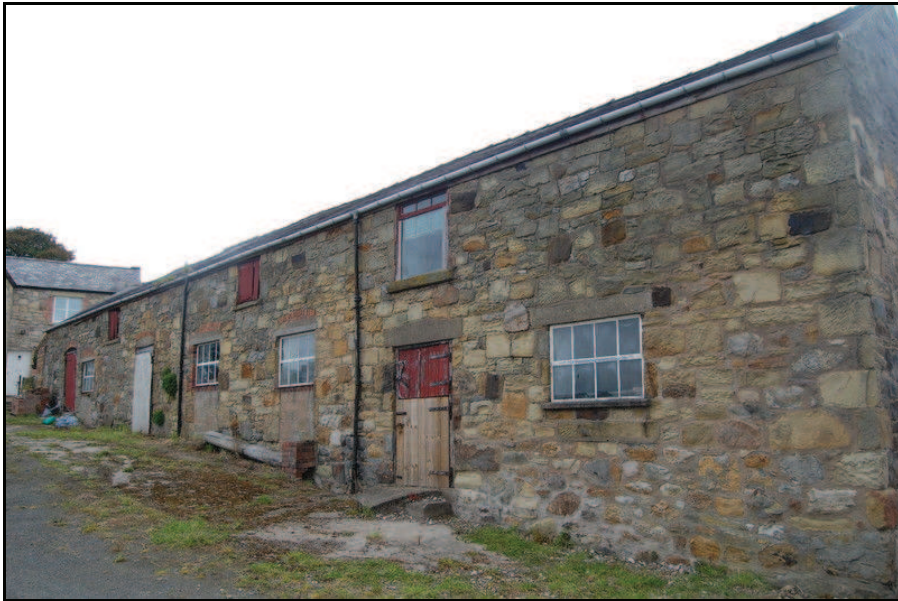
### 1. Front (south facing) elevation of the main barn

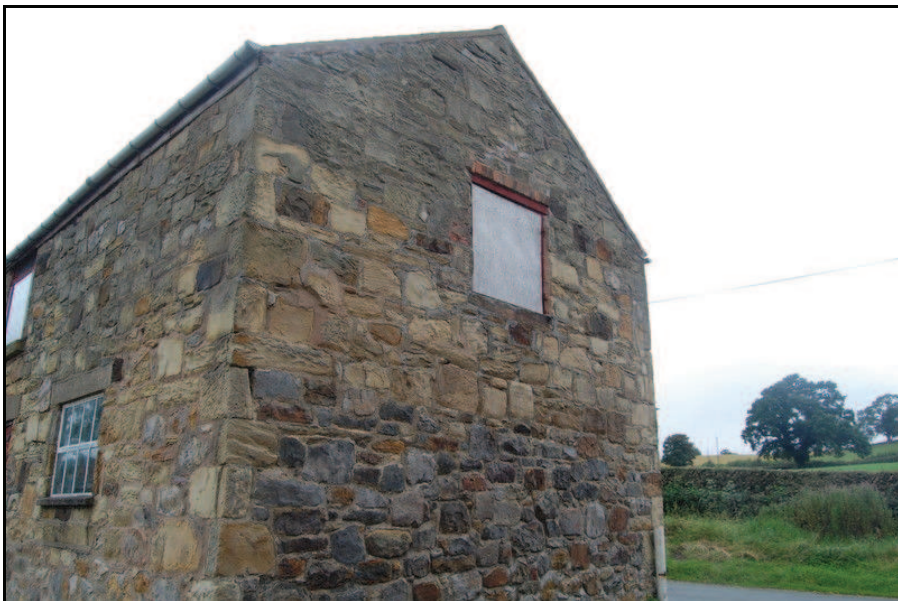
### 2. Gable end

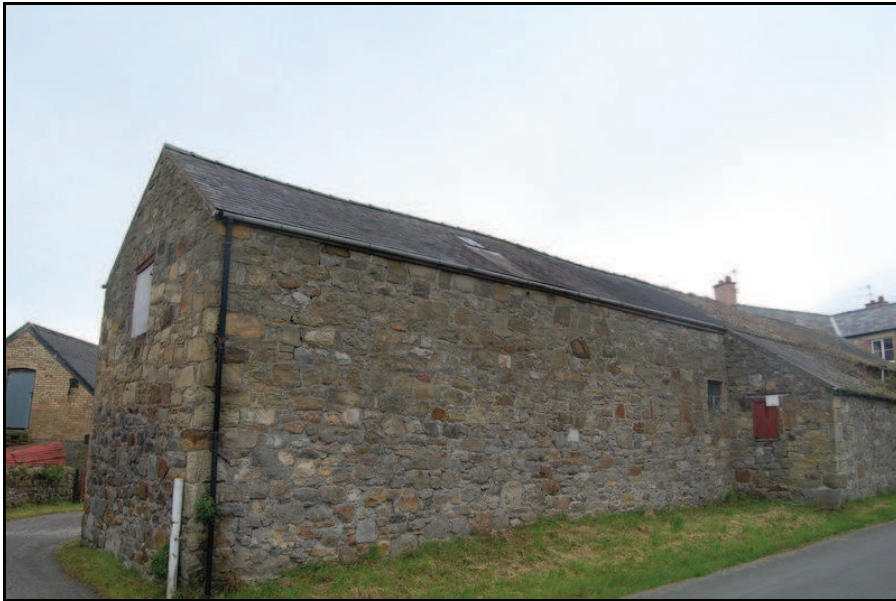
### 3. Rear elevation

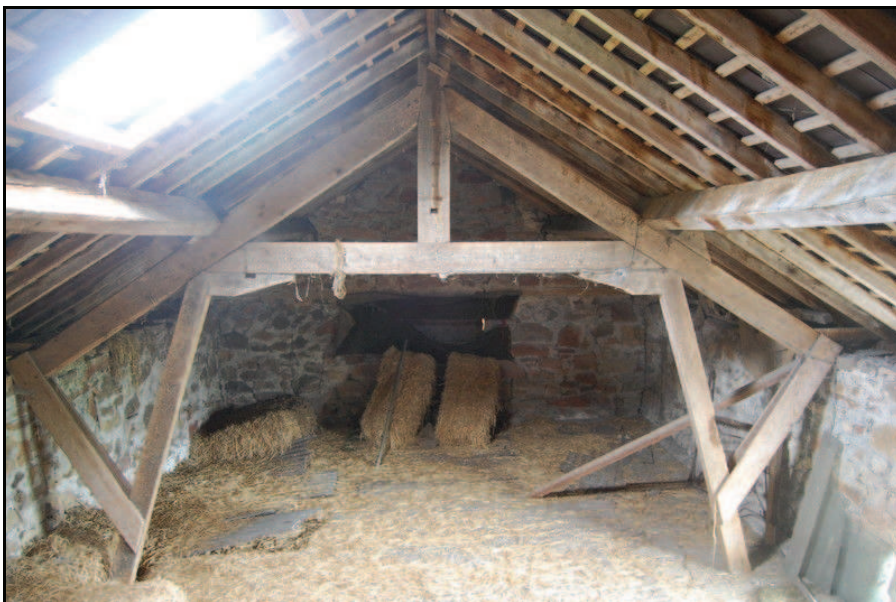
As discussed the loft area is quite light with natural illumination provided by the glass skylight panels and also from a few small gaps in the roof and the side doors/windows. There is no underfelt or roof lining so all areas can be clearly viewed from the wall plate to the ridge.

The internal roof areas and timbers are covered in cobwebs and dust suggesting little movement by roosting bats. The timbers do not generally support features suitable for bats although there are one or two crevices where joints had moved, these were inspected with an endoscope and showed no signs of use by bats.

### 4. Part of the main loft area

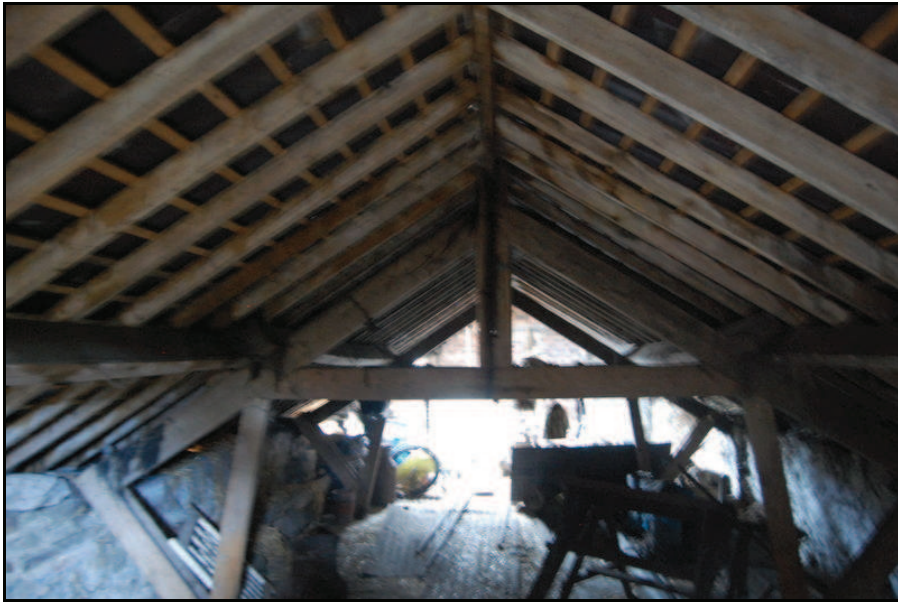
**5. Remaining loft area**

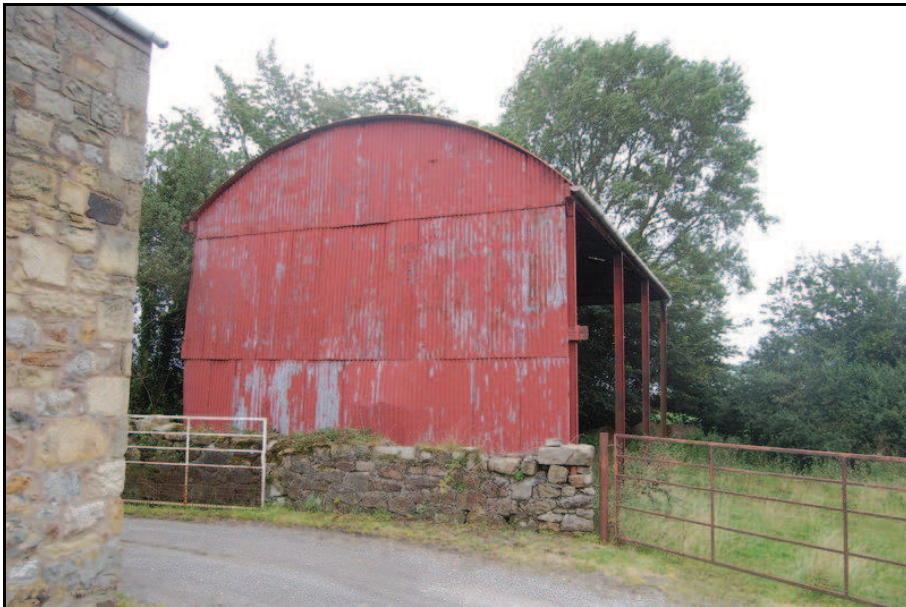
The Dutch barn is completely open and unsuitable for bats. The small block shed is also unsuitable for use by bats due to its construction, lack of suitable roosting areas and high levels of light.

**6. Dutch barn to be removed**

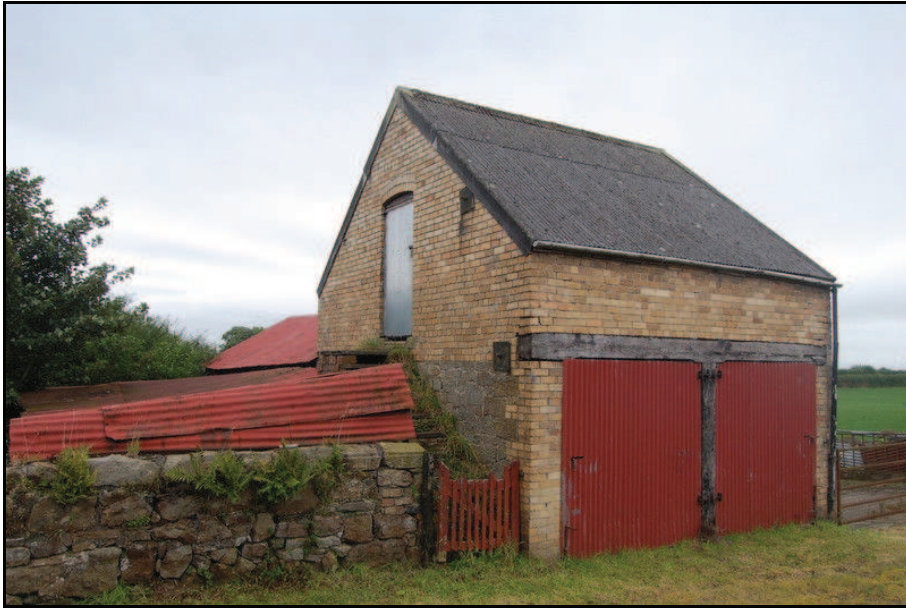
The tin lean-to attached to the shippon (out of the application area) is almost completely collapsed and unsuitable for bats.

- 7. Shippon to be retained but the metal lean-to will be removed. The shippon itself is outside the application area**

**A suitable scheme for the swallows will need to be agreed before any works commence. One suggestion would be to create suitable access into the shippon which appears to be suitable.**

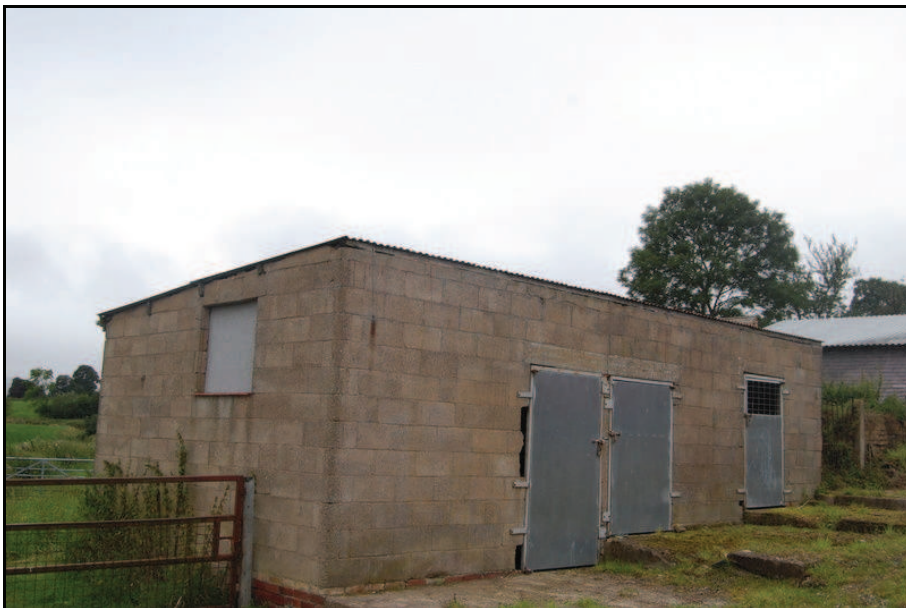
**There is minor evidence of nesting birds within the lower areas of the main barn including a number of swallow nests. The block shed to be demolished has free access through the gaps by the front doors and could be used by nesting birds including swallow.**

- 8. Block shed to be removed – note bird access through the gaps at the side of the door**

**Care should be taken if undertaking any works during the bird nesting season to avoid any disturbance. If a nest was found (or in the course of being made) then all work should cease until the young have fledged. Particular care should be taken with swallows because they will often be present until well into September.**
