**Bat & Bird Survey Report**

**Plas Power Barns, Coedpoeth**

**Ref: 1130**

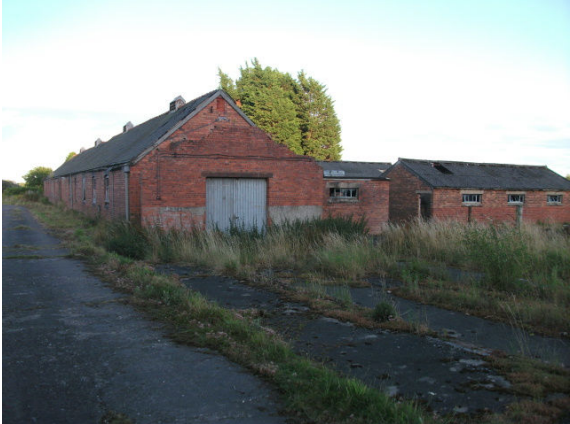
| <p><b>Photograph 1 – Barn 1</b></p> | |

Barn 1 is a large brick barn in a poor state of repair. Potential roosting sites for bats exist in the form of gaps beneath roof and ridge tiles, gaps in roof timbers and gaps and crevices in the brickwork of the walls of the barn. Potential access points for bats are available into the interior of the barn through broken windows, open doors and holes in the roof of the building. The building has timber fascias and there is potential for bats to roost behind the fascias boards. Overall the barn was assessed as having moderate to high potential as a roosting site for bats.

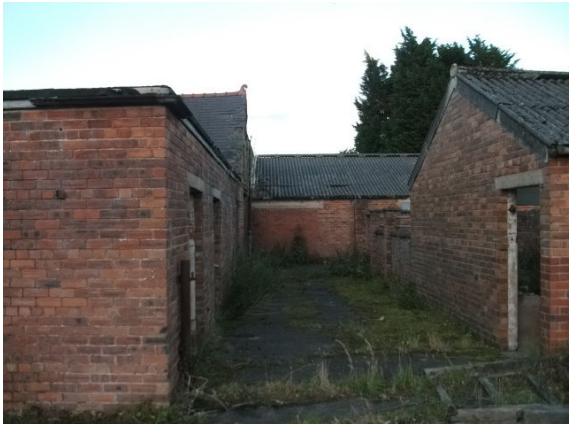
| <p><b>Photograph 3 – Single-storey sections to south of barn 1</b></p> | |

- 3.1 Plas Power Farm is located on the southern side of Ruthin Road between Wrexham and Coedpoeth.
- 3.2 The site comprises a disused farm with a range of traditional brick and stone barn buildings. The barns have not been used for some time and are in a generally poor state of repair. The site layout is shown on drawing D/JWE/1130/002 (Appendix 1).
- 3.3 Barn 1 is a large single-storey brick cattle shed located to the south of the site. The northern part of the building has a slate roof and is open to the roof on the interior (see photographs 1 and 2, Appendix 2). A number of single-storey brick extensions with a combination of pitched corrugated sheet and flat roofs are located on the southern side of the building (see photographs 3 and 4, Appendix 2).

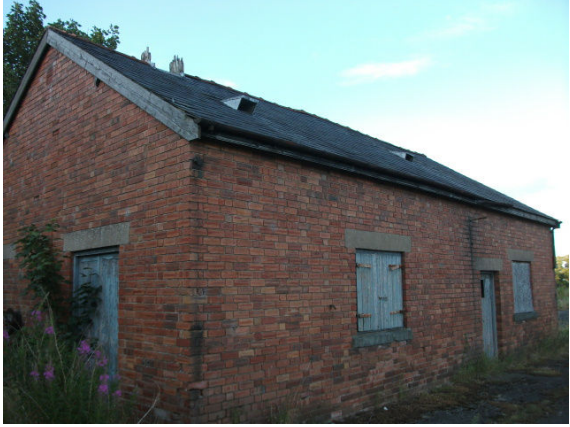
| <p><b>Photograph 5 – Barn 2</b></p> | |

Barn 2 is a single-storey barn with a combination of stone and brick walls (see photograph 5, Appendix 2). The building has a pitched slate roof and is open to the roof on the interior (see photograph 6, Appendix 2). The interior of the roof is torched.

Barn 2 is a single-storey brick and stone barn with a pitched slate roof. The building is in a generally good state of repair but has a number of unblocked door and window openings. Potential access for bats exists in the form of gaps beneath some of the roof tiles, gaps along the eaves and gaps behind the timber fascias at the gables of the building. Overall the building was assessed as having moderate to high potential as a roosting site for bats.

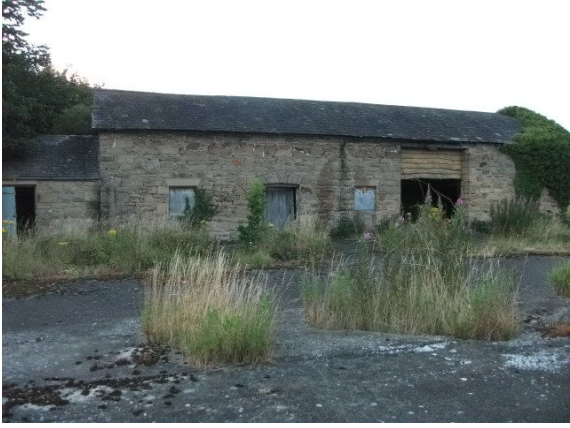
| <p><b>Photograph 7 – Barn 3</b></p> | |

Barn 3 is a two-storey stone barn with a pitched slate roof (see photograph 7, Appendix 2). The roof of the barn is in a poor state of repair making the first floor of the barn unsafe for access (see photograph 8, Appendix 2). At the western end of this barn is a single-storey brick extension with a slate roof. The roof over this part of the barn has largely collapsed.

Barn 3 is a two-storey stone barn with a pitched slate roof. Numerous potential roosting sites for bats exist in the barn in the form of gaps beneath roof and ridge tiles, gaps and crevices in roof timbers and numerous gaps in the interior and exterior stonework of the walls of the building. Access for bats into the interior of the barn is freely available through unblocked door and window openings, holes in the roof of the building and a large timber dormer on the northern side of the roof. The second floor of the eastern side of the barn also forms an enclosed dark area with suitability as a roosting site for species such as brown long-eared bats. Overall the barn was assessed as having high potential as a roosting site for bats.

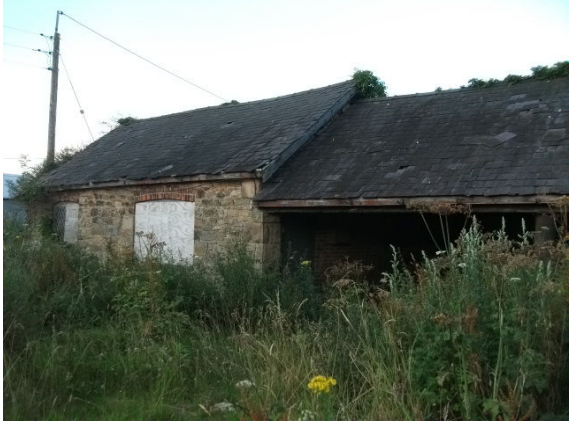
| <p><b>Photograph 9 – Barn 4</b></p> | |

Barn 4 is a single-storey stone cart shed with a slate roof located to the north-east of the site (see photograph 9, Appendix 2).

Barn 4 is an open-sided cart shed. Access for bats into this barn is freely available through holes in the roof and the cart openings on the western side of the building. Numerous potential roosting sites for bats exist in the form of gaps beneath roof and ridge tiles and gaps and crevices in the stone walls of the barns. Overall the barn was assessed as having high potential as a roosting site for bats.

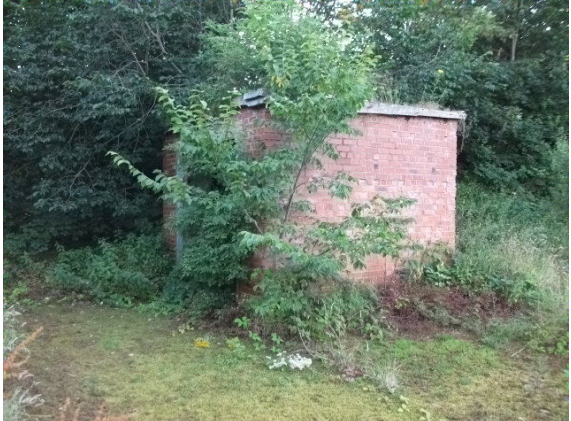
| <p><b>Photograph 10 – Building 7</b></p> | |

Building 7 is a flat-roofed brick sub-station building (see photograph 10, Appendix 2)

Building 7 is a flat-roofed brick sub-station building. The roof of the building has largely collapsed. This building offers limited roosting opportunities for bats and was assessed as having low potential as a roosting site.

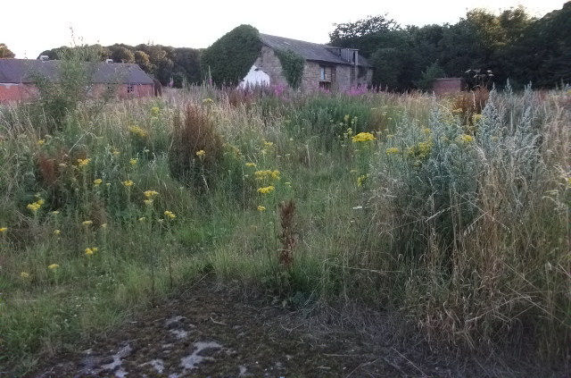
| <p><b>Photograph 11 – Yard areas</b></p> | |

- 3.4 The buildings are bordered by disused yard areas comprising areas of concrete hard-standing, rough grass, tall herbs and scrub (see photograph 11, Appendix 2).
