**Kronospan, Chirk**

**Building Demolition Preliminary Bat Survey**

**28:11:2012**

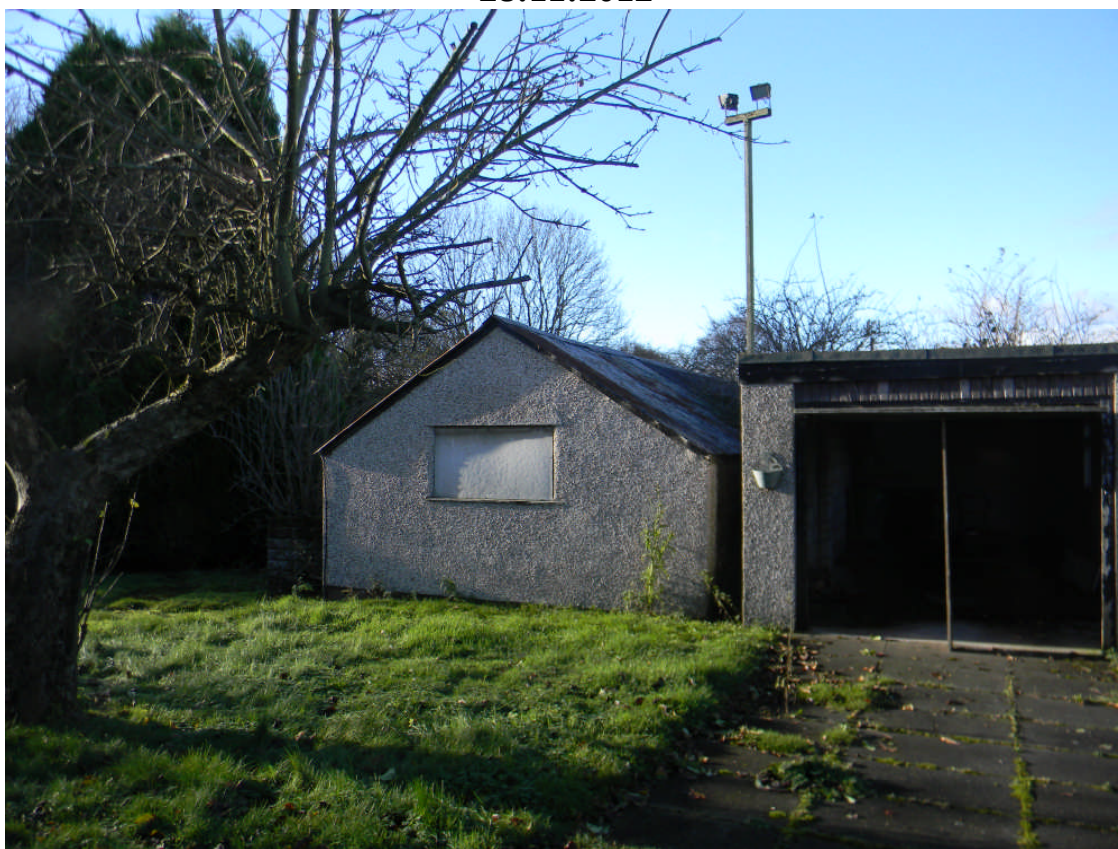
Above: The two garages proposed for demolition

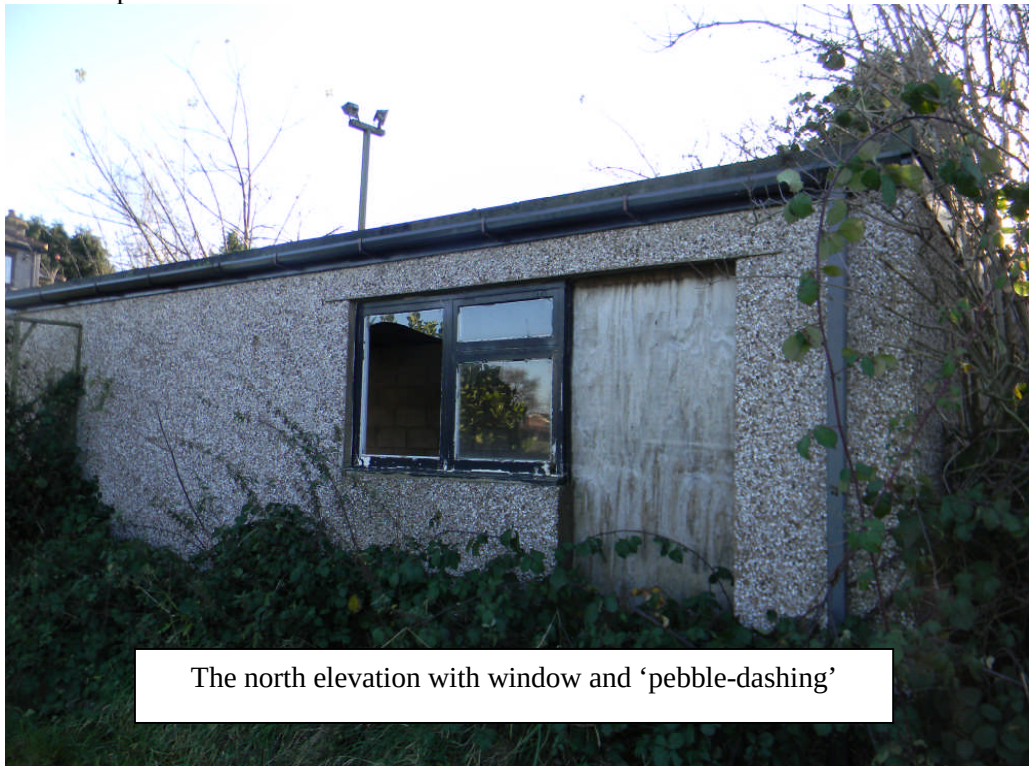
The northern-most building is a single garage constructed of concrete blocks with a flat, felted roof. The exterior is 'pebble-dashed' leaving no crevices in the masonry and

is sealed at the eaves leaving no potential bat access points under the roof covering. On the interior, light levels are very high due to the permanently propped open door and a large window in the north elevation. There are no potential internal roosting crevices and no separate roof void.

The north elevation with window and 'pebble-dashing'

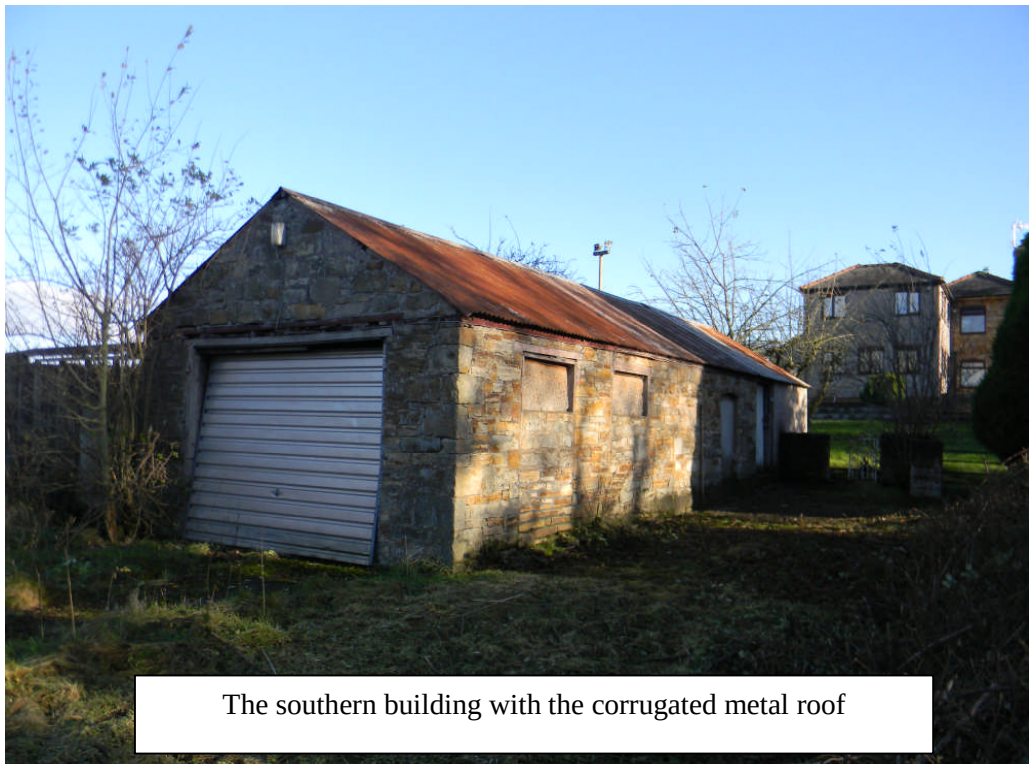
The southern-most building is divided internally into two sections. The western section is a stone structure on which the exterior pointing is in good condition leaving no potential roosting crevices and the eastern section has a 'pebble-dashed' exterior, again leaving no crevices. The roof is clad with corrugated metal sheeting. There is no apparent bat access to the interior of the building in which there are also no potential roosting crevices

The southern building with the corrugated metal roof

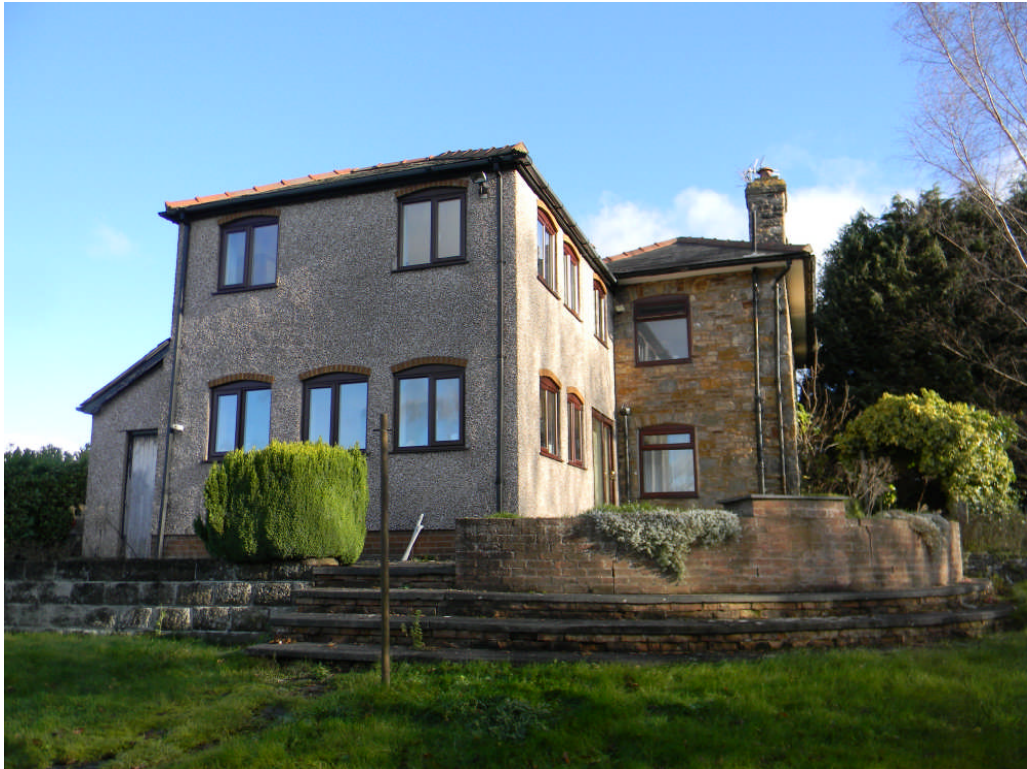
The residential property which will be unaffected by the proposals is a two-storey structure with a slate roof. The roof is in very good condition with no potential access gaps under the slates. The exterior of the building is a combination of effectively pointed stone and pebble-dashing leaving no crevices in the masonry. There are some minor gaps behind the soffits on the northern and eastern elevations.

Above: The residential property.

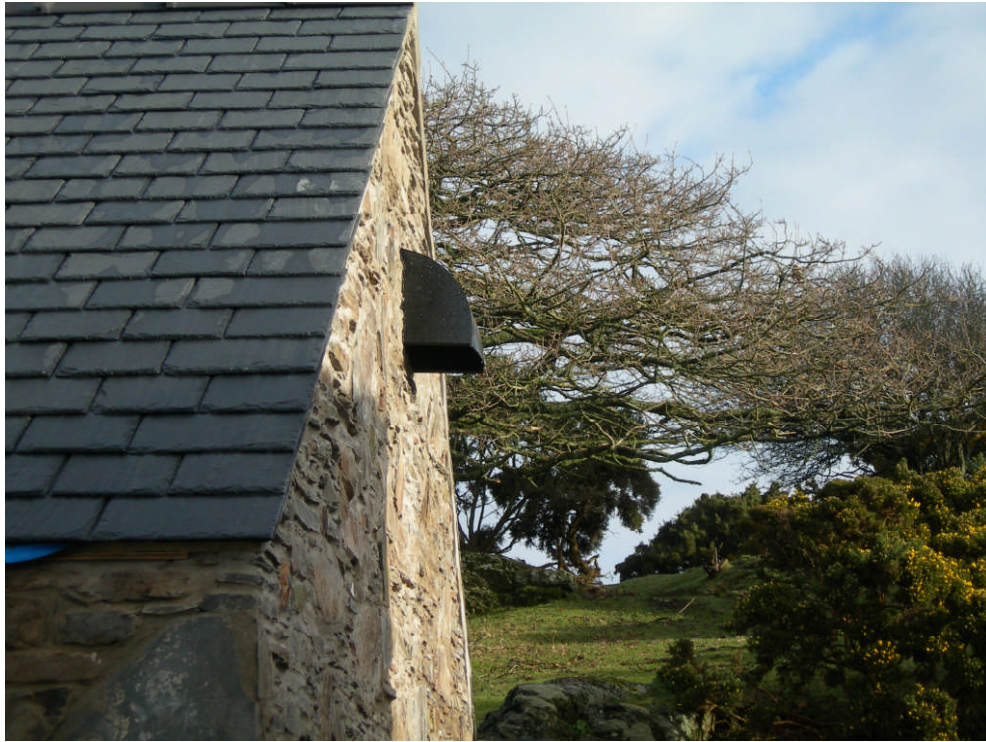
Above: Lesser horseshoe bat access cowling

- As lesser horseshoe bats need to be able to fly through the entrance this will be 300mm in width and 200mm in depth.
- A cowl should be fitted to the bat access to both reduce light levels and discourage access by owls. (See Figure 3 for cowl design).
