## **PROTECTED SPECIES SURVEY**

### **LONG VIEW**

### **BRYN ROAD, MOSS**

### **WREXHAM, NORTH WALES**

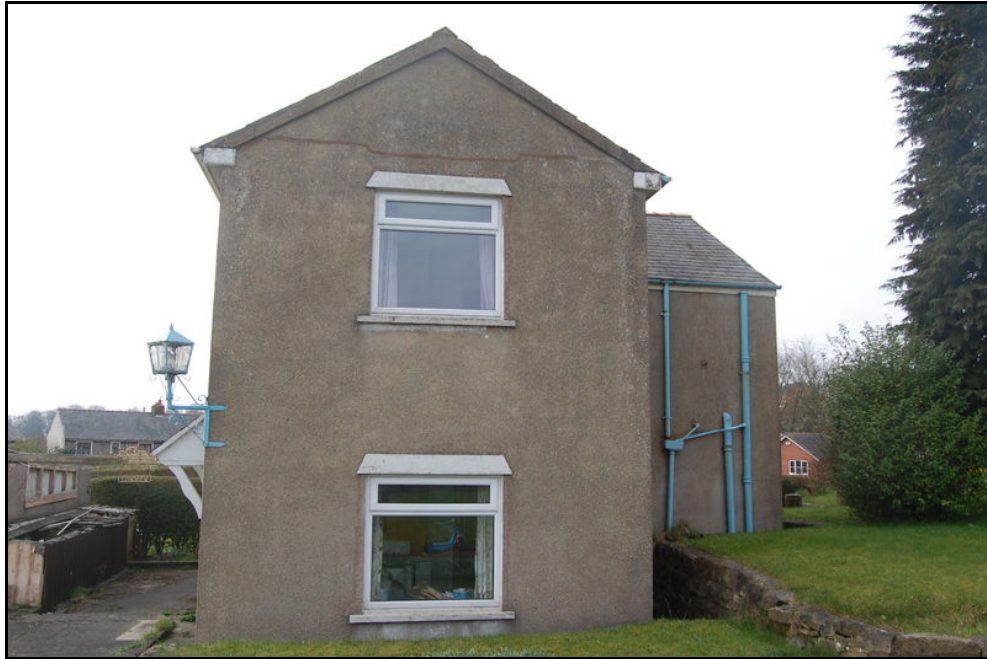
### 1. East elevation

Externally the house is very well sealed around the roof area. The gable ends do not support weather boards and are completely sealed with mortar. The small section of boxed soffit shown in the photo is well sealed to the wall with no gaps. The timber boarding supporting the gutters is very tight to the wall with insufficient gaps which bats could use. The flashing on the chimney is very tight to the brickwork with no obvious gaps. The potential for this building to support bats is low.

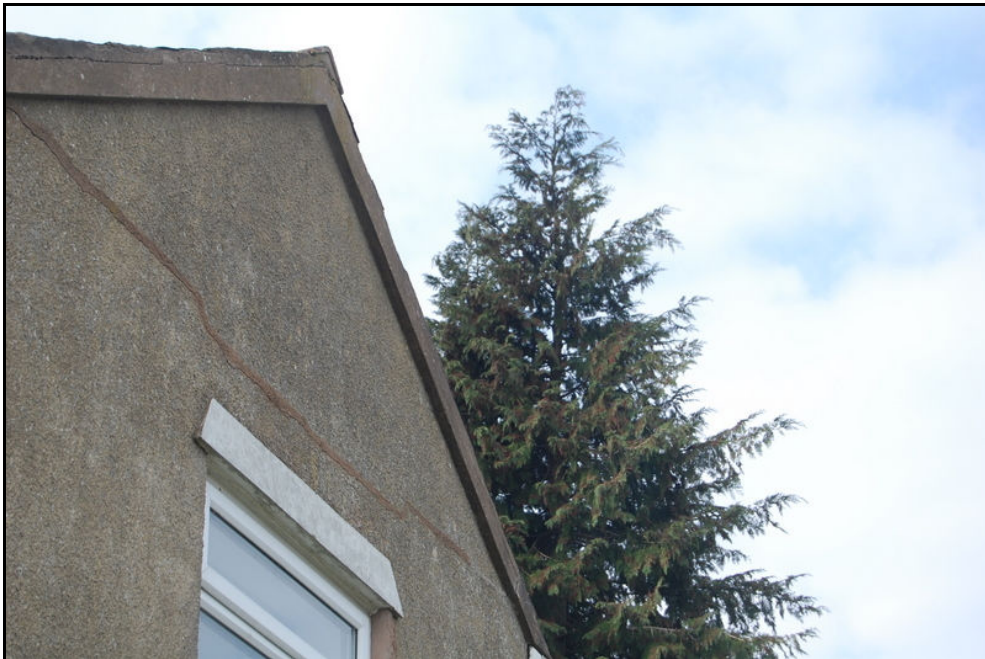
### 4. Completely sealed at gable ends

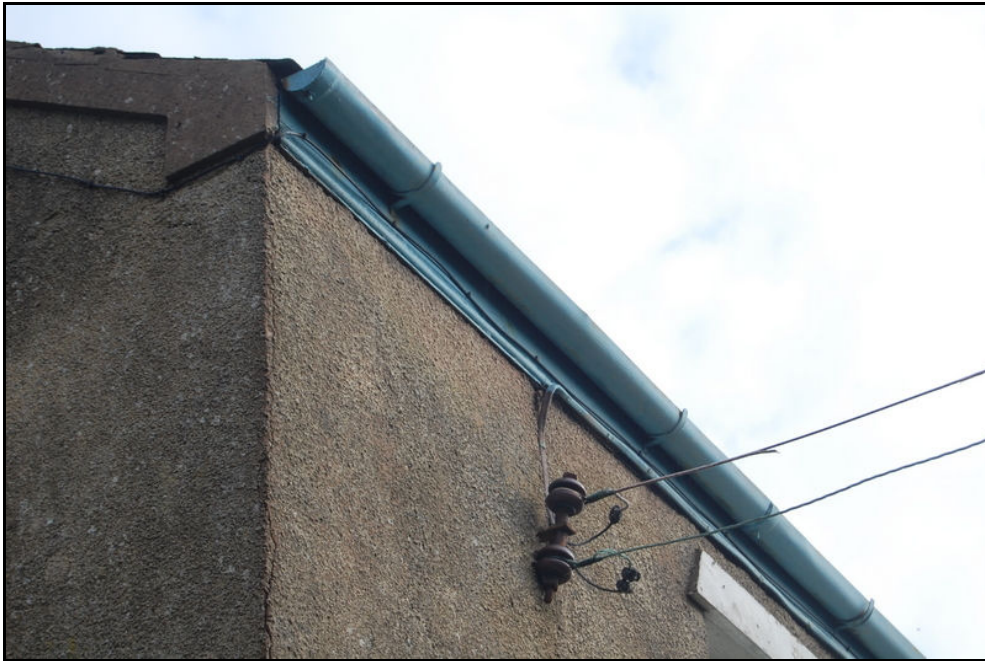
**5. Timber boarding supporting gutters has no gaps large enough for bats or birds**

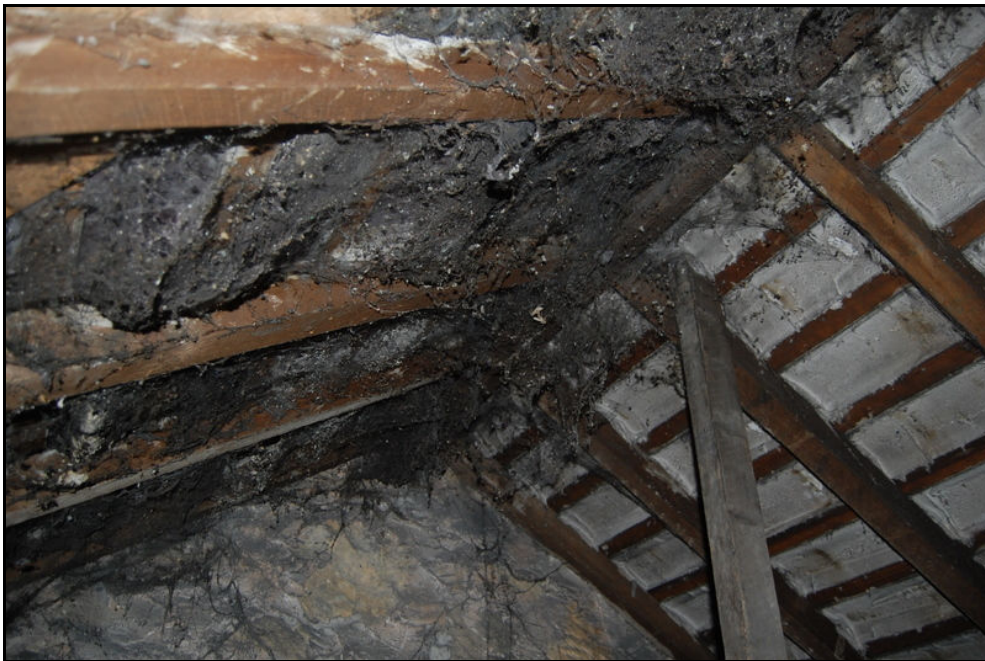
No evidence of bats was found anywhere inside or outside of the building. No droppings were apparent on the floor, roof and wall areas and there were no signs of feeding perches. The internal roof timbers are not very large and do not support any features suitable for roosting bats. The loft space is quite small and is covered in an extremely dense layer of dust and hanging cobwebs. The presence of these cobwebs would be detrimental to roosting bats and in this situation they would also have the advantage of catching any droppings from past roosting bats.

**6. Interior of the loft has dense cobwebs and dust throughout**

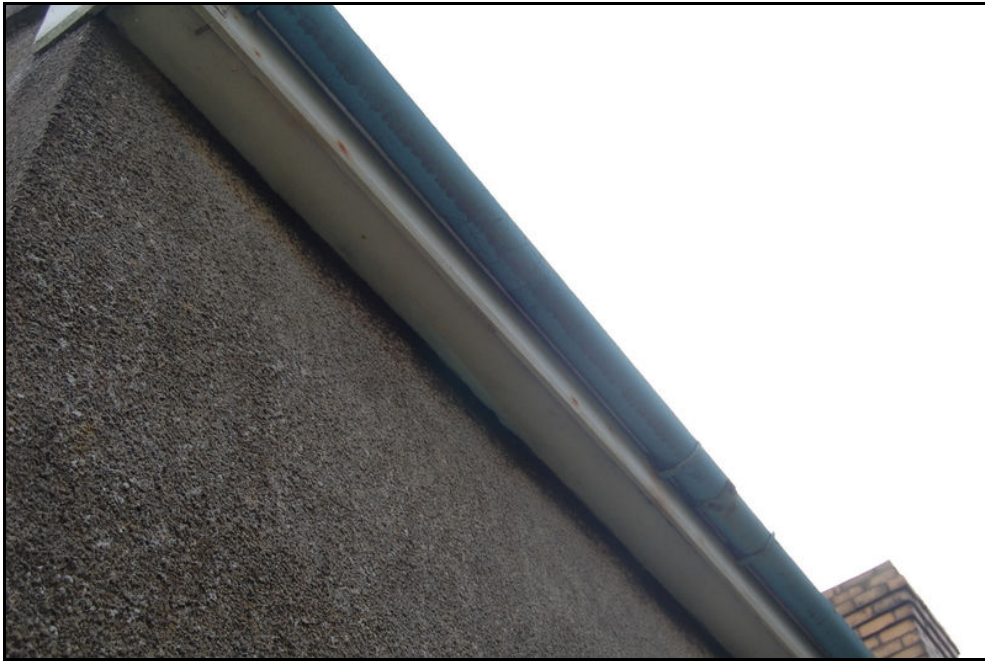
**7. Small boxed section is completely sealed with no gaps**

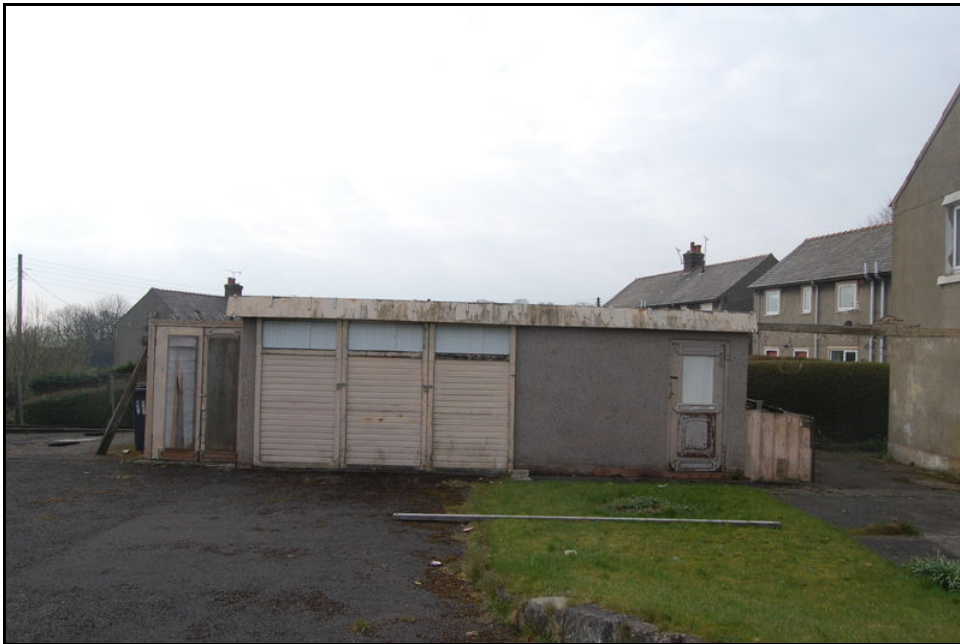
**8. Garage**

The garage building is unsuitable for use by bats. The timber sheds are in a very poor condition and are unsuitable for bats.

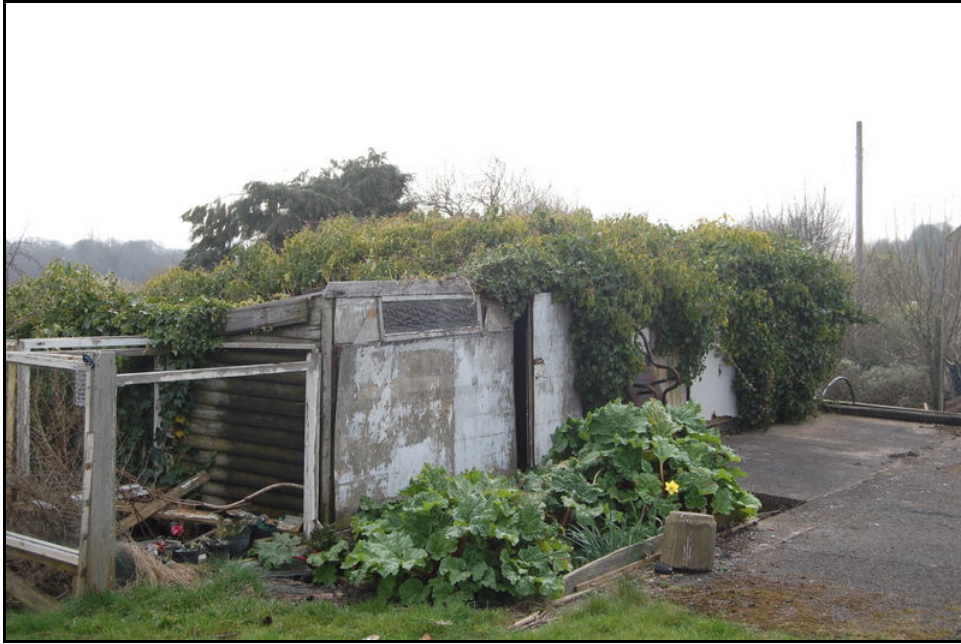
## 9. Timber sheds

No evidence could be seen in respect of nesting birds. The timber sheds (which are partially collapsed) are covered in very dense ivy. It is very likely that this will support species of nesting bird. Therefore it is recommended that the sheds should only be demolished between October and February inclusive.
