Re: Tree Root Report for Trenching Investigation\_r1

**Site Address:** Alyndene, Chester Road, Rossett.

**Drawing ref no:** DW/CR/R/TS/A\_r5 [BS: 5837 Tree Survey dated: 14. 05. 11]

**Location of the tree/s:** One Yew tree **T-09** situated in the adjacent Church Yard and including various cut tree stumps within the site and on the west stone wall boundary.

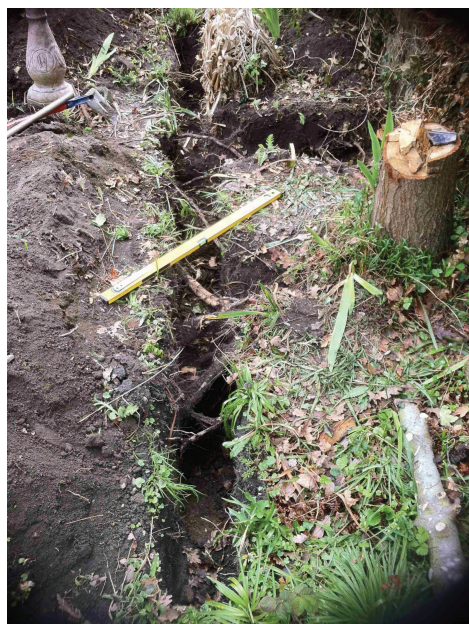
### Image 1 – Overview of the trench looking south east

**4.1** The collection of data was undertaken by assessing the position of the tree roots within the trench in relation to the four cut tree stumps along the length of the cut trench, which provides adequate space to establish any presence of Yew tree roots.

**4.2** Tree and shrub roots were seen at various levels within the trench, with fine feeder roots 2mm diameter occupying the upper 100mm.

**4.3** Roots 25mm in diameter were seen at approximately 200mm in depth. Below this were more substantial roots of 40mm in diameter.

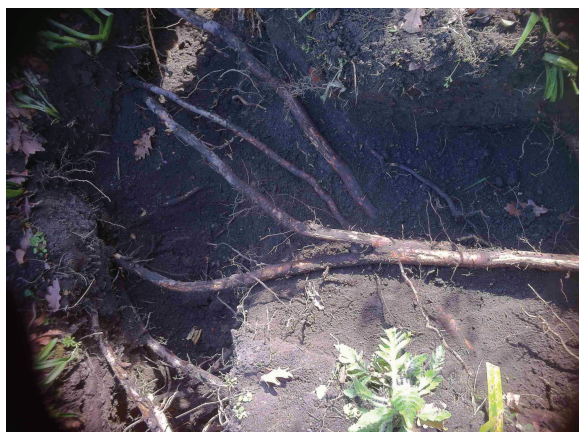
**Image 2 – View of the roots traced back to the cut stump of T-10 at the boundary wall**

**4.4** After brushing off the surface soil, the texture of 25mm & 40mm diameter roots within the trench were seen to display the same texture pattern. To establish these roots came from the adjacent tree stump, the soil was dug out to follow the tree roots. This established that these tree roots with this texture pattern came from the Oak tree Stump **T-10**.

**4.4** To confirm the roots as seen in Image 2 belong to **T-10** a small section of bark / stem tissue was removed to display the pink colour that is associated with Oak tannins for dye.

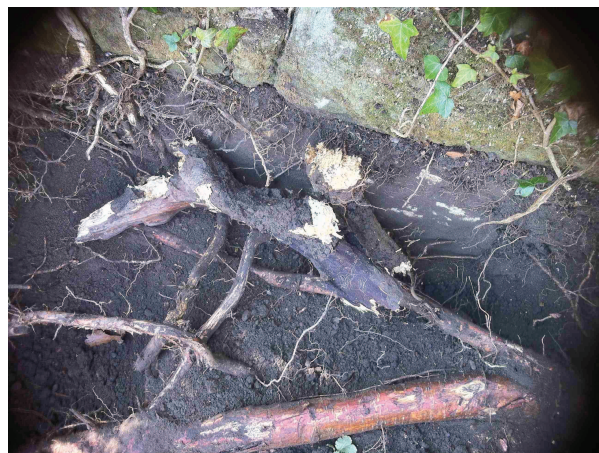
**Image 3 – Dead tree roots considered to belong to T-08.**

**4.5** Underneath the 40mm diameter Oak tree roots within the trench were several similar size roots that displayed a different texture pattern.

**4.6** As the ground was being dug to trace these roots with a different texture pattern back to their trunk they broke apart and were all found to be dead tree roots.

**4.7** It is considered that these dead tree roots came from T-08 an Oak tree that has been felled and reported to be in fair / poor condition with 30% dieback.

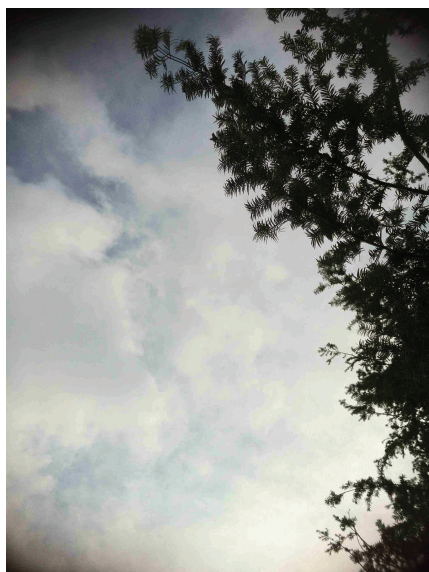
**Image 4 – Standing in the trench looking upwards.**

**5.3** Standing in the trench looking upwards as seen in Image 4 to the left illustrates the level of pruning required.

**5.6** The trench is 400mm deep. Therefore the lower 200mm is below the ground level in the churchyard. If roots from the Yew had grown into the Site, I would expect to see evidence of them within this area. As the ground in the bottom of the trench appears to be wholly undisturbed by root action, I conclude that the Yew tree's actual root area lies wholly within the Churchyard and not within the Site

**5.4** This pruning is required to facilitate the approved development and should be undertaken to maintain a minimum 1m branch clearance between building line and Yew tree branches as seen in Image 4 to the right.

**5.5** The Yew tree should be carefully cleared by the Church's grounds maintenance team of Ivy; as it is forming clumps within the canopy and will disfigure the canopy if left un-checked.
